FORT HUACHUCA, CAVALRY STABLE
(Building No. 30024)
(Building No. 86)
(Building No. 122)
(Building No. 3035)
Clarkson Road
Sierra Vista vicinity
Cochise County
Arizona

HABS
AZ-210-B

FORT HUACHUCA, CAVALRY STABLE
(FORT HUACHUCA, BUILDING 30024)
(FORT HUACHUCA, BUILDING 86)
(FORT HUACHUCA, BUILDING 122)
(FORT HUACHUCA, BUILDING 3035)

HABS NO. AZ-210-B

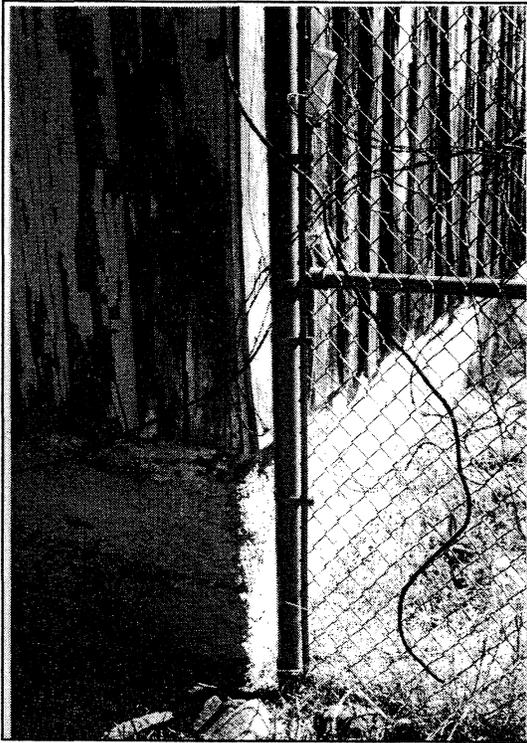
2. Foundations: Foundations are hand-poured, board-formed concrete and comprise a continuous 8-inch-thick stem wall. It is unlikely there is any steel reinforcing in this foundation. Due to the site slope, the stem wall is not visible at the east end of the building, but it is exposed along most of the south façade and the entire north and west facades. Its hand-poured quality is seen in occasional voids and seams from uneven board placement. The stem wall is painted tan to match the current color of the walls. The stem wall is currently in fair condition with some cracks, abrasion, and corner deterioration. There is no sign of major structural cracking. Where the wall has deteriorated or in voids, it can be seen that a large stone aggregate was used in the original concrete mix (Figure B.3).

FIGURE B.3. CONCRETE STEM WALL, SOUTH-WEST CORNER (PHOTOGRAPH BY JANET PARKHURST, JANUARY 2005).

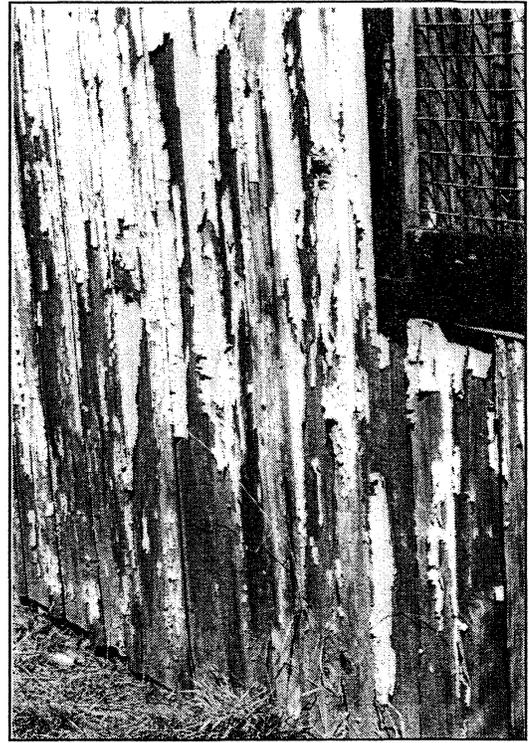
The condition of the exterior walls at this time ranges from fair to poor, with the poor condition largely on the south and west walls. There is considerable paint peeling, some broken and dislodged boards and battens, and dislodging of nails. Deterioration is especially evident on the bottom half of the south wall, where much of the original Kelly green paint layer can be seen (Figure B.4).

FIGURE B.4. BADLY WEATHERED BOARD-AND-BATTEN WALL, SOUTH FAÇADE, SHOWING PAINT PEELING (PHOTOGRAPH BY JANET PARKHURST, JANUARY 2005).

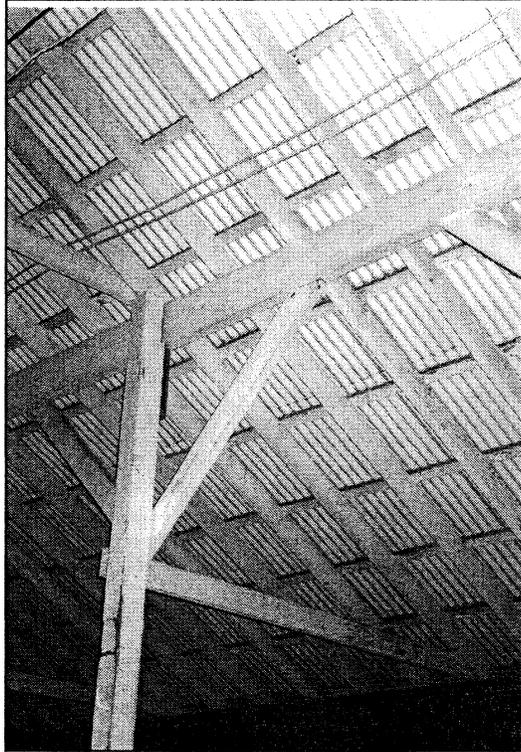
The posts are 6" x 6" redwood timbers that extend from below the floor to the bottom edge of a rafter. Except for the large 3" x 10" support header and the 3" x 6" tie beam at the top of the posts, framing members are 2" x 6"s. Although some unskilled modification has compromised the structural system in Building 30024, posts should be tied at the top and at 9 ft, 7 inches above the floor with flanking, diagonal, braces. Each post is also connected to the top of the nearest wall by a tie beam attached to a rafter and the wall plate. Such tying occurs on the east side of every sixth rafter. All longitudinal ties at the 9-ft, 7-inch level, and some cross ties are currently missing (Figure B.5).

Structural members in Building 30024 are in fair-to-poor condition due to removal without replacement of some structural members that contribute to an integrated system. The structural system should be investigated.

FIGURE B.5. DETAIL OF ROOF FRAMING, SHOWING THAT LONGITUDINAL TIE IS MISSING AT THE LEVEL OF THE LATERAL TIE BELOW THE DIAGONAL BRACES (PHOTOGRAPH BY JANET PARKHURST, JANUARY 2005).

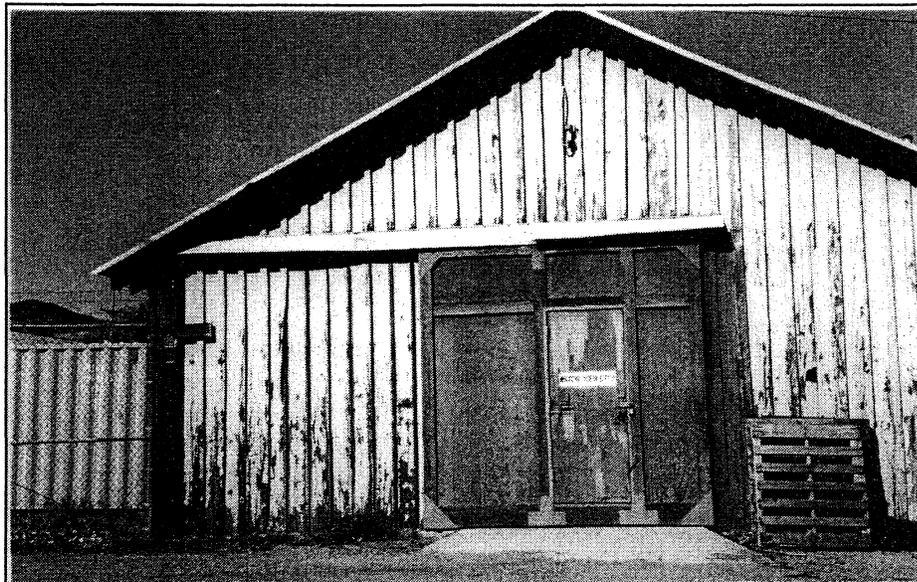
The east or principal entry has a large, single leaf sliding door containing a personnel door. It is a non-original assembly of the same vintage as the doors on most of the other stable buildings, being more recent than 1941. The sliding door is suspended on metal brackets that slide in a steel track above. The track has a red-brown painted, sheet metal cover that is dislodged and deformed in places. The door leaf is 10 ft, 0 inches wide and 10 ft, 0 ½

inches high. It is an assembly of plywood in grooved board stiles and rails. The corners are secured by diagonal sheet metal plates. The metal elements, which appear on both faces of the door, are through-bolted. The personnel door, a 2-ft, 8-inch by 6-ft, 8-inch swinging flush door, is located off-center in the sliding door (Figure B.6).

FIGURE B.6. NON-ORIGINAL EAST SLIDING DOOR WITH CENTRAL PERSONNEL DOOR. DOOR IS A PLYWOOD AND BOARD ASSEMBLY THAT MATCHES DOORS ON SEVERAL OTHER STABLE BUILDINGS (PHOTOGRAPH BY JANET PARKHURST, JANUARY 2005).

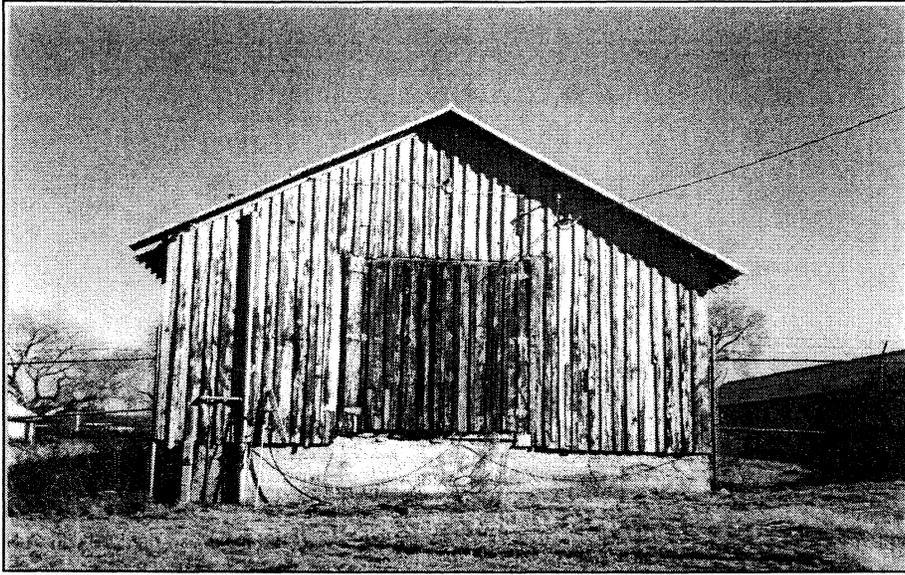
The west doorway has a pair of custom-built, swing-type doors that appear to be very early in vintage (Figure B.7). (As mentioned, no pictures of original west doors have been found.) The opening is 9 ft, 0 inches wide by 9 ft, 4 ½ inches high. The door leaves are constructed of large vertical boards with ¾-inch by 3 ¼-inch battens. The board-and-batten exterior face is attached to wide boards in a "Z" configuration on the back. Apparently, the north doorway also has a swinging board-and-batten door in its opening. It cannot be observed inside due to stored furnishings.

FIGURE B.7. WEST FAÇADE, SHOWING PAIR OF SWINGING BOARD-AND-BATTEN DOORS. DOORS ARE ORIGINAL OR EARLY REPLACEMENTS (PHOTOGRAPH BY JANET PARKHURST, JANUARY 2005).

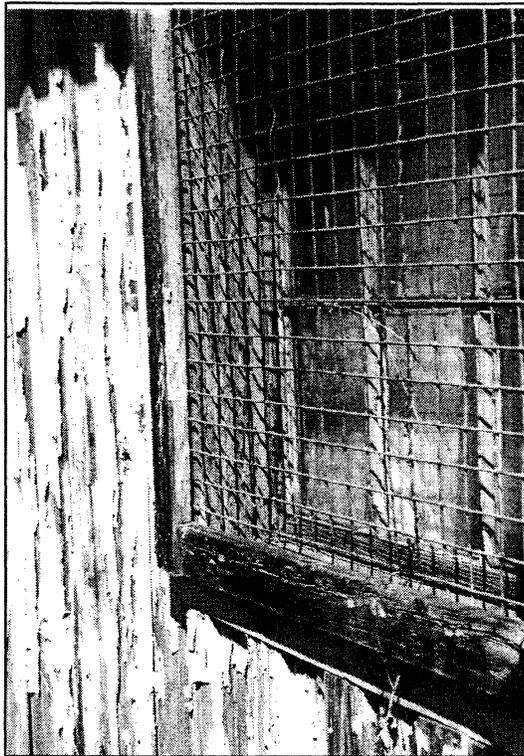
The windows, exterior casing and grill frames are very weathered but repairable (Figure B.8). There is some broken glazing and an occasional broken mullion. One hopper sash is missing on the south façade.

FIGURE B.8. PARTIAL VIEW OF DOUBLE-HUNG WINDOW, SOUTH WALL, SHOWING DETERIORATION OF GRILL AND SASH (PHOTOGRAPH BY JANET PARKHURST, JANUARY 2005).

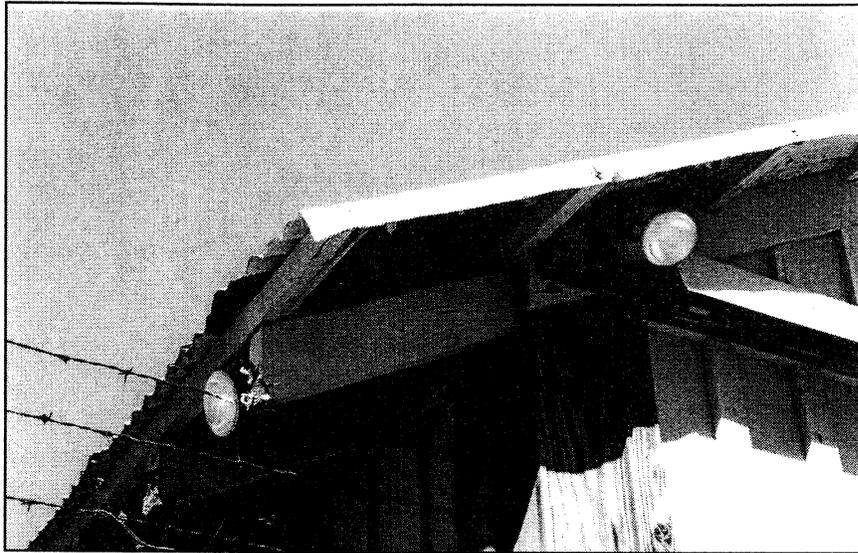
cornice board at the rakes and eaves. Eaves are generally in fair condition, because framing members have been painted. There is weathering of rafter ends and paint peeling on the underside of the roofing (Figure B.9).

FIGURE B.9. DETAIL OF EAVES, SOUTHEAST CORNER (PHOTOGRAPH BY JANET PARKHURST, JANUARY 2005).

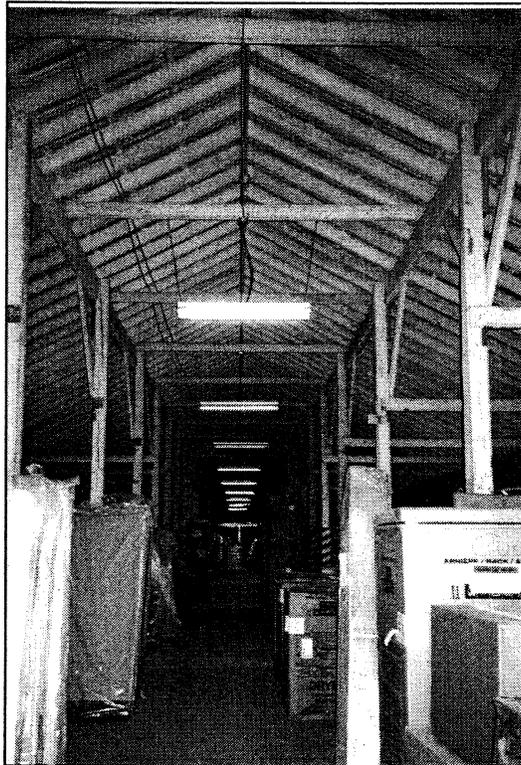
FIGURE B.10. INTERIOR VIEW TO WEST, DOWN CENTRAL CORRIDOR OF FORMER STABLE AREA (PHOTOGRAPH BY JANET PARKHURST, JANUARY 2005).

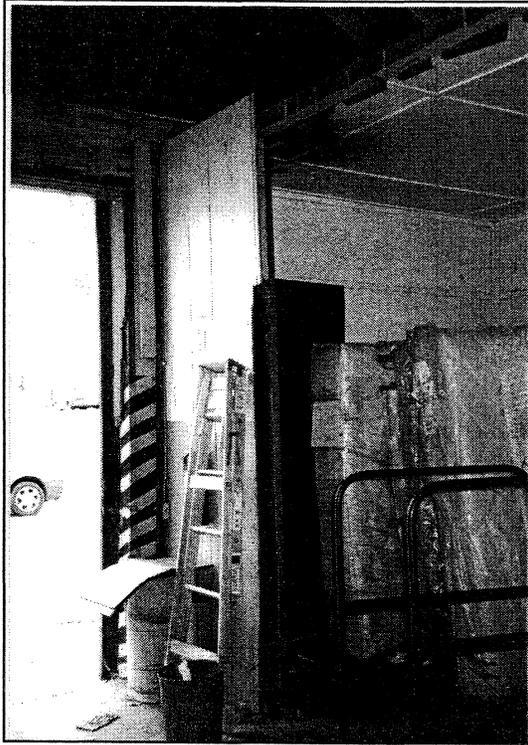
The south saddle shop zone features one remnant of the original aisle wall near the east entry door. It consists of vertical 9-inch boards, painted gray at the bottom and white at the top (Figure B.11). Installed on what remains of the interior walls of the south storage rooms are plywood sheets with small wood strips over the joints. The wainscot level is painted green with cream white above.

FIGURE B. 11. REMNANT OF ORIGINAL AISLE WALL FOR FORMER SOUTH SADDLE SHOP. NOTE VERTICAL BOARD CLADDING (PHOTOGRAPH BY JANET PARKHURST, JANUARY 2005).

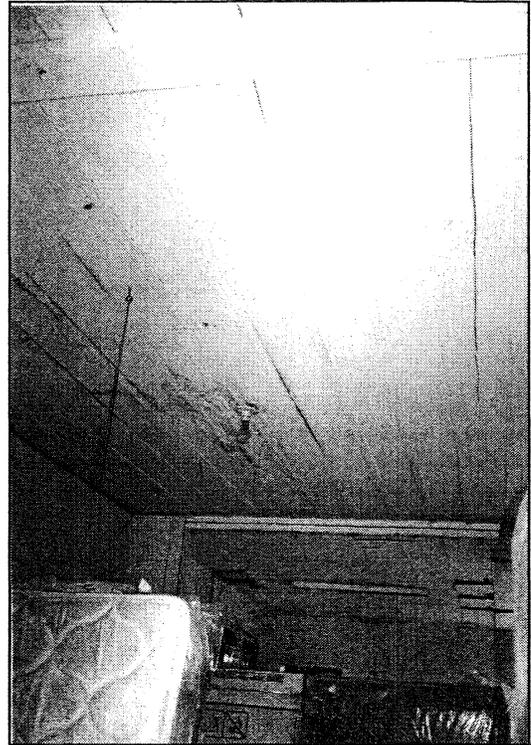
north saddle shop. It is board and batten, longitudinally installed, and consists of 1" x 9" boards with 1" x 2" battens, painted white (Figures B.12; HABS No. AZ-210-B-4). The ceiling in the south storeroom zone is an early vintage plywood with wood strips to match the walls. It is painted white.

FIGURE B.12. REMNANT OF ORIGINAL BOARD-AND-BATTEN CEILING IN FORMER NORTH FEED ROOM AND SADDLE SHOP (PHOTOGRAPH BY JANET PARKHURST, JANUARY 2005).

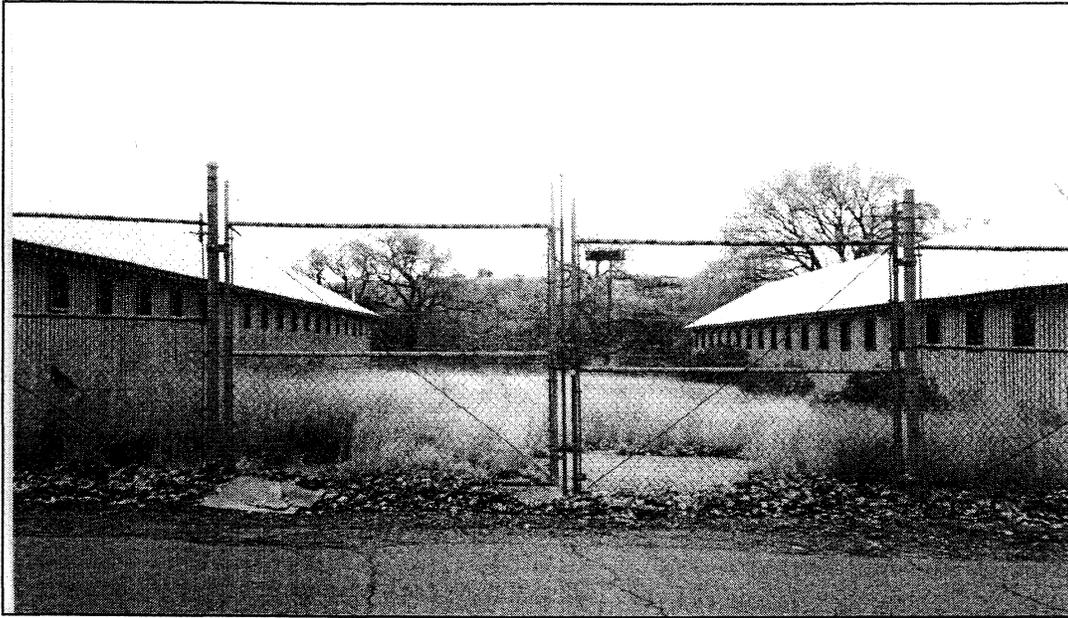
FIGURE B.13. VIEW OF FORMER NORTH PADDOCK, ENCLOSED BY CHAIN-LINK FENCE
(PHOTOGRAPH BY JANET PARKHURST, JANUARY 2005).
