Peak House
322 South Second
Manhattan
Riley County
Kansas

HABS No. KS-69

HISTORIC AMERICAN BUILDINGS SURVEY
PEAK HOUSE

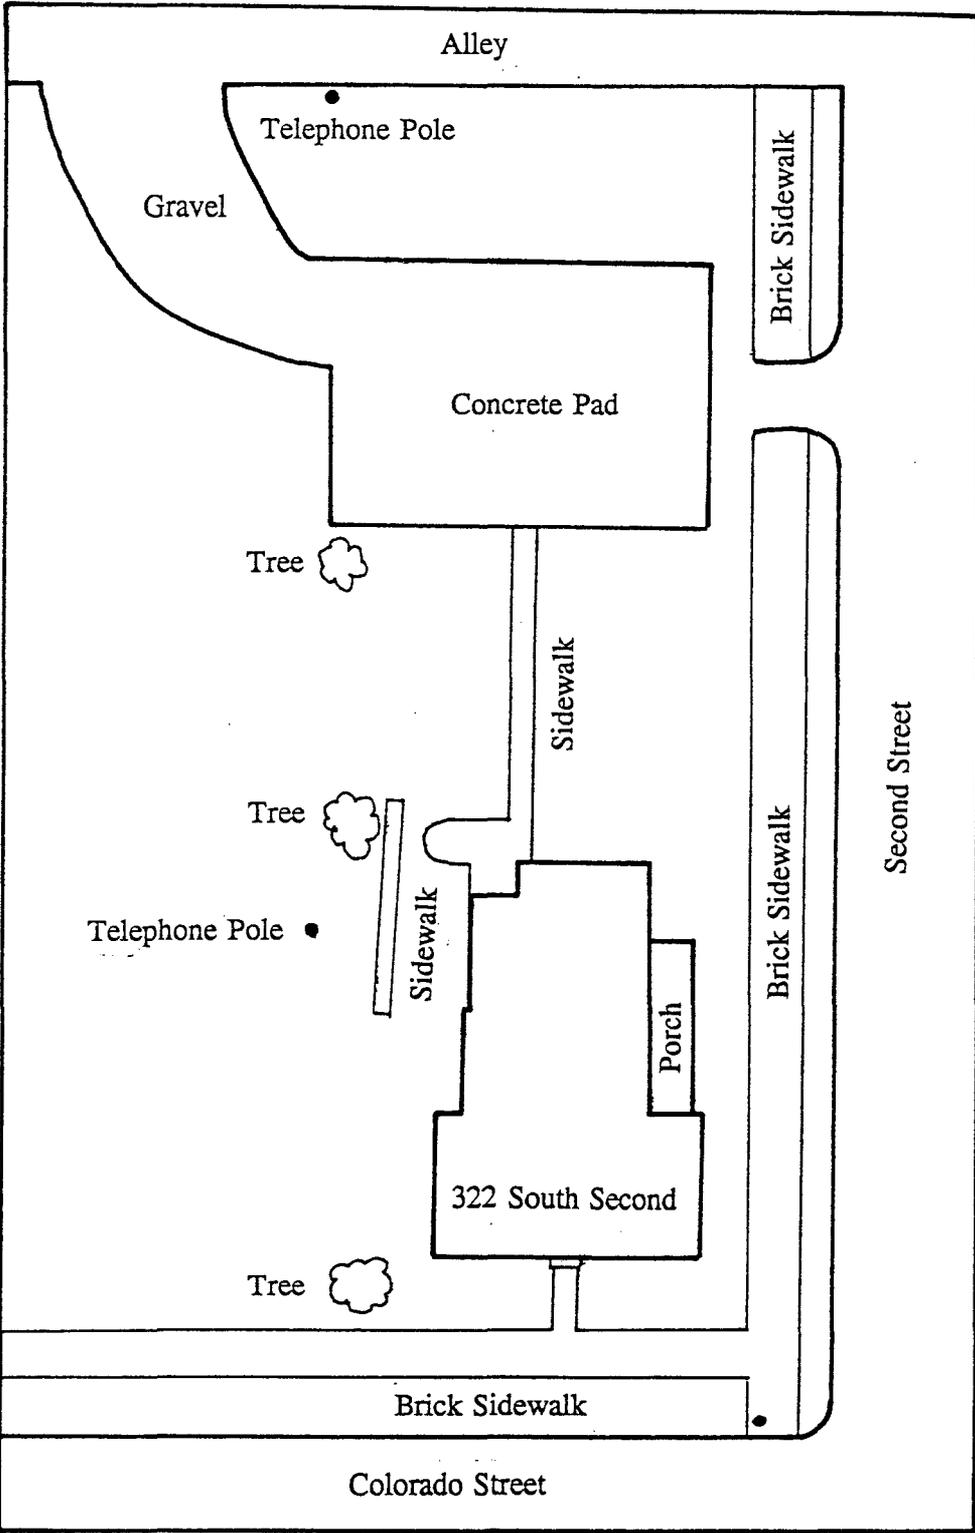
Figure 2 Site plan.

The Peak house sits 21.4 feet north of Colorado Street and 13.4 feet west of Second Street. The house is a 1½ T-plan National Folk wood frame building with side-gable roofs clad in asphalt shingles. The house has stone foundations that differ in depths. At least part of the foundation for the south section of the house rests upon a foundation from an earlier structure.² The north one-story section has a limestone foundation at least seven feet deep. The exterior walls of the house are finished with three and five inch lap board. Except for two additions on the northwest corner of the house which are clad in the three inch wood siding, the building is entirely clad in five inch lap board. The two-story main section of the house fronts Colorado Street on the south. This section is accented at the gable level with fish-scale and diamond wood shingles. A beaded cornice board separates the decorated gable from the lower level finished in lap board. The two-story section has a symmetrical front with a centered single entry door flanked by two single double-hung windows with single upper and lower glass panes on the first story and two single glass hopper windows on the upper story. The wood entry door has two panels separated by a single rectangular glass window. The one-story asymmetrically arranged rear section of the house fronts Second Street. The one-story part has a porch added on the east and two additions on the west. The two-story front section of the house has triangular shaped lintels with beaded molding while the one-story part has plain rectangular framing for windows and doors.

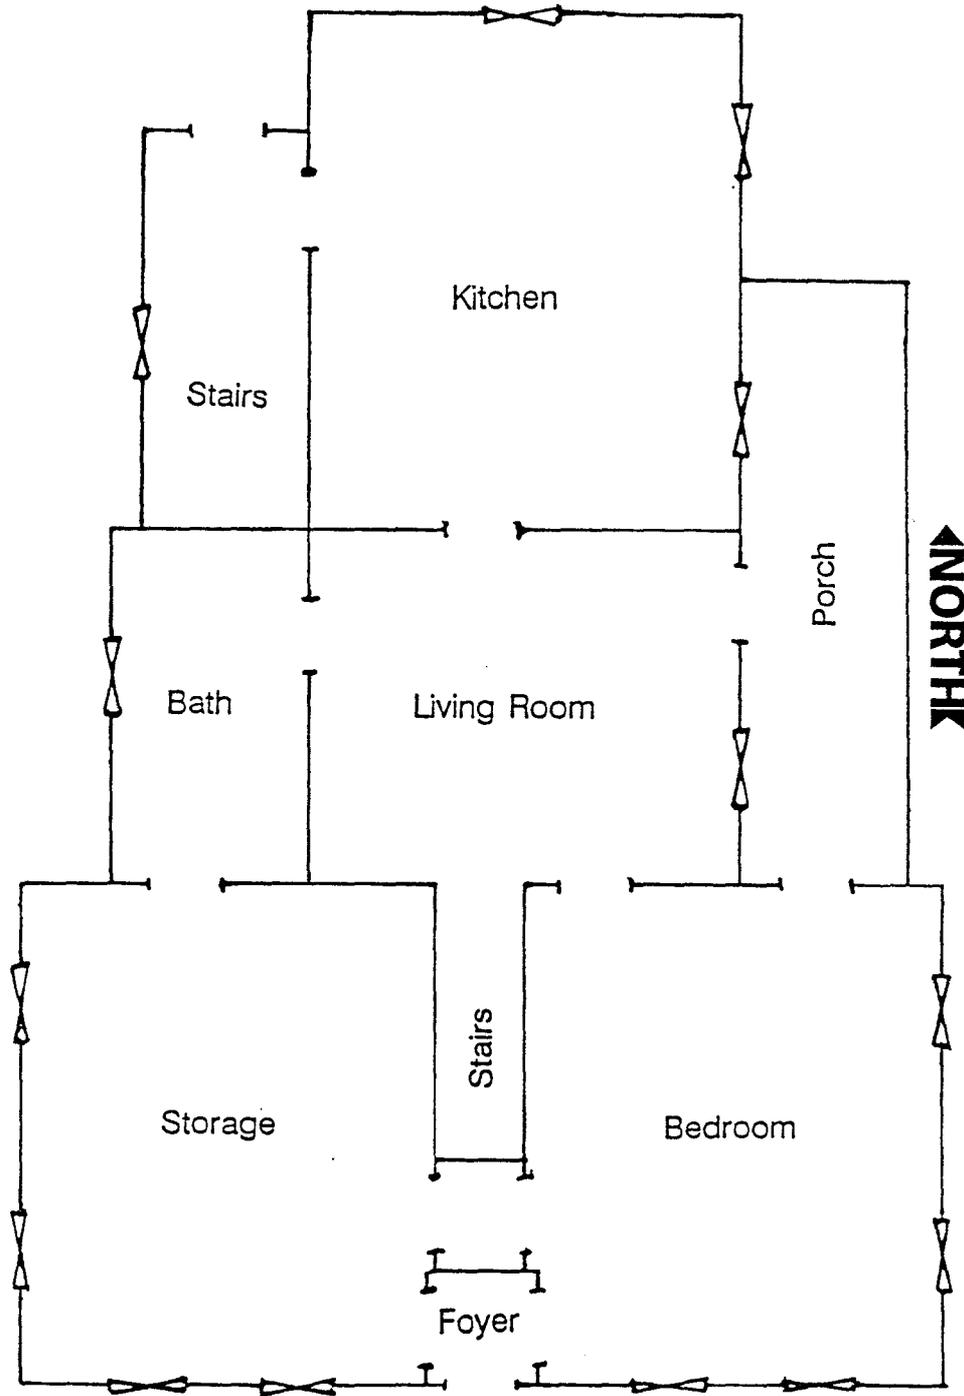
Figure 3 Interior sketch 1st floor.

The interior of the house exhibits several distinctive features. The wall joining the front and rear sections of the house is 8.75 inches thick. The floor plan of the front (or south) section of the house is a symmetrical room arrangement of two up and two down. The first floor rooms are separated by a center foyer while those on the second floor are divided by a stairwell (See Figures 3 and 4). The rear section of the house has two original rooms arranged on a north-south axis. Additions on the rear section include a bathroom and a rear porch entry that provides basement access. The floor of the basement is dirt; the walls are stone. The basement cement steps are three feet wide. The rise varies from seven to 7.5 inches and the run from 8.5 to nine inches.

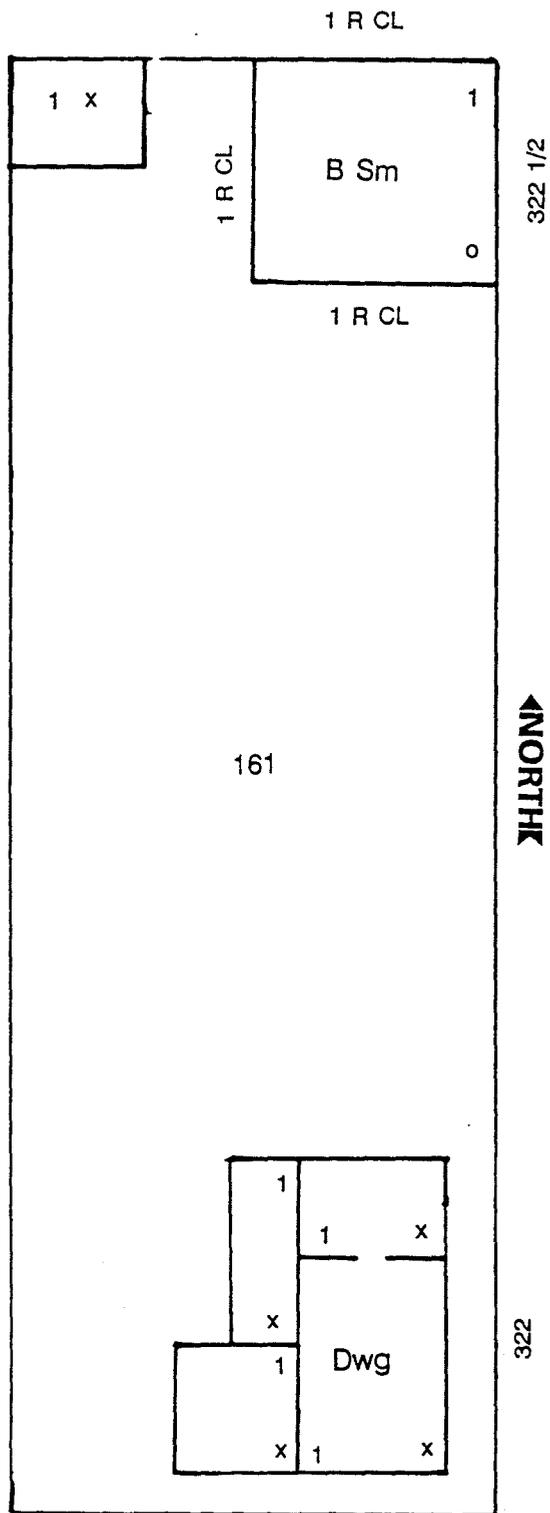
Figure 5 1890 Sanborn Insurance map, Lot 161

It is possible the one-story section of the house may predate the two-story section, possibly by as many as thirty-seven years. Riley County tax records indicate improvements were first made on the city lot in 1868.⁵ Sanborn Fire Insurance Maps of the city of Manhattan, Kansas, for the period from 1890 to 1930, show the evolution of the property (See Figures 5 through 10). By 1890, two additions were attached to the one-story dwelling. Within the next seven years, at least one of these had been removed (See Figures 5 and 6). By 1905 the two-story section of the house had been either built or relocated to the property. If the one-story section at the rear of the house is the section that existed from 1868 through 1897, it was moved further north on the property at the time the two-story section came into existence. By 1923 the bathroom had been added. Within the next seven years, both porches were in place on the one-story section.

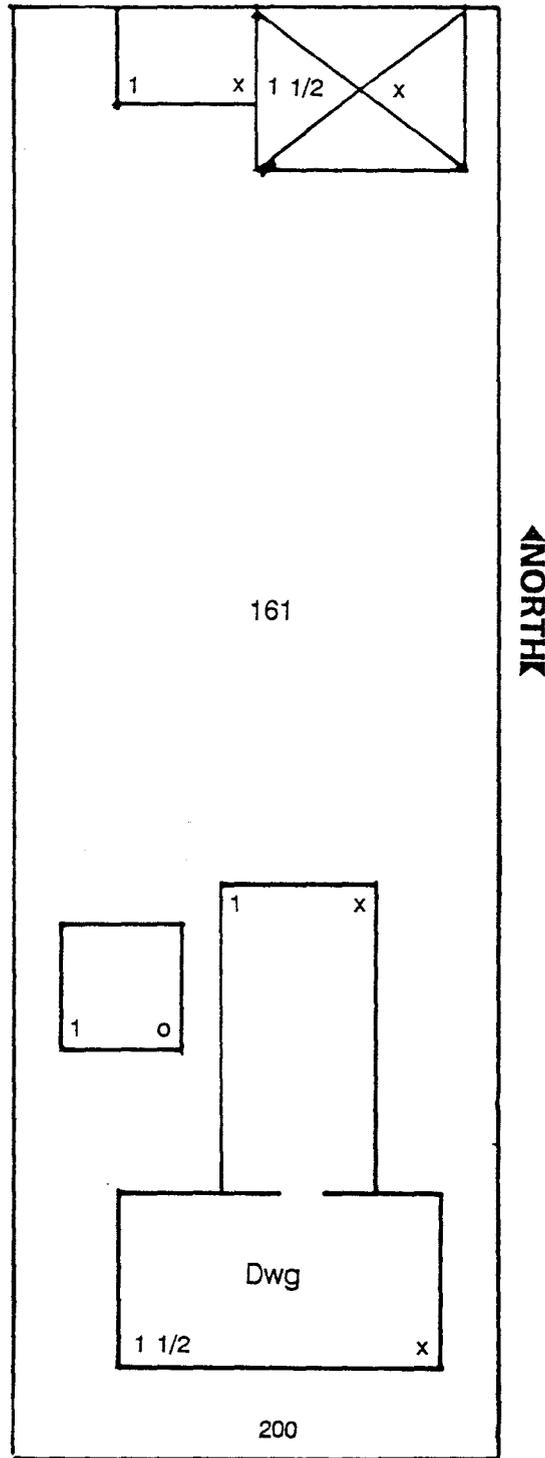
Figure 7 1905 Sanborn Insurance map, Lot 161

The house has been named after Frank Peak, owner and resident of the property beginning in 1897. He was the individual selected for this distinction because the house became T-shaped between 1897 and 1905, while Peak owned and resided at the location. Peak was a farmer whose father owned and operated a blacksmith shop and saloon. The house at 322 North Second had a blacksmith shop at the rear of the property in 1890 (See Figure 4). The property remained in the Peak family until at least the 1920s.⁶ During the prohibition period of the 1920s, the Peak family operated a bootleg enterprise from the rear of the property.⁷
