GILPIN'S FALLS COVERED BRIDGE
Spanning North East Creek at Former (Bypassed) Section of North
East Road (SR 272)
North East
Cecil County
Maryland

HAER MD-174
HAER MD-174

WRITTEN HISTORICAL AND DESCRIPTIVE DATA

Structural Type: Burr truss

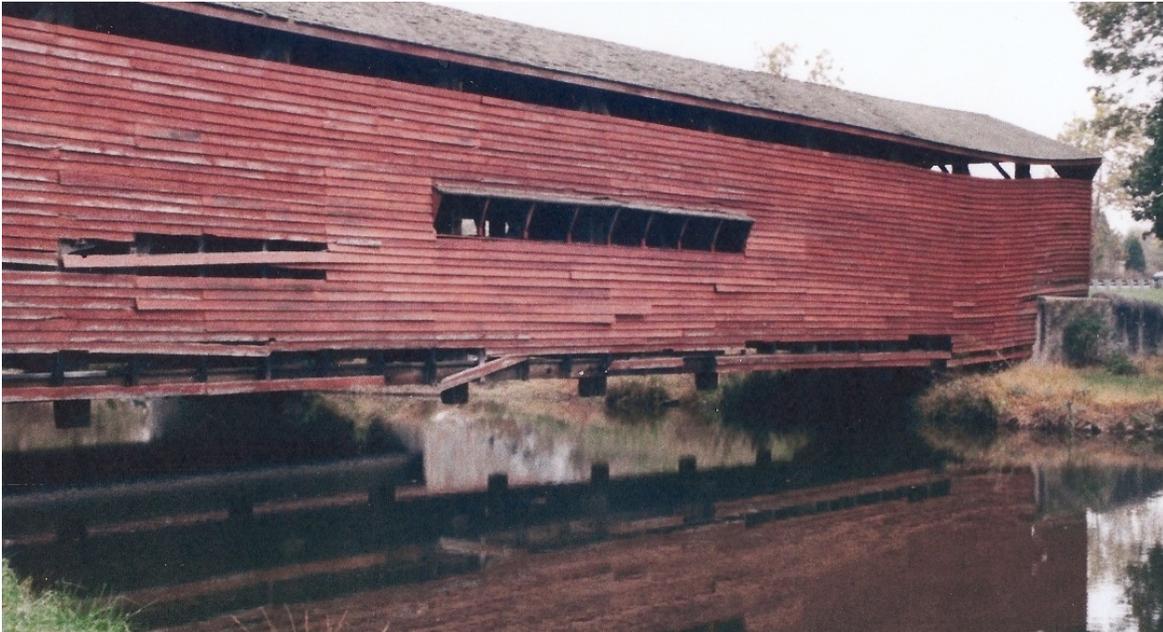
Figure 1: View of the bridge four years before the rehabilitation project. Failures in the lower chord contributed to the noticeable negative camber. W. Earl Simmers, 2005.

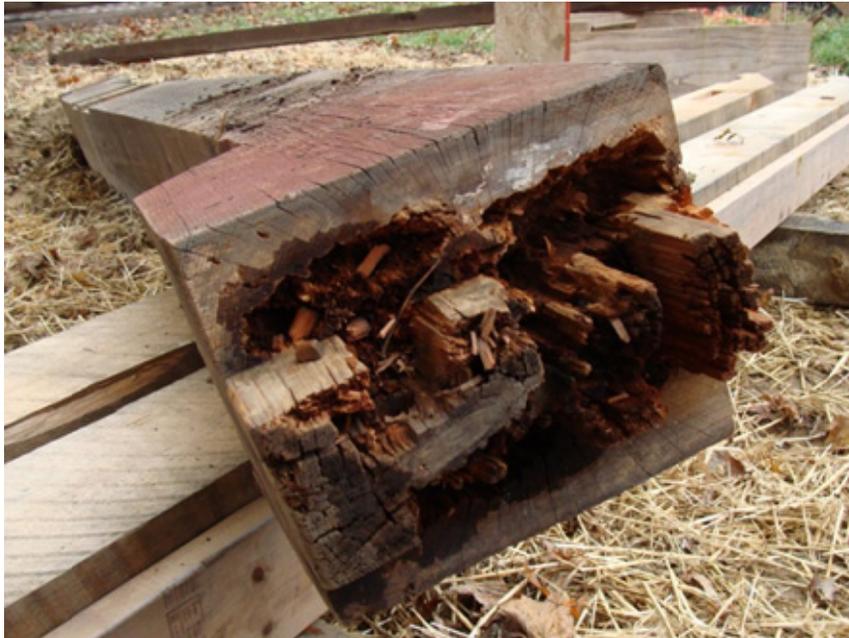
Although recent flooding caused the most catastrophic failures in the truss, it was in a severely weakened state before the flood even occurred. The most apparent areas of deterioration were the ends of the arches and where the arches met the abutments. During a previous rehabilitation effort in 1959, the abutments had been rebuilt with "bedded" timbers—12" x 12" timbers inset into the face of the abutment, positioned to bear the load of the arches and embedded in concrete. Structural investigation showed that rot and insect infiltration resulted in extremely compromised embedded timbers, and the replaced sections of arches were rotten and crushed at their ends. This area of decay revealed the causes that contributed to the failure of the bridge. The force of the arches had crushed the crumbling embedded timbers, as well as the ends of the rotting arches. The movement caused by decomposition created room for the arches to extend, flatten and deform. This had the effect of partially unloading the arches and placing additional load on the truss. The additional strain on the truss, and decades of decay, crushed and damaged the joints between truss members. Initially, before rehabilitation work began, Andrews estimated that 20 percent of the truss timbers needed to be replaced, but after disassembly it became evident that the number was far higher (Figure 2).

Figure 2: This photograph of the top of a post shows the typical condition of the truss members between joints. Field photograph, Timothy Andrews, 2009.

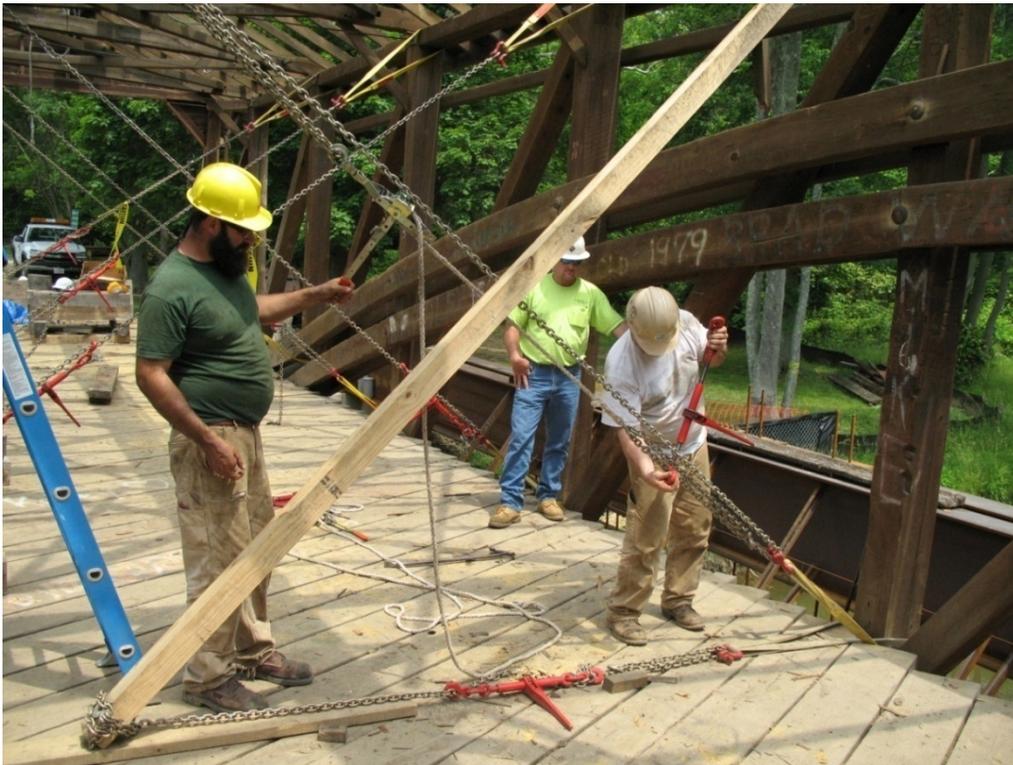
Figure 3: Cross chains installed to straighten the bridge in plan. Also note the deck planks are laid diagonally, which was not original. The planks were returned to the perpendicular arrangement later in the project. Field photograph, Jeremy Mauro, 2009.

With the temporary platform in place, Andrews, Truax and Woodliff began to stabilize and realign the bridge. The first step of this process was to cross-brace the structure diagonally through its interior using chains and jacking the lower chord at panel points (Figure 3).

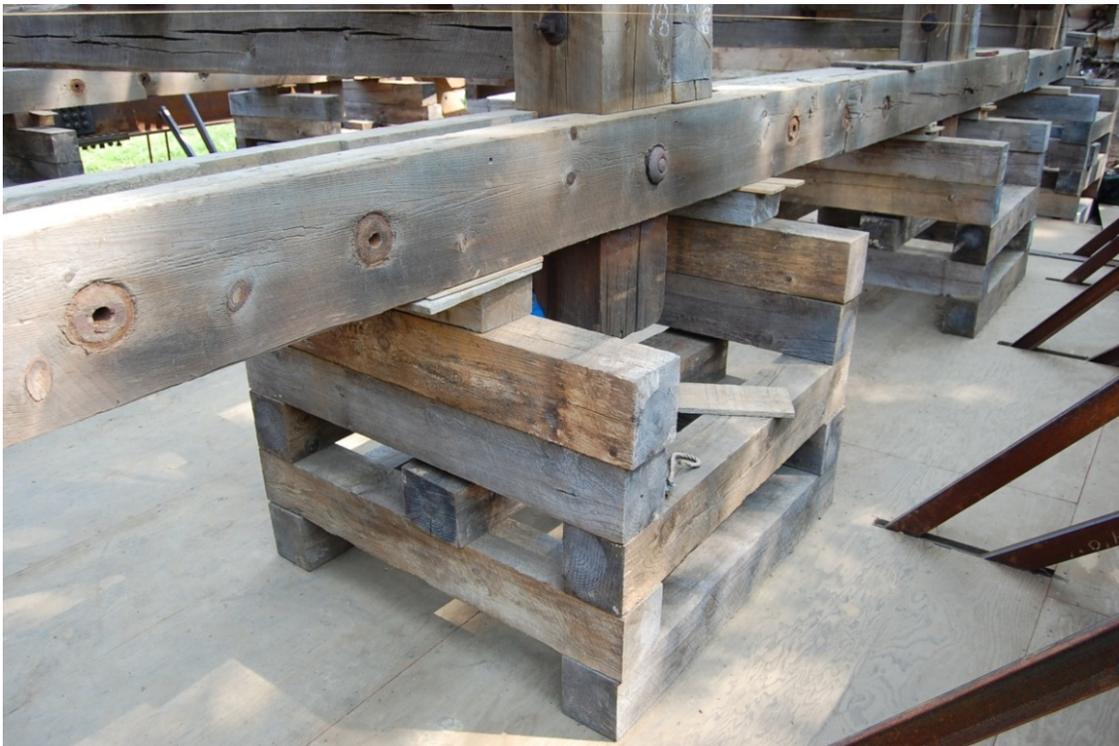
Figure 4: Photo of the lower cord supported by falsework. The crib towers transfer the weight of the bridge to the temporary platform. Field photograph, Jeremy Mauro, 2009.

The cross-bracing lessened the lateral stresses while jack supports relieved the abutments and truss of carrying the load of the bridge. This process reduced tension from the truss and made it possible to straighten the bridge laterally, which was done by tightening the cross-chains at specific points. After removing the lateral bow, a second alignment technique known as longitudinal clamping was initiated. Four threaded rods, measuring 1" in diameter, were positioned in pairs running the entire length of both lower chords and threaded through wood blocks placed near the bottom of each post. The rods acted as temporary lower chords and were tensioned by turning nuts set against the wood blocks. This technique of longitudinal clamping both "gathered back" gaps created by failures in the bottom chord and fixed the position of each post. The next step involved stacking numerous 5" x 7" x 4' timbers into tall temporary crib towers, or falsework, that raised the height of the upper chord (Figure 4). These supports carried and controlled the upper part of the truss and helped return the bridge to positive camber. Finally, a series of eight 4" x 4"s, post-tensioned with chains attached to the temporary steel platform, acted as outriggers by buttressing the bridge posts and holding them securely in a vertical position

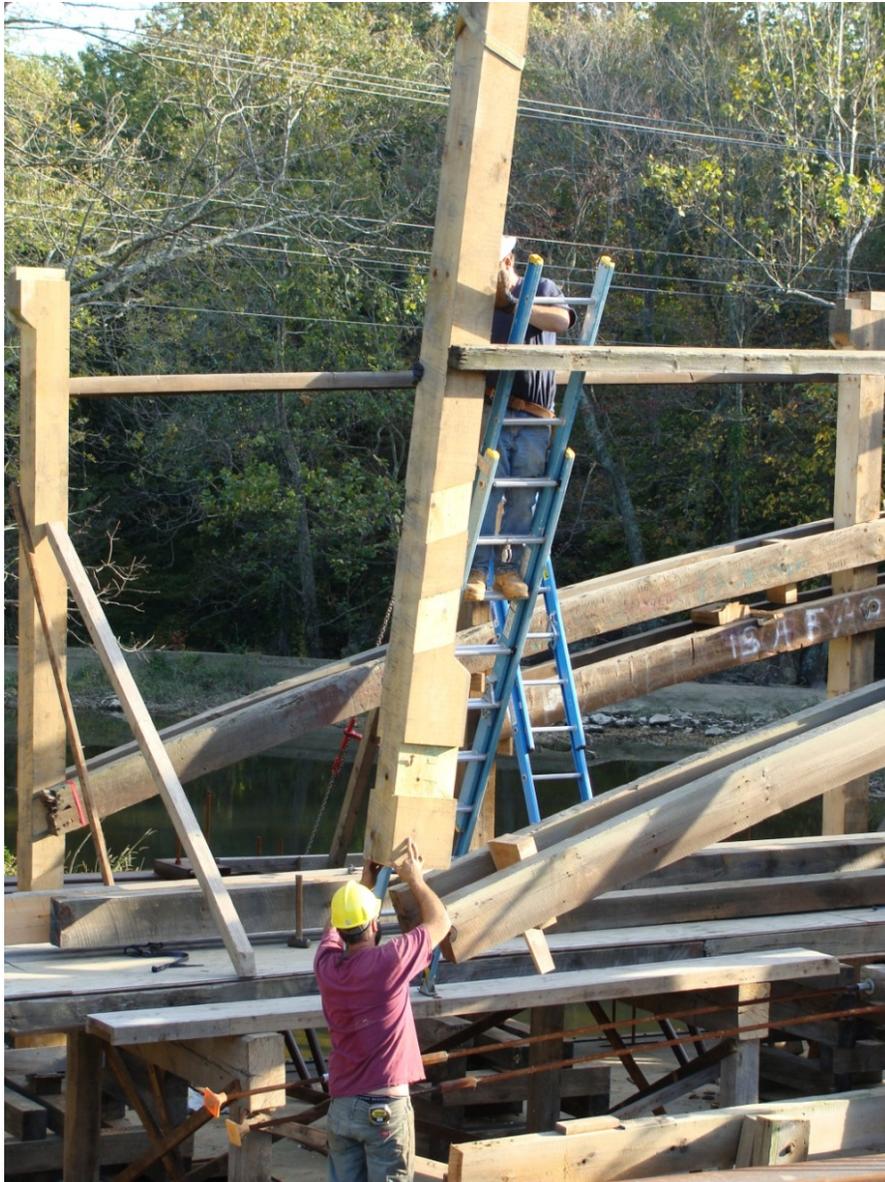
Figure 5: Timothy Andrews (top) and Jeremy Woodliff (below) guide a new endpost into position. A crane, not shown in the photograph, is lowering the post. Field photograph, William Truax, 2009.

were replaced one-at-a-time in a “one out, one in” fashion using a crane (when available), a backhoe with an extended boom or by hand using a come-along (Figure 5). As new truss members were inserted, the joints were finely chiseled by hand to ensure proper fit between the vertical posts and diagonal braces. After carefully replacing the truss members, the team next addressed the rotten ends of the arches. New arch segments were shaped in place against the other components they interlocked. The joints of the replacement sections of the arches were staggered to increase strength and prevent them from acting like a hinge under load.

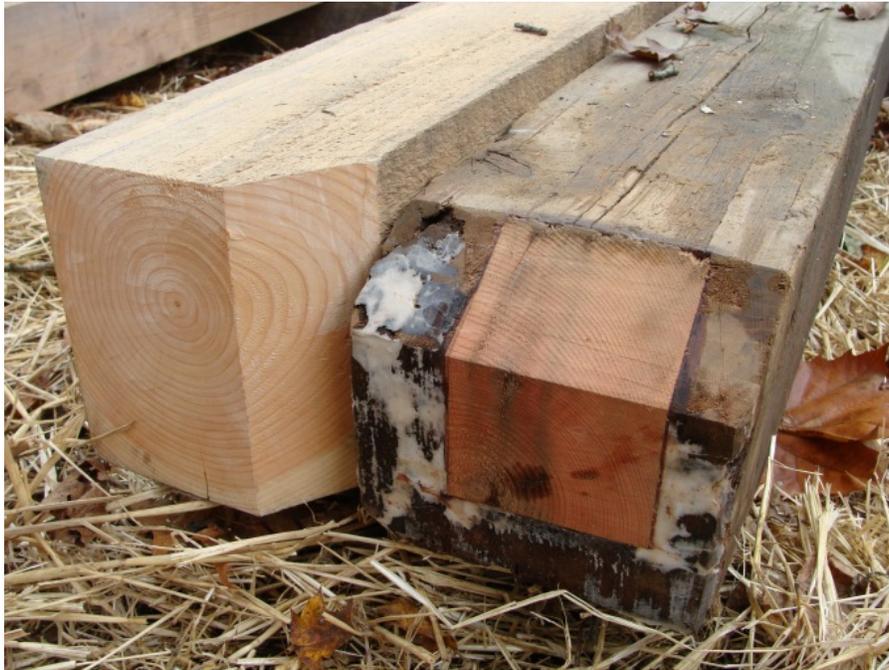
Figure 6: Historic fabric was repaired rather than replaced whenever possible. The photograph shows a repair to the end of a diagonal brace. Field photograph, Christopher Marston, 2009.

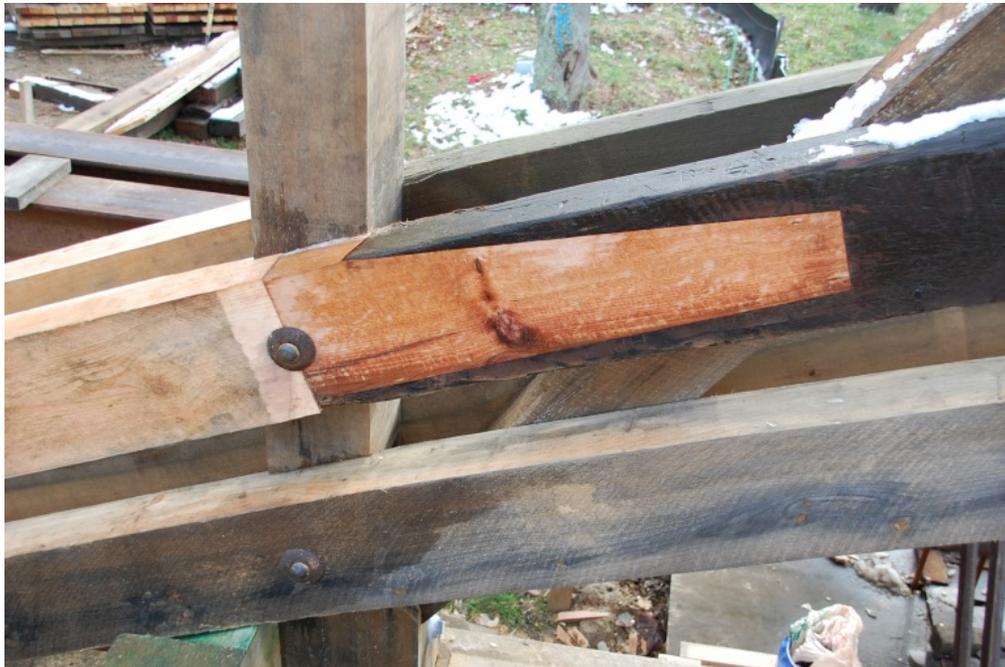
Figure 7: A "Dutchman" repair to the arch is shown. This repair method preserved as much historic fabric as possible while ensuring structural reliability. Field photograph, Christopher Marston, 2009.

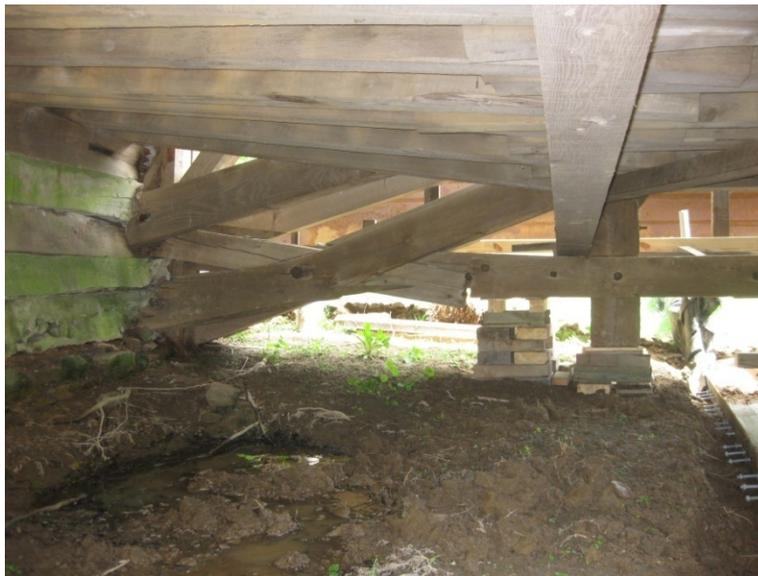
Figure 14: Northeast corner of Gilpin's Falls Covered Bridge in May 2009. Failure of lower arch and lower truss chord can be readily seen here. Temporary support of the first interior post and lower chord prevented further collapse. Photograph by Rachel H. Sangree.

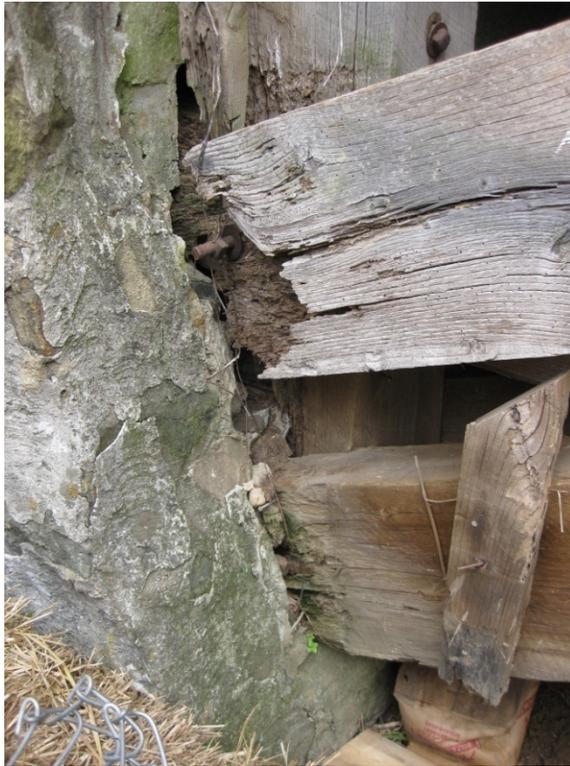
Figure 15: Southeast corner of bridge exhibited decay of arch ends and end post. Photograph by Rachel H. Sangree.

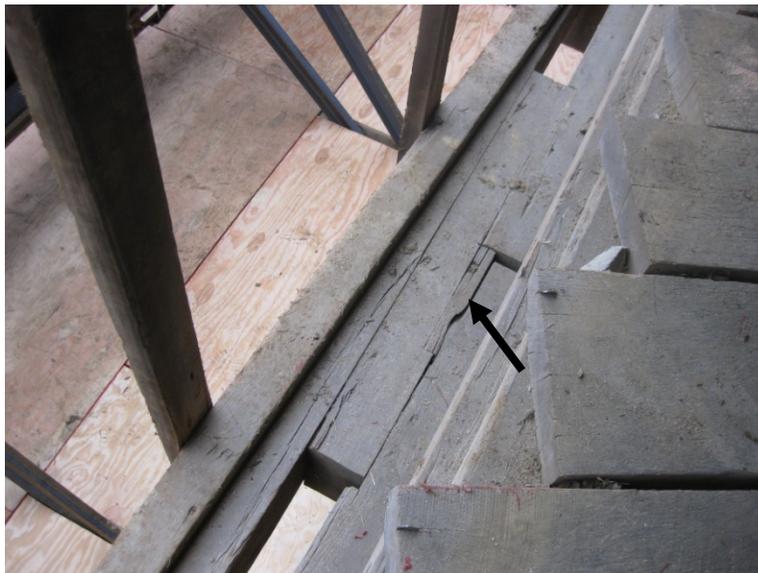
Figure 16: Typical shear failure of a lower chord / fish plate splice on the east truss. Photograph by Rachel H. Sangree.

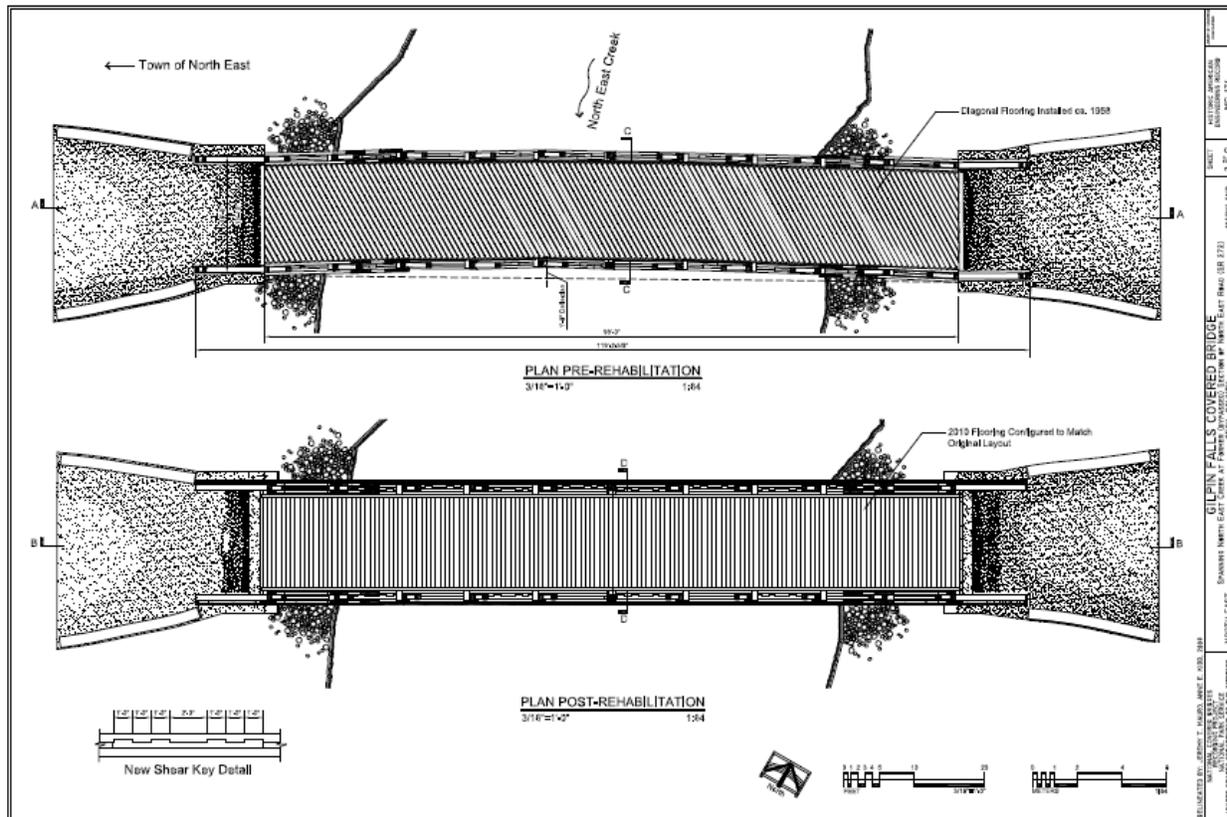
Figure 17: Jeremy T. Mauro and Anne E. Kidd, delineators, Gilpin's Falls Covered Bridge, HAER No. MD-174, Sheet 2 of 9, 2009. Note lateral bow prior to rehabilitation (top plan).

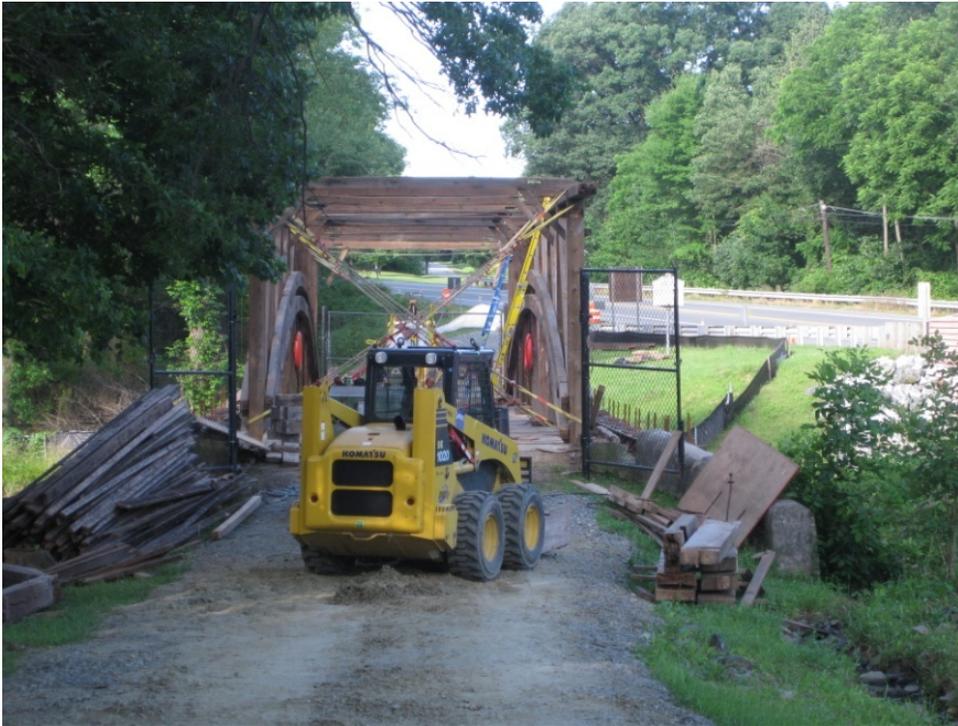
Figure 19: Failure of the east truss caused significant lateral movement of the entire structure. Here, the builders have used cross chains to help bring the trusses back to their vertical position. Photograph by Rachel H. Sangree.

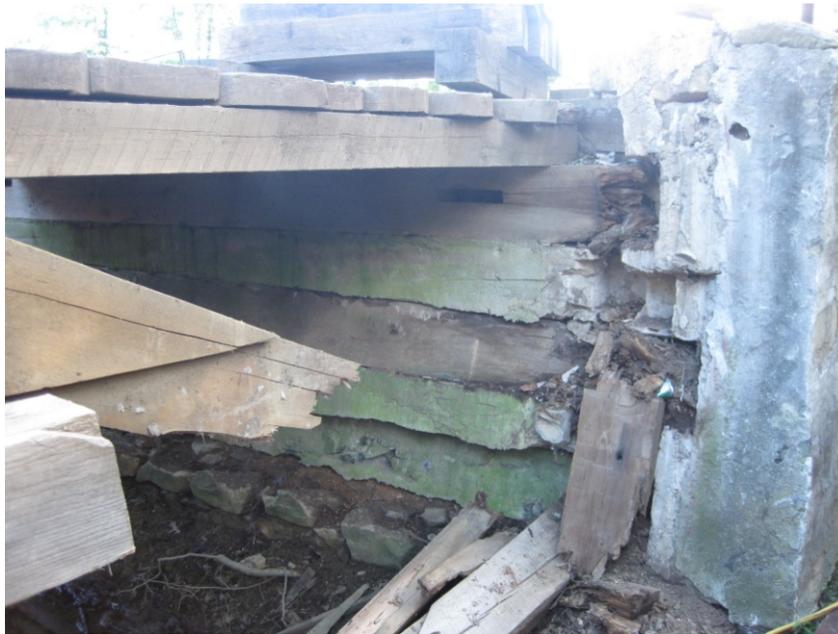
Figure 20: Photograph taken at the northeast corner of the bridge, where lower arch and lower chord ends were removed after the bridge was stabilized. Photograph by Rachel H. Sangree.

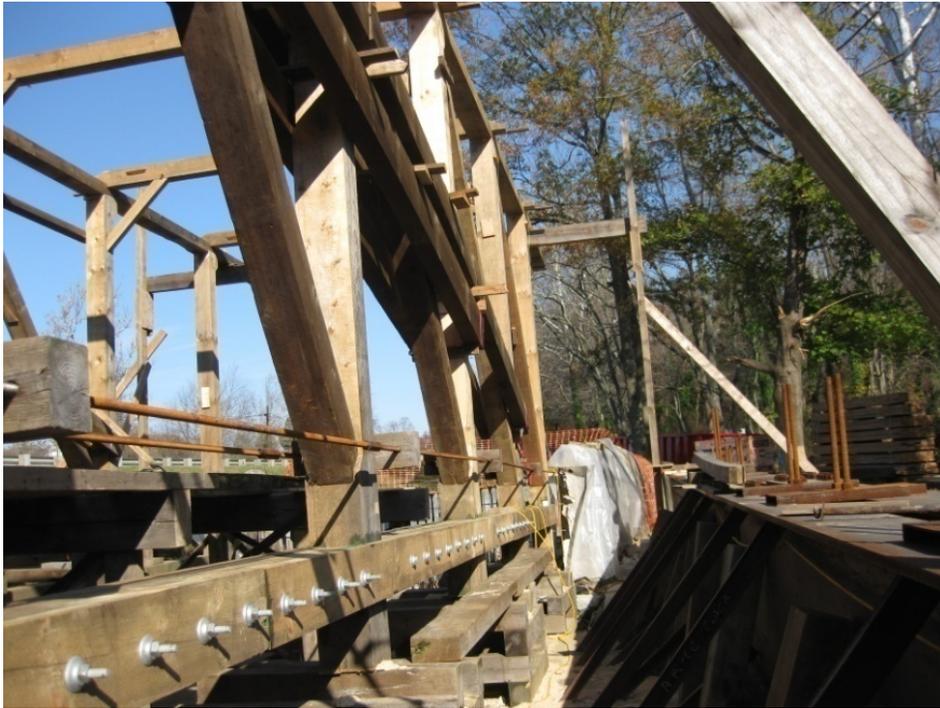
Figure 21: East truss with newly-installed lower chord and tie rod still in place. Note: the tie rod was removed shortly after this photo was taken, as it was no longer needed. Photograph by Rachel H. Sangree.

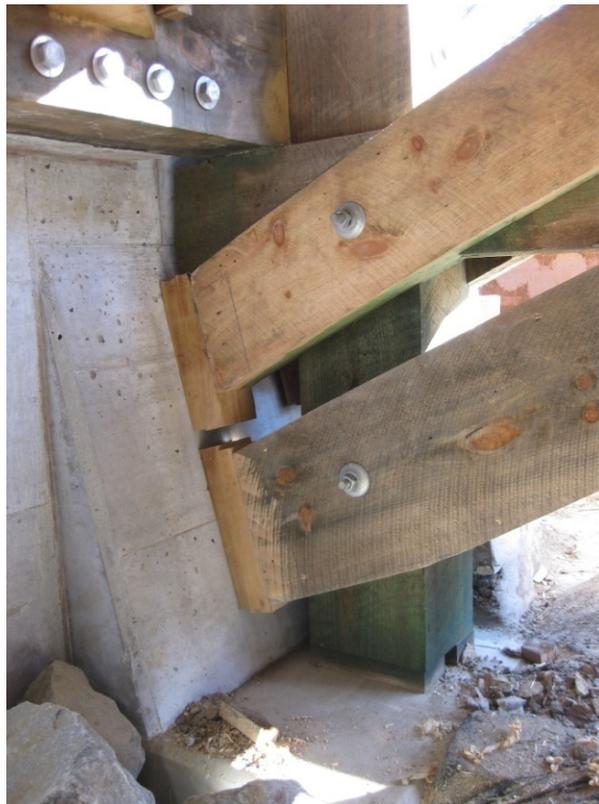
Figure 23: Northeast corner of bridge showing arches engaged with the abutment face via black locust wedges. Photograph by Rachel H. Sangree.

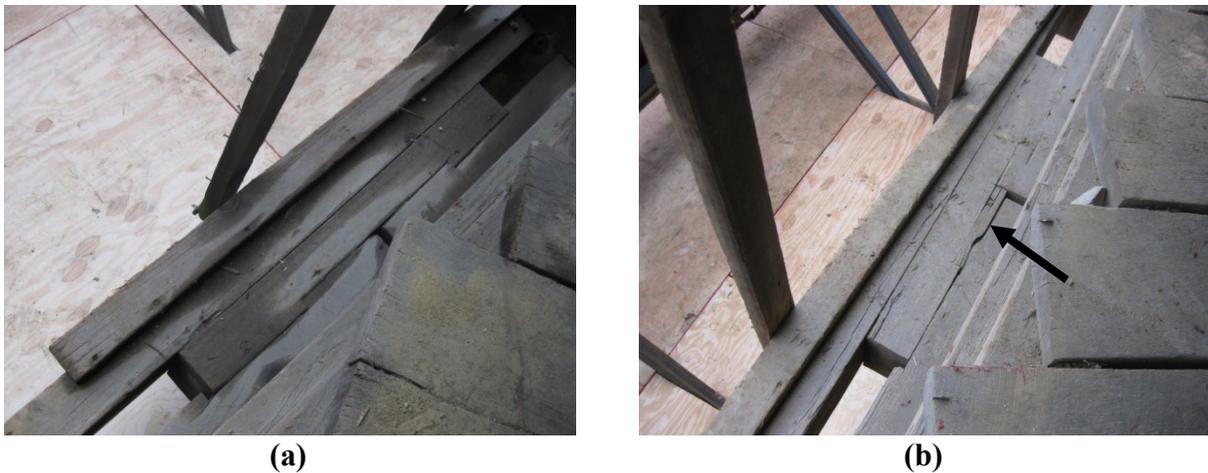
Figure 44: (a) Original lower tension splice in Gilpin's Falls Bridge and (b) typical shear failure of a tension splice (note the movement of the lower chord due to joint failure). Photographs by Rachel H. Sangree.
