House (Tract #1801B)
east side extension of Route KK, .8 miles southeast
of Valley View
Warsaw Vicinity
Benton County
Missouri

HABS No. MO-1238

HISTORIC AMERICAN BUILDINGS SURVEY HABS No. MO-1238

HOUSE (Tract #1801-B)

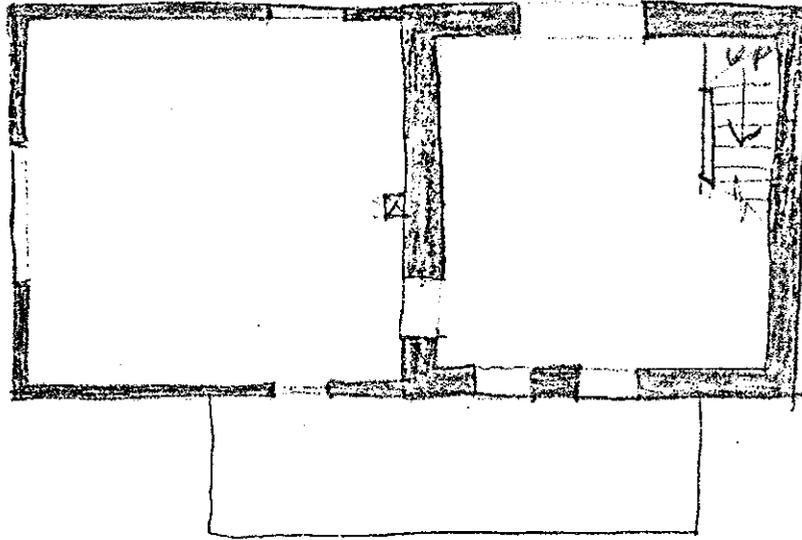
FIRST FLOOR PLAN #1801-B

1. Floor plans: This house consists of two roughly square rooms side by side, forming a long rectangle. The room to the west is the original portion of the house and is constructed of logs. The second floor also has two rooms.

2. Stairways: The stairway is located in the southwest corner of the house. The winders start in the corner and the stair rises steeply along the west wall. The stair is enclosed on the west by the exterior log wall and on the east by the interior partition.
