**CEDAR PASS VISITOR CENTER**  
(Ben Reifel Visitor Center)  
Badlands National Park  
Highway 240  
Interior  
Jackson County  
South Dakota

**HABS NO. SD-23**

## HISTORIC AMERICAN BUILDINGS SURVEY

### CEDAR PASS VISITOR CENTER (Ben Reifel Visitor Center)

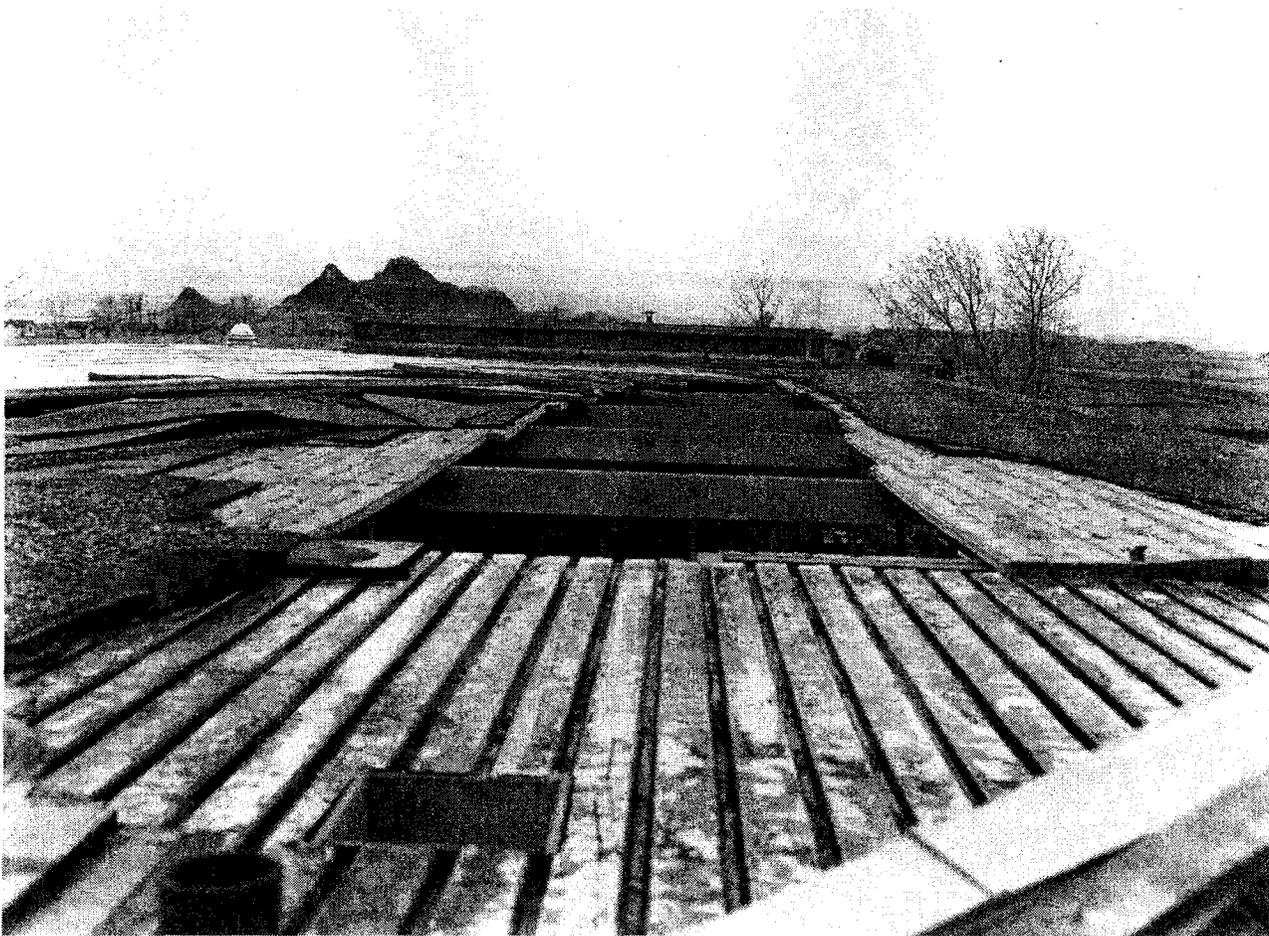
Emergency roof repair: On May 1, 1972, the Cedar Pass area sustained a damaging wind storm with wind speeds estimated at seventy-five to eighty miles per hour. Portions of the visitor center roof, primarily along the perimeter of the porch area, were lifted up and peeled back. Closer investigation revealed that in the affected areas, the contractor had used two six penny nails to fasten the roof beam clips to the wood roof decking. The original drawings called for this attachment to be made with a single spike. The wind also damaged areas of the guttering, portions of the exterior split-face concrete veneer, and two roof vents. Repairs to the roof began on May 19, 1972, and consisted of replacing the damaged areas of roofing, guttering, and the two vents. The damage to the exterior cladding was also repaired. This work was completed June 1, 1972, by Brablec Construction Company of Rapid City, South Dakota, at a cost of \$14,370.00.

**Figure 8:** “View of damaged roofing, taken from portion over restrooms toward the lobby area. Note vent frame in foreground, steel decking, and damaged roof laid back over office area to left.”  
photographer not known, not dated (but taken immediately following windstorm of May 1, 1972), Image and copyright held by Badlands National Park, Interior, South Dakota.

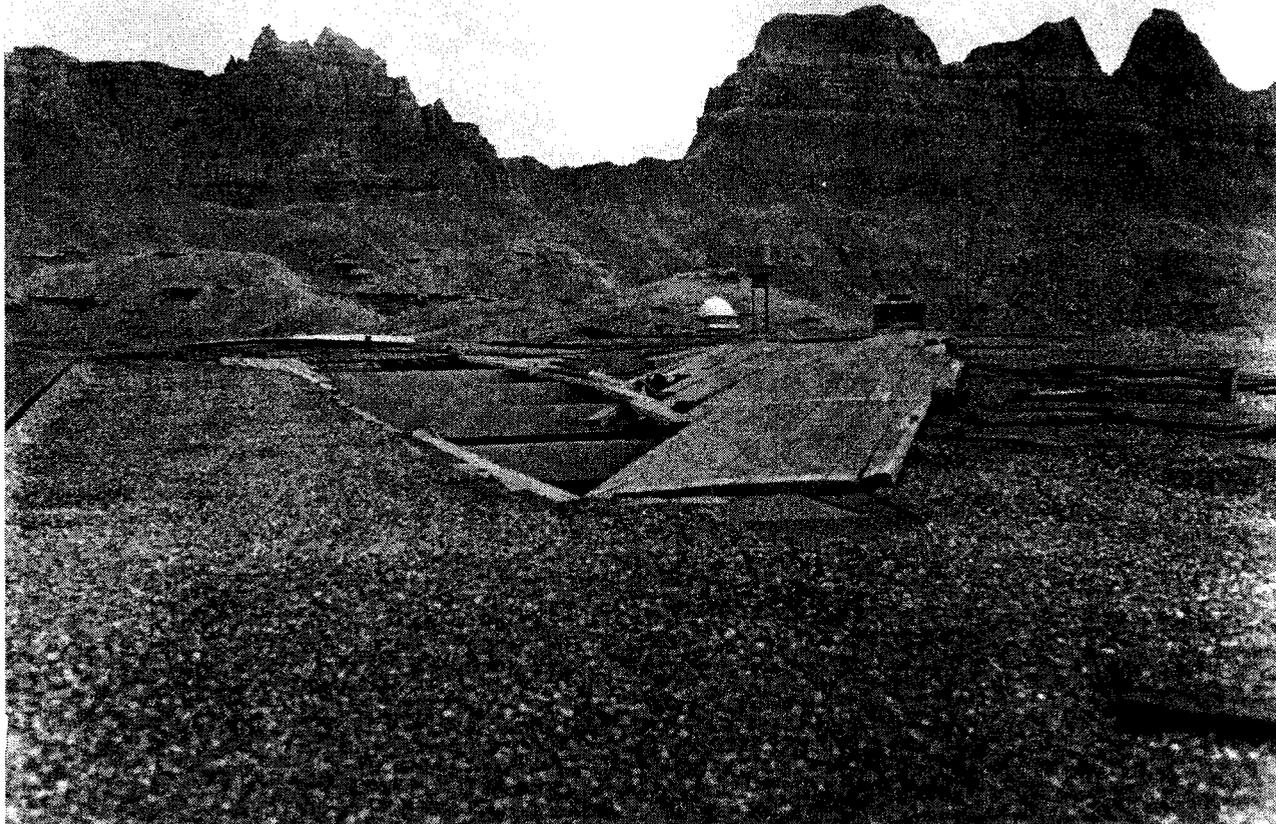
**Figure 9:** “View from over lobby area showing damaged section, ventilator which came from near vent pipe over women’s restroom.” photographer not known, not dated (taken immediately following windstorm of May 1, 1972), Image and copyright held by Badlands National Park, Interior, South Dakota.

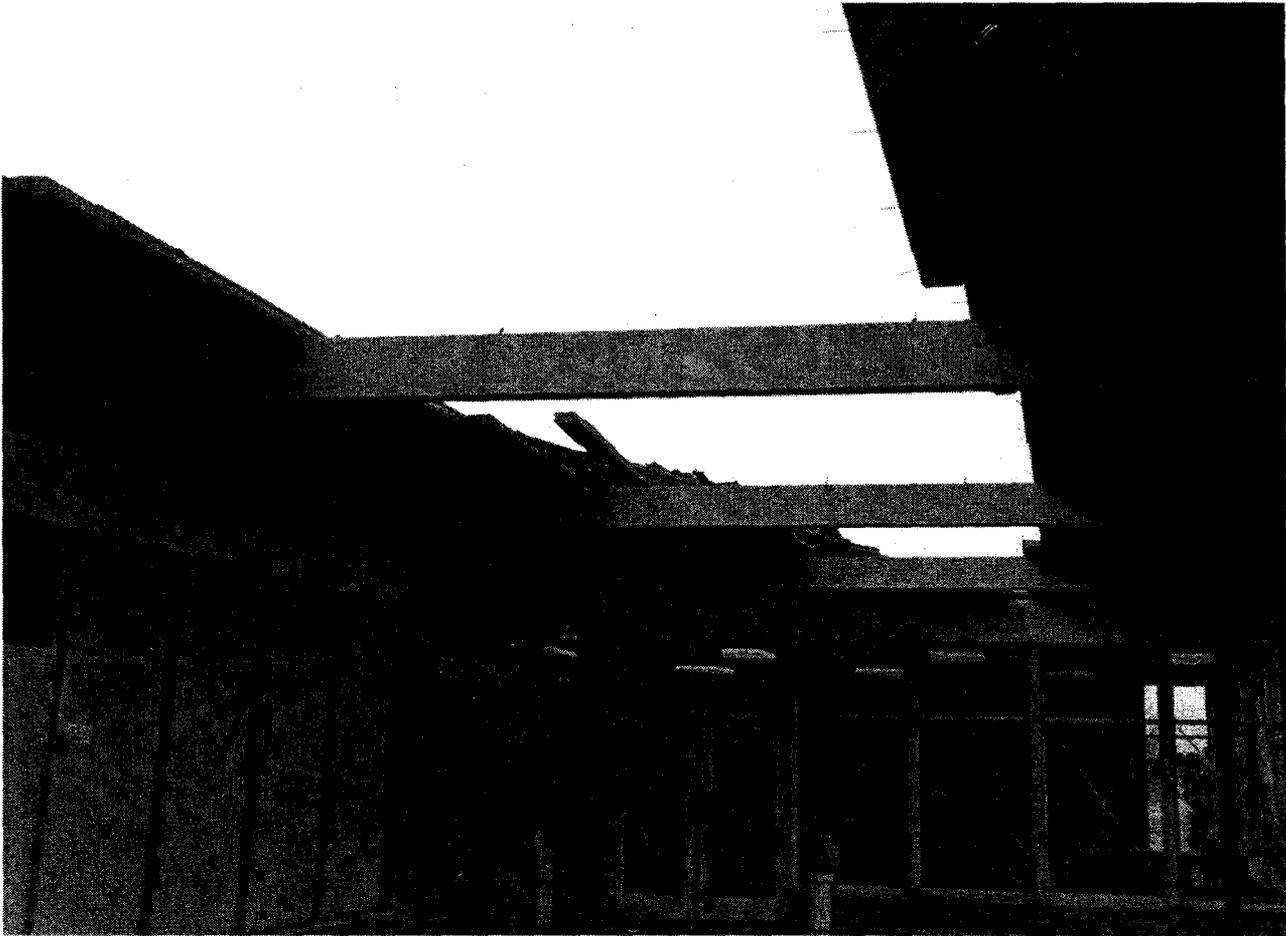
**Figure 10:** “View from porch note taped windows and the area where the roof had laid over.”  
photographer not known, not dated (taken immediately following windstorm of May 1, 1972), Image and  
copyright held by Badlands National Park, Interior, South Dakota.

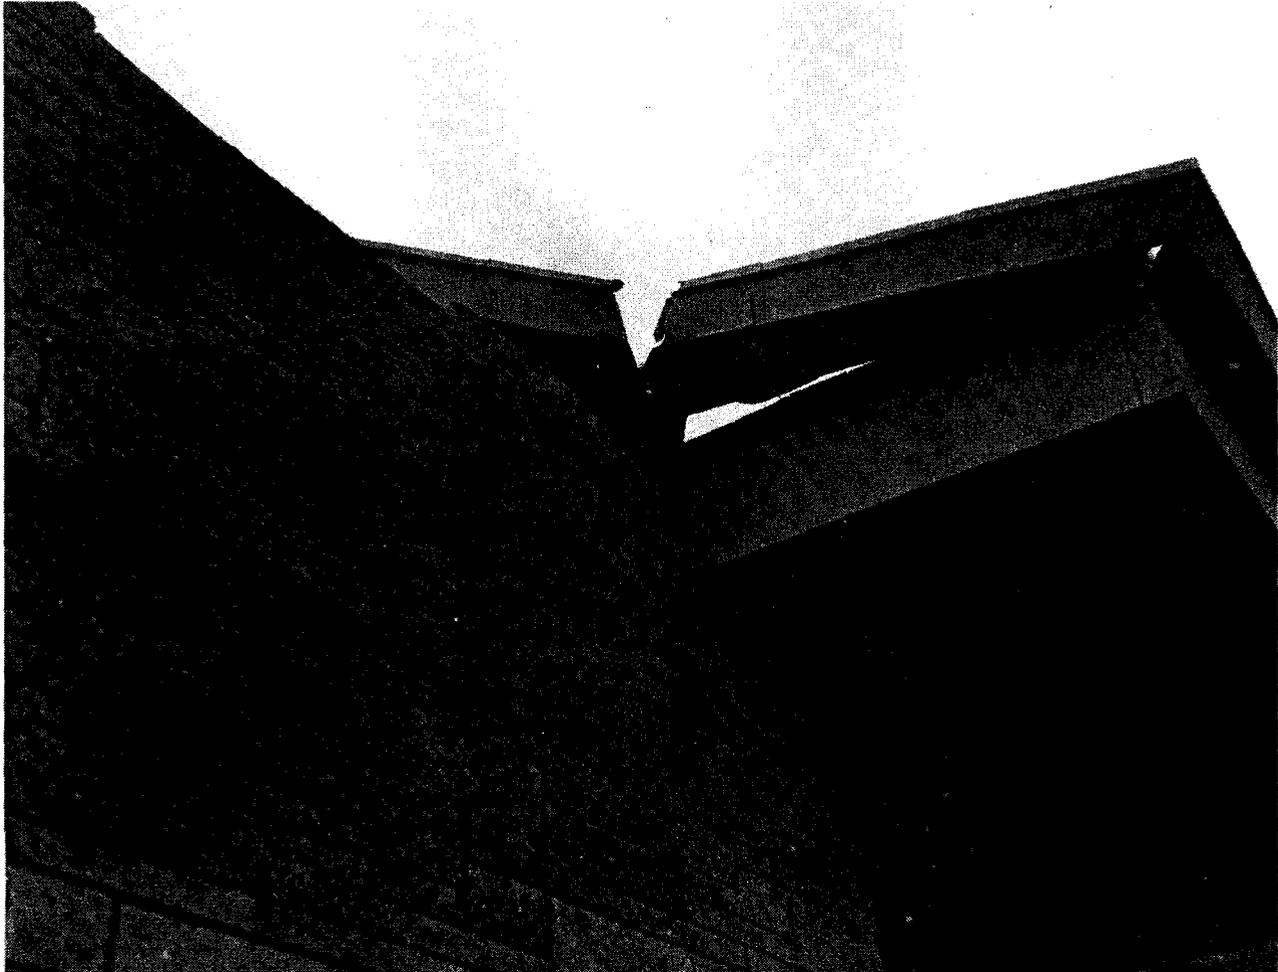
**Figure 12:** “Corner of roof near women’s restroom. Note damaged gutter corners and separated brick siding. Also note separation of wood plank facing from metal support beam.” photographer not known, not dated (taken immediately following windstorm of May 1, 1972), Image and copyright held by Badlands National Park, Interior, South Dakota.

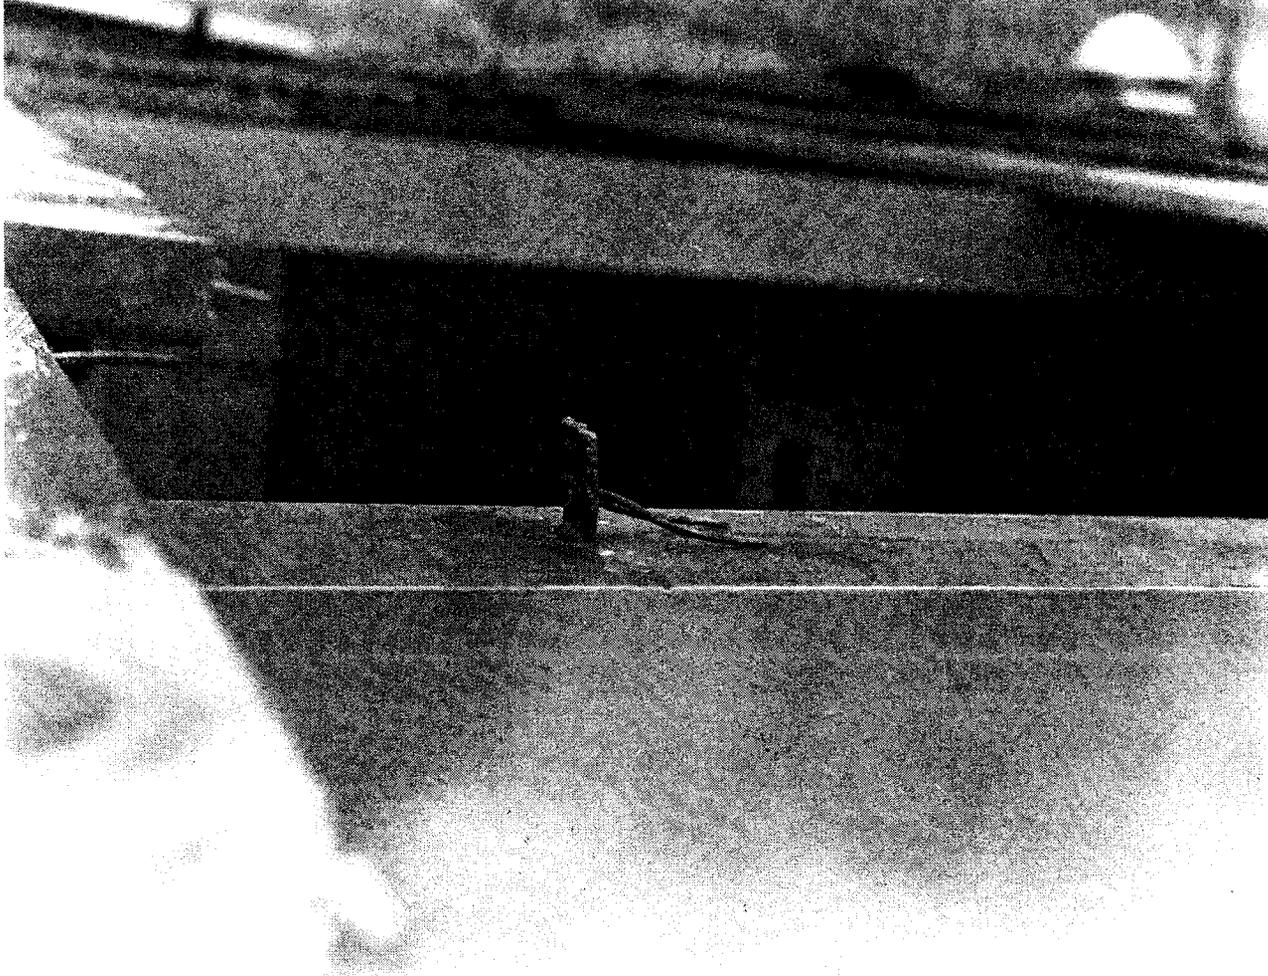
**Figure 13:** “Clip with two, six-penny nails in lieu of spike. Note spike driven through planking to left. The culprit of the damage.” photographer not known, not dated (taken immediately following windstorm of May 1, 1972), Image and copyright held by Badlands National Park, Interior, South Dakota.

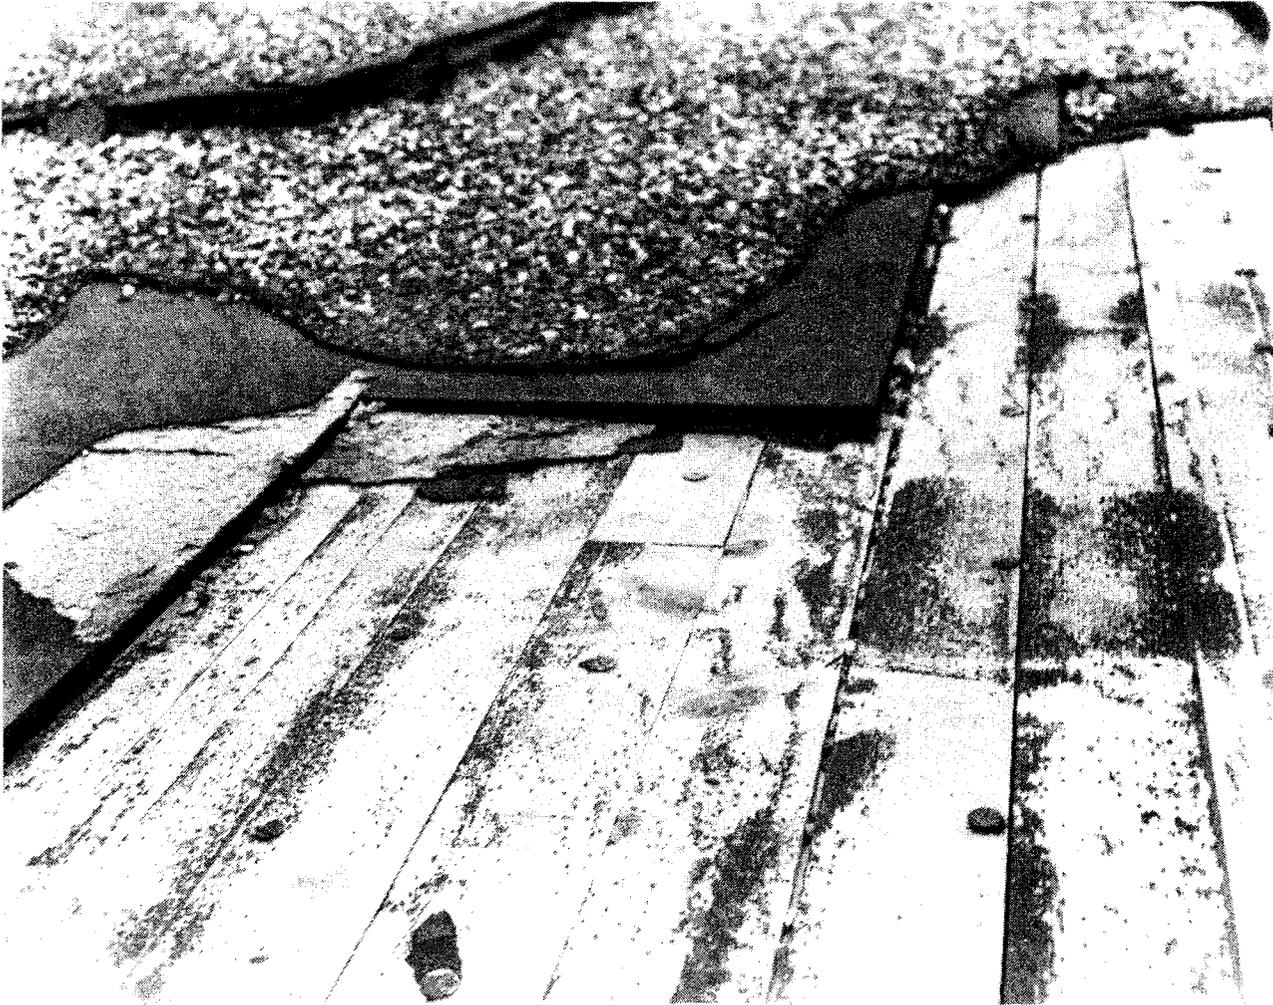
**Figure 14:** “Portion of planking roofing showing tar paper, under 1 inch insulation mat, and four ply asphalt and gravel roof.” photographer not known, not dated (taken immediately following windstorm of May 1, 1972), Image and copyright held by Badlands National Park, Interior, South Dakota.

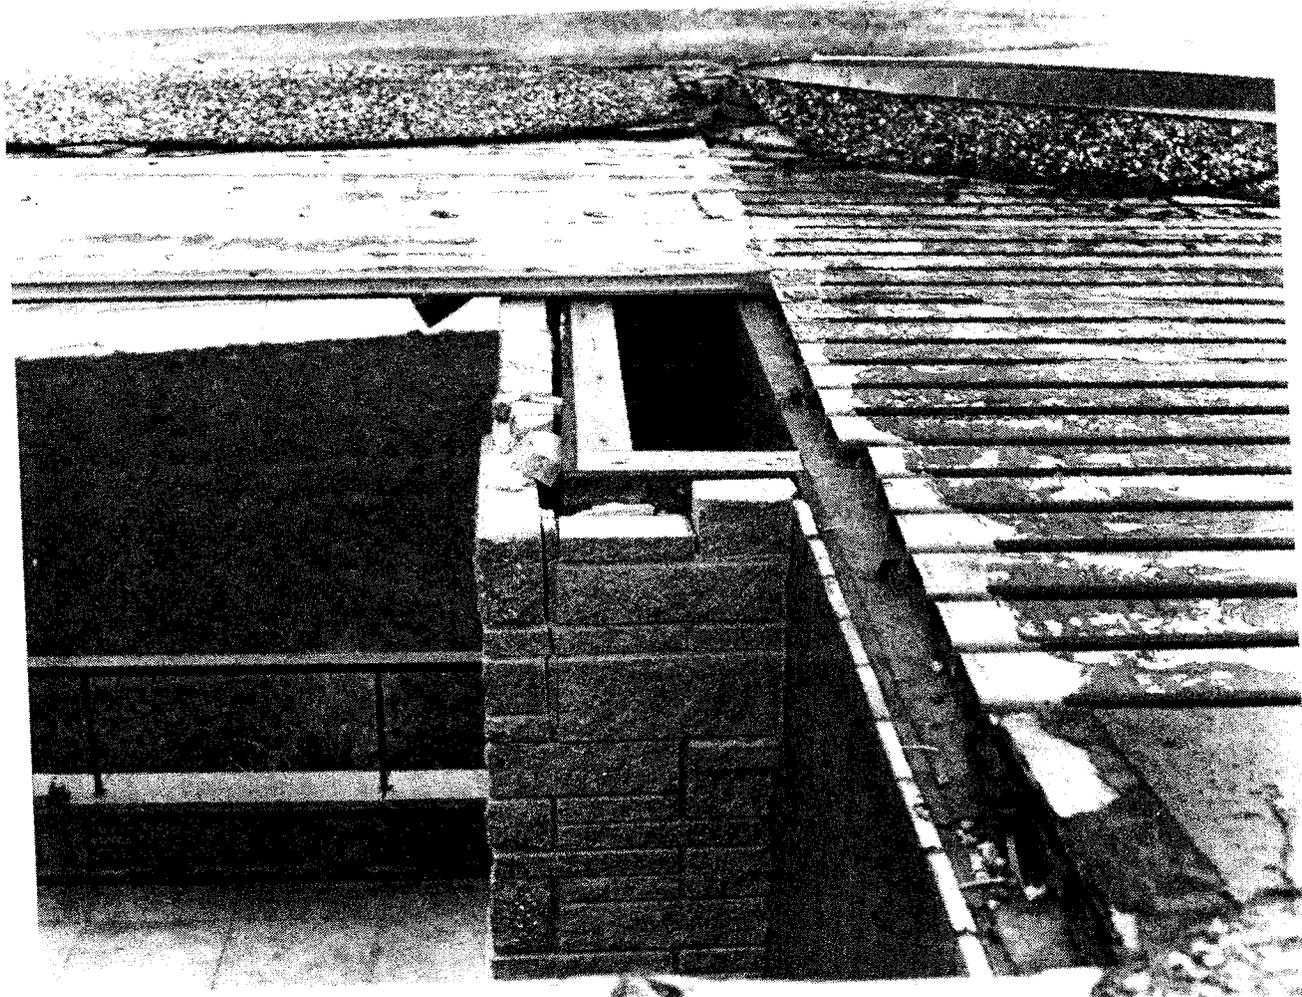
**Figure 15:** "Section showing plank deck and metal decking over restrooms. Note separation of brick facing. This portion, and that over the lobby required emergency repair to prevent rain damage." photographer not known, not dated (taken immediately following windstorm of May 1, 1972), Image and copyright held by Badlands National Park, Interior, South Dakota.

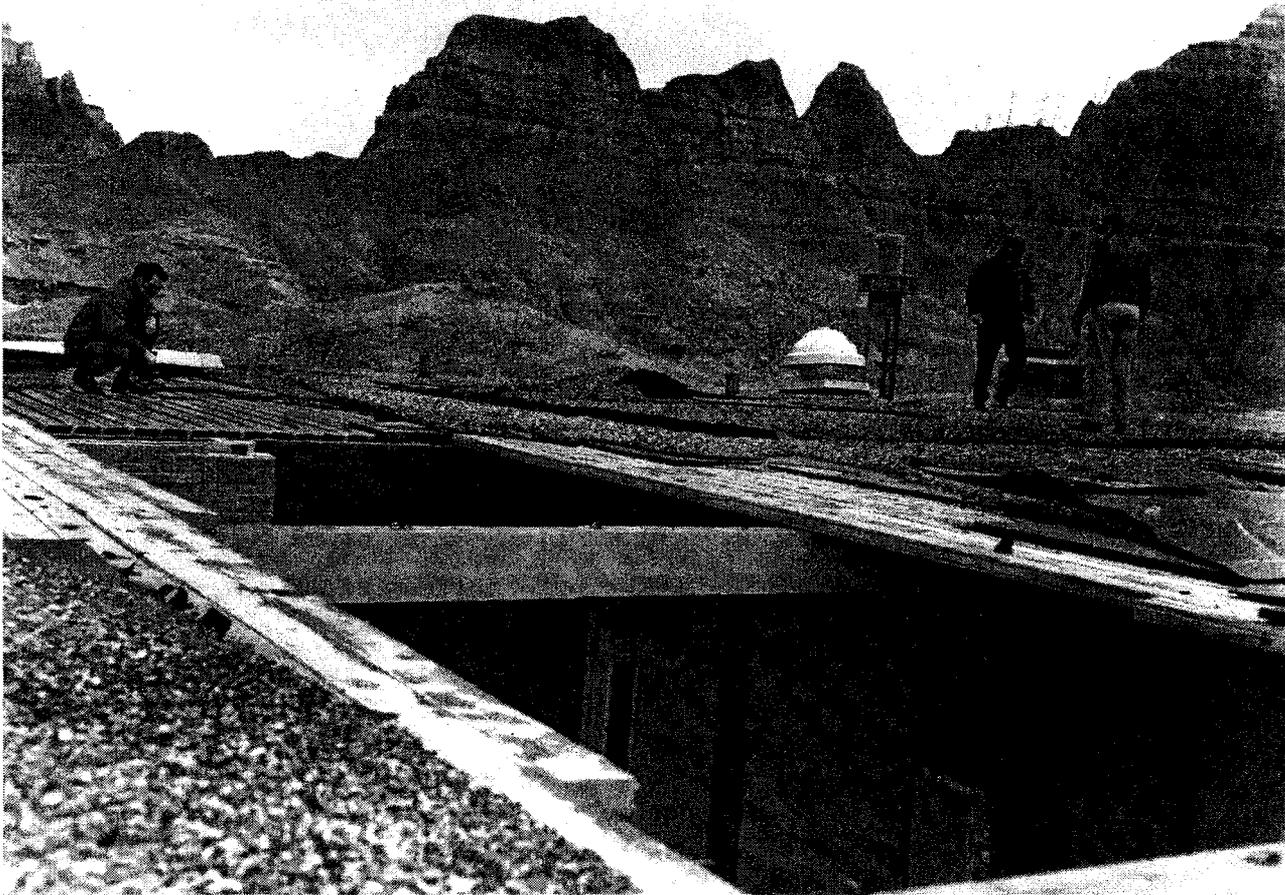
**Figure 16:** “General view of porch roof. Note the ventilator near fire siren which came from the frame below Mr. Harrington’s left foot.” photographer not known, not dated (taken immediately following windstorm of May 1, 1972), Image and copyright held by Badlands National Park, Interior, South Dakota.

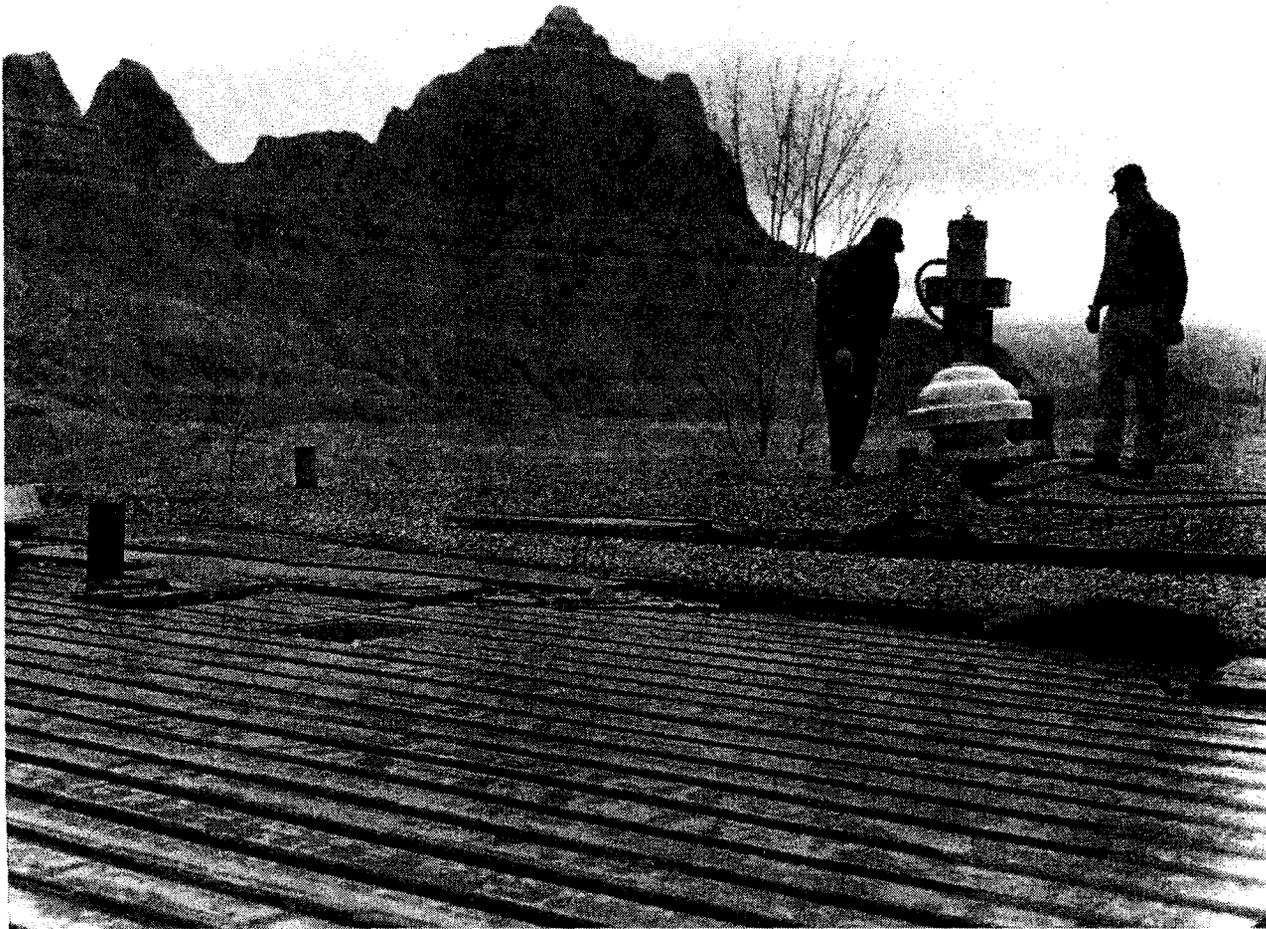
**Figure 17:** “View over restrooms showing vent frame and approximately 25 feet away the ventilator with motor.” photographer not known, not dated (taken immediately following windstorm of May 1, 1972), Image and copyright held by Badlands National Park, Interior, South Dakota.

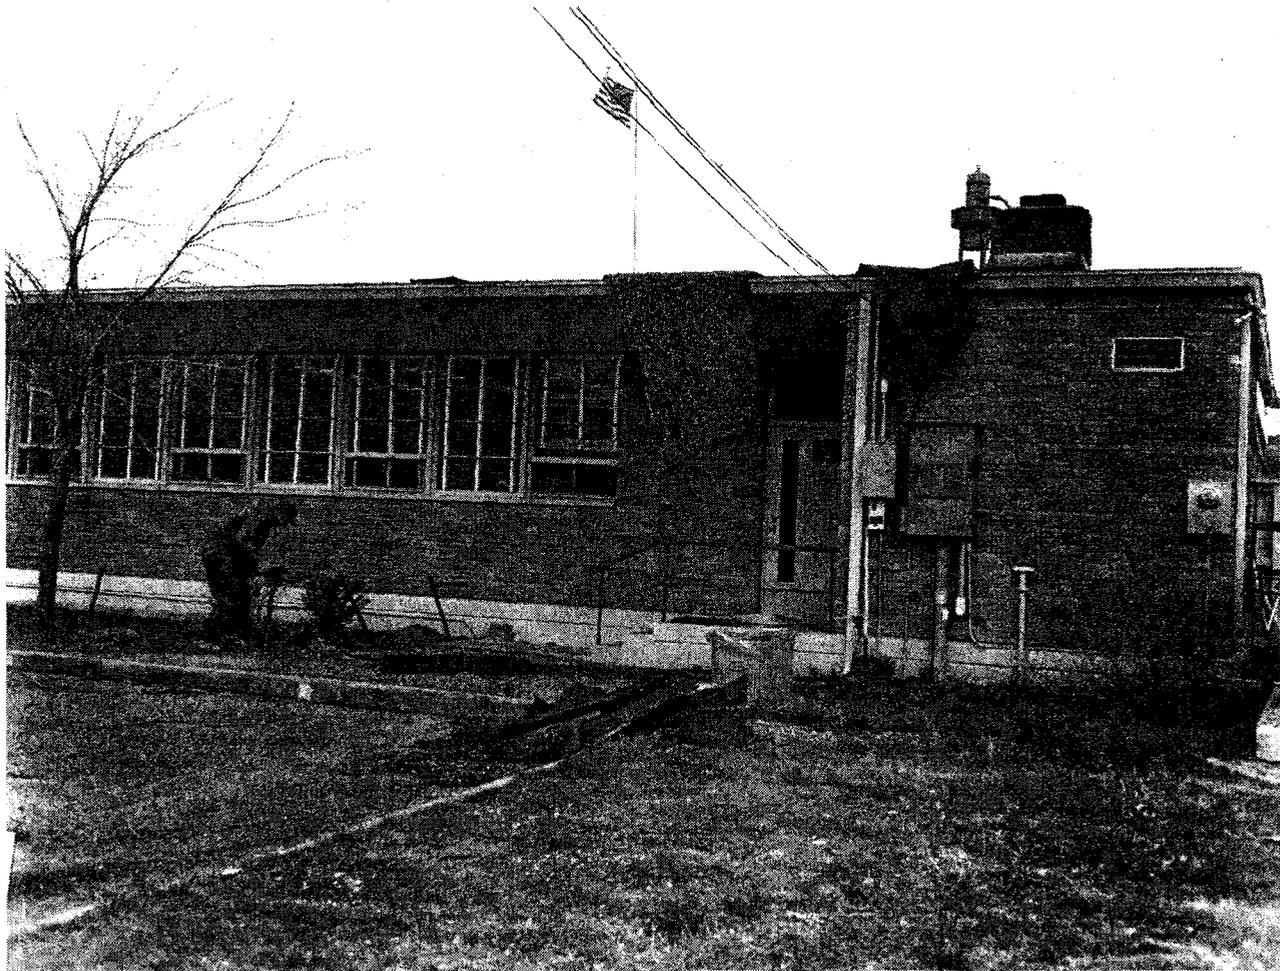
**Figure 18:** “Rear of visitor center showing debris which blew over and off the roof. One car parked in the first space had several large cracks and pit marks in the windshield, plus chipped paint.” photographer not known, not dated (taken immediately following windstorm of May 1, 1972), Image and copyright held by Badlands National Park, Interior, South Dakota.
