FORT HUACHUCA, CAVALRY STABLE
(Building No. 30023)
(Building No. 85)
(Building No. 121)
(Building No. 3034)
Clarkson Road
Sierra Vista vicinity
Cochise County
Arizona

HISTORIC AMERICAN BUILDINGS SURVEY

FORT HUACHUCA, CAVALRY STABLE
(FORT HUACHUCA, BUILDING 30023)
(FORT HUACHUCA, BUILDING 85)
(FORT HUACHUCA, BUILDING 121)
(FORT HUACHUCA, BUILDING 3034)

HABS NO. AZ-210-A

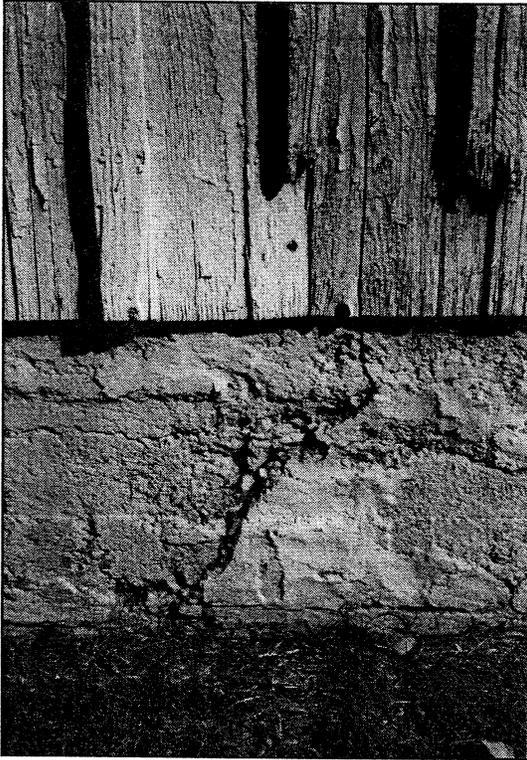
2. Foundations: Foundations are hand-poured, board-formed concrete and comprise a continuous 8-inch- to 10-inch-thick stem wall. It is unlikely there is any steel reinforcing in this foundation. Due to the site slope, the stem wall is not visible near the east end of the building, but it is exposed along the entire north façade and elsewhere. The stem wall shows approximately 1 ft, 9 inches from grade to the lower edge of siding boards on the southwest corner and 4 ft, 2 inches on the northwest corner. Its hand-poured quality is seen in occasional voids and seams from uneven board placement. In places, the stem wall has been coated with a thin layer of cement material, and it is painted tan to match the current color of the walls. The stem wall is currently in fair condition with some cracks, abrasion, and corner deterioration. There is no sign of major structural cracking. Where the wall is deteriorated or in voids, it can be seen that a large stone aggregate was used in the original concrete mix (Figure A.3).

FIGURE A.3. CONCRETE STEM WALL SHOWING A CRACK AND ABRASION. SOUTH SIDE NEAR THE WEST END (PHOTOGRAPH BY JANET PARKHURST, NOVEMBER 2004).

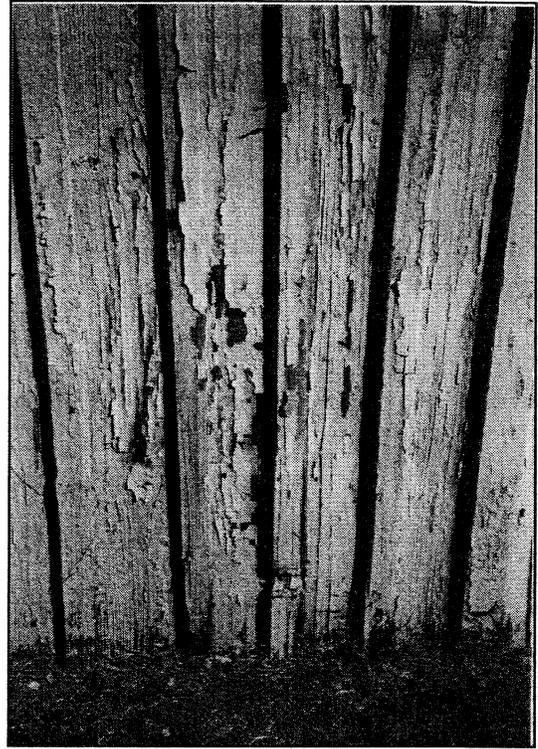
The condition of the exterior walls at this time ranges from fair to poor, with the poor condition largely on the south and west walls. Although painted, some boards and battens are split and broken or dislodged from the frame. Deterioration is especially evident along the lower edges. The last coating of paint is also weathered and deteriorating, especially on the south façade (Figure A.4).

FIGURE A.4. BOARD-AND-BATTEN SHEATHING ON SOUTH WALL, SHOWING FLAKING PAINT AND BROKEN BATTEN (PHOTOGRAPH BY JANET PARKHURST, NOVEMBER 2004).

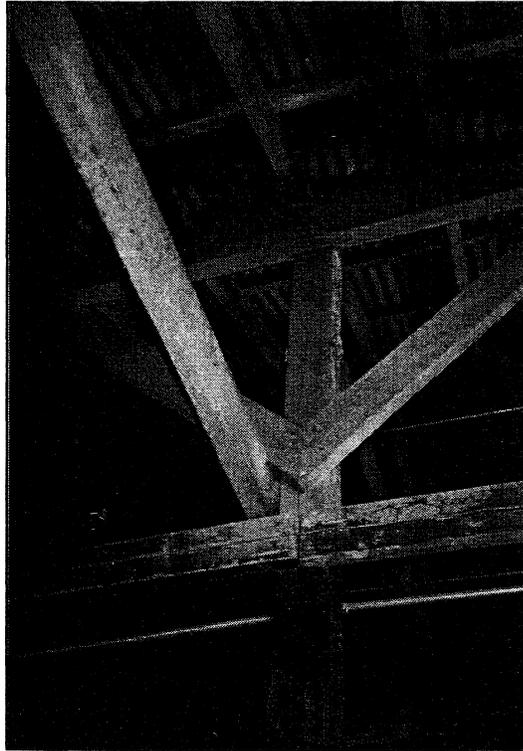
appear to be of redwood, whereas wall studs and exterior board siding are probably of fir (Figure A.5; HABS No. AZ-210-A-12; HABS No. AZ-210-A sheet 3, building sections).

FIGURE A.5. TYPICAL INTERRELATED FRAMING COMPONENTS (PHOTOGRAPH BY JANET PARKHURST, NOVEMBER 2004).

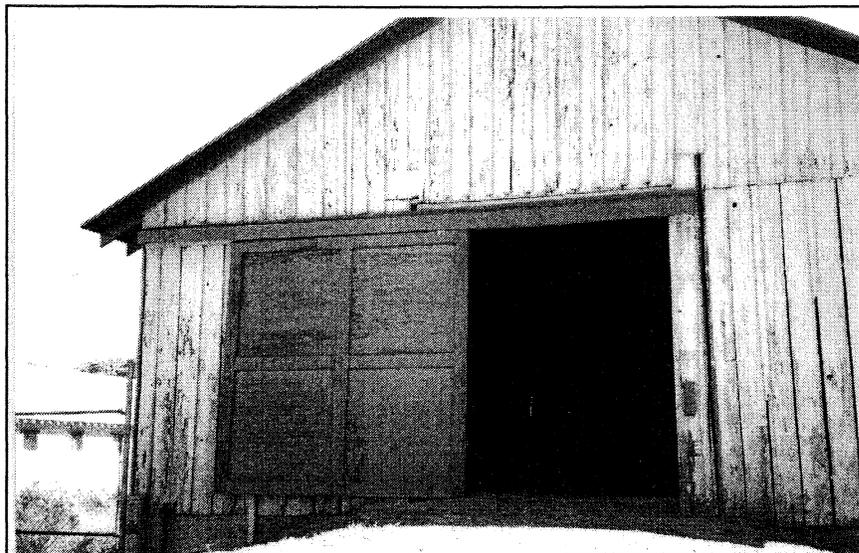
The west opening is 7 ft, 10 ½ inches wide by 9 ft, 0 inches high. On the exterior is a non-original, single-leaf sliding door suspended by metal brackets from a metal track. This door is wider than its opening and slides to the north. It, too, is an assembly of plywood and wood stiles and rails, but it is framed so that its inner face is flush. It is secured by screws and lacks the sheet metal elements found on the east door (Figure A.6).

FIGURE A.6. WEST SLIDING DOOR, AN ASSEMBLY OF PLYWOOD AND BOARD STILES AND RAILS (PHOTOGRAPH BY JANET PARKHURST, NOVEMBER 2004).

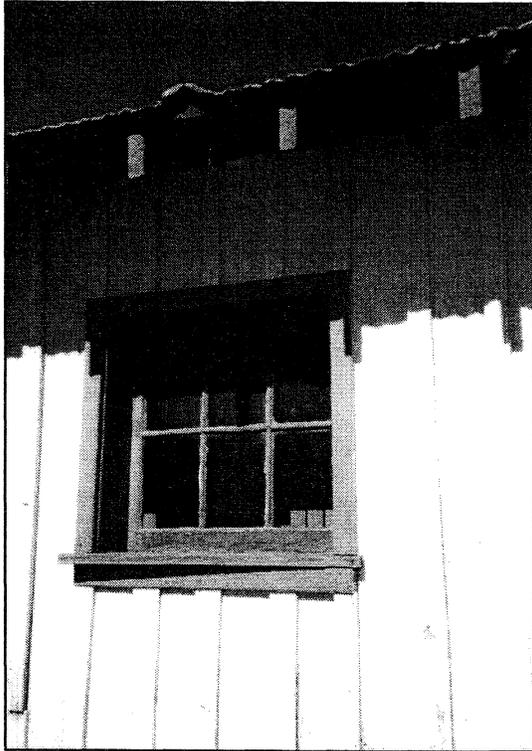
Identical, six-over-six double-hung windows are found on the east end to serve the former saddle shop and the grain storage room. There are three on the south façade and two on the north. They are in 2-ft, 8-inch by 5-ft, 2-inch rough openings (HABS No. AZ-210-A-7). Window sashes of the stalls have six panes and slide open inside on unusual, custom-built 6-ft, 4-inch-long tracks. Windows and tracks have a tongue and groove to facilitate positioning. The windows are installed in 2-ft, 10-inch by 2-ft, 9 ½-inch openings. While the other cavalry stables have the same size and type of sash, the existence of the tracks for sliding has not been found elsewhere (Figure A.7).

FIGURE A.7. TYPICAL SIX-LIGHT STALL WINDOW, SOUTH WALL (PHOTOGRAPH BY JANET PARKHURST, NOVEMBER 2004).

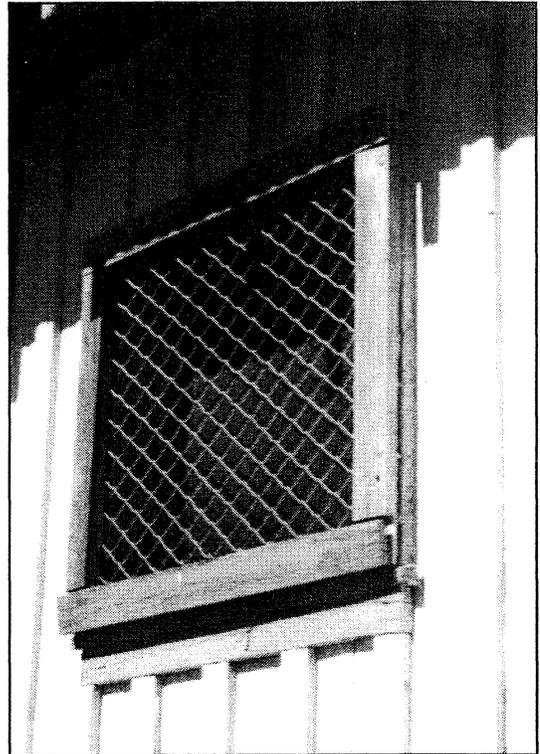
On the north wall in the former veterinary zone, the two westernmost windows have been modified into fixed windows. Their tracks have been removed, and they have screens on the exterior. All other windows in this zone are now open without sash. They have welded metal screen on the inside and are secured outside by a chain-link type, metal mesh in a wood frame bolted through the window casing. The frame for this grill is a 1 ½" x 3 ½". This security grill type is used on several other cavalry stables (Figure A.8).

FIGURE A.8. FRAMED WIRE-MESH WINDOW GRILL FOR VETERINARY CARE AREA, SOUTH WALL (PHOTOGRAPH BY JANET PARKHURST, NOVEMBER 2004).

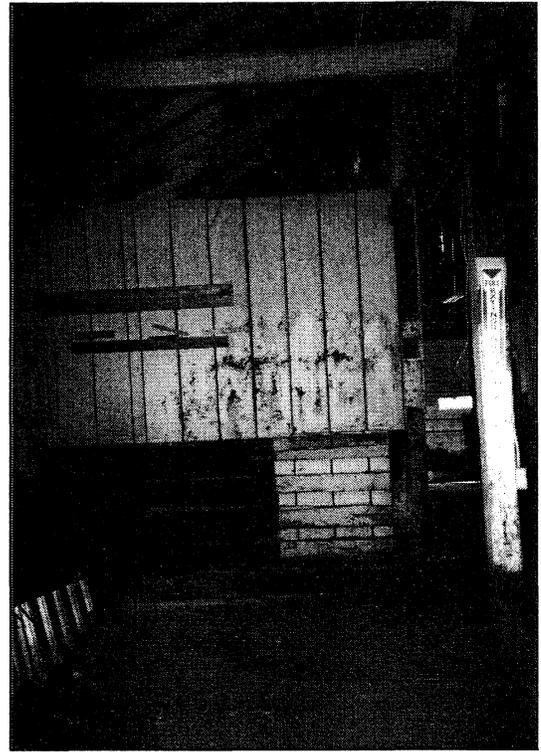
The outer faces of the west walls of the storage additions contain a most important revelation. These walls are partly constructed from the original stall rails. From this discovery, it is now possible to know how all stalls were railed initially. By examining the posts, it is evident that stalls were probably open on the aisle end, as in the original troop stables. The rails, varying in size from 2" x 5"s to 2" x 8"s, were framed into the wall side of each post. There were five rails with a lower nailing board. (Today, the lower board is partly exposed on the wall and otherwise nearly buried in the earth between some of the stalls.) On the top rail is a metal strip attached by tiny nails to prevent wood gnawing by the occupants of the stall (Figure A.10).

FIGURE A.10. WEST WALL OF NORTH STORAGE ROOM ADDITION SHOWING INCORPORATION OF ORIGINAL STALL RAILS AND PAINTING SCHEME OF BLACK BELOW, WHITE ABOVE (PHOTOGRAPH BY JANET PARKHURST, NOVEMBER 2004).

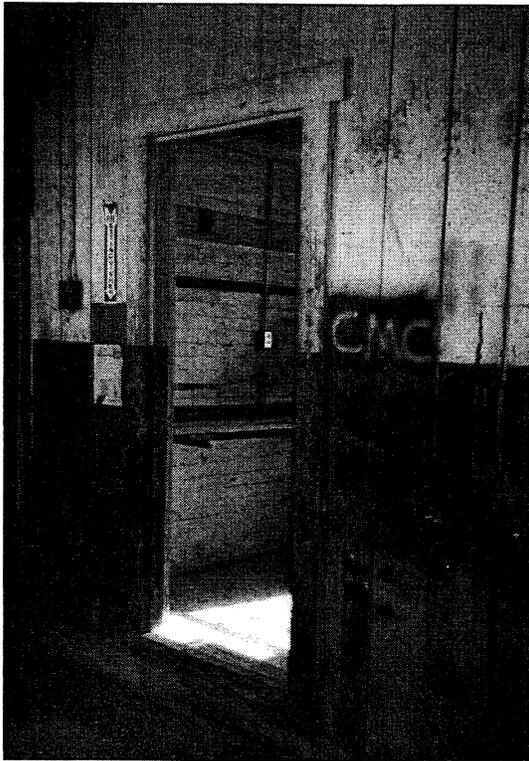
FIGURE A.11. SADDLE ROOM DOOR OPENING, MISSING ITS DOOR, FROM AISLE. NOTE RAISED THRESHOLD (PHOTOGRAPH BY JANET PARKHURST, NOVEMBER 2004).

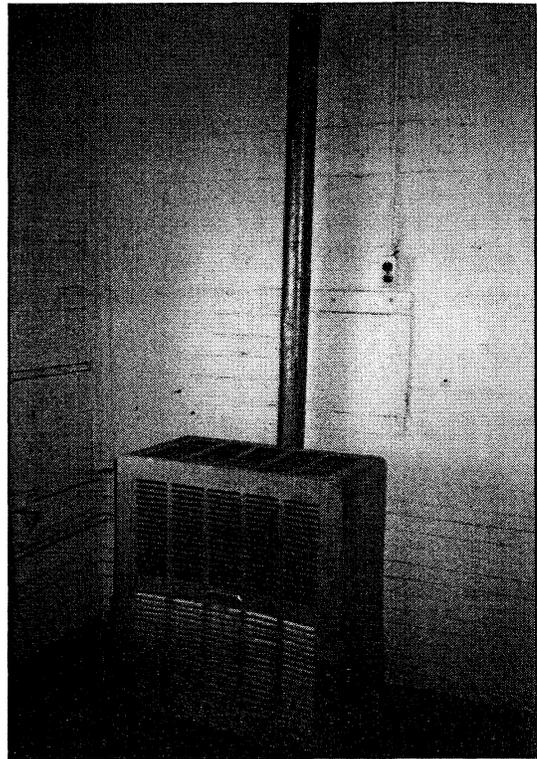
a. Heating, air-conditioning, ventilation: When first constructed, the building had no mechanical equipment. Ventilation, a necessity for a stable, was provided through operable windows. According to the real property record, the space heater in the east office of the modified north saddle room was installed in 1974 (U.S. Army Form 2877). It is a dented, "Brilliant Fire" gas heater with a 4-inch-diameter flue that passes through a makeshift hole in the roof. It has a 1-inch gas connection (Figure A.14).

FIGURE A.14. SPACE HEATER IN NORTH-EAST CORNER OF THE EAST OFFICE OF THE NORTH SADDLE ROOM (PHOTOGRAPH BY JANET PARKHURST, NOVEMBER 2004).
