SHIP SHOAL LIGHT STATION  
(Ship Shoal Lighthouse)  
Gulf of Mexico  
~~Berwick~~ vicinity  
Terrebonne Parish  
Louisiana

HAER No. LA-12

SHIP SHOAL LIGHT STATION

Report Prepared by: Greenhorne & O'Mara  
Roger Kilgore  
Project Manager  
Marlene Walli Shade AIA  
Principal Historian

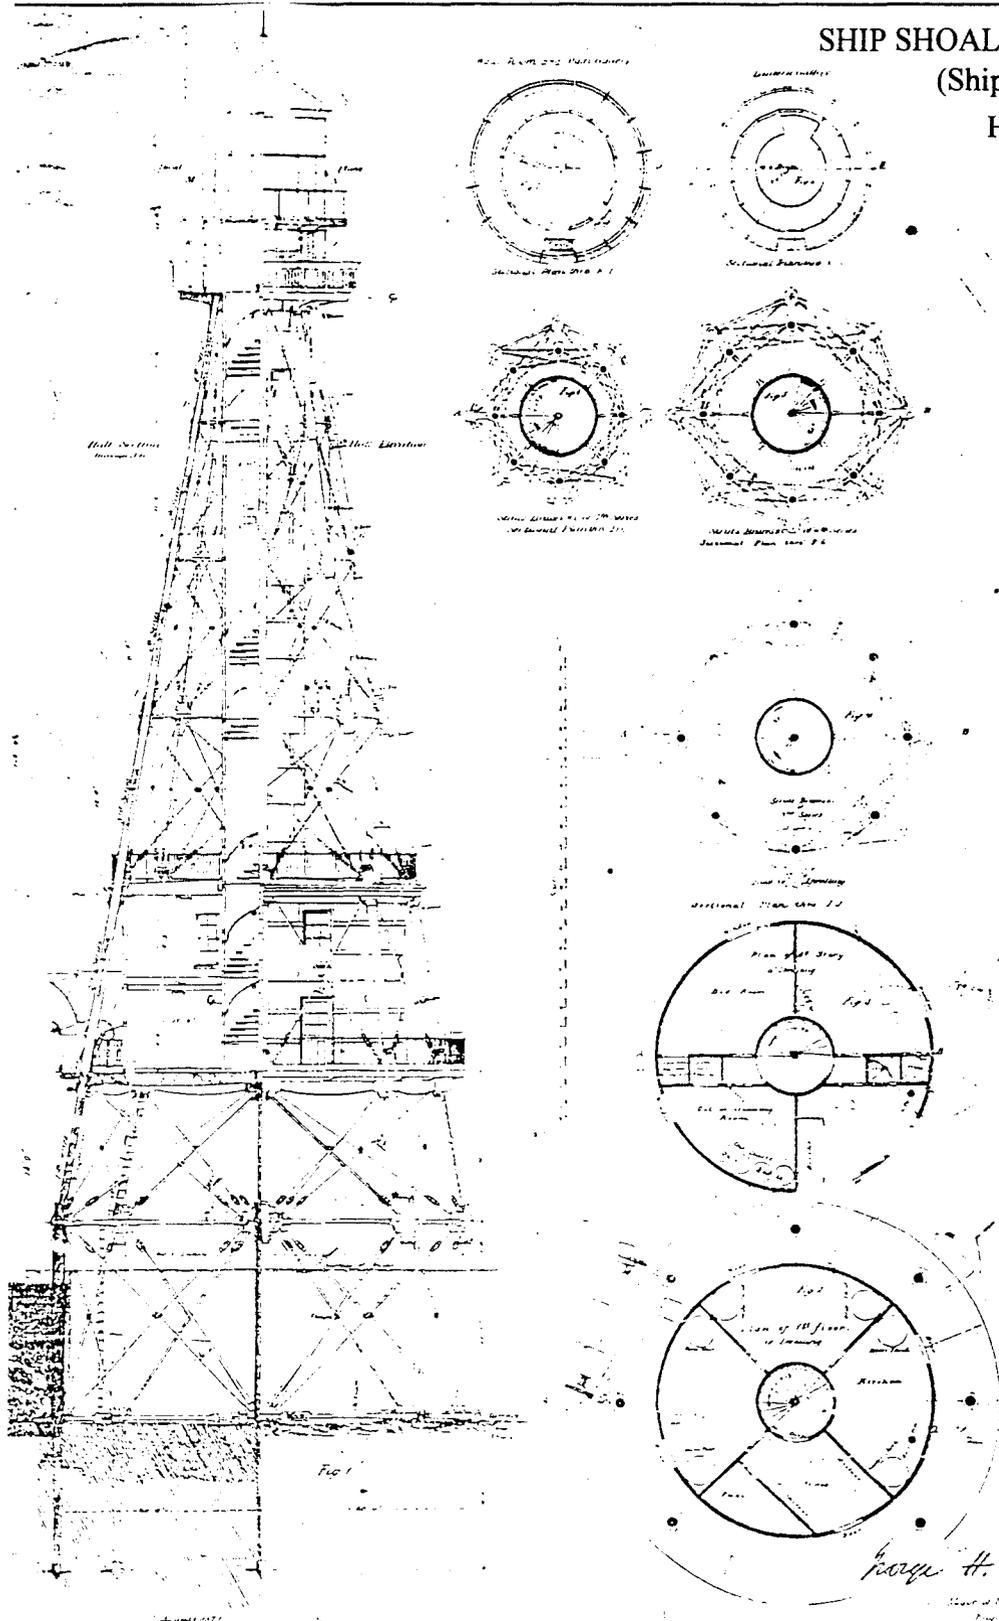
A section/elevation and floor plans of the dwelling unit that appear on a drawing dated 1871 was found in the possession of Gulf South Engineers of Houma, LA. (Figure 3) This drawing was not found at the National Archives but appears to be copies of pieces of the original drawings compiled onto one sheet and reissued as part of renovations. This drawing, prepared by George H. Elliott, Major of Engineering, show sectional plans of the lighthouse at seven levels. The largest diameter occurred at the first floor of the dwelling and is shown on the drawings as a circle, with a diameter of 27'6". This circle was pierced by a 8'0" diameter stair tower. The first level was split into four main pie shaped rooms, three of which contain two water storage tanks each. The fourth level was split into a corridor with storage and a second room for fuel storage. A door led from the corridor to the gallery which surrounded this dwelling and another to the stair tower. The west quarter of the circle was occupied by an unidentified room<sup>9</sup> and the east quadrant by the kitchen. A vertical pipe which collected water from the roof passed through this room.
