WEST RIM DRIVE
(Grand Canyon Route #8)
Between Grand Canyon Village
and Hermit Rest
Grand Canyon National Park
Coconino County
Arizona

HAER No. AZ-42

WEST RIM DRIVE
(Grand Canyon Route #8)
(~~Hermit Rim Road~~)
HAER No. AZ-42

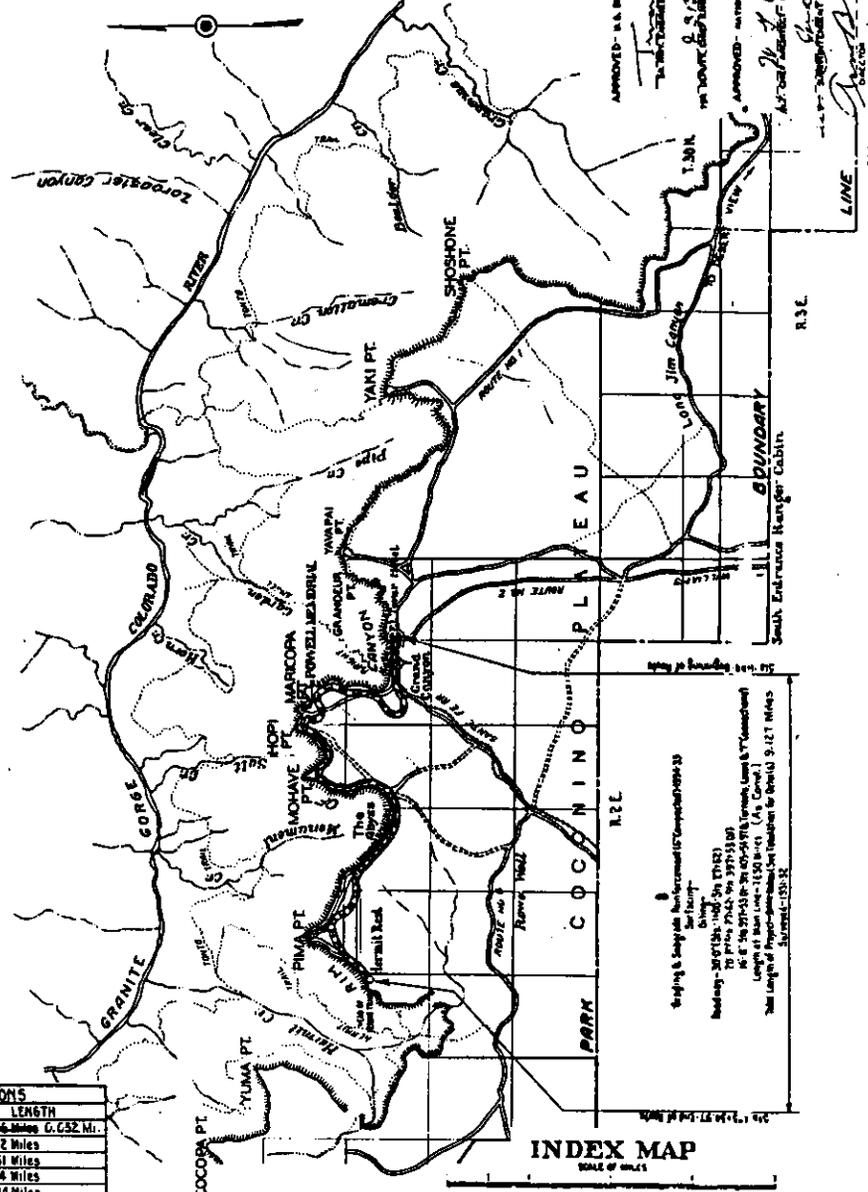
AS CONSTRUCTED PLANS FOR
PROJECT NR-8, GRADING AND
SUBGRADE REINFORCEMENT
ROUTE NO. 8 ~ HERMIT REST
GRAND CANYON NATIONAL PARK
HIGHWAY SYSTEM
ARIZONA

APPROVED FOR CONSTRUCTION -
Project NR-8, Grading and Subgrade
Reinforcement. Sta. 1+100 - Sta. 405+54.97.
Contract includes turnouts, loops and "Y"
connections as shown in tabulation at left.

Figure 4. Specifications cover sheet for the 1934-35 construction of West Rim Drive.

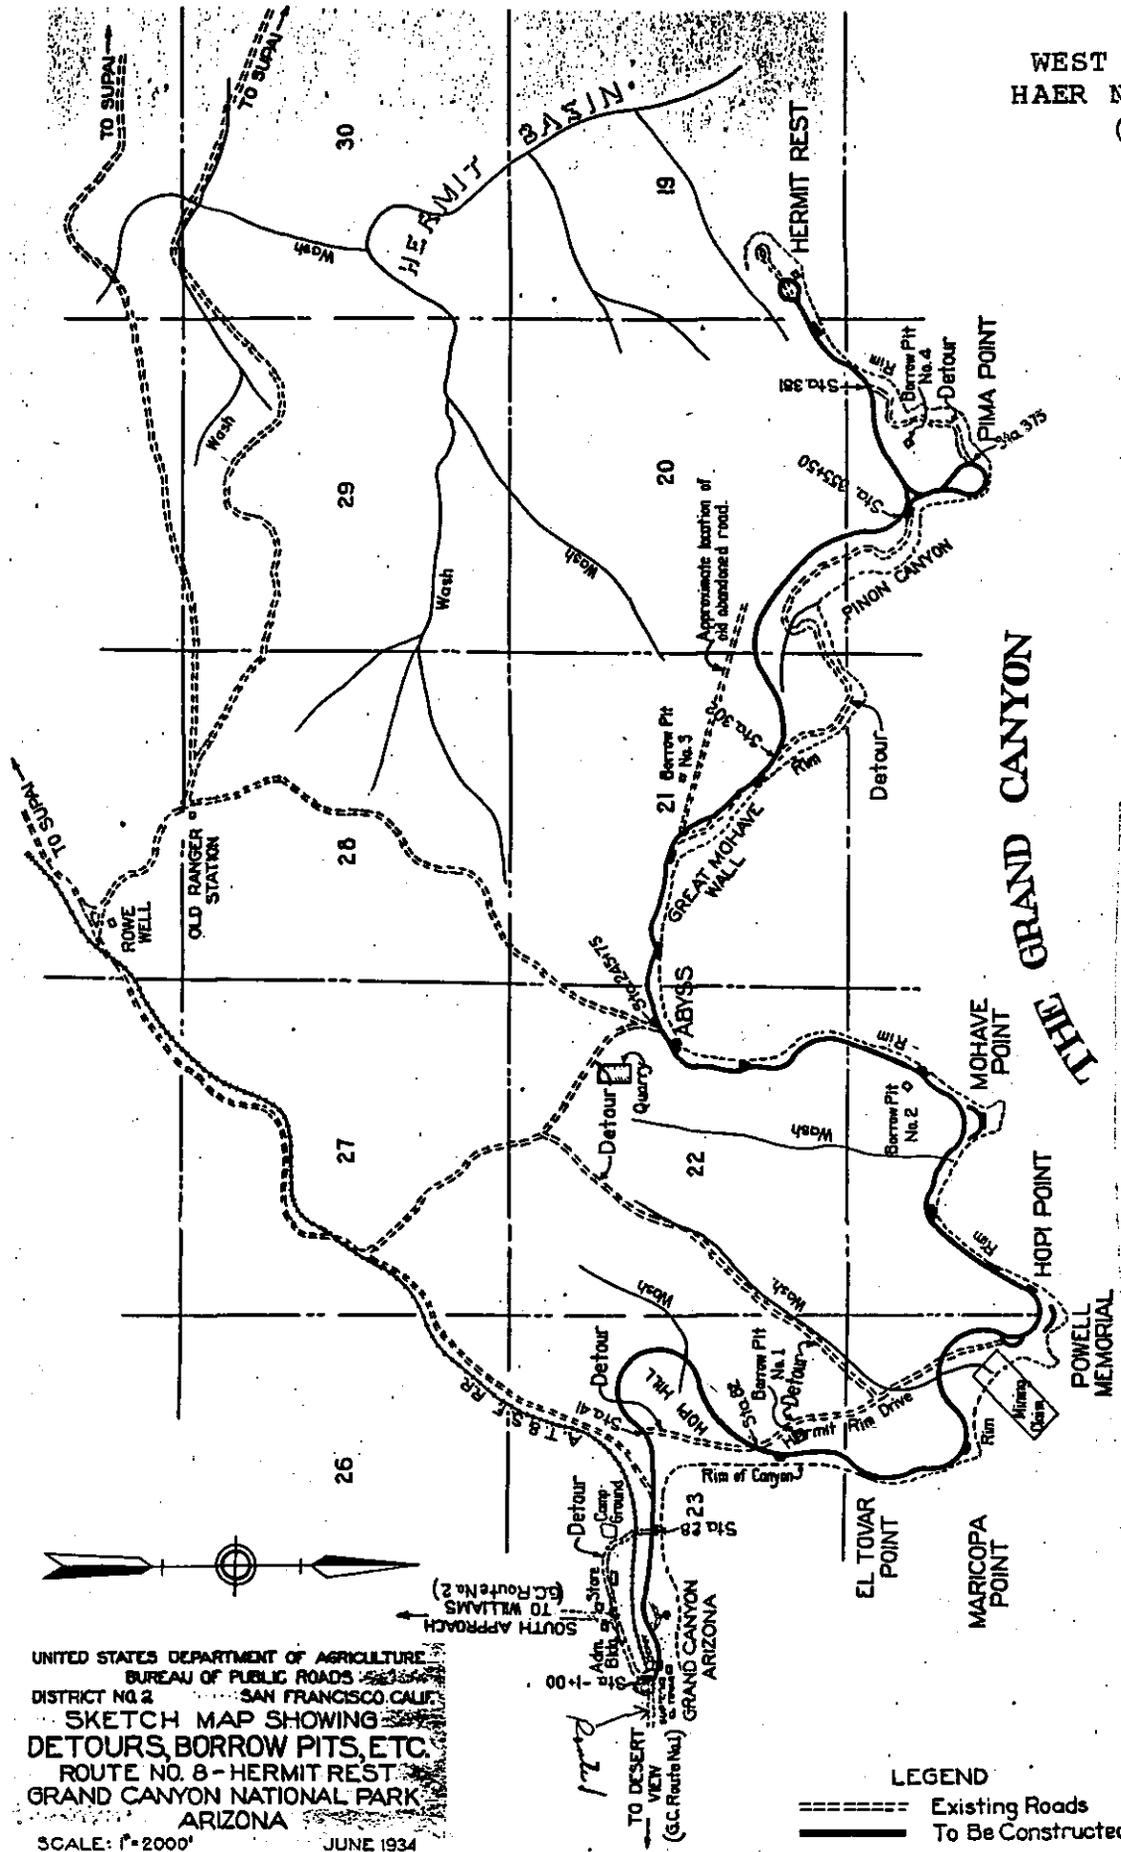
Figure 5. Sketch map from 1934 construction specifications indicating the alignment of the old Hermit Rim Road as well as the new West Rim Drive

Wallace and Horton located the new line atop the old alignment from the Powell Memorial and Hopi Point area to Station 302+00, with only minor exceptions. From Station 302+00 to 381+00 the new line continued a short distance away from the rim and old alignment, touching briefly at Station 355+50 to allow a scenic spur loop at Pima Point. While Hermit Rim Road extended to the south and west of Hermit Rest (the segment used today to the Boucher Trailhead parking area), the new line ended at Station 405+54.97 in a loop parking area, directly east of Hermit Rest.⁹

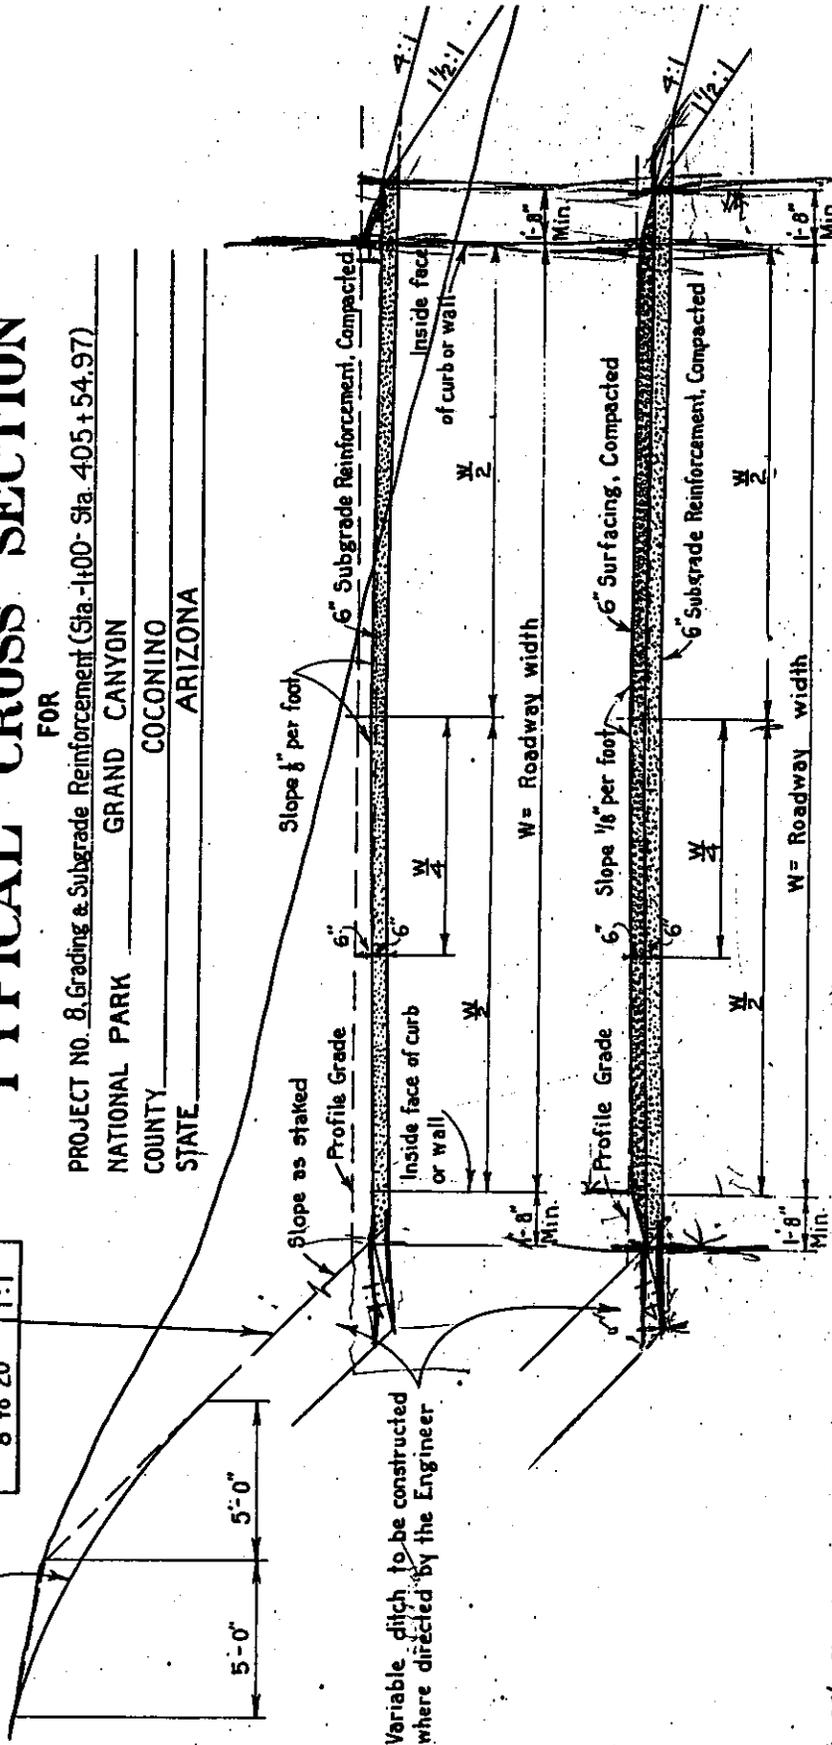
TYPICAL CROSS SECTION

SHOULDER CUT	SLOPE
0' to 5'	2:1
5' to 8'	1 1/2:1
8' to 20'	1:1

Cut slopes rounded in accordance with the specifications

W = 30' - Sta. -1400 - Sta. 27+62.
 W = 20' - 8" - Sta. 27+62 - Sta. 397+53.01.
 W = 16' - 8" - Sta. 397+53.01 - Sta. 405+54.97 (Hermi Rest Loop) and turnouts, loops and Connections.

All curves are to be widened and superelevated as per instructions.
 Where drainage conditions require larger side ditches the necessary widening shall be done.
 Maximum Superelevation = 0.128' per foot width of roadway.

Figure 6. Cross section of road grade for the 1934-35 project.

The BPR completed final survey and specifications in summer 1934. The project called for 0'-6" of compacted subgrade reinforcement and 0'-6" of compacted grade surfacing from Station -1+00 to 405+04.53 on the main road, for a total of 7.65 miles; and an additional 1.491 miles of wye connections, spurs, loops, and turnouts, for a total project length of 9.141 miles. The 18' roadway (widened at curves and with 3' shoulders) was designed with a 7 percent maximum grade, minimum radius curves of 345', a center crown sloping toward the shoulders at a rate of 1/8" per foot, and superelevations amenable to a maximum speed of 30 miles per hour. Loops and spurs were designed for speeds not to exceed 15 miles per hour.

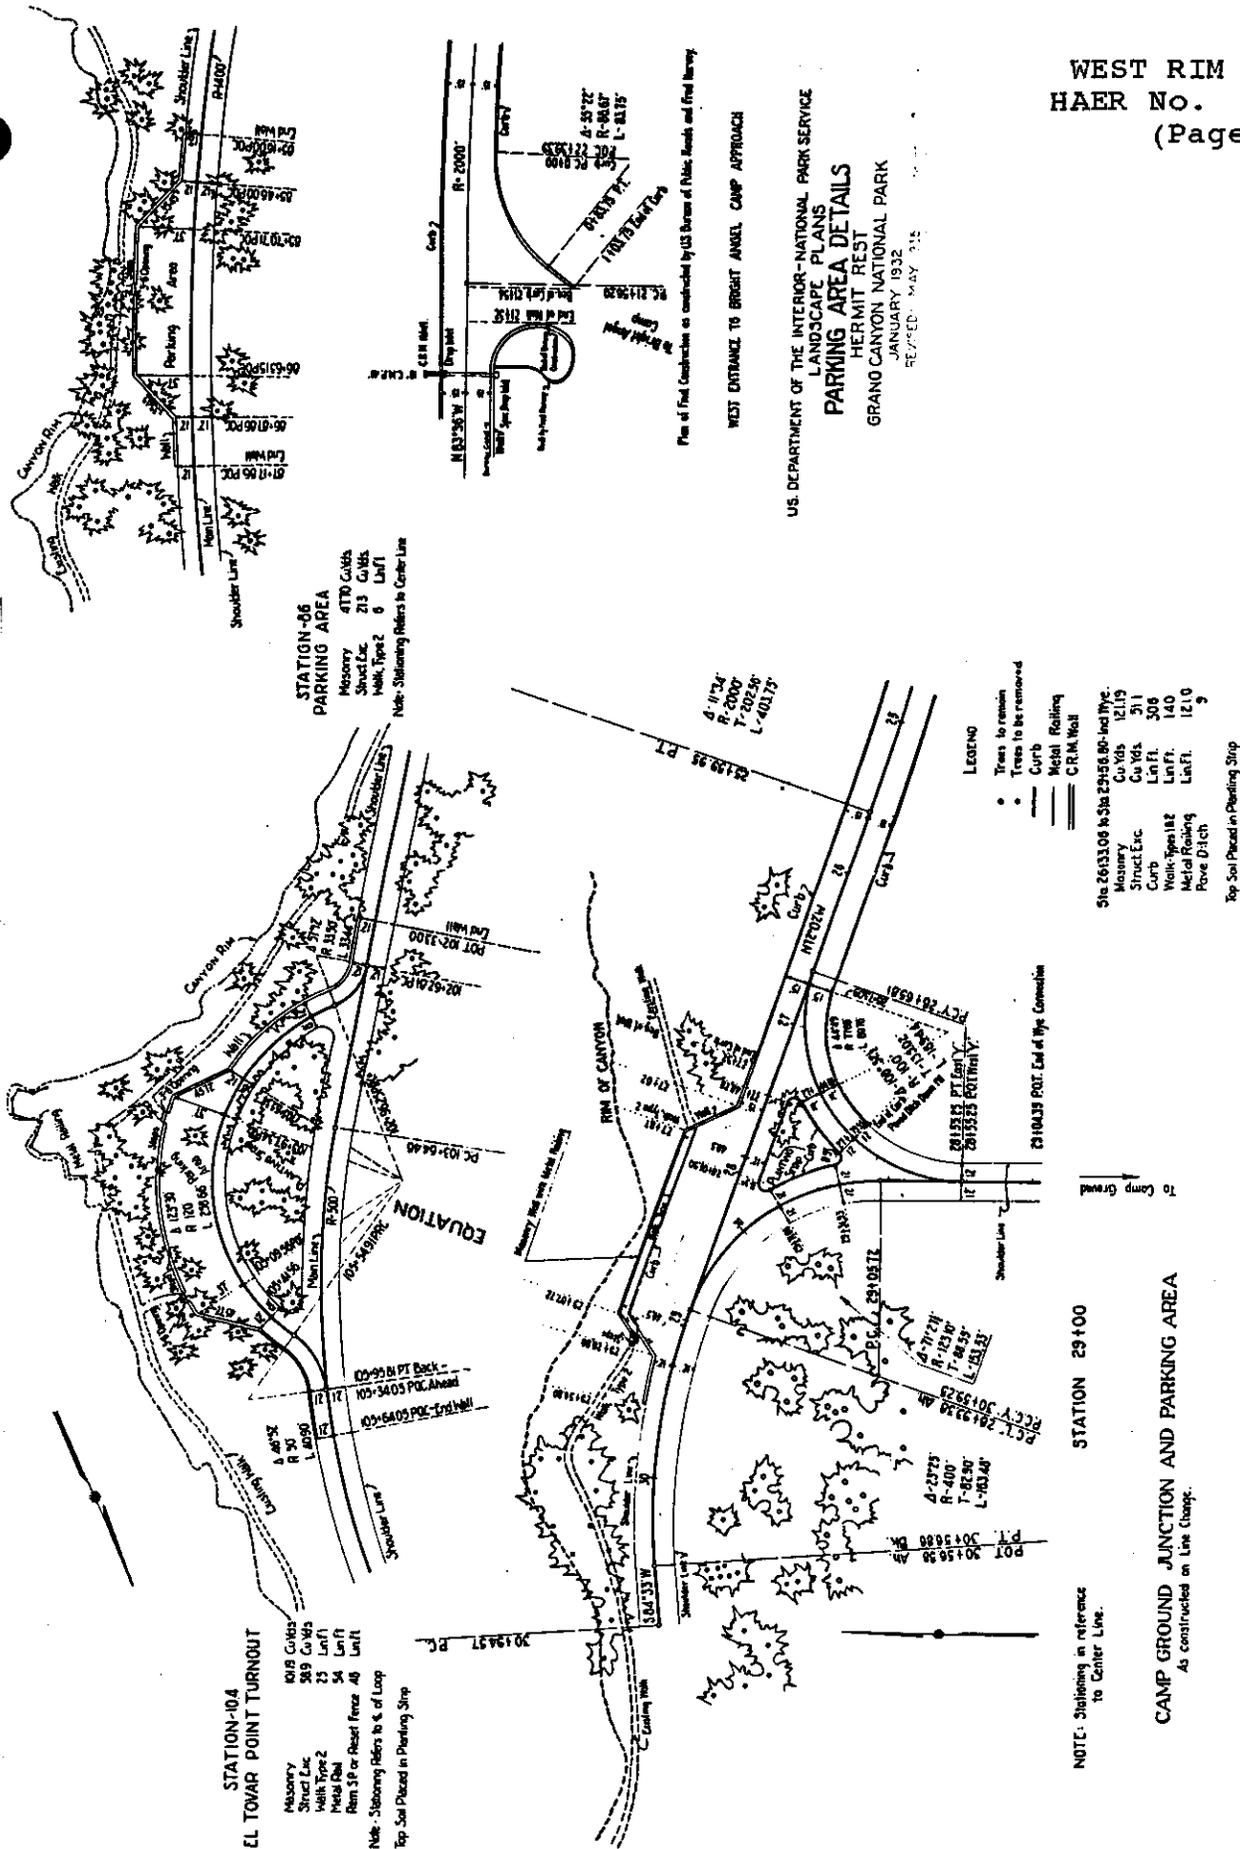
Figure 7. Detail sheet from 1934-35 construction drawings showing the major turnouts and intersections.

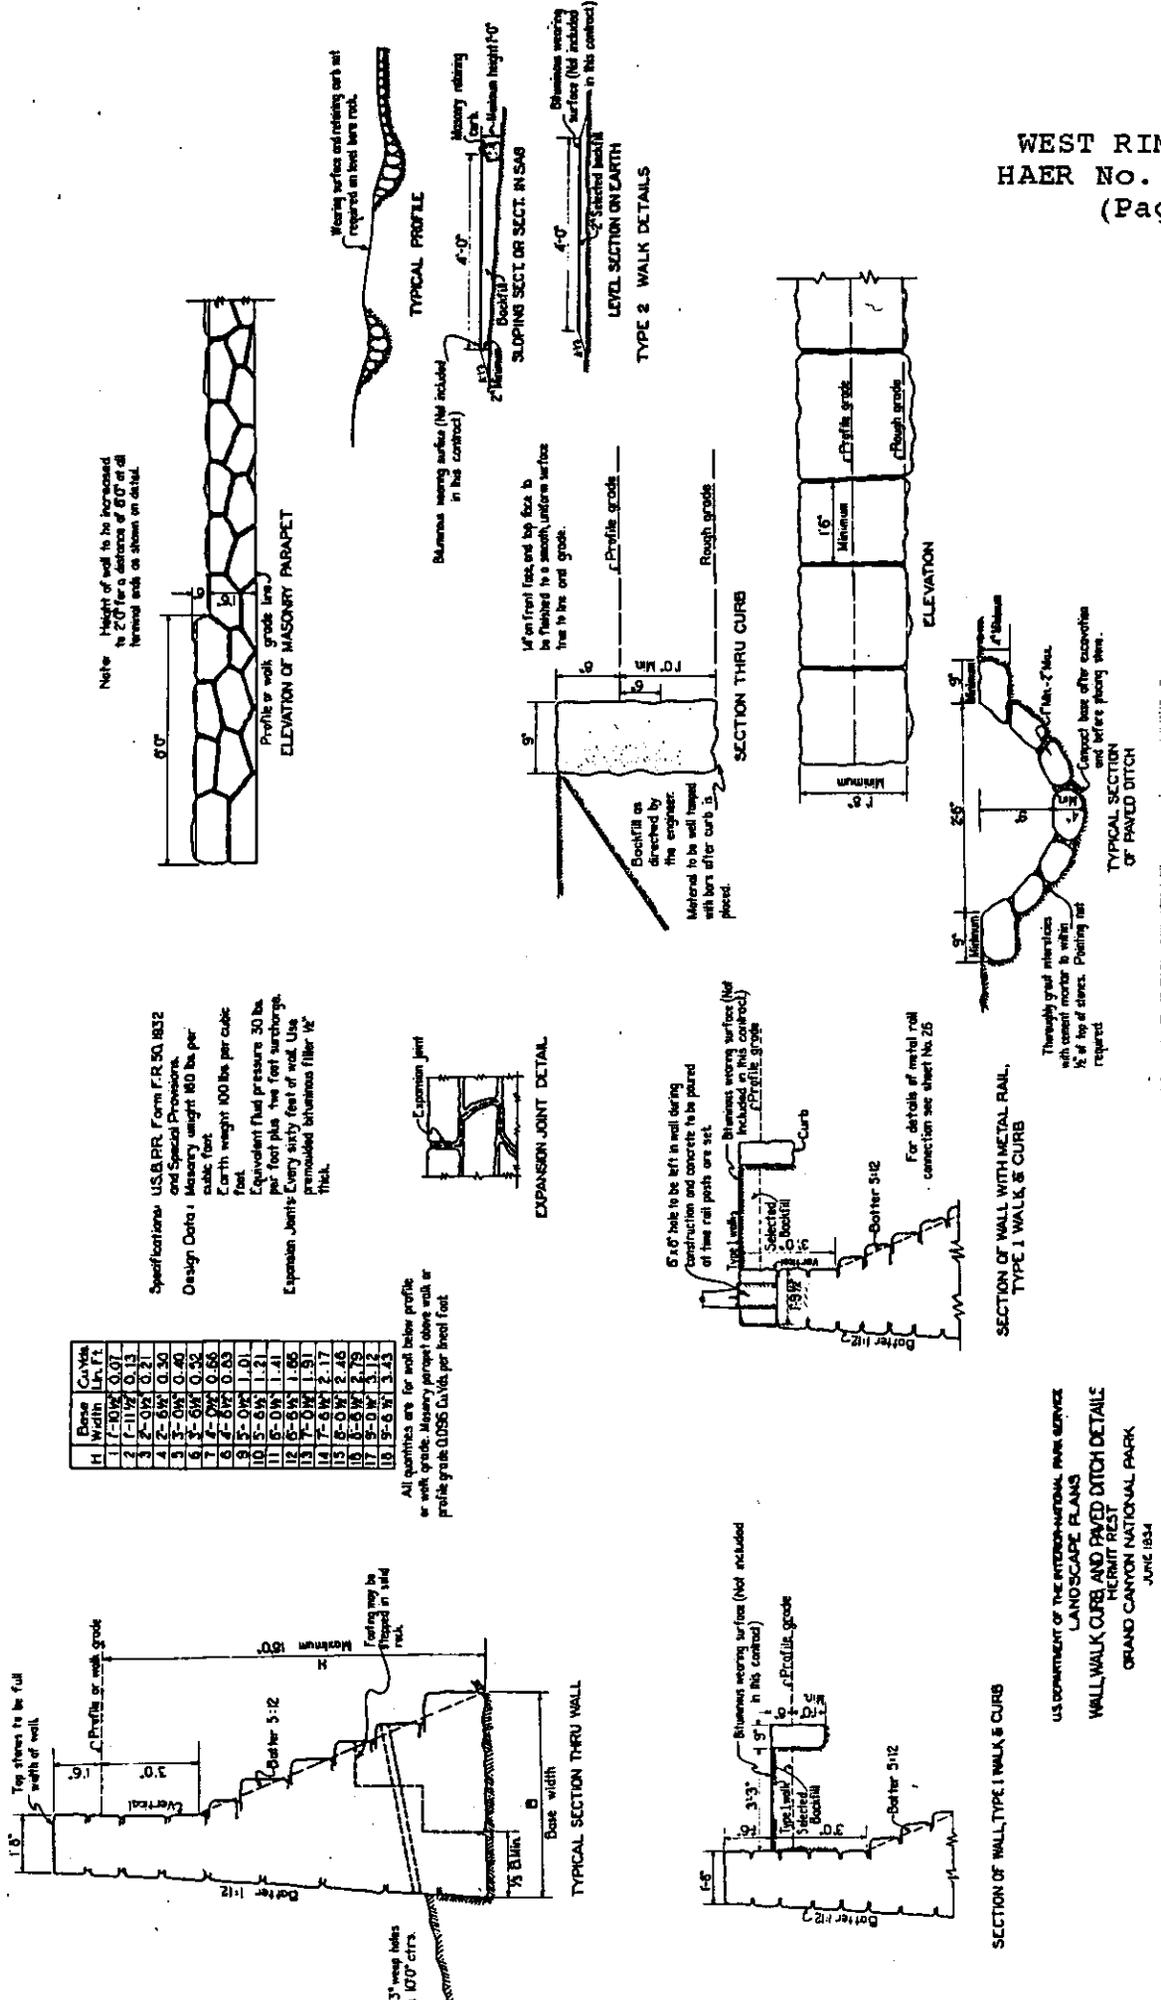
Figure 12. Paved ditching, walls, walks, and curbs specifications from 1934-35 construction drawings.

U.S. DEPARTMENT OF THE INTERIOR-NATIONAL PARK SERVICE
LANDSCAPE PLANS
WALL WALK CURB AND PAVED DITCH DETAILS
HERMIT REST
GRAND CANYON NATIONAL PARK
JUNE 1934

The masonry walls at this pullout were constructed per 1934 specifications with native stone (typically weathered, which is preferred), and completed in May and June 1935. These walls as well as all masonry walls in the 1934-35 project, are of rock quarried from the pits west of the Abyss or Pinon Cove and built to the necessary height below profile grade with uniform 16" parapets above profile grade. These walls generally have 8'-long end sections which are two feet in height--also called for in the original specifications. Major portions of these walls--perhaps 90 percent or more of all walls along the roadway, loops, spurs, and parking areas today--appear to date to the 1934-35 project.

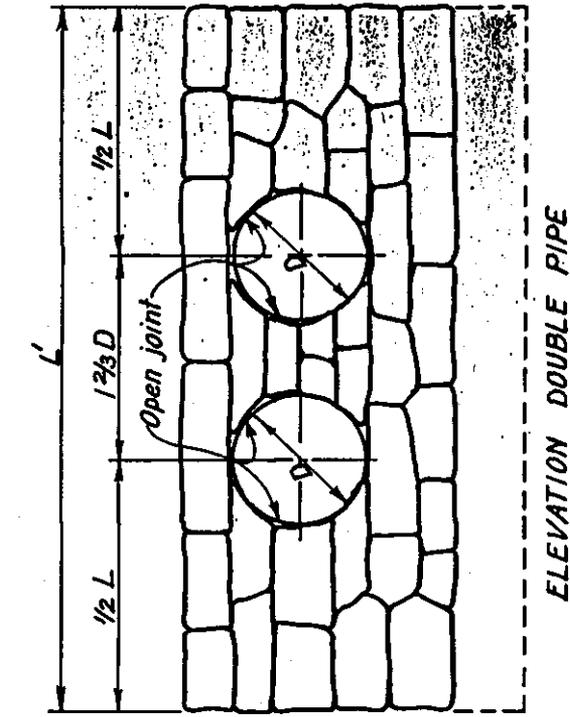
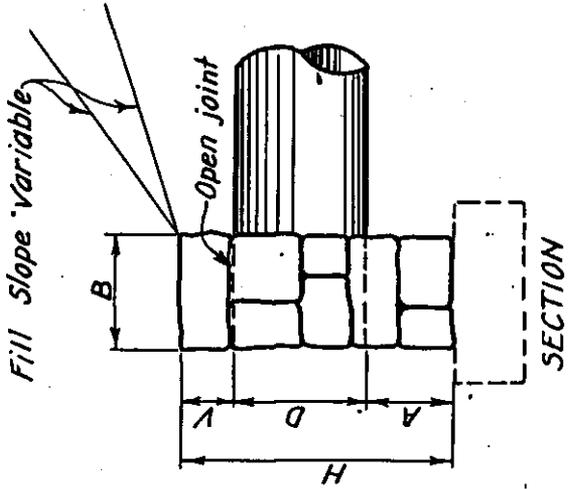
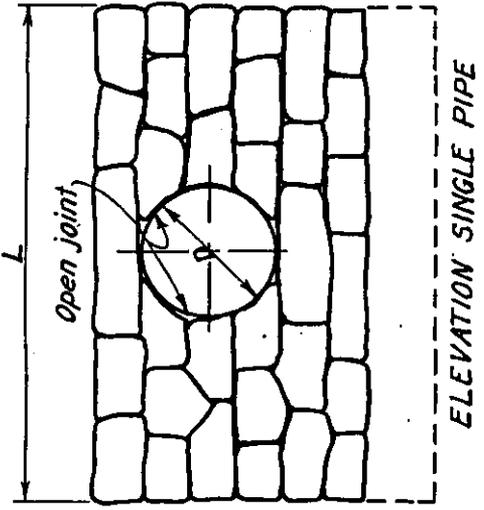
ELEVATION DOUBLE PIPE

ELEVATION SINGLE PIPE

Notes:
 Specifications, Bureau of Public Roads Form F.R. 50, Revised 1932.
 Dimension "v" can be varied from 6" to 9", so that advantage can be taken of the stratification of available stone. Pay Quantities and the values of "H" are based on "v" = 6".
 12" and 15" pipe to be used only for farm entrances/crossings.
 Headwalls in all cases to be parallel to center line of road.
 Provide good foundations under headwalls. Dimension "A" given in table are minimum values to be used except in solid rock. Where necessary to go deeper for good foundation make footings as indicated by the dotted lines.
 Joints between the pipe and headwall above center line of pipe to be left open for expansion.

UNITED STATES DEPARTMENT OF AGRICULTURE
 BUREAU OF PUBLIC ROADS
 DISTRICT NO. 2 SAN FRANCISCO
 SPECIAL MASONRY HEADWALLS
 FOR
 PIPE CULVERTS

Figure 13. Culvert masonry headwall specifications from 1934-35 construction drawings.

slope to maintain an even grade. Specifications called for seven 18" and one 36" culverts with masonry headwalls beneath the roadway along this segment.

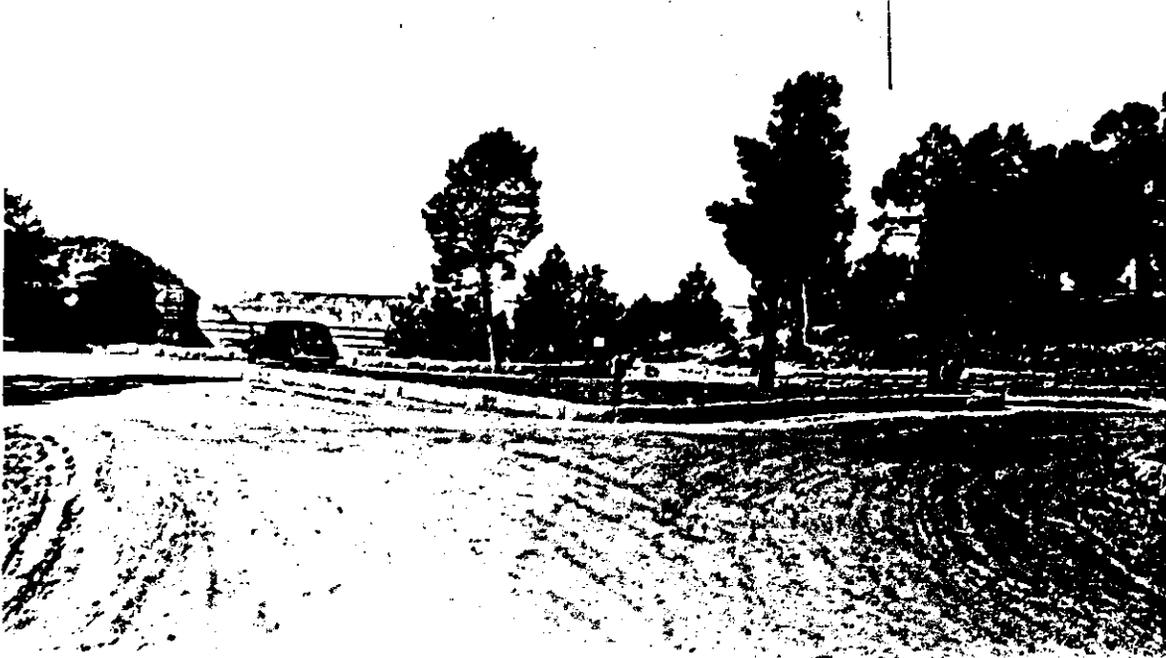
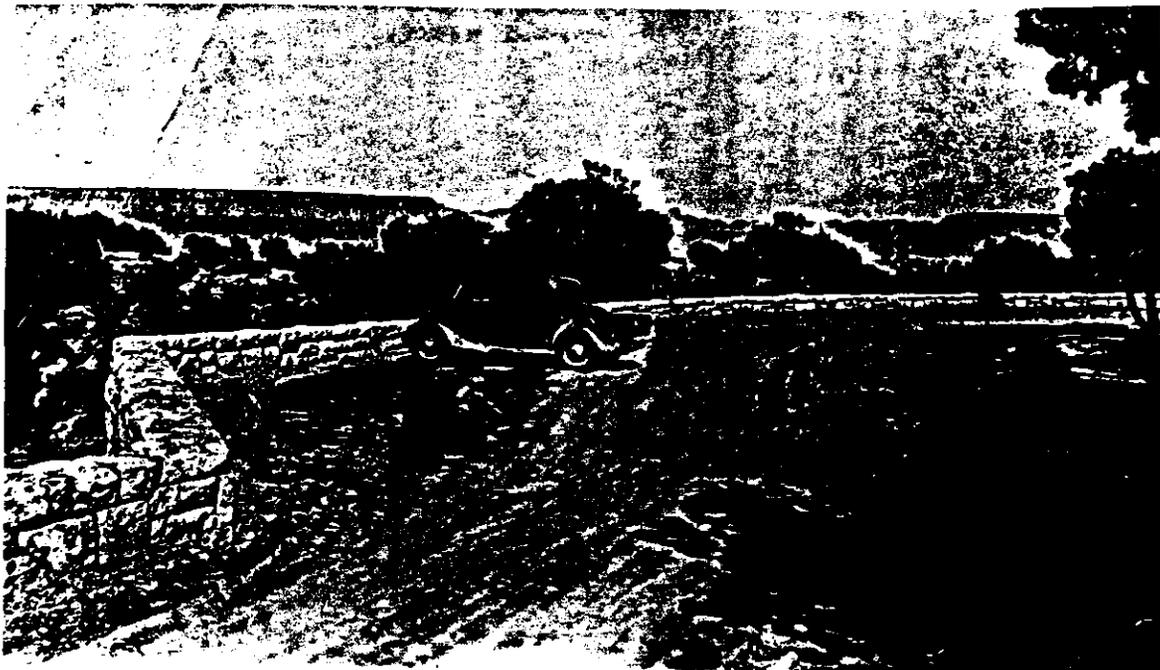
Figure 14. Above: Island with masonry curbing at Station 28, the beginning of today's West Rim Drive, facing north, 1935. Note the auto at the first pullout. (GCNP Photo Collection, Image #7601).

Below: A pullout along the recently completed West Rim Drive, 1935. (GRCA Image #7600, GCSC)

The road as completed in 1935 contained a landscaped island at the center of the wye intersection, surrounded by masonry curbing. This island, which channeled 150 automobiles and five or six Fred Harvey busses per day in 1935 (contemporary traffic estimates) is replaced today by a wye intersection painted in yellow atop the asphalt. A shuttle bus stop occupies the space on the north side of the roadway approximately between Stations 26+75 and 27+35, and the entire roadway is blocked by wooden fencing and gates. The latter features are new, results of increased traffic on West Rim Drive (a dead end road) which

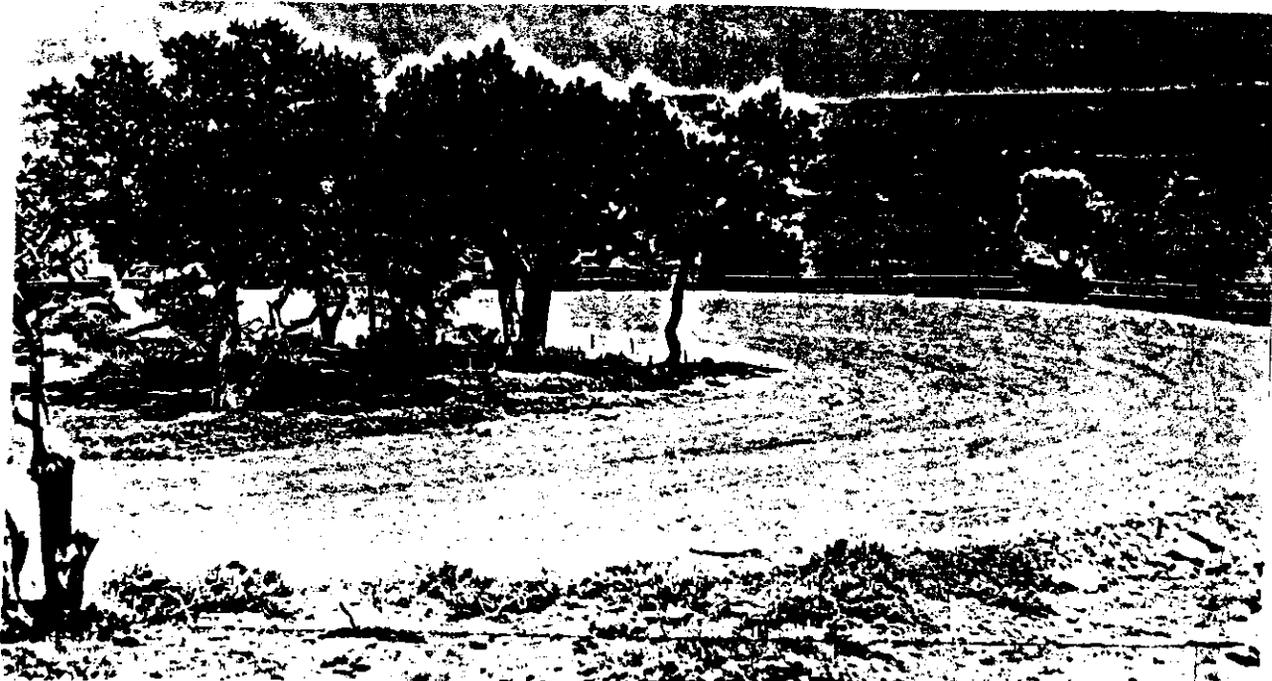
Figure 16. Hopi Point loop under construction, 8 July 1935. (GRCA Image #2985, GCSC)

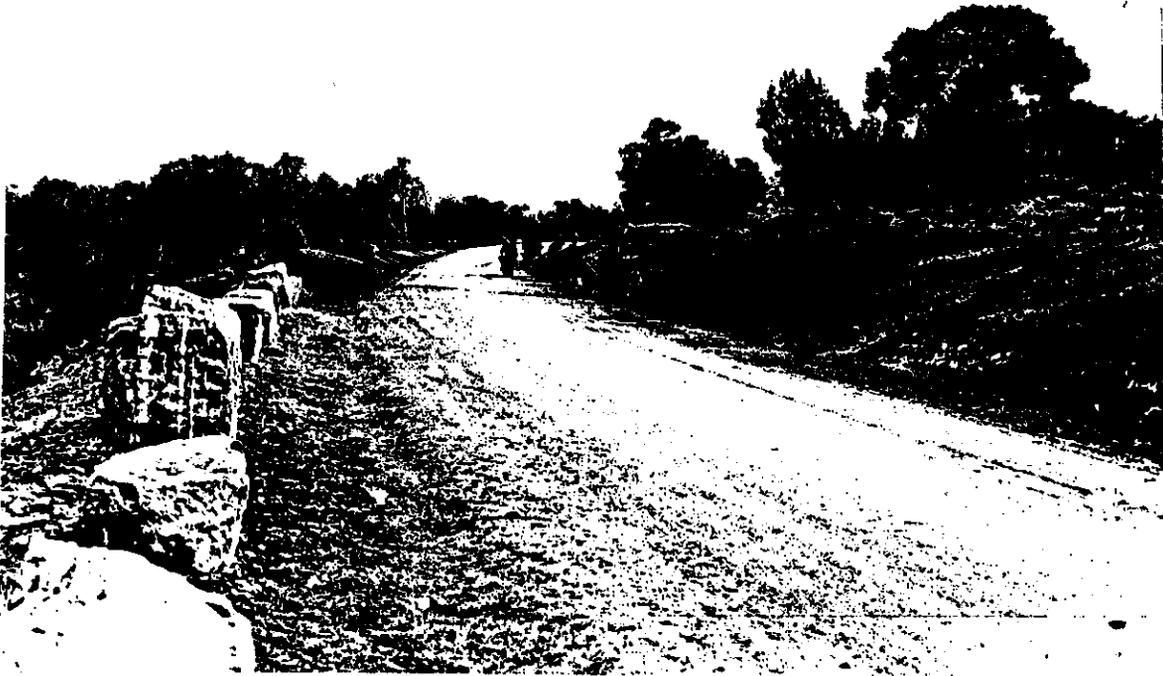
Figure 17. Workers engaged in roadside cleanup and old road obliteration, 1935. (GRCA Image #2873, GCSC)

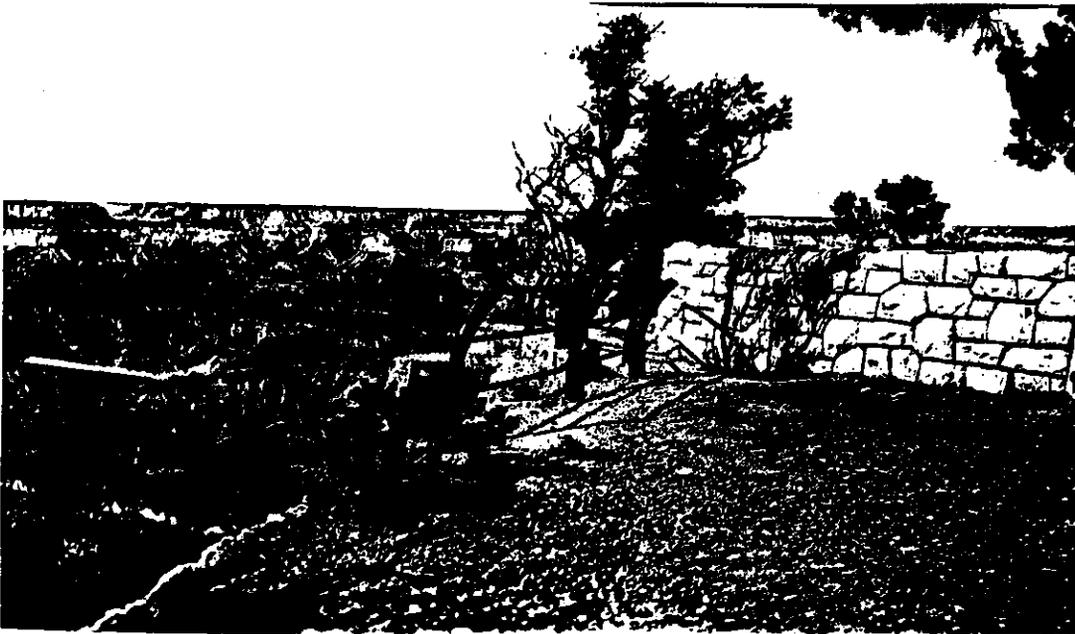
Figure 18. Fine masonry wall beside pedestrian guardrails at a pullout, 1935. (GRCA Image #8873, GCSC)

Metal railings at this pullout are also typical of 1934 specifications and representative of all railings at scenic overlooks, spurs, and loops along West Rim Drive. These are galvanized wrought-iron posts with metal pipe rails. Posts are curved inward toward the onlooker and bolted into 16" of concrete atop masonry walls (as found at this pullout), or similarly bolted into rimrock limestone where walls are not present. Three pipe rails (1-1/2" diameter on top; 1-1/4" diameter in the middle and bottom) are inserted through cored holes in the posts, which are spaced 9'-6" apart. Unskilled laborers assembled these

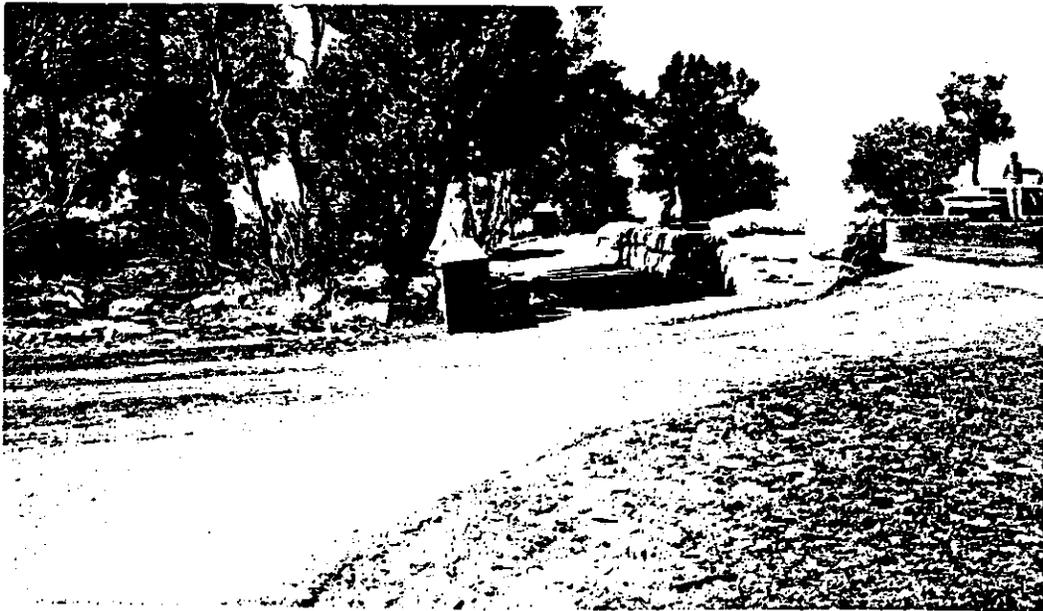
Figure 19. 1962 modifications: Bituminous walk with masonry curb and wall (background) at Hermits Rest. (From completion report, GRCA 61773, Box 6, GCSC; all following photos from same report)

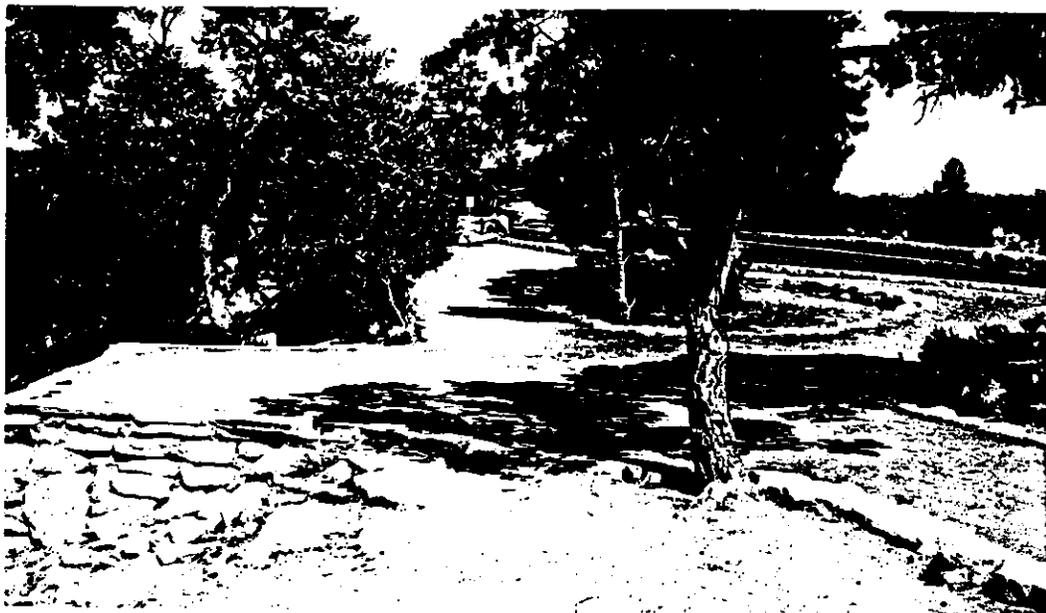
1962 modifications: Bituminous walk with masonry curbing at Hermits Rest.

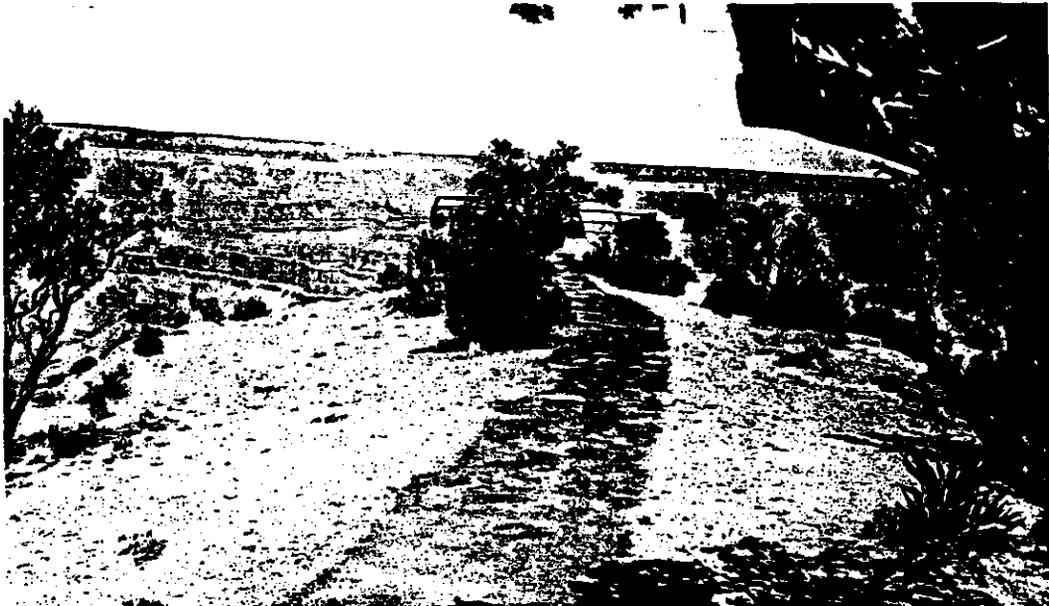
Figure 20. 1962 modifications: Bituminous walk leading to Maricopa Point viewpoint.

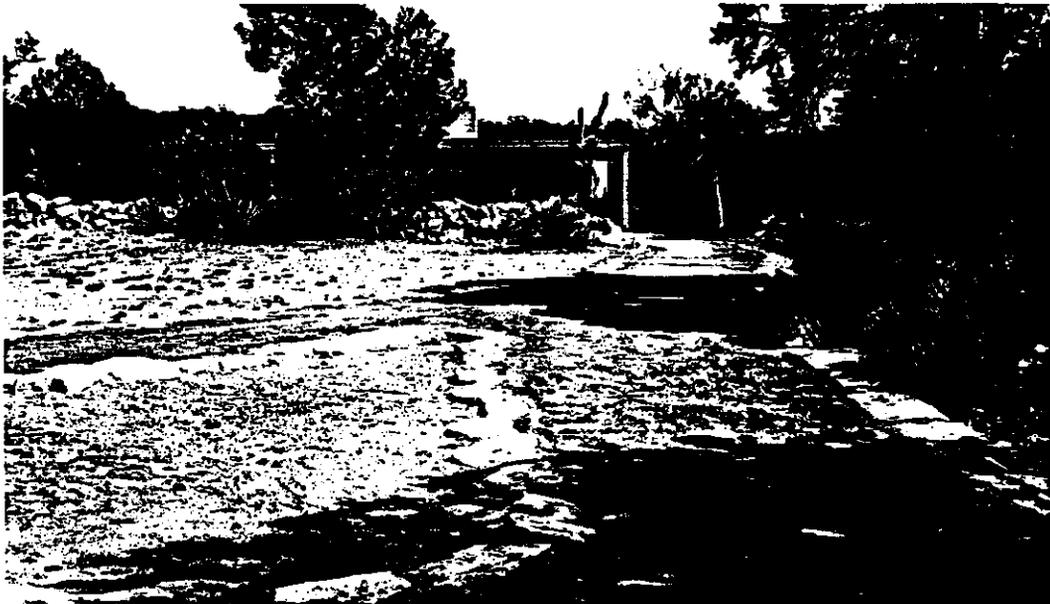
1962 modifications: Bituminous walk with masonry curb leading to "comfort station" at Hermits Rest.

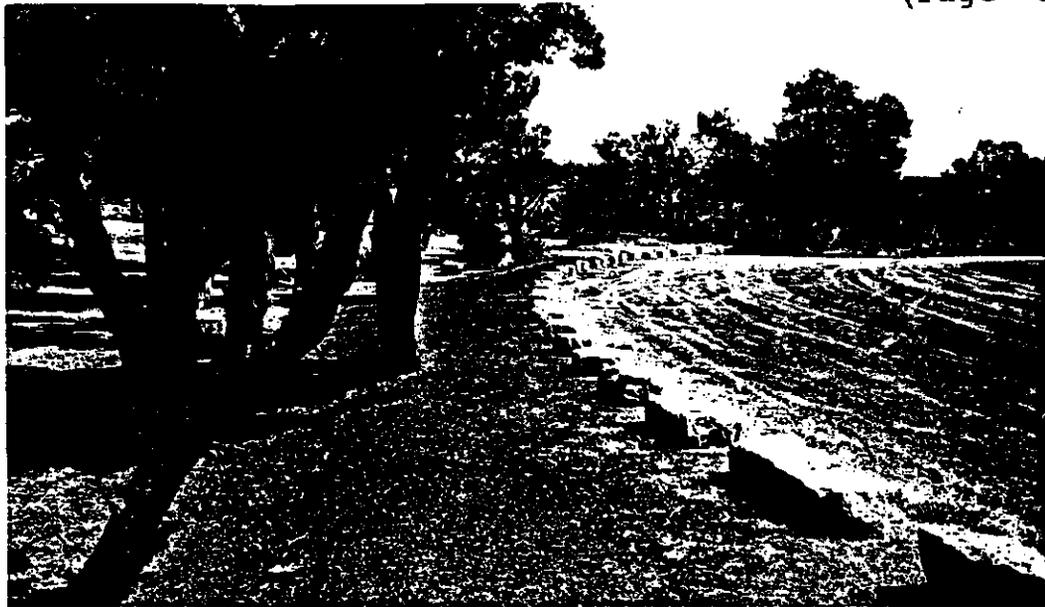
Figure 21. 1962 modifications: Bituminous walk behind rock curbing at Maricopa Point parking loop.

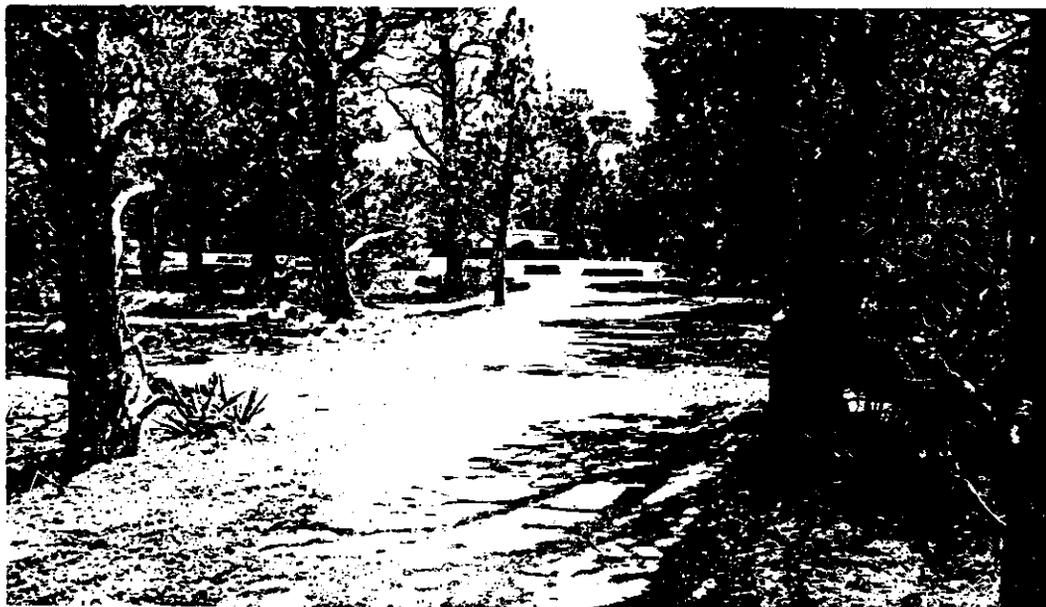
1962 modifications: Bituminous walk from Maricopa Point parking loop to the rim walk.

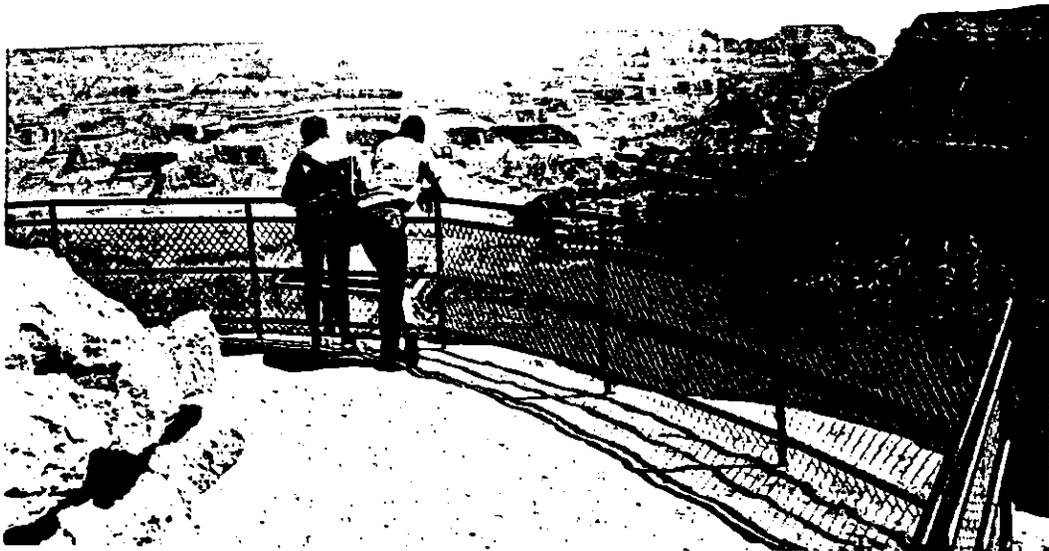
Figure 22. 1962 modifications: New guardrail and chain link fencing at Trailview pullout.

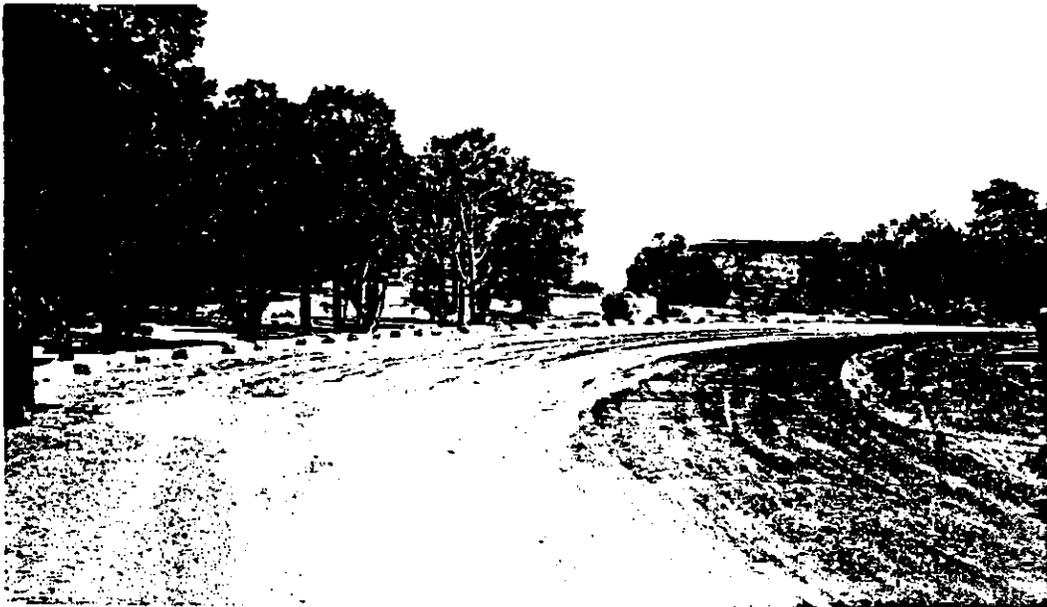
1962 modifications: Rock curbing at Maricopa Point parking loop.

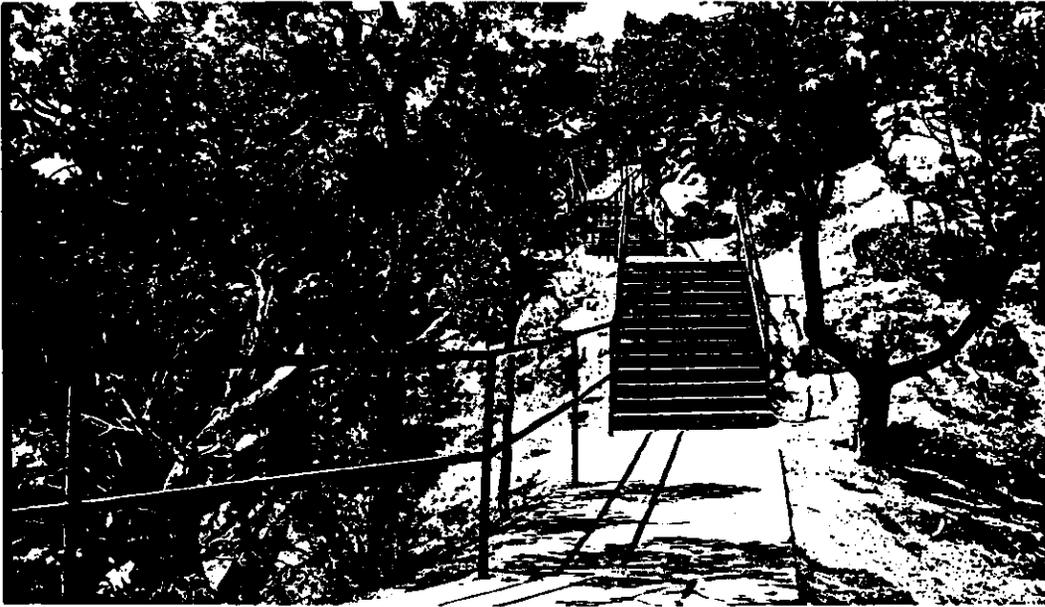
Figure 23. 1962 modifications: Lower level concrete walk, steps, and pipe handrail at Trailview Point.

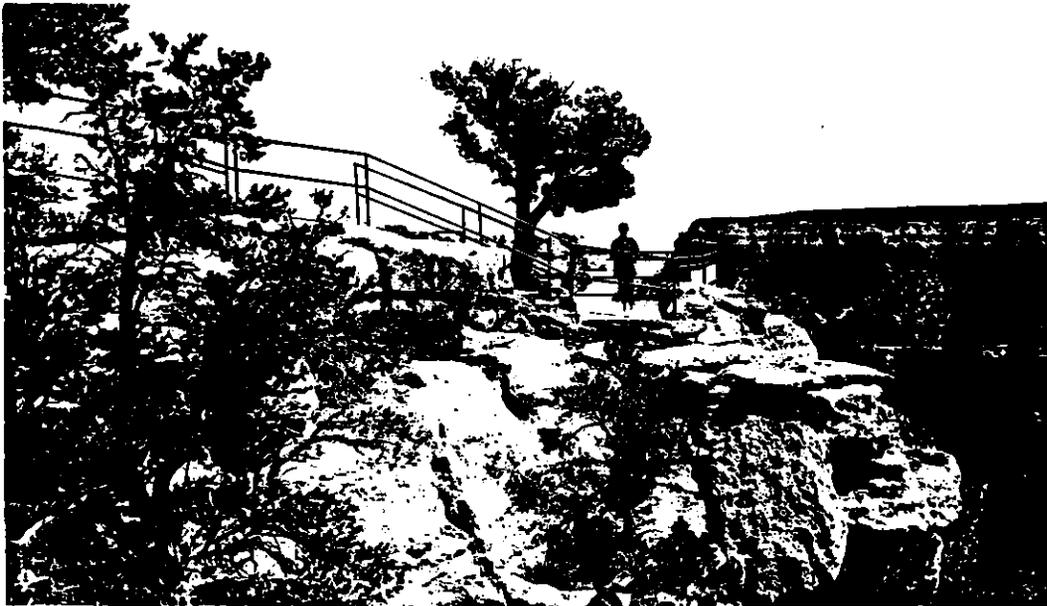
1962 modifications: Lower level concrete walk, steps, and pipe handrail at Trailview Point.

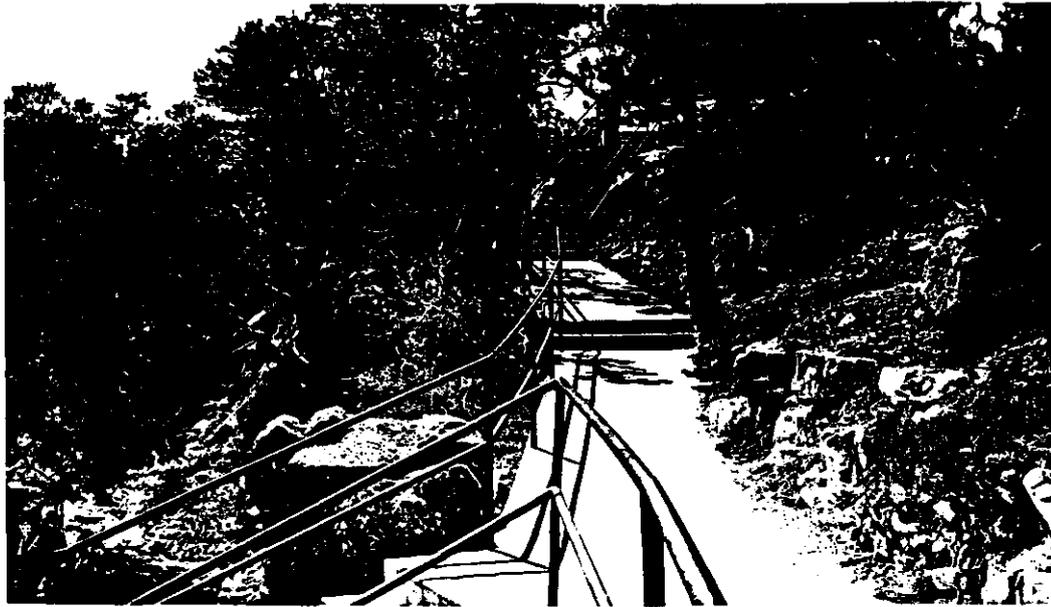
Figure 25. 1962 modifications: Upper level concrete walk, steps, and pipe handrail at Trailview Point.
