WEST RIM DRIVE
(Grand Canyon Route #8)
Between Grand Canyon Village
and Hermit Rest
Grand Canyon National Park
Coconino County
Arizona

HAER No. AZ-42

WEST RIM DRIVE
(Grand Canyon Route #8)
(~~Hermit Rim Road~~)
HAER No. AZ-42

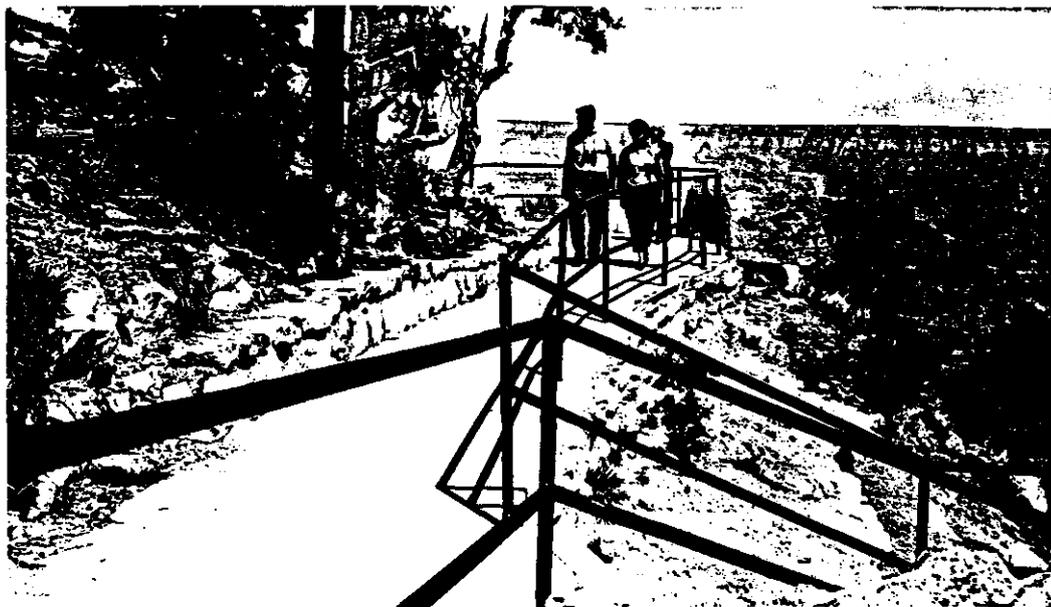
1962 modifications: Upper level concrete walk, handrail, stone curbing, and stone foundation at Trailview Point.
