LANCASTER COUNTY CENTER
4845 Cedar Avenue
Lancaster
Los Angeles County
California

HABS No. CA-2350

HISTORIC AMERICAN BUILDING SURVEY
LANCASTER COUNTY CENTER (~~CEDAR AVENUE STRUCTURES~~)

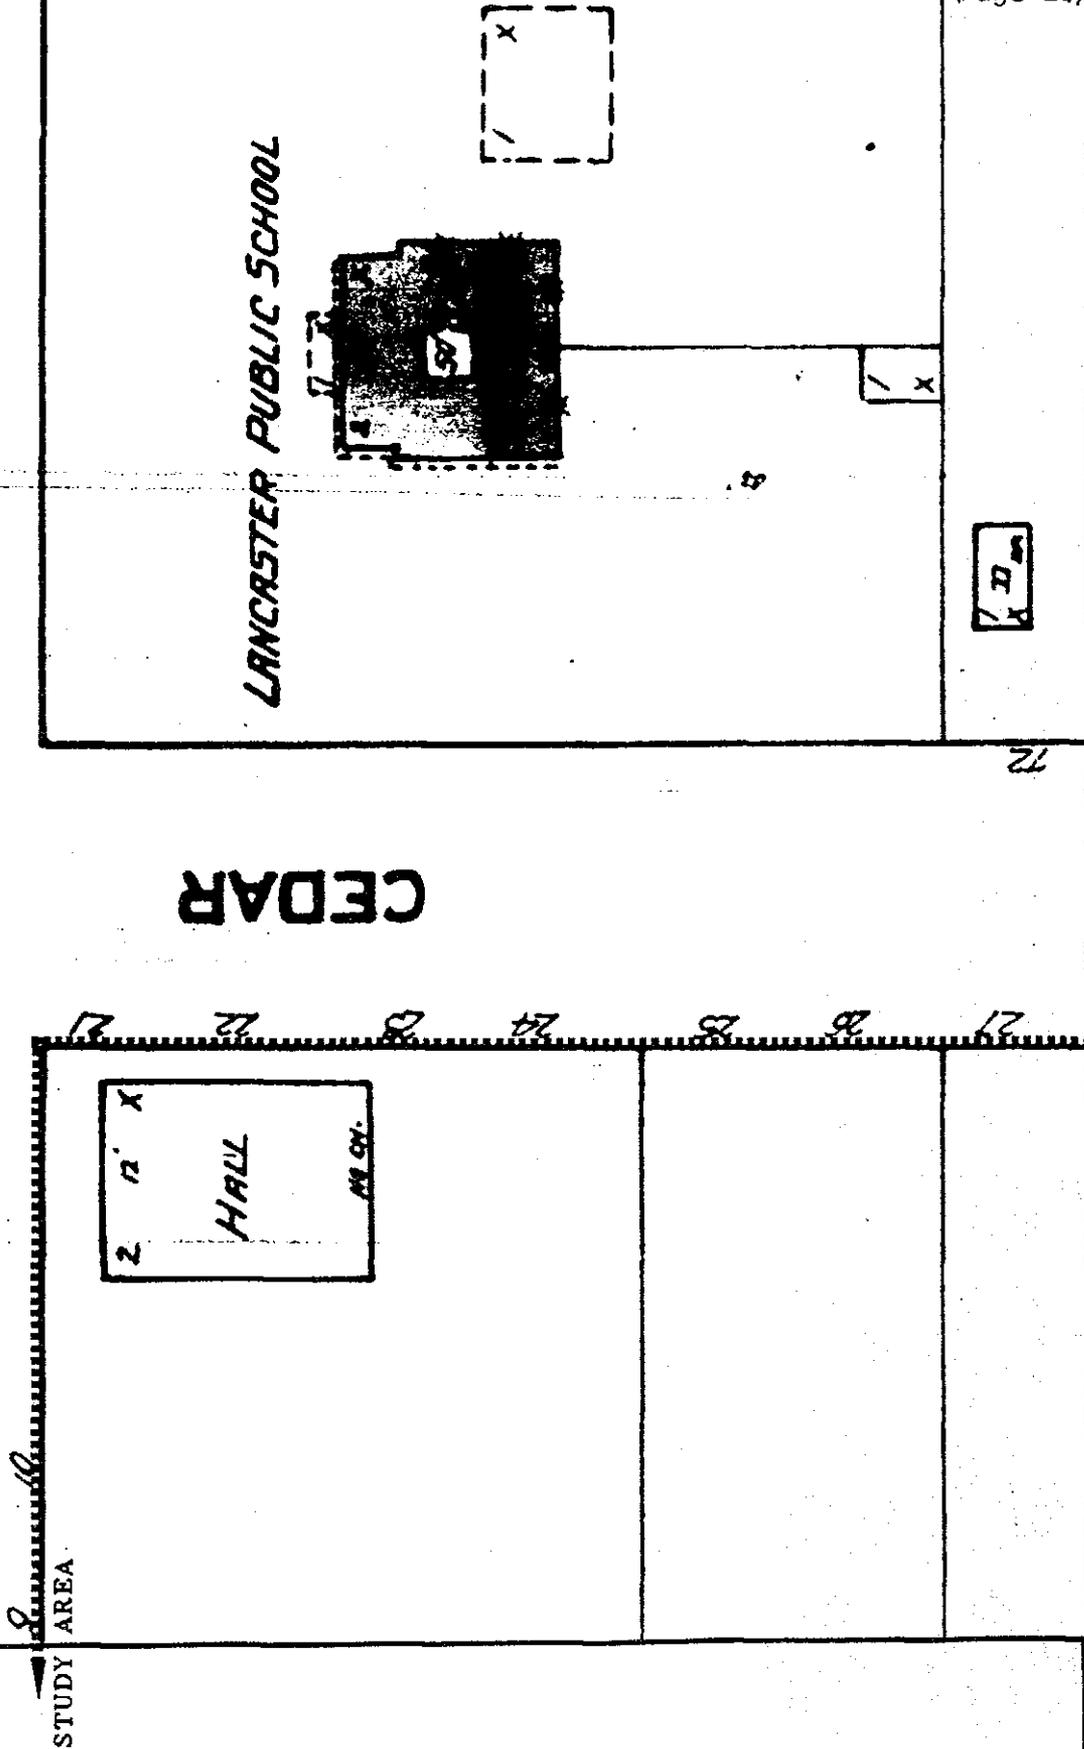
Figure 2. 1910 Sanborn Fire Insurance map showing the former "Hall" in the present study area. Note the public school across the street.

1910 is also the first year of documented occupation of the present study site. The Sanborn Fire Insurance Map of June 1910 shows a single structure located on the southwest corner of 10th and Cedar in Lot 8. The building is listed as a two story "hall" (Figure 2). This building was known by 1912 as the Women's Independence Hall and housed the

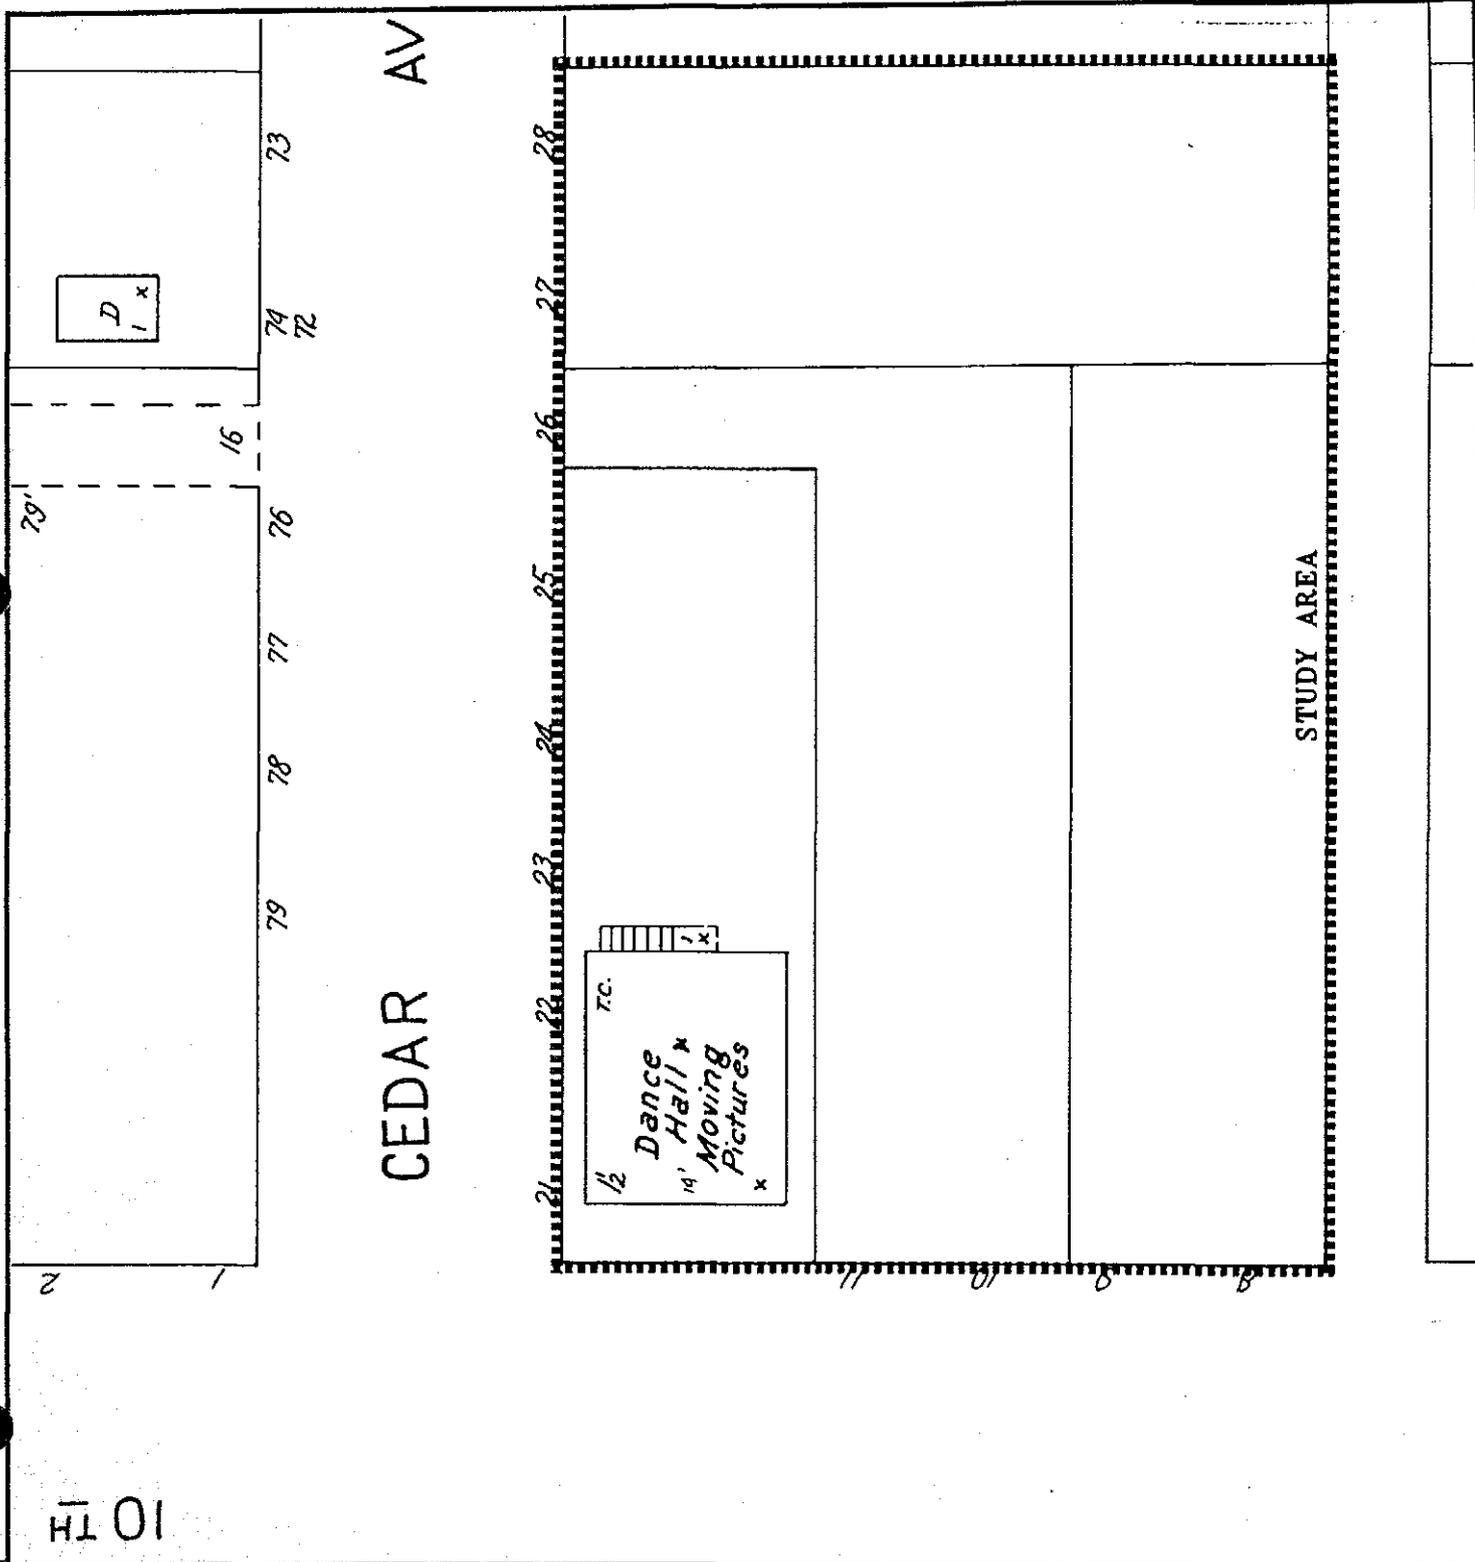
Figure 3.
1918 Sanborn
Fire Insurance
map showing the
former Dance
Hall and Moving
Picture Theater
in the study
area.

Meanwhile, Los Angeles County and local community institutions and services were beginning to be established in Lancaster to serve the valley residents. In 1913 the county opened one of its 165 branches of the County Free Library in Lancaster. The branch was first set up in a local drug store until the new grade school was completed later that year. The library then moved into the old brick school building (Los Angeles County Public Library 1962:8; Settle 1983:27). In 1915 Lodge 437 of the Masons were formed in Lancaster and took over the old school's second floor as their lodge hall. The building was renamed the Masonic Building. By May 1918 the Masonic Building housed the county library branch and the Chamber of Commerce offices on the first floor and its lodge hall on the second floor (Settle 1983:27; Sanborn Map 1918) (Figure 3).

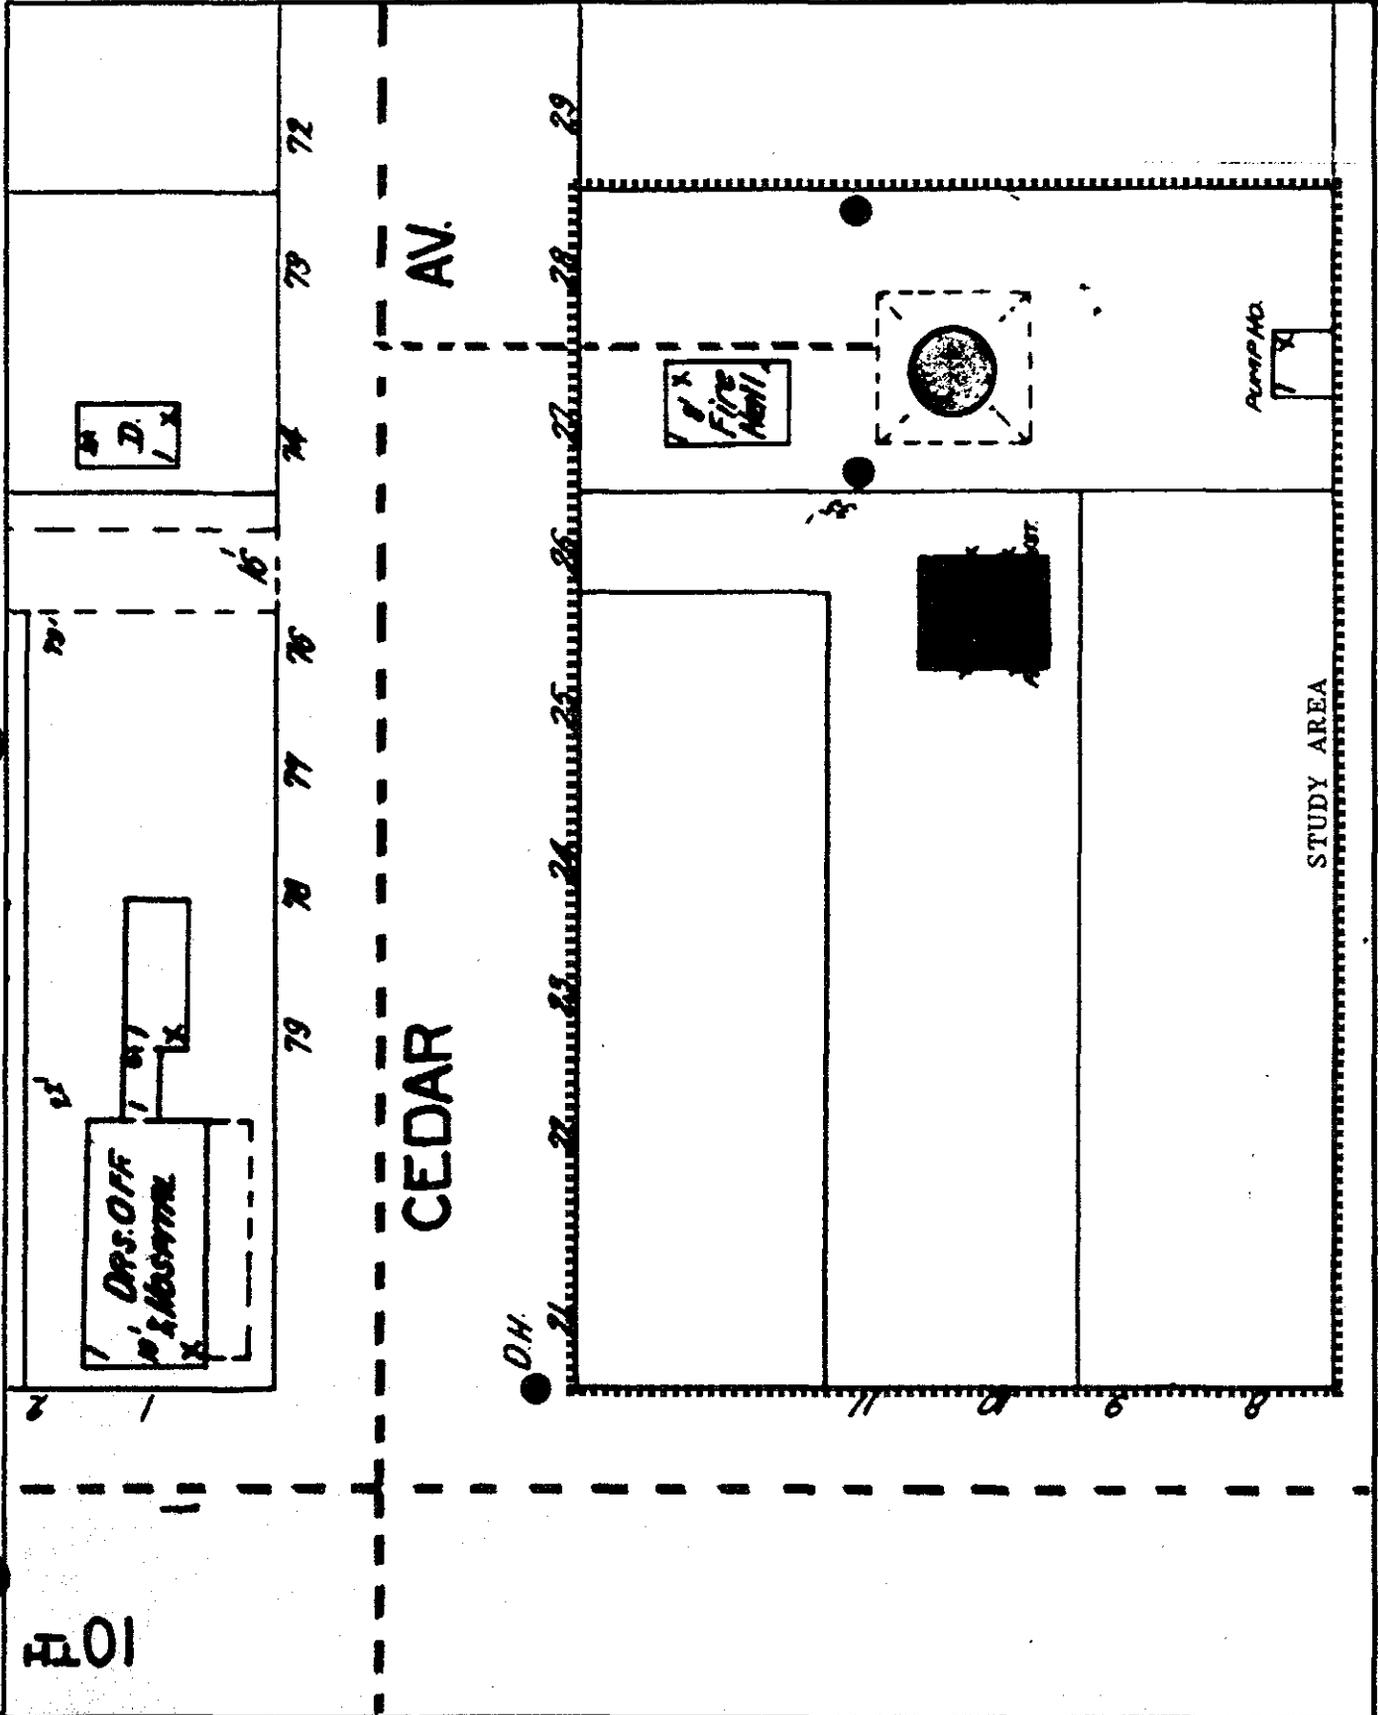
Figure 4. 1923 Sanborn Fire Insurance map of the study area showing the Jail, Fire Hall, Water Tank Tower, and Pump House locations.

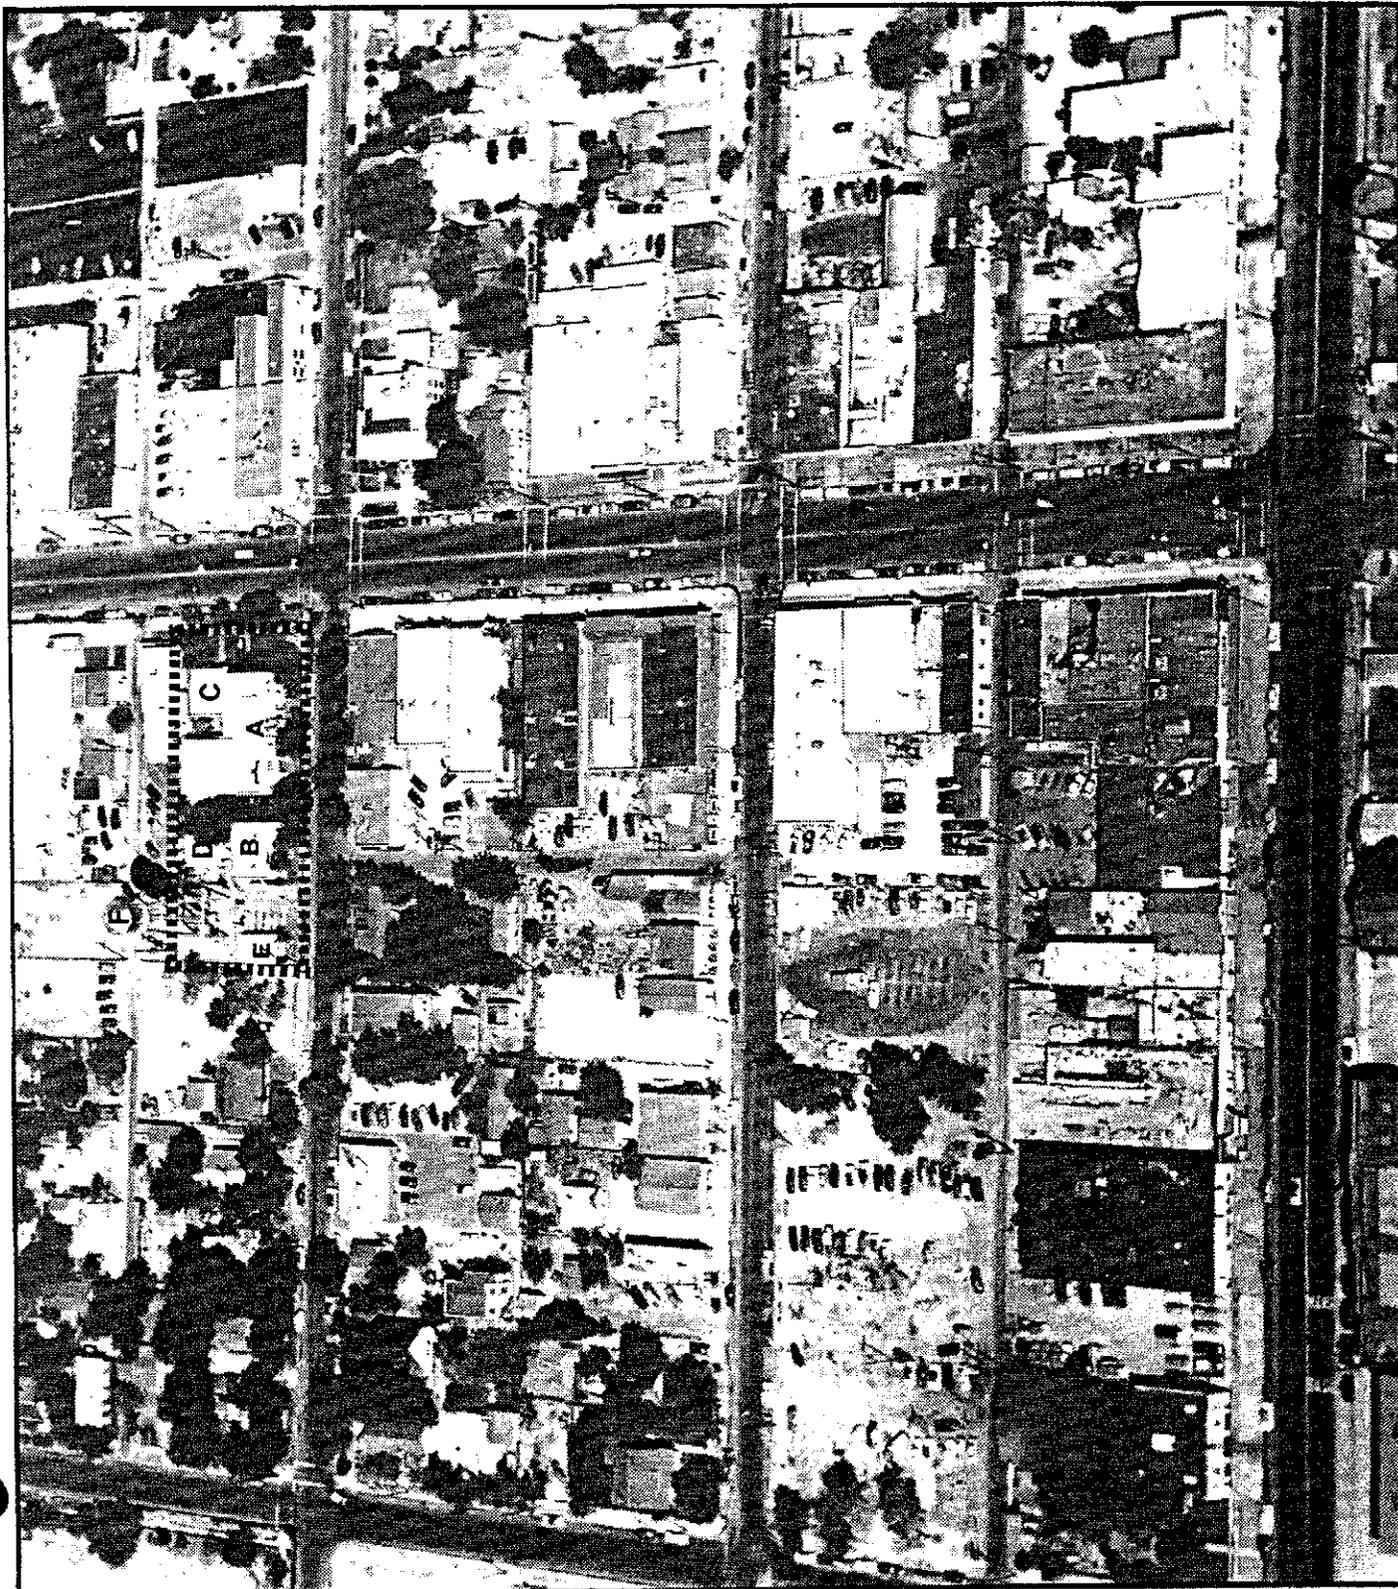
Figure 5. Sanborn Fire Insurance map showing the structures in the study area in 1927.

- A = Memorial Hall and Courthouse / Library
- B = Sheriff's Substation
- C = Health Center Office
- D = Jail
- E = Sheriff's Garage
- F = Water Tower

Gazette 12-27-1927:1; 1-15-1922; 7-13-1923; 5-18-1923). By November 1927 the property housed the new library-court building, the jail, the fire hall, and water works (Sanborn Map 1927) (Figure 5).

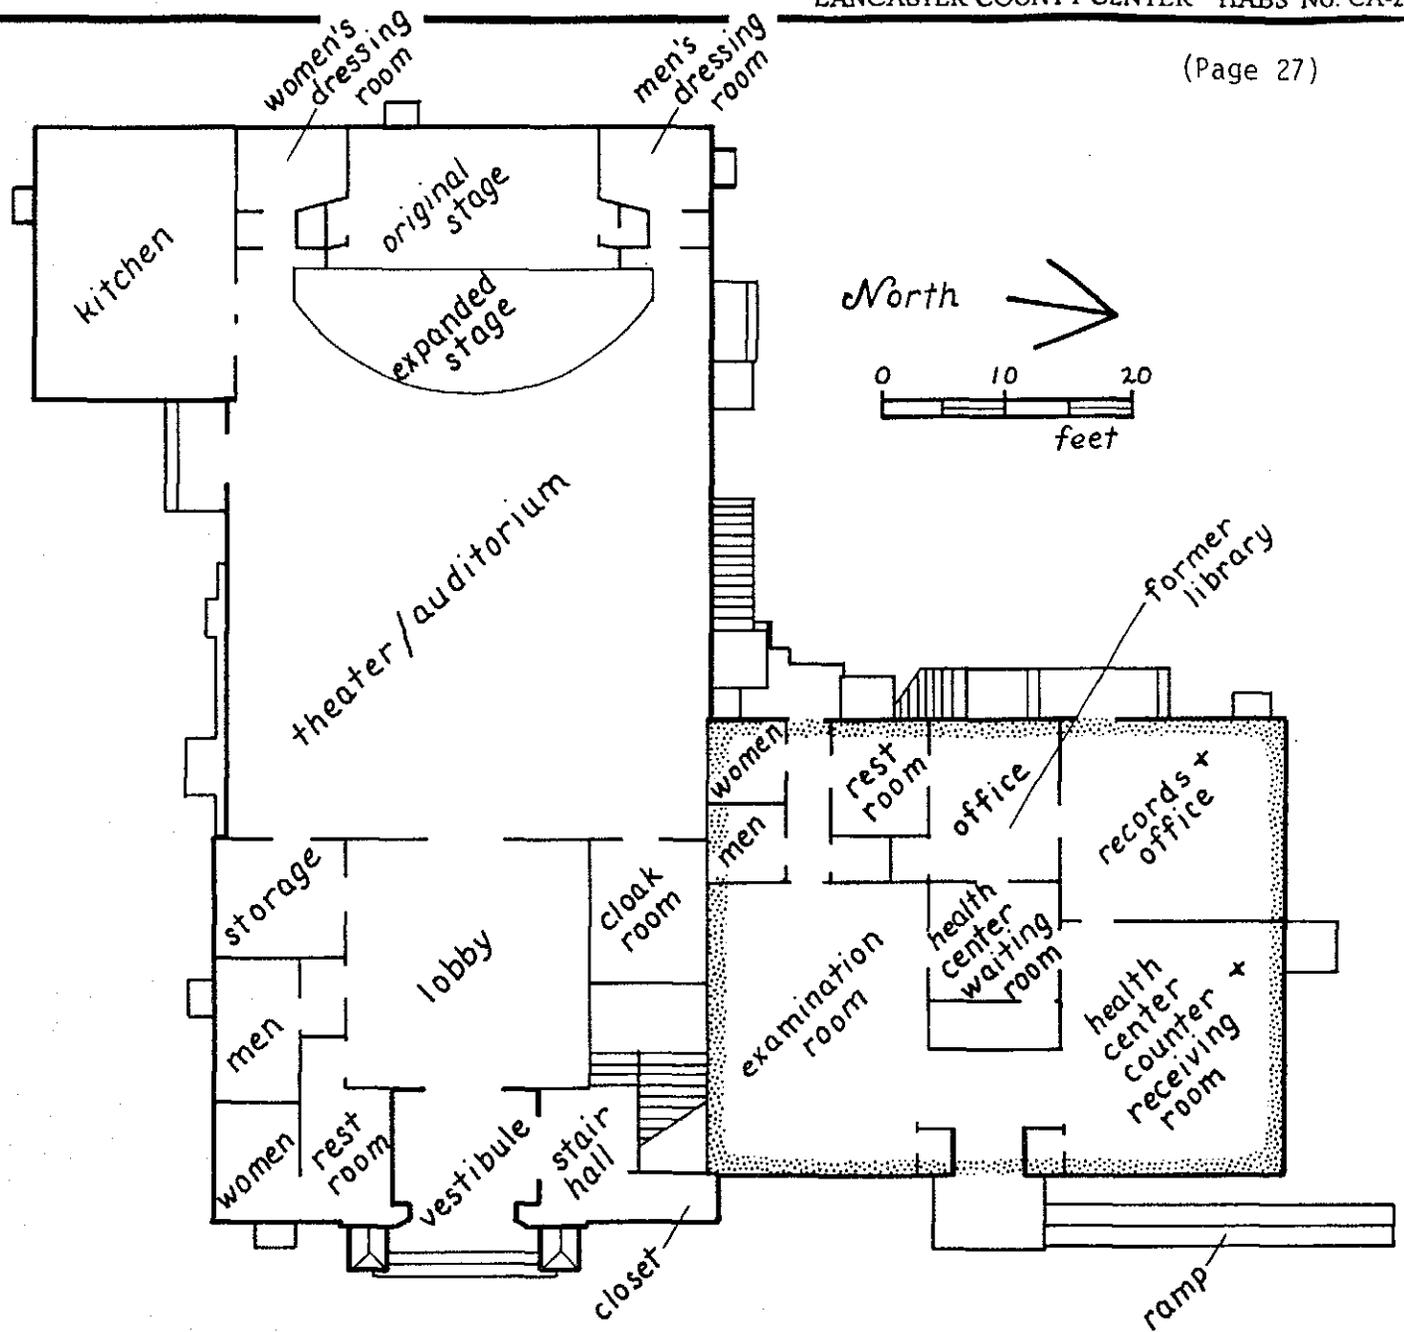
Figure 8. Plot plan of the Old Lancaster County Center.

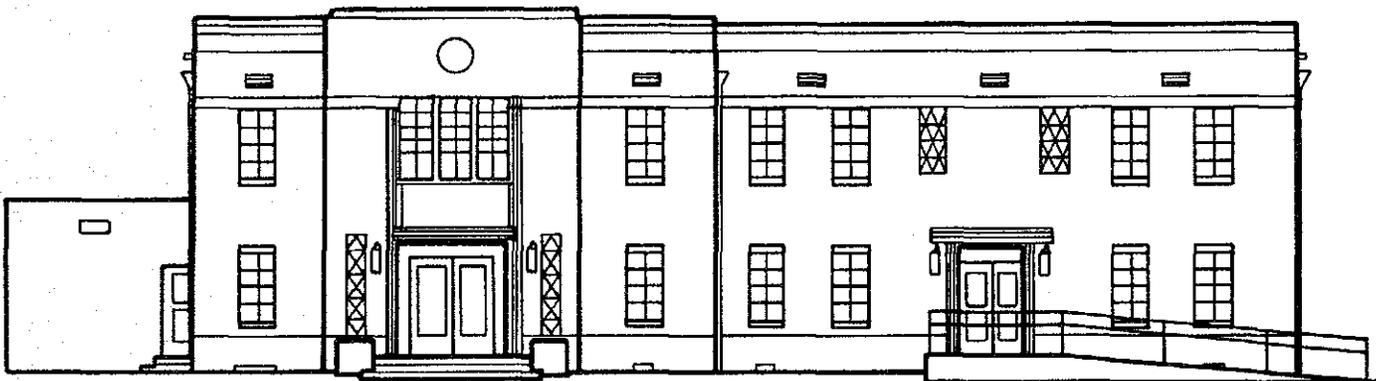
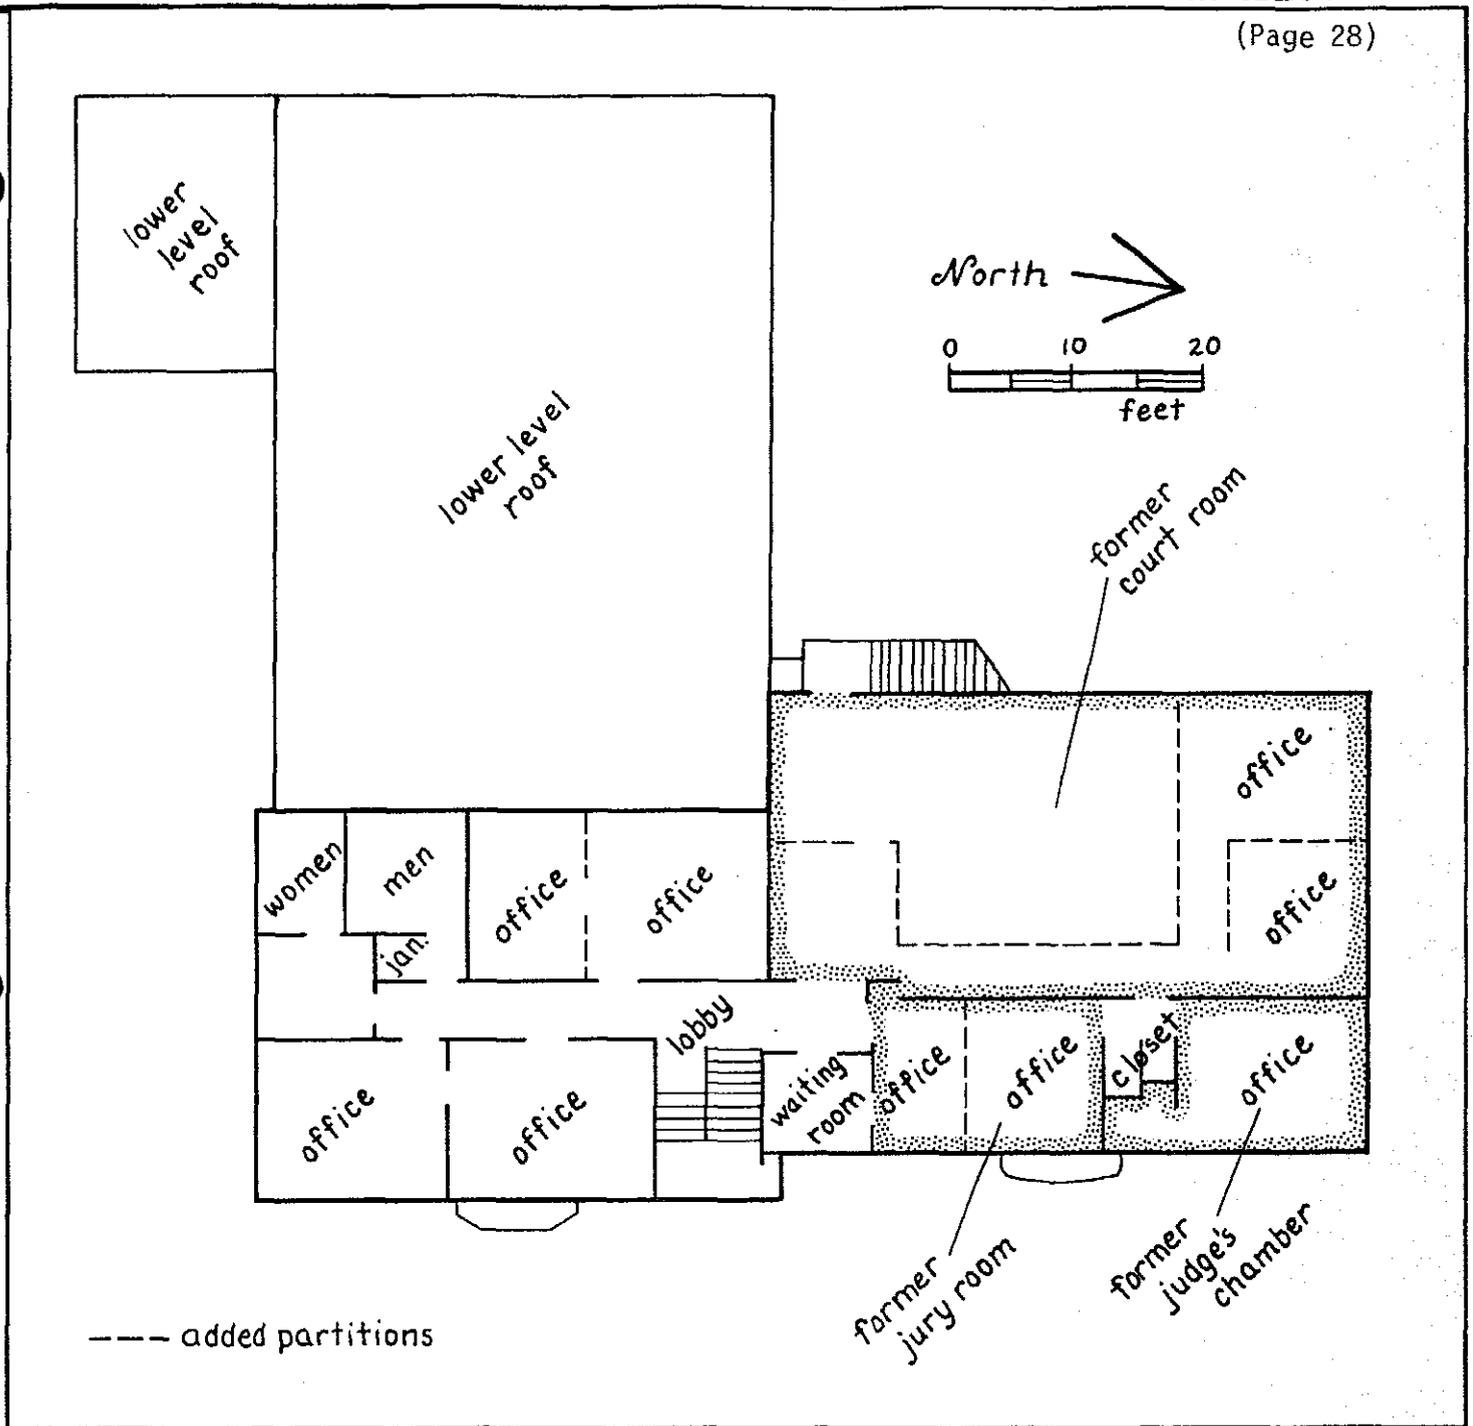
Figure 9. Front (east) elevation and first floor plan of the former Memorial Hall and Courthouse/Library. (From: Architectural Resource Group 1988.)

1. Overall dimensions: The building is a two story structure consisting of two wings that form an "L" shaped footprint that measures approximately 85 by 104 feet (Figures 9 & 10).

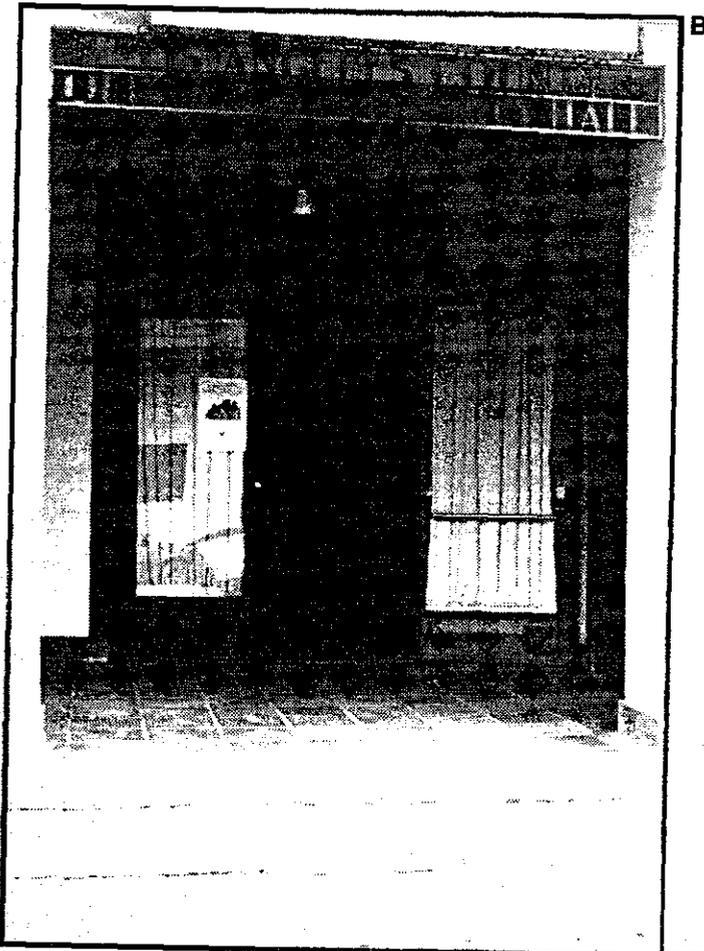
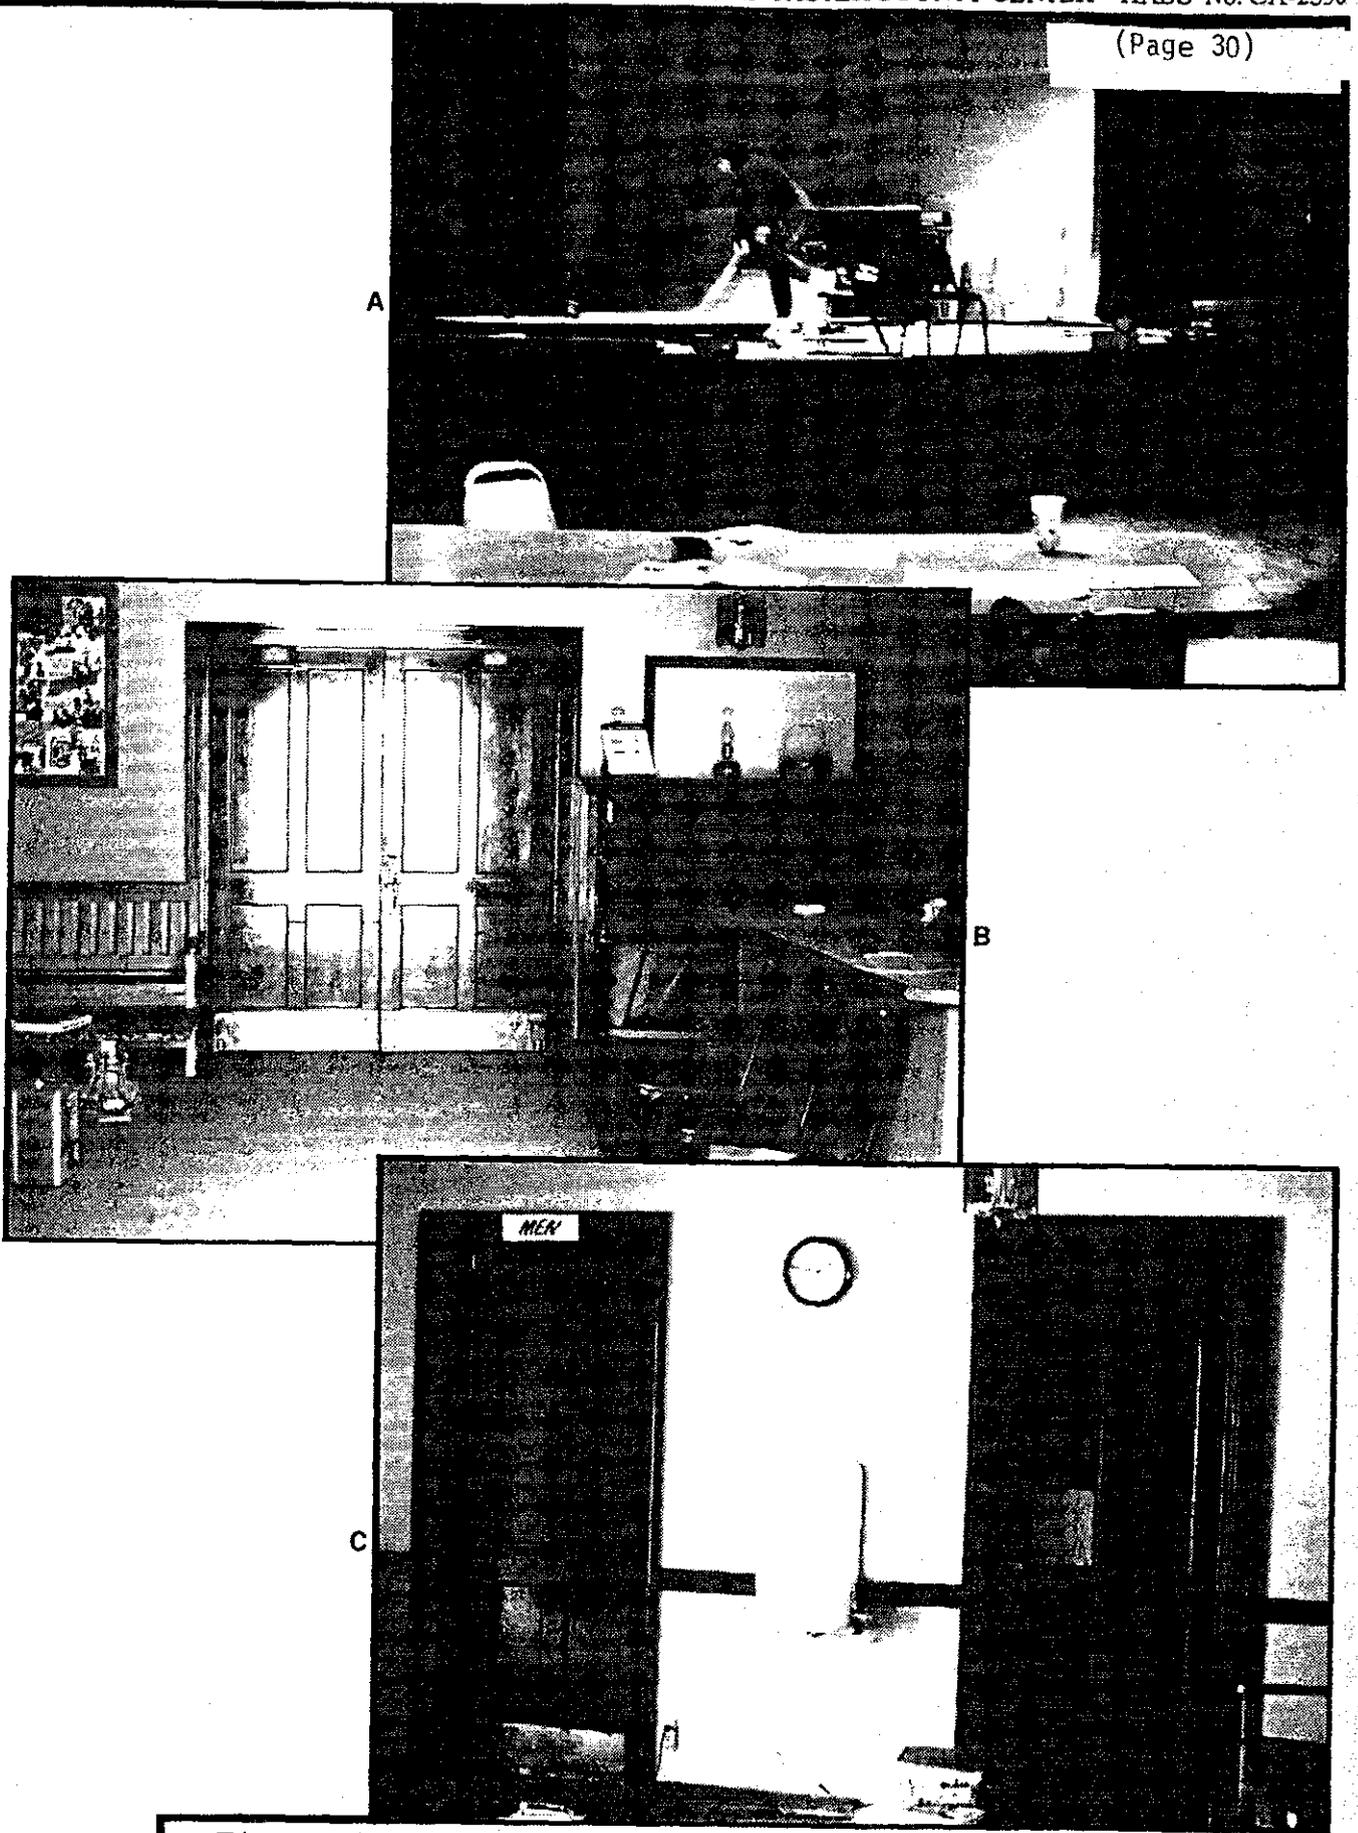
Figure 11. Entrance to the former Memorial Hall.
A = Vestibule entrance
B = Front doors and lobby

a. Doorways and Doors: The structure has two main entrances, both on the Cedar Avenue (east) facade. The southern entrance provides access to the original assembly hall and to the main staircase leading to the original courtroom. The entry is expressed on the facade by projecting this portion of the building forward from the northern section by three and a half feet and by highlighting the entry. Three tile and brick steps, flanked by low concrete buttresses, lead up to recessed double doors, each with a single large pane of glass. A large transom window above spans over the doors. A flat sheet metal canopy with three horizontal bands extends out from the facade above the transom window. On either side of the entry, three sets of stucco bands extends vertically up the facade, each one stepping further inward. They terminate at the heads of three sets of double-hung windows centered over the entry doors below. Above the band is a raised circular medallion. Five decorative windows aligned vertically and set in precast concrete, flank the entry. They are centered above the small buttresses and have opaque glass.

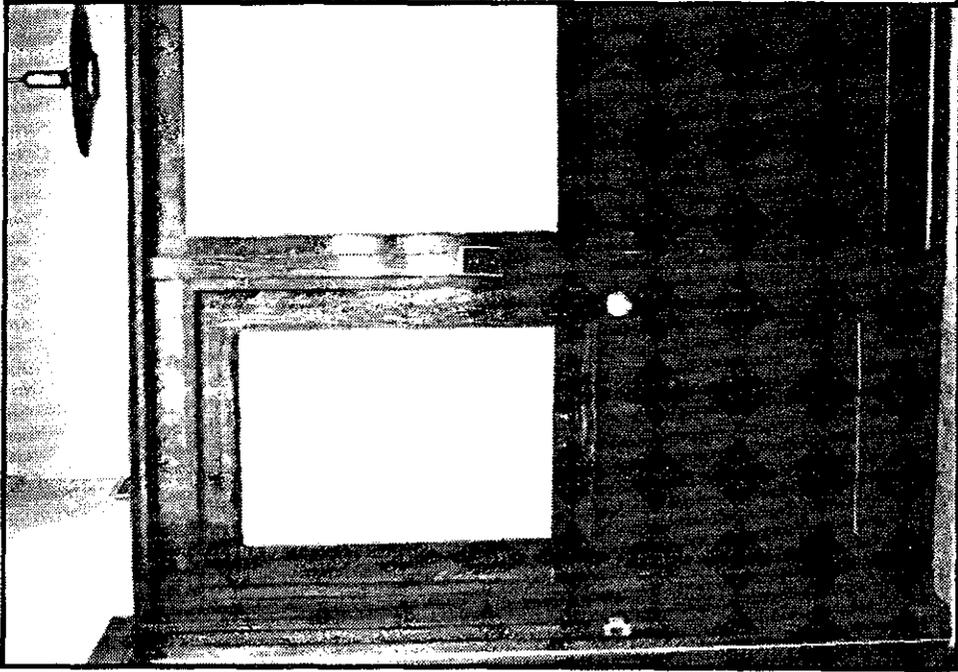
Figure 13. Interior details of the former Library and Health Clinic floor of Memorial Hall.
 A = Bathroom sink
 B = Doorways and moldings
 C = Gate

Both floors exhibit original linoleum floors and plastered walls and ceilings as well as original cabinetry, bathroom fixtures, and many original doors and light fixtures. The first floor woodwork still has the original varnish finish, but much of the second floor woodwork has been painted (Figures 13-15).

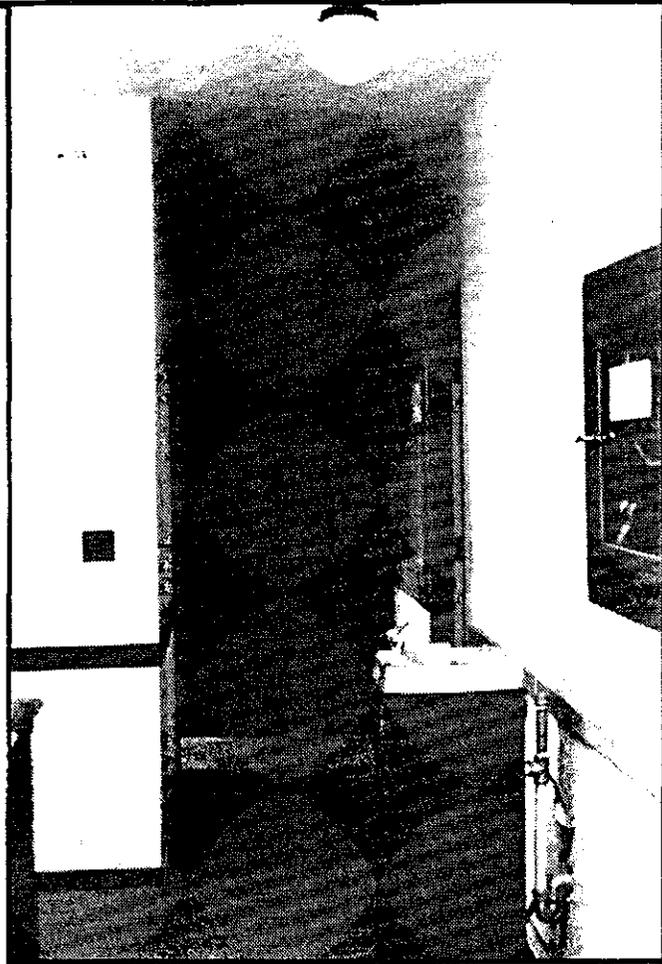
Figure 14. Original doors and wooden room dividers of the former Library and Health Clinic floor.

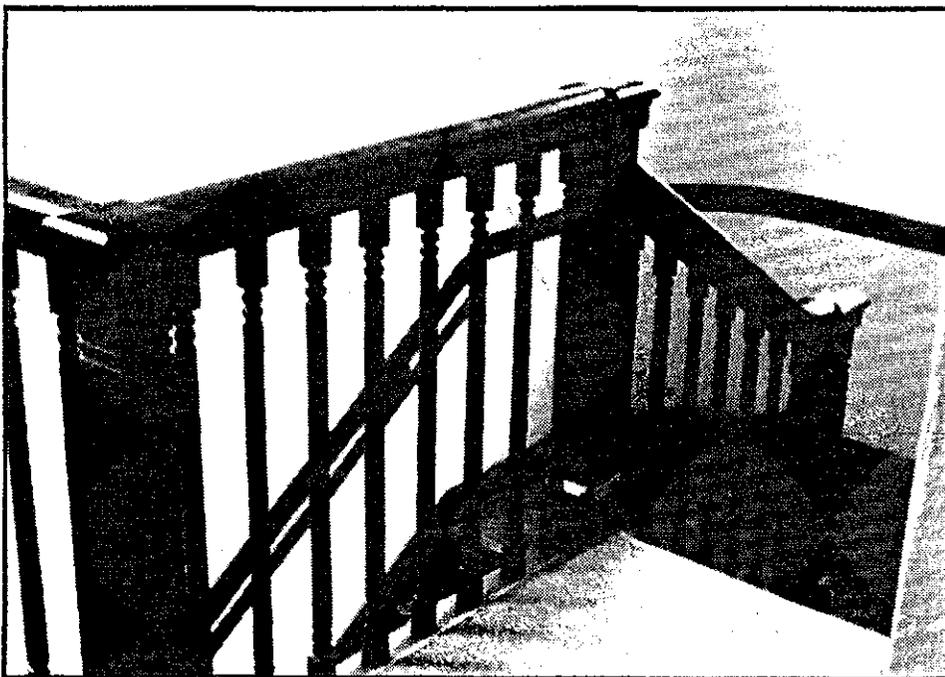
Figure 15. Hallway and stairwell bannister in the former Courthouse and County Offices floor.

2. Stairways: As discussed above the courtroom is accessed through a stairwell on the north side of the Memorial Hall vestibule. The wooden stairs have a plain brown painted baseboard and steel hand rail mounted on the wall for the first flight and a painted wooden banister on the second.

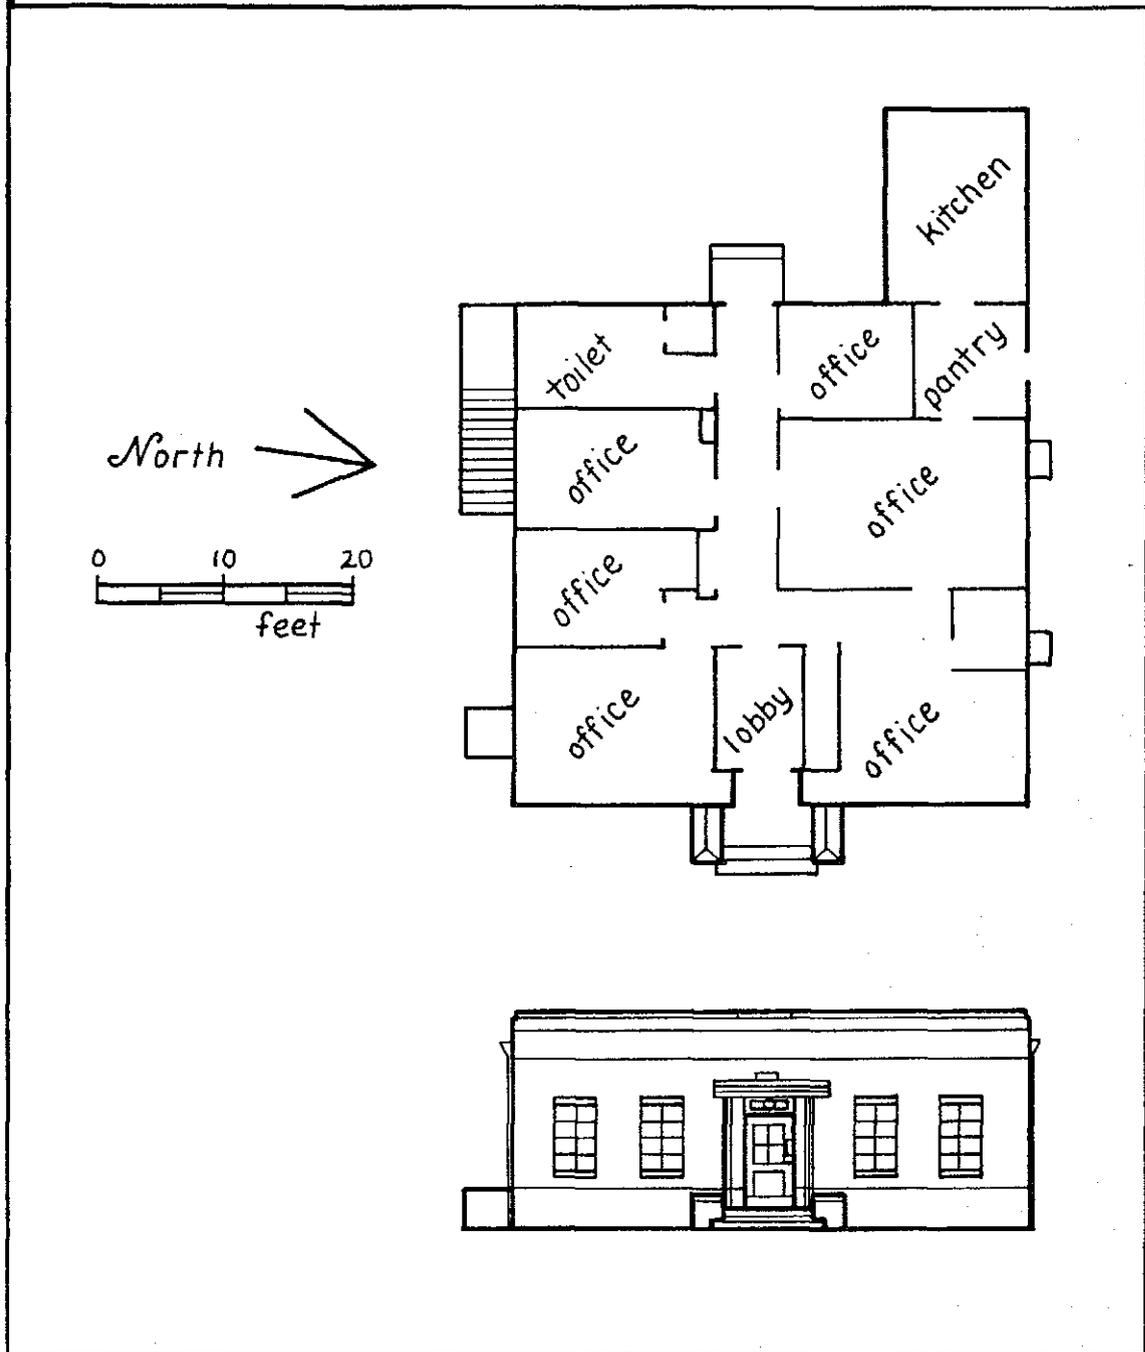
Figure 16. Floor plan and front (east) elevation of the former Sheriff's Substation. (From: Architectural Resources Group 1988.)

The former Sheriffs Substation (Figures 16-17) is an irregular rectangular shaped structure measuring approximately 40 by 55 feet. The front door is centered on the Cedar Avenue facade and is similar in design to the Library entry on Cedar Avenue. The substation entry also has a sheet metal canopy that extends out from the facade with horizontal bands. Double hung four over four light windows, identical in style to those of the Memorial Hall, are paired on each side of the entry into the stucco facade.

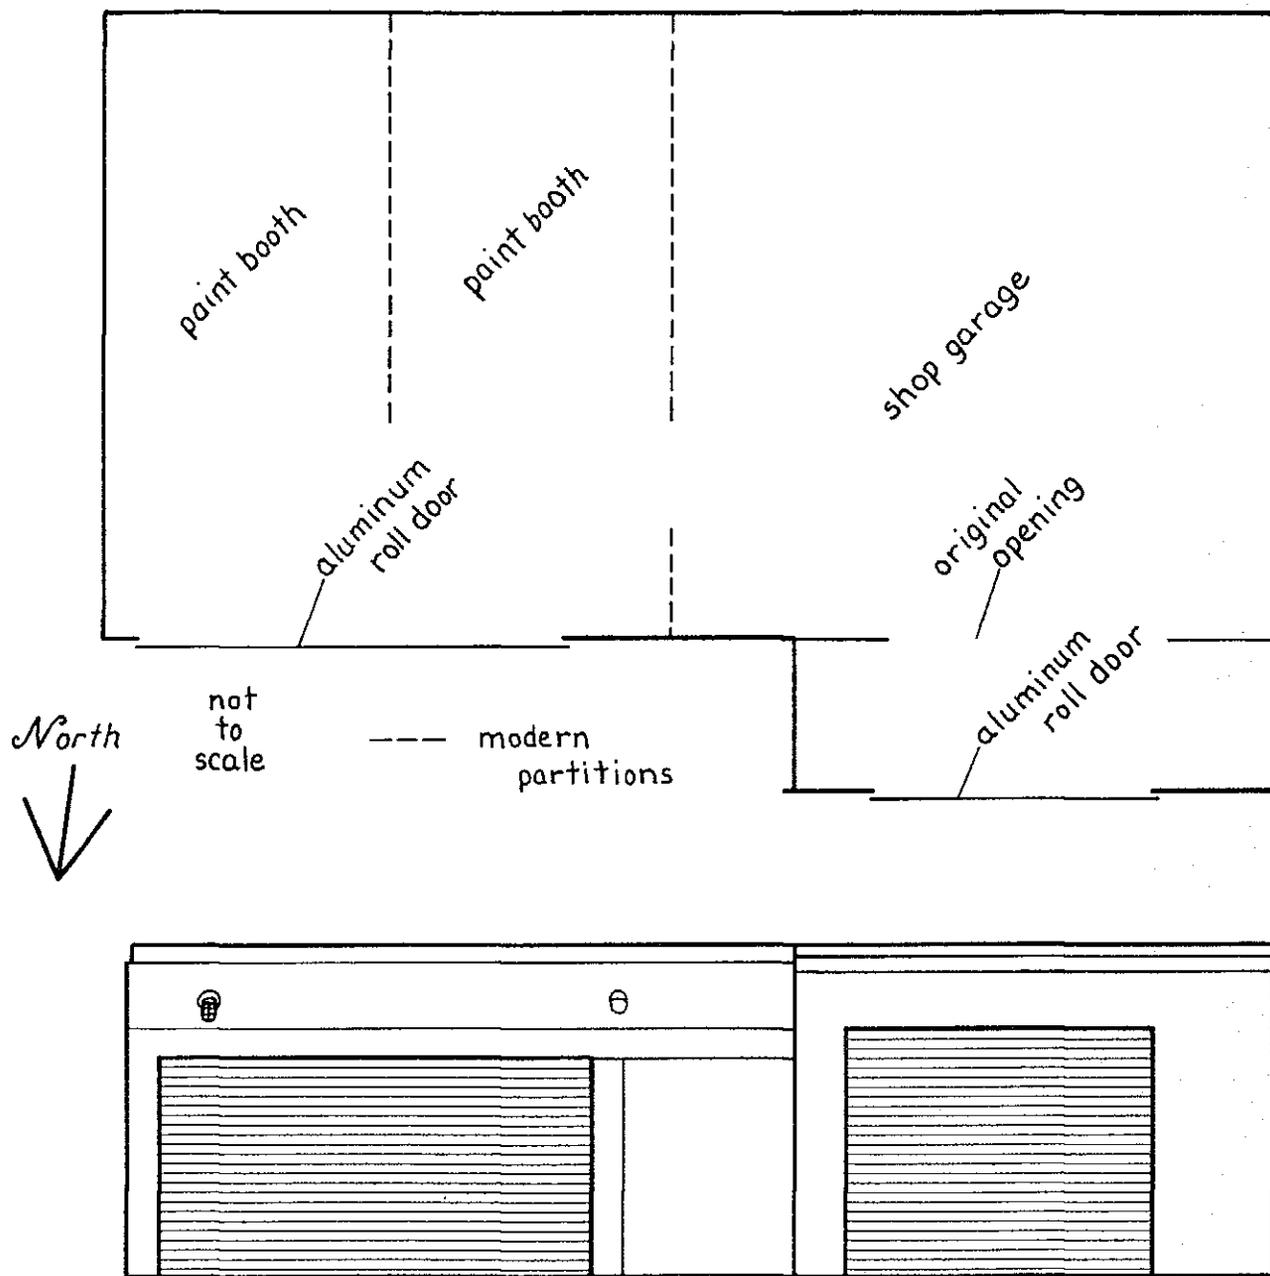
Figure 18. Field sketch of the floor plan and front (north) elevation of the former Sheriff's Garage.

The Sheriff's Garage is a single story rectangular structure that measures approximately 20 by 30 feet (Figure 18). It is of stud frame construction and has been severely altered. The front wall on the west side has been expanded and new partitions have been added inside to form individual stalls. It contains no original hardware, furnishings, or finish details. The building is currently used as a maintenance and storage facility. It has been altered to the point that it has very little if any historic integrity left.
