LANCASTER COUNTY CENTER
4845 Cedar Avenue
Lancaster
Los Angeles County
California

HABS No. CA-2350

HISTORIC AMERICAN BUILDING SURVEY
LANCASTER COUNTY CENTER (~~CEDAR AVENUE STRUCTURES~~)

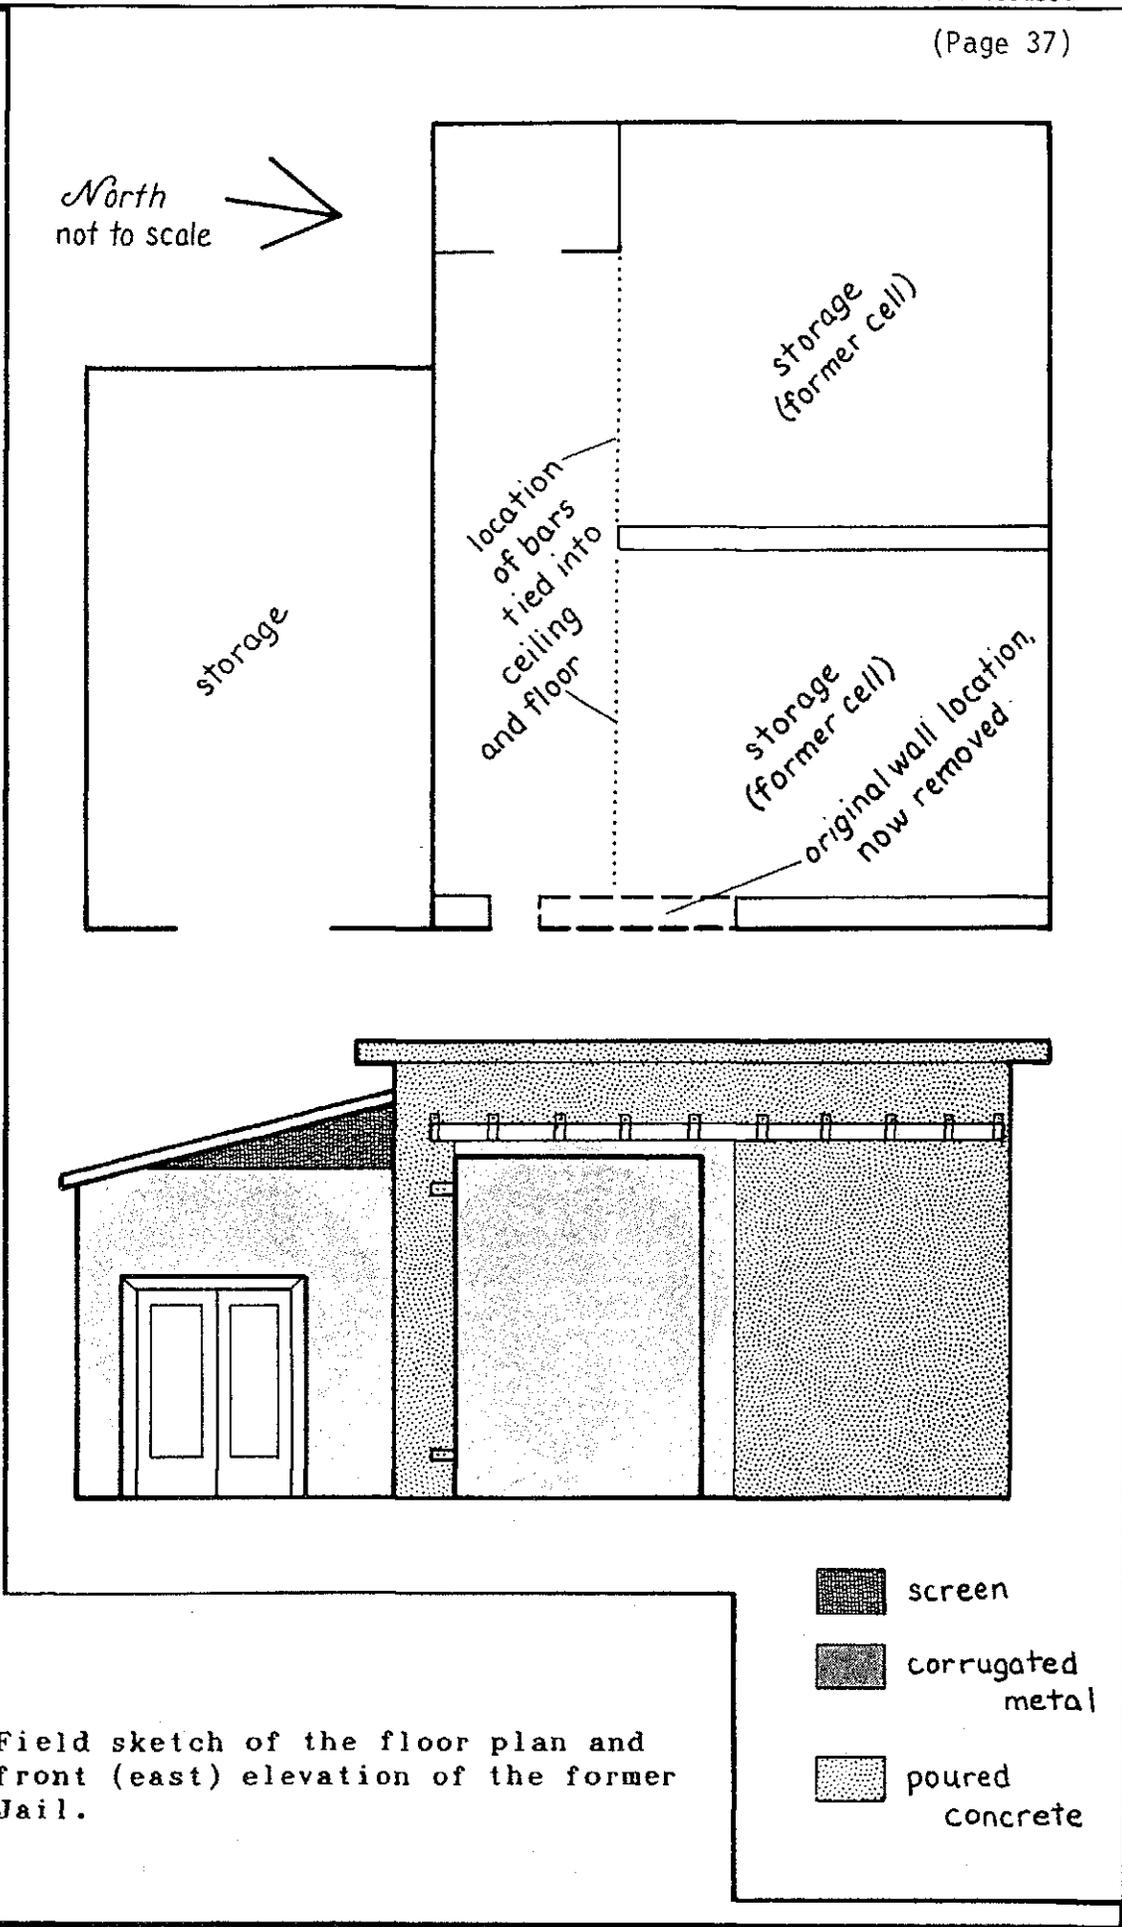
Figure 19. Field sketch of the floor plan and front (east) elevation of the former Jail.

The Jail is a single story poured concrete building with a concrete slab roof. A corrugated metal shed has been attached to the south side. The original door on the east side has been enlarged to single car garage door size and the building is now used for storage (Figure 19).

The Jail is a simple rectangle that measures approximately 20 by 24 feet. The structure is built of concrete with concrete footings, floor slab, walls, and roof/ceiling slab. The large rolling metal garage door on the east side takes up half the facade. The north and south facades each have two arched windows with heavy horizontal and vertical bars. The sills are 6 feet above ground. The west facade has no openings. The corrugated metal storage shed on the south side abuts the south wall.

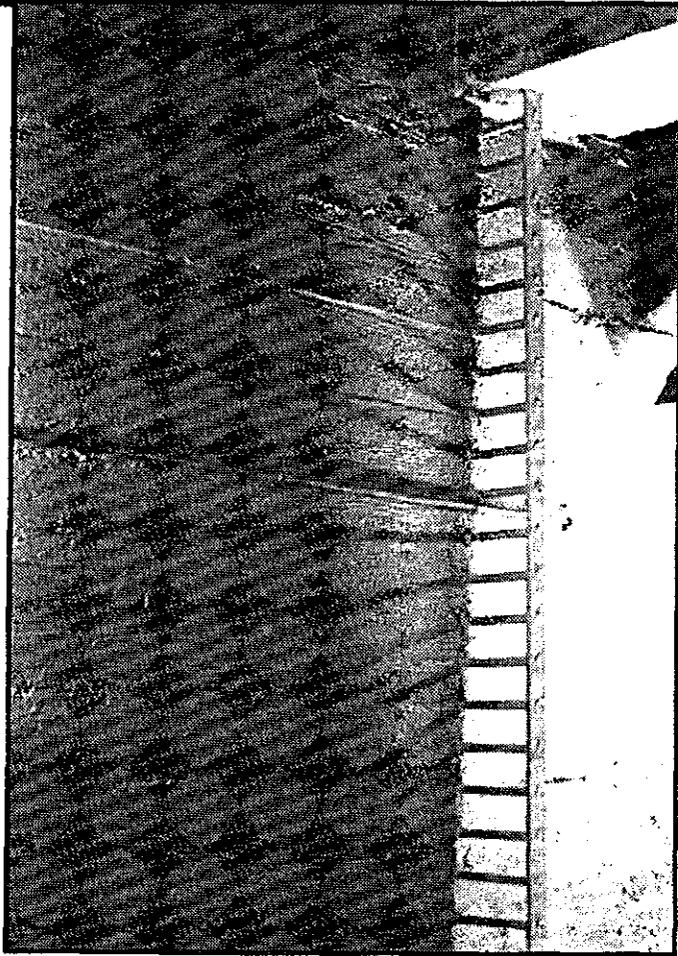
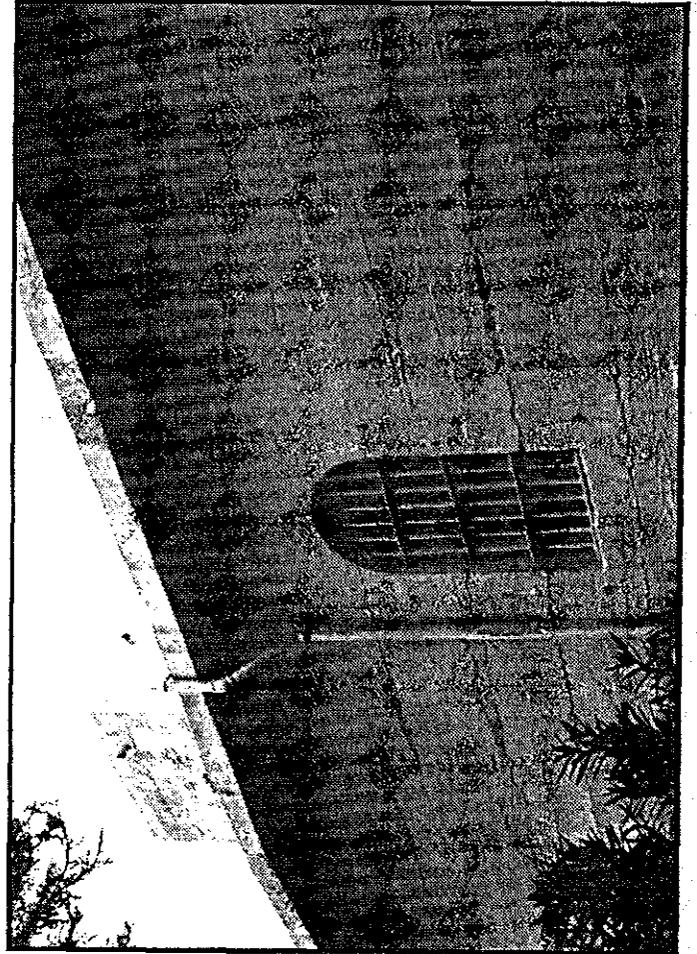
Figure 20. Details of the former Jail.
A = Storage area doors
B = Exterior showing bars in window
C = Cut off cell bars protruding from ceiling

The building is entered through the enlarged opening. Two large bays on the north side of the structure represent the original cells which held eight bunks each when in use (*Antelope Valley Ledger-Gazette* 7-30-1920). Remains of steel bars that enclosed these cells on the south side protrude from the ceiling and can be seen in the concrete slab floor where they have been cut off. Original steel bars are still in place in the arched windows on the north and south walls. A storage area with heavy wire mesh and steel doors is located in the southwest corner (Figure 20).

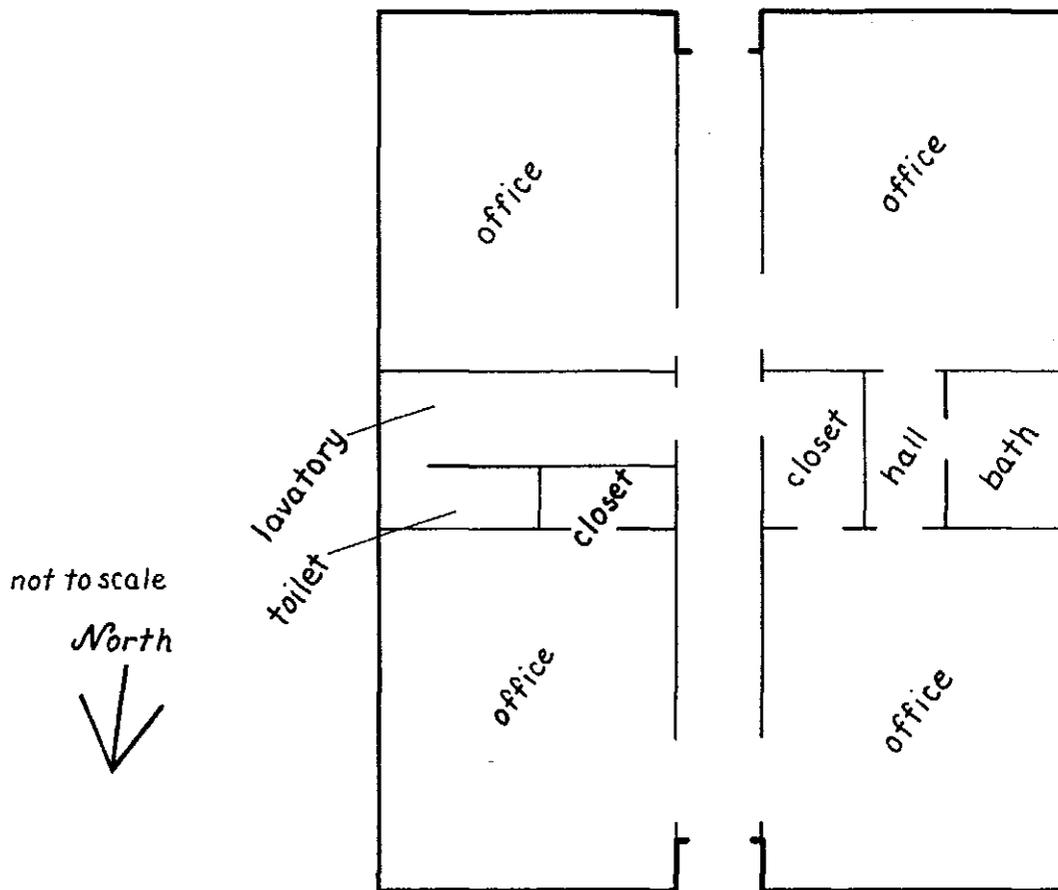
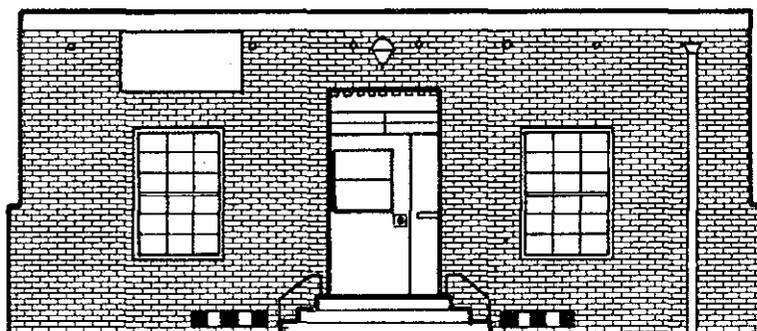
• plastered over viga

Figure 21. Field sketch of the floor plan and front (north) elevation of the former Health Center.

The former Health Center structure is a single story, rectangular shaped brick building (Figure 21). It is painted a light cream color and faces north onto Lancaster Boulevard. The building was completed in 1930 prior to the Memorial Hall and Courthouse and was originally a Pueblo Revival style building with false wooden rafters or vigas protruding from the front facade at ceiling level.

The former Health Center structure is a single story rectangular shaped brick building measuring 35 by 40 feet. The original false vigas have been removed and the structure has very little other exterior ornamental detailing. The Lancaster Boulevard facade is symmetrical in design with a central door flanked by a single window on each side. The windows consist of six over six lights in double-hung sashes set deep into the facade. A lintel of vertically placed bricks spans the doorway and above this is a simple row of dentils, formed by projecting bricks.

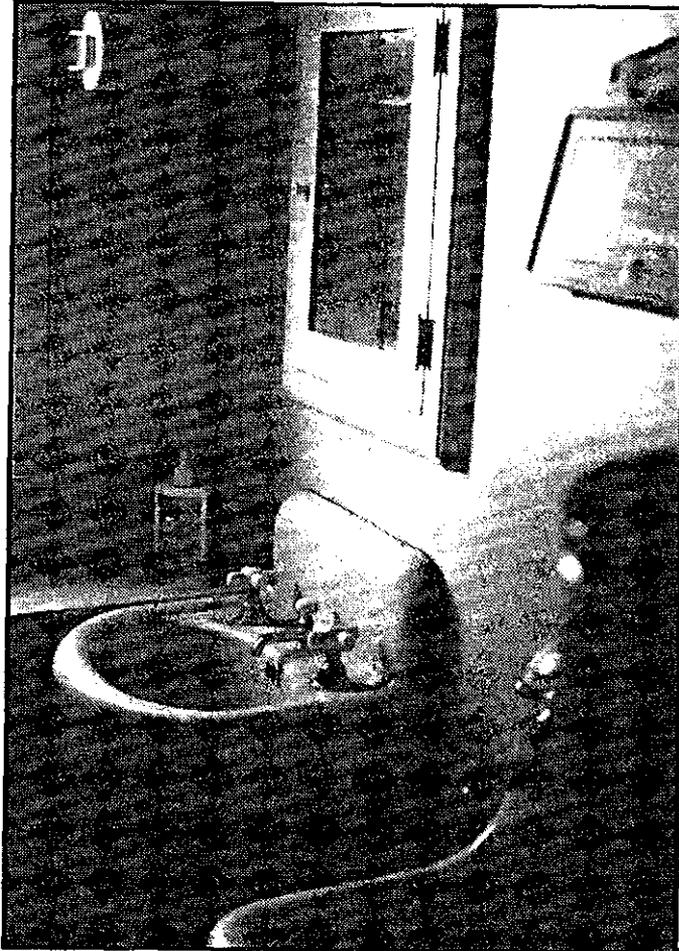
Figure 22. Original bathroom fixtures in the former Health Center.

The structure is entered through recessed doors on the front and back (north and south facades). The doors lead into a main hallway. Four individual offices and a bathroom on the east side of the structure are entered from the hallway. In addition, a closet and bathroom separate the offices on the west side of the building. The interior fabric of this structure is very intact in spite of modern carpet and linoleum floors. Almost all interior fixtures appear to be original except for a few doors. All original woodwork has been painted white (Figure 22). expand on fixtures
