FORT BAKER, GARAGE
(Building No. 556)
Golden Gate National Recreation Area
Kober Street, behind Building No. 533
Sausalito vicinity
Marin County
California

HABS CA-2643-D
CA-2643-D

FORT BAKER GARAGE
(BUILDING No. 556)

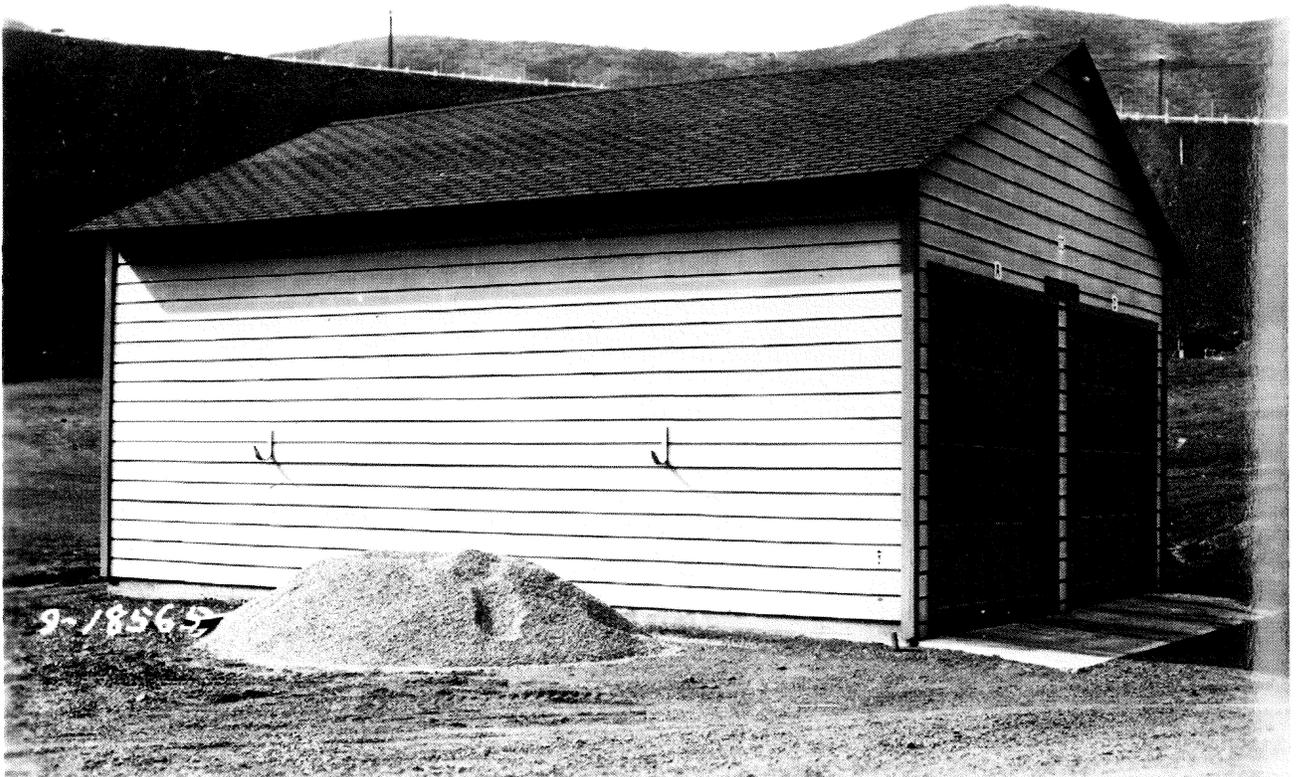
Building 556 (photo date probably between 1938 to 1940); U.S. Army Quartermaster Form 117, negative # P91-005.933; Golden Gate National Recreation Area Park Archives and Records Center, San Francisco, CA.

B. Historic views: Historic photograph of Building 556 from the Quartermaster General Office Form No. 117; the date of the photo is probably between 1938 and 1942. The photograph shows an oblique view of northern and eastern elevation of the building. The negative number for this 4" x 5" image is P91-005.933 and is located at the Golden Gate National Recreation Area Park Archives and Records Center.
