Cheese Ranch
161 Holman Way
Sedalia Vicinity
Douglas County
Colorado

HABS No. CO-48

ARCHITECTURAL DATA FORM

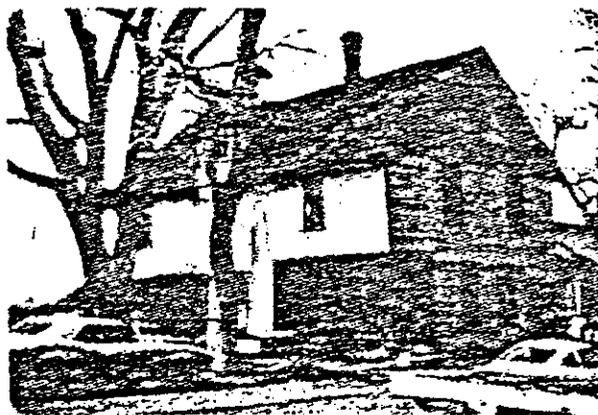
13. Photograph:

1. Name of Structure: Farmhouse, Cheese Ranch
 2. Site # 2
 3. Name of District: Highlands Ranch
 4. Location: East of Daniels Park Rd. Douglas County
 5. Ownership: Highland Ventures Corp Public: Private: Y
 6. Use: Original Farmhouse Present: same
 7. Accessibility to Public: closed

8. Building Material: a. clapboard x b. stone c. brick d. board & batten e. cobblestone f. stucco g. other
9. Structural System: a. wood frame with interlocking joints
 b. wood frame with light members x
 c. masonry load bearing walls
 d. metal (explain)
 e. other
10. Condition: a. excellent b. good c. fair x d. other, (describe)
11. Integrity: a. original site. x b. moved. if so when and from where?
 c. list major alterations & dates:
 Addition on rear (north side) for a cheese manufacturing area, date unk.
12. Map location: NW $\frac{1}{4}$ of NW $\frac{1}{4}$, sec 8, T6 R67 W.

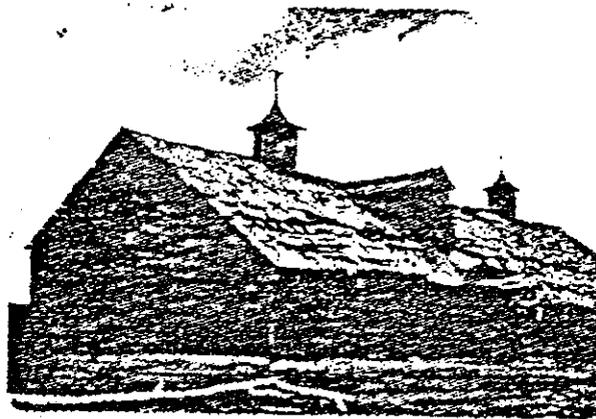
13. Photograph:

8. Building Material: a. clapboard x b. stone c. brick d. board & batten e. cobblestone f. stucco g. other
9. Structural System: a. wood frame with interlocking joints x
b. wood frame with light members
c. masonry load bearing walls
d. metal (explain)
e. other
10. Condition: a. excellent b. good c. fair d. other, (describe) deteriorated, repairable
11. Integrity: a. original site. x b. moved. if so when and from where?
c. list major alterations & dates:

14. Threats to building: from developers

This picturesque barn, now sadly deteriorated, was an exceptional period barn. Extremely solidly constructed, it has withstood the ravages of weather, wind and neglect. The interior structure is of particular interest, with rows of solid support beams.

This multi-purpose barn has several characteristics making it typical of the period. Obviously hand-built, the gable roof and cupola'd vents helped to make it not only serviceable but also a thing of beauty.

Because of its condition, I cannot recommend preservation. However, it is repairable at this time, and I can recommend that an estimate be taken, and a decision made when it can be determined whether or not it is practical to attempt to restore it.
