RED ROCKS PARK, MOUNT MORRISON CIVILIAN
CONSERVATION CORPS CAMP
300 Union Avenue
Morrison
Jefferson County
Colorado

HALS CO-8-A
HALS CO-8-A

WRITTEN HISTORICAL AND DESCRIPTIVE DATA

MOUNT MORRISON CIVILIAN CONSERVATION CORPS CAMP, RED ROCKS PARK

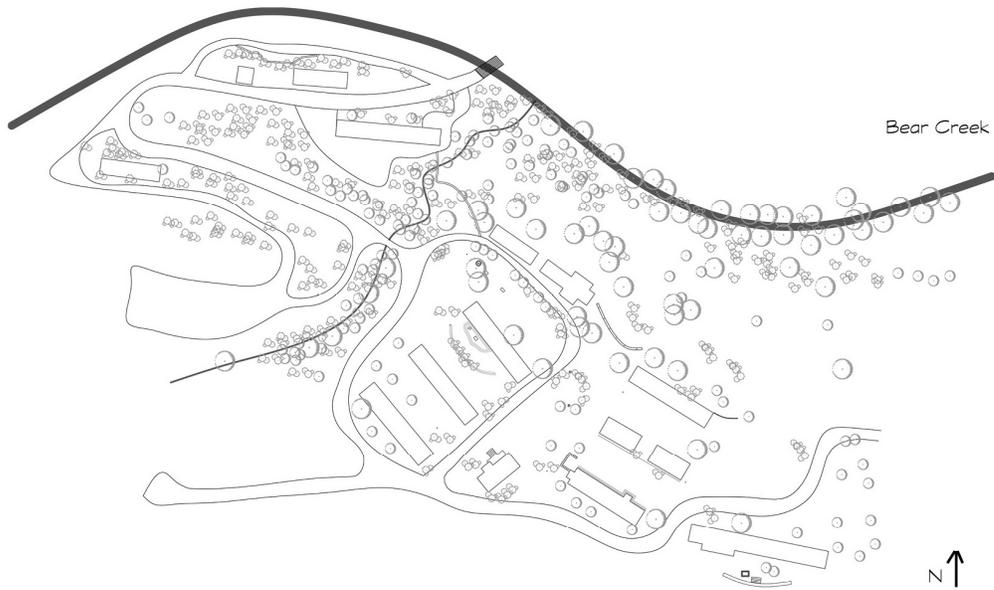
Mount Morrison Civilian Conservation Corps Camp 2011

Site plan of Mount Morrison CCC Camp. (Kelly Halpin, September 10, 2011).

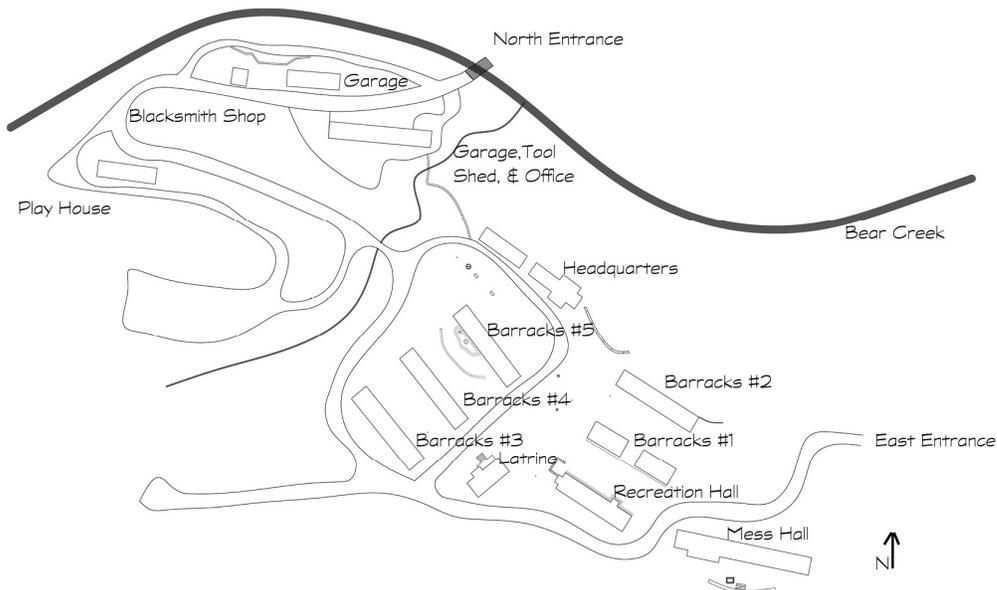
Mount Morrison Civilian Conservation Corps Camp

Site Plan of Mount Morrison CCC Camp showing building name and placement, location, entrances, road and Bear Creek. (Kelly Halpin, September 10, 2011).

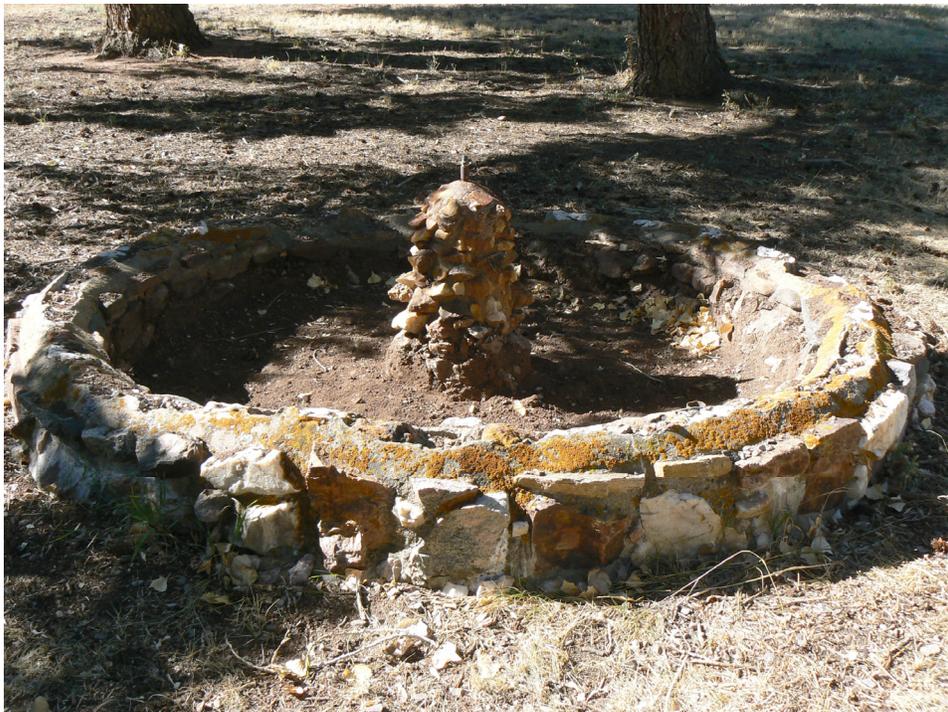
The stone fountain in the area between Barracks #5 and the Headquarters building. (Kelly Halpin, September 10, 2011).

The circular stone fountain located between the former Headquarters Building and Barracks #5 is well maintained but non-functional. The fountain is made from rock and mortar similar to other fountains from the era of the conservation corps; they exhibited the skill of the CCC men while creating esthetic value and a focal point of the camp. There is a reference to a fishpond in the map from 1937; this can be distinguished in the aerial images from 1948 and 1955 but is not currently in existence on the site (figs. 5.2-5.5).

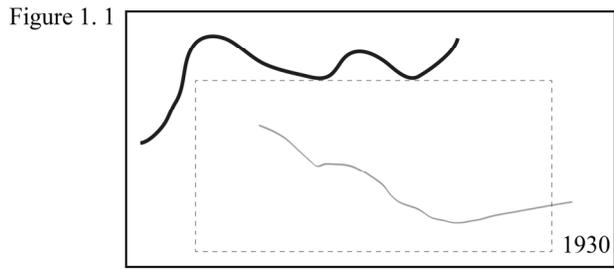
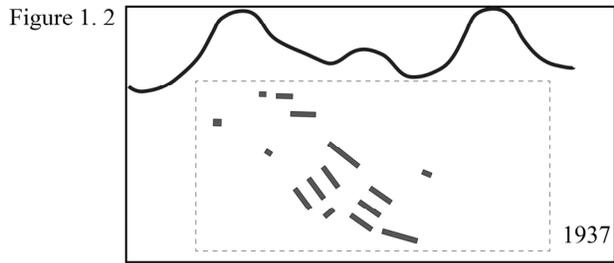
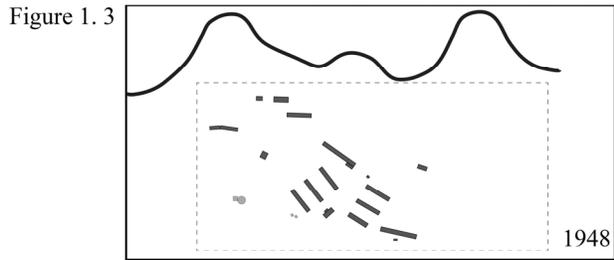
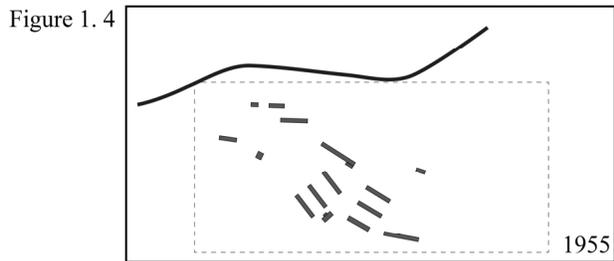
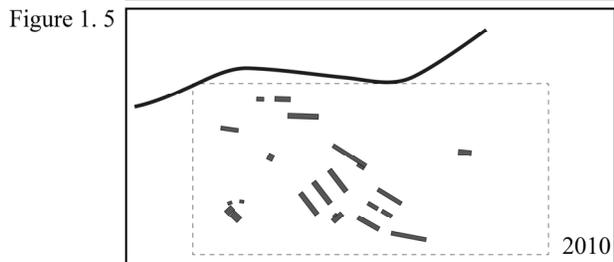
Figure 1. Building Footprints 1930-2010. (Kelly Halpin, October 15, 2011).

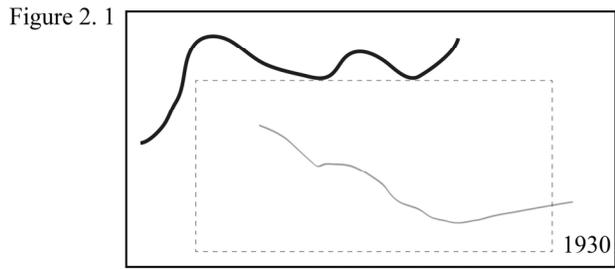
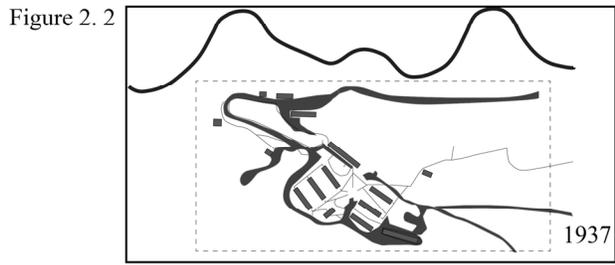
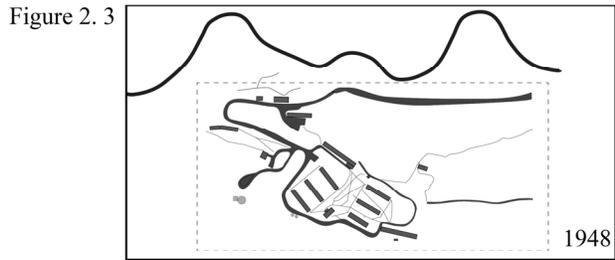
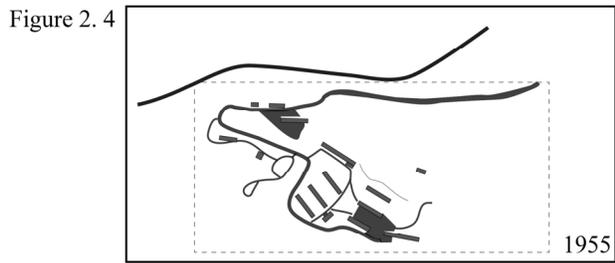
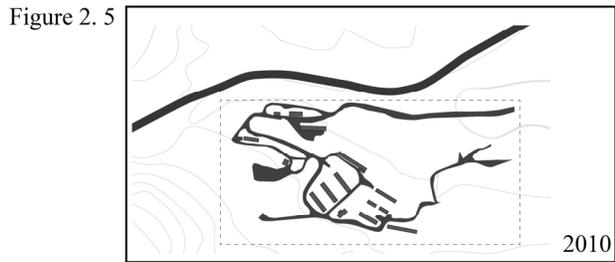
Figure 2. Roads and Trails 1930-2010. (Kelly Halpin, October 15, 2011).

The road was originally dirt and gravel with parts of the road covered with asphalt. The southern segment of the road behind Barracks #3, and the recreation hall and spur road behind the garage and shop are gravel and dirt. Traces of the original dirt road are detected in the 1930s aerial photograph and can still be discerned behind the Headquarters Building and Barracks #2 (see fig. 2.1). The spur road around the Playhouse leading to the old water plant is clear in the 1955 aerial image (see fig. 2.4) but was a dirt path prior to 1937 (see fig. 2.2) and 1948 (see fig. 2.3); therefore, this spur road was not part of the original road system. The spur road that runs behind the garage and shop was built sometime between 1955 and 2010 (see figs. 2.4, 2.5).

The road became clearly defined between 1937 and 1948 as the vegetation began to grow and new camp uses changed the requirements of the site. The parking lots were expanded, primarily around the garages (figs. 2.2-2.5) and a section of the original road was no longer in use between the Latrine and Recreation Hall (fig. 2.2). The original roads have the same alignment and cross-section, thus retaining integrity in all aspects except materials.

example of a footpath from the CCC era is on the east side of the current Denver Mountain Parks offices. On that footpath a bridge extends over the artificially fed drainage flowing from the water plant in the southwest part of the camp (see fig. 2.2). The path is made of compacted dirt with rocks lining the edges. The footpath leads to the northeast side of the headquarters building and is approximately 115'-0 x 3'-0 in length and width. During the 1930s, the footpaths within the camp were heavily used, but by 2010 a noticeable deterioration of the original system is evident (see fig. 2). The trails that originally led from the camp to the trout ponds and the park are no longer visible in the 2010 aerial image. The trout ponds are now located on private property. The flagpole encircled by lilac bushes still has the openings for the entrances leading into the circle with clear axes but the paths are less visible.

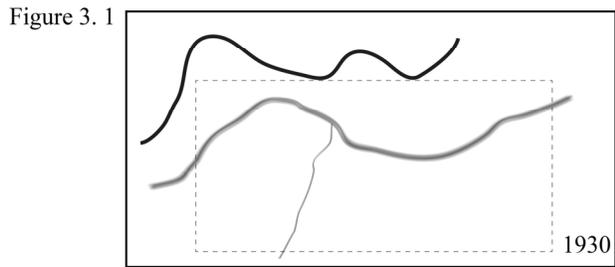
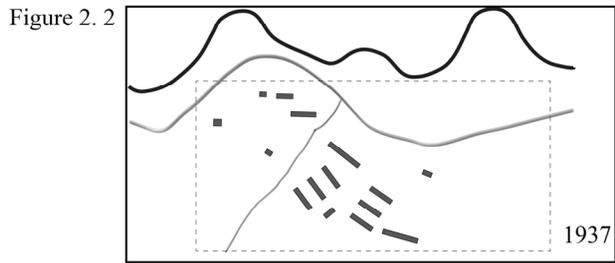
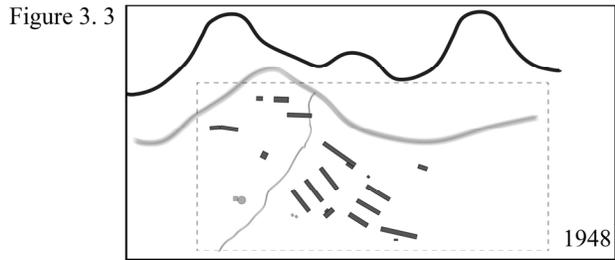
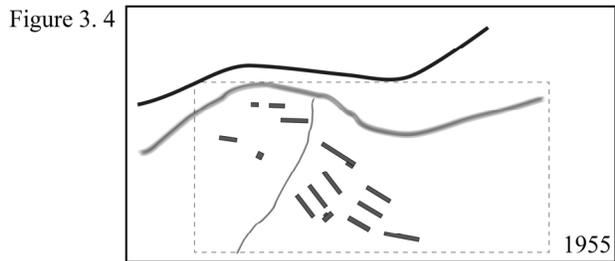
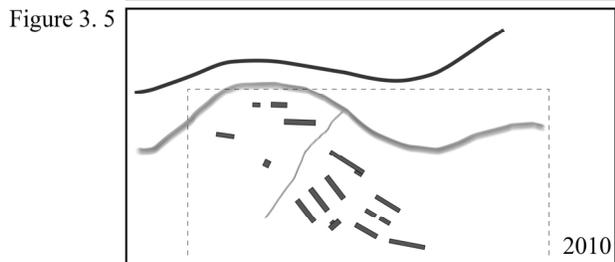
Figure 2. River 1930-2010. (Kelly Halpin, October 15, 2011).

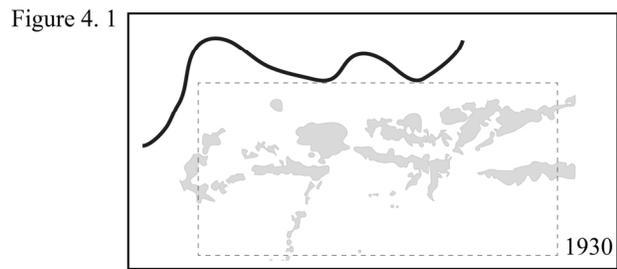
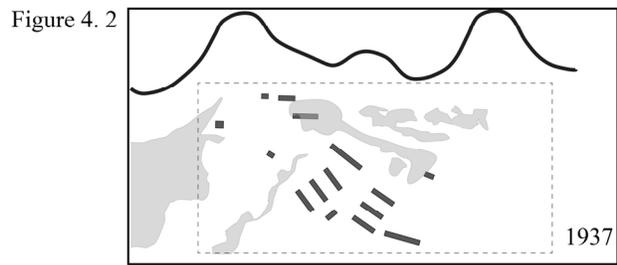
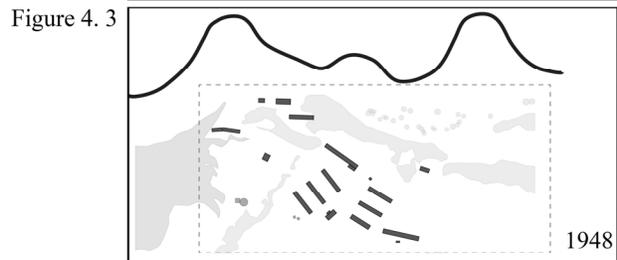
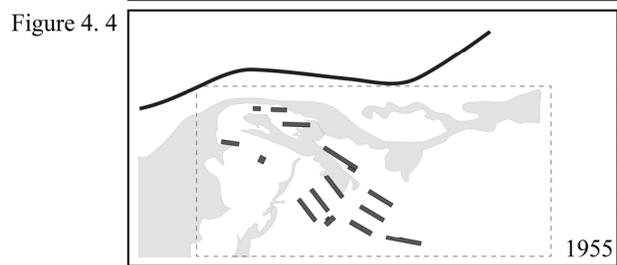
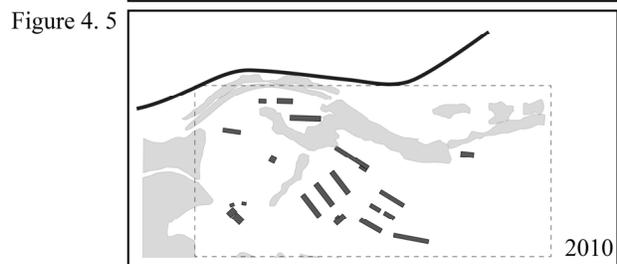
Figure 4. Vegetation 1930-2010. (Kelly Halpin, October 15, 2011).

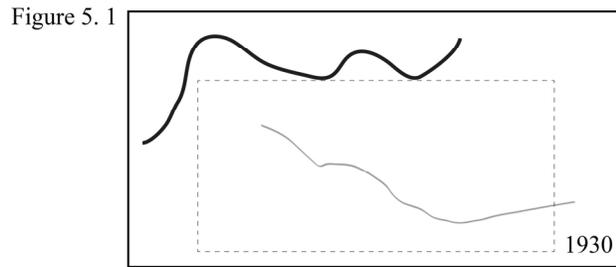
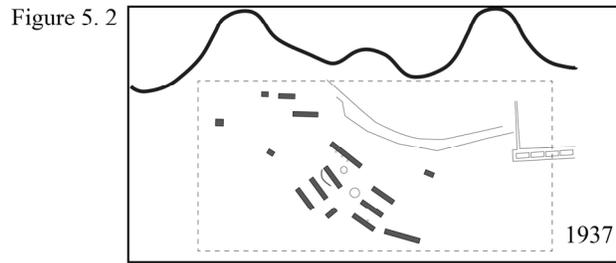
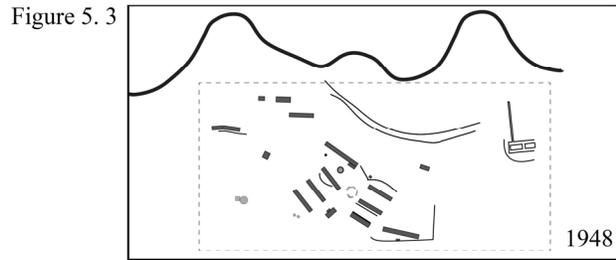
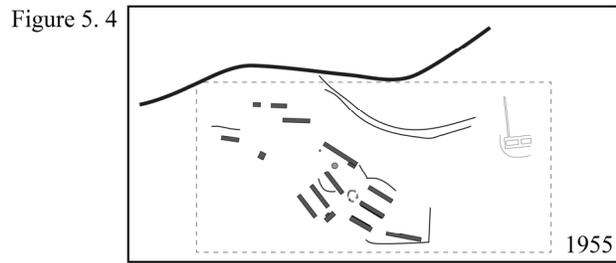
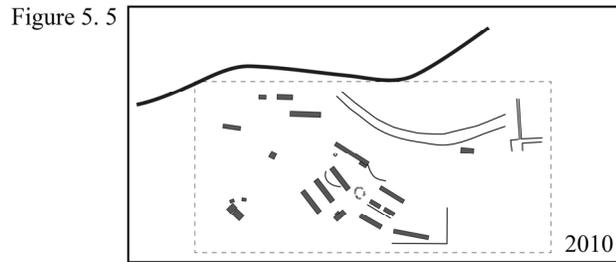
Figure 5. Landscape Features 1930-2010. (Kelly Halpin, October 15, 2011).

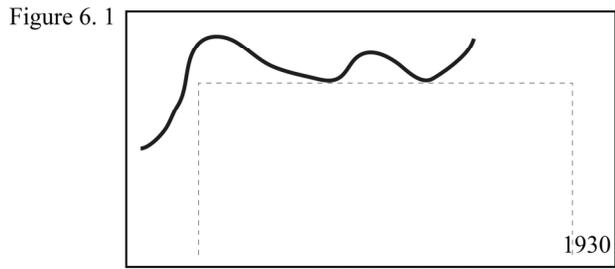
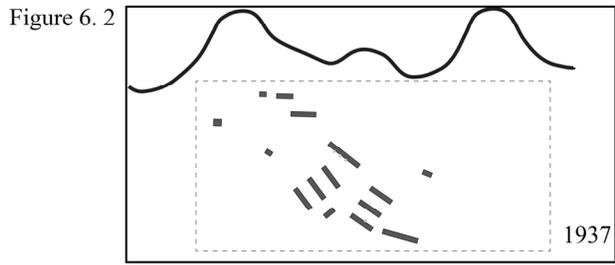
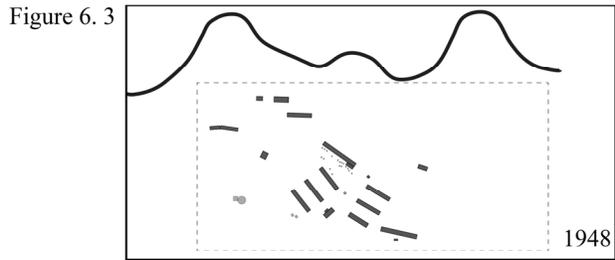
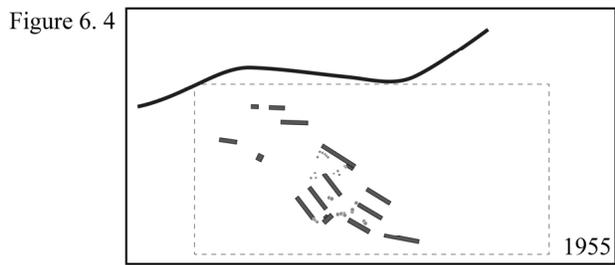
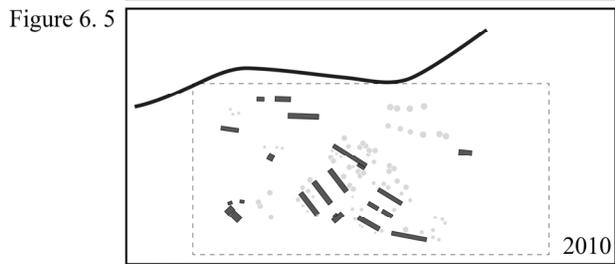
Figure 6. Trees 1930-2010. (Kelly Halpin, October 15, 2011).
