ST. ELIZABETHS HOSPITAL, ATKINS HALL  
(Building No. 31)  
2700 Martin Luther King Jr. Avenue, Southeast, 518-542 Redwood  
Street, Southeast  
Washington  
District of Columbia

HABS DC-349-T  
*HABS DC-349-T*

ST. ELIZABETHS HOSPITAL, ATKINS HALL (BUILDING 31)

HABS NO. DC-349-T

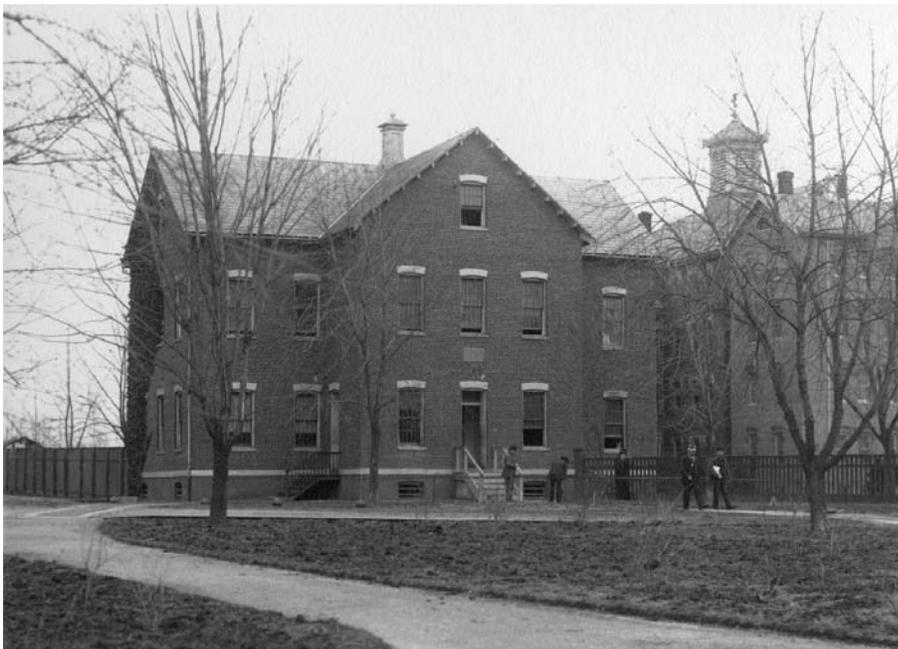
*Figure 2. Atkins Hall, 1897. Source: 1896 Annual Report and GSA archive, image DC1343SE0P009.*

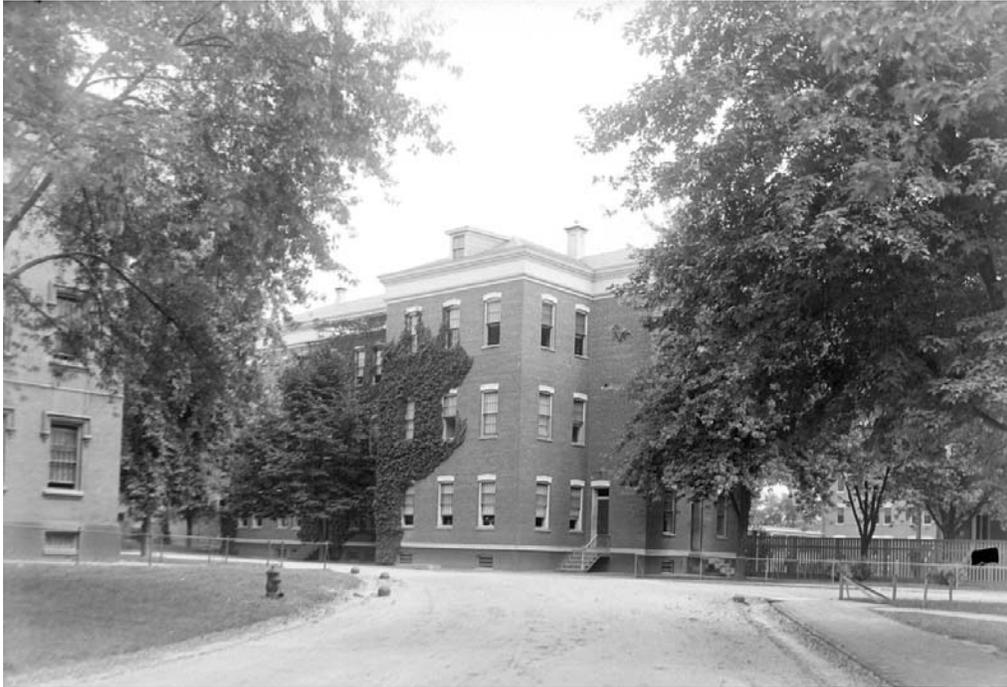
Figure 5. View of Atkins Hall from the northwest, 1900. Source: GSA archive, image DC1343SE0P002.

A \$5,000 appropriation was made in 1898 to provide for replacement of floors, installation of brick fireproof partition walls, and construction of the wood-framed piazzas.<sup>11</sup> By 1900, the third floor addition had been completed. Contrary to some of the earlier plans for the building, no interior brick fireproof partitions were built. The renovated building included a hip roof and sheet metal rooftop ventilators as well as shed roof dormers that projected from the roof face on the end of each of the four wings of the plan. The original floor and ceiling framing was removed and replaced by a steel beam-framed structure with brick vaults for the first, second, and third floors. The new interior finishes consisted of wood floors, picture rail, plaster walls, and plaster ceilings applied to the underside of the brick vaulting. Pendant light fixtures were suspended from the ceiling.<sup>12</sup> The existing iron fire escape, installed in 1883 along the east facade of the building, was removed during the expansion project and the second floor door opening was replaced by a window.<sup>13</sup>

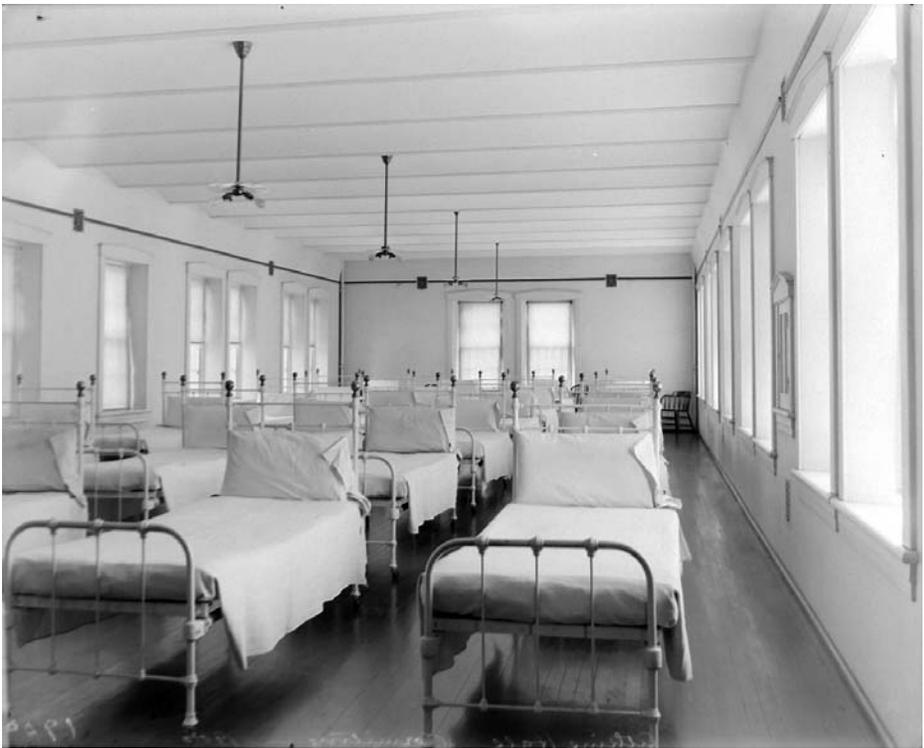
Figure 8. Dormitory, Atkins Hall, 1900. Source: GSA archive, image DC1343SE0P006.

Pendant lighting in the dormitory and sitting rooms were replaced with ceiling-mounted light fixtures attached to the underside of the brick vaulted ceiling.<sup>20</sup>

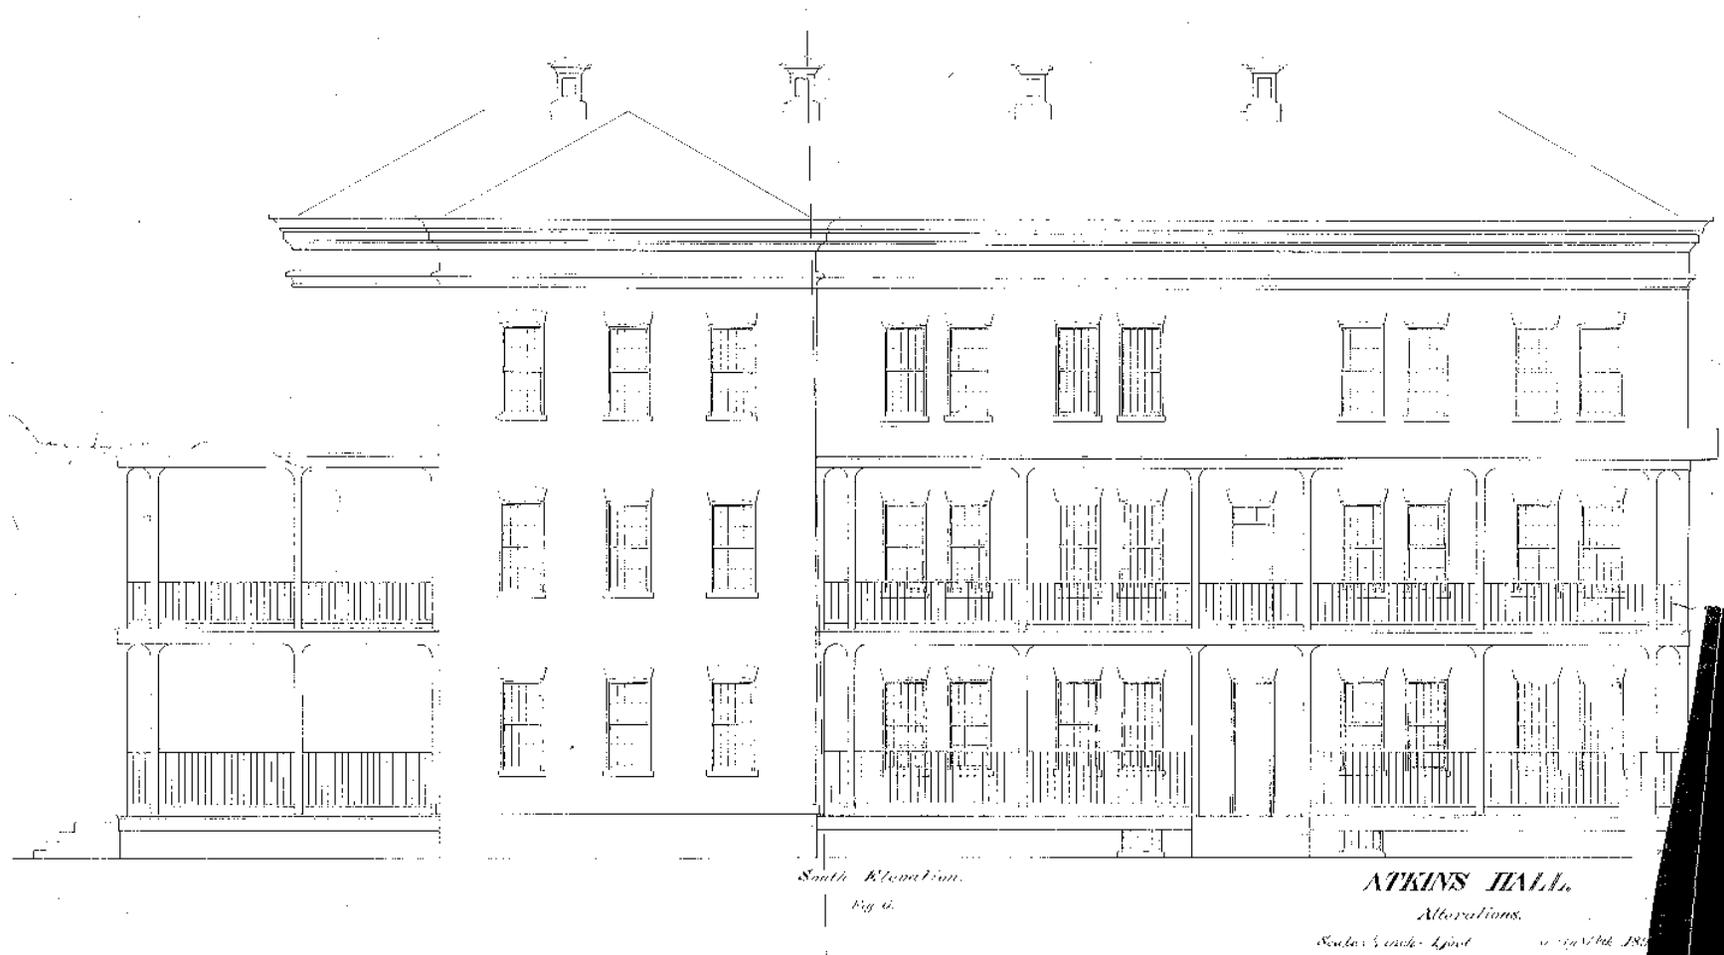
Figure 6. Drawing of the south elevation, Atkins Hall alterations, 1896. Source: GSA archive, image DC1343SE0106.

In the late 1890s, it was decided to keep Atkins Hall as a patient ward facility rather than convert it into a patient therapy building as originally planned. Plans were generated for an extensive renovation of the building which included the addition of a third floor, alterations to the existing floor plan, construction of piazzas, and improvements to fireproofing. Drawings were developed in 1896 for a third floor addition of brick and a decorative cornice and entablature. The addition was surmounted by a hip roof with vent hoods and provided a second dormitory ward, thus doubling the building's patient occupancy.<sup>10</sup>

<sup>10</sup> The drawings also show a two-story piazza along the south facade of the building and wrapping around the west facade; however, this piazza was not constructed in its entirety. The drawings also do not depict the shed dormers that archival photographs indicate were a part of the original construction.

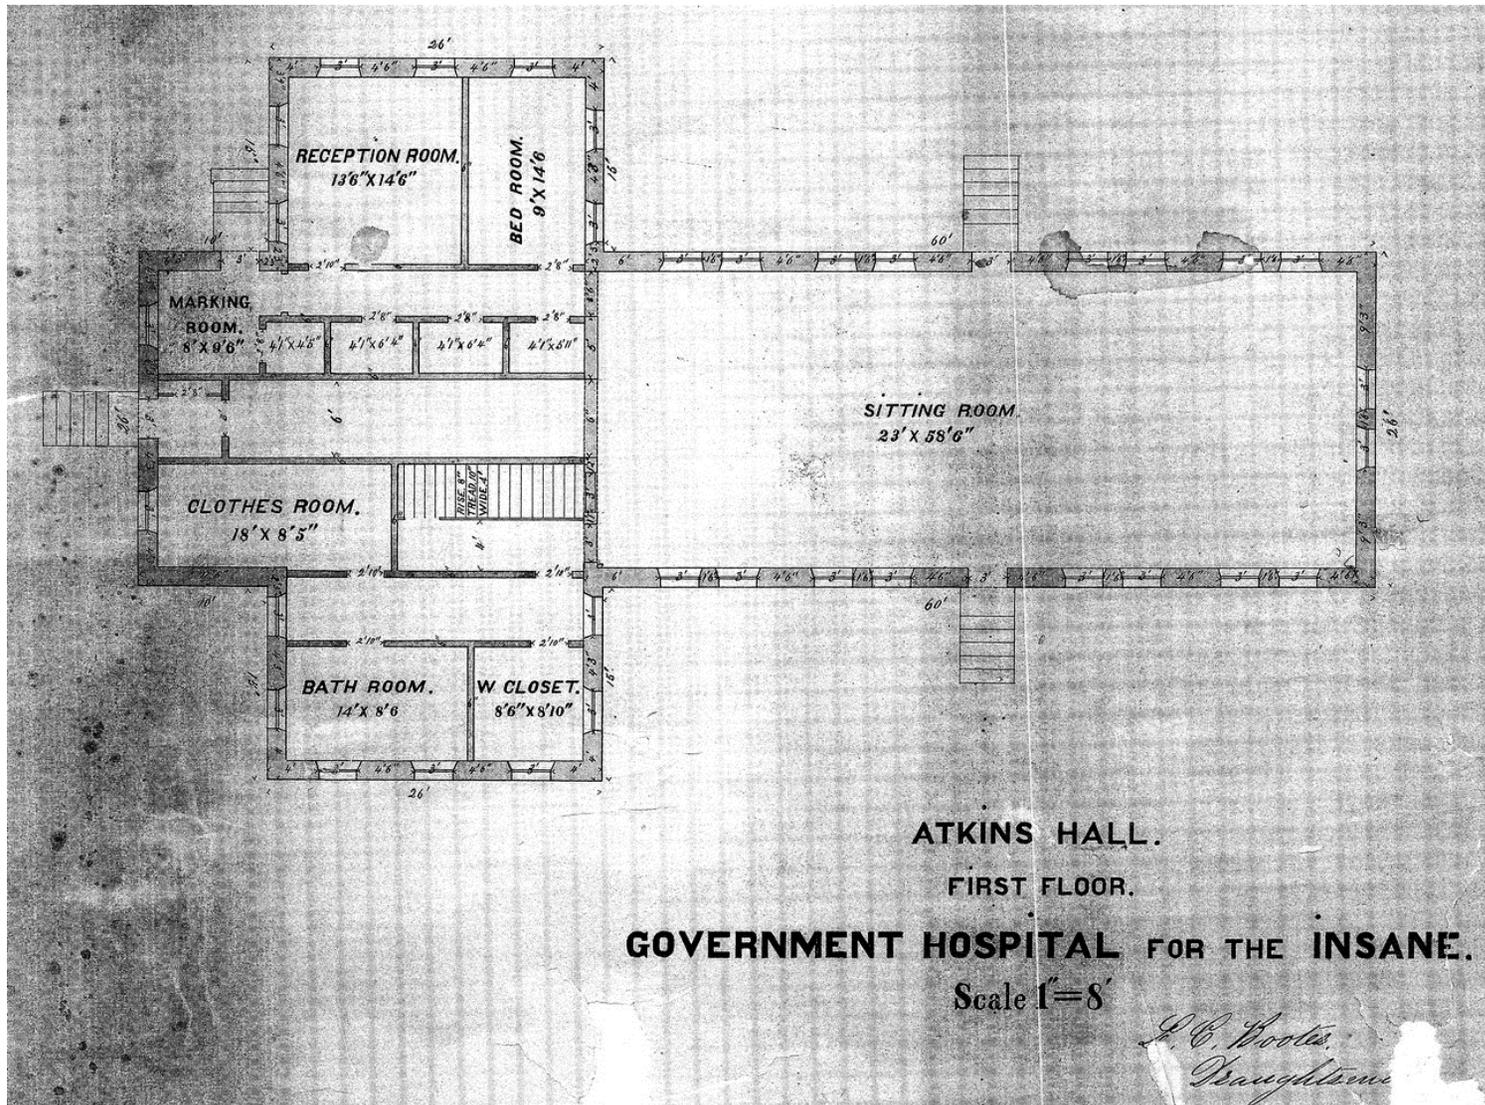
Figure 7. First floor drawing of Atkins Hall, undated. Source: GSA archive, image DC1343SE0108.

1. Floor plans: The Latin cross-shaped plan of Atkins Hall is reflected in the interior layout. The long eastern wing originally contained a large sitting room on the first floor and open dormitories on the second and third floor. These large spaces were subdivided by partitions erected in the early 1980s.
