ST. ELIZABETHS HOSPITAL, CENTER BUILDING  
(Building Nos. 1 and 2)  
539-559 Cedar Drive, Southeast  
Washington  
District of Columbia

HABS DC-349-W  
*HABS DC-349-W*

### ST. ELIZABETHS HOSPITAL, CENTER BUILDING (BUILDINGS 1 AND 2)

HABS NO. DC-349-W

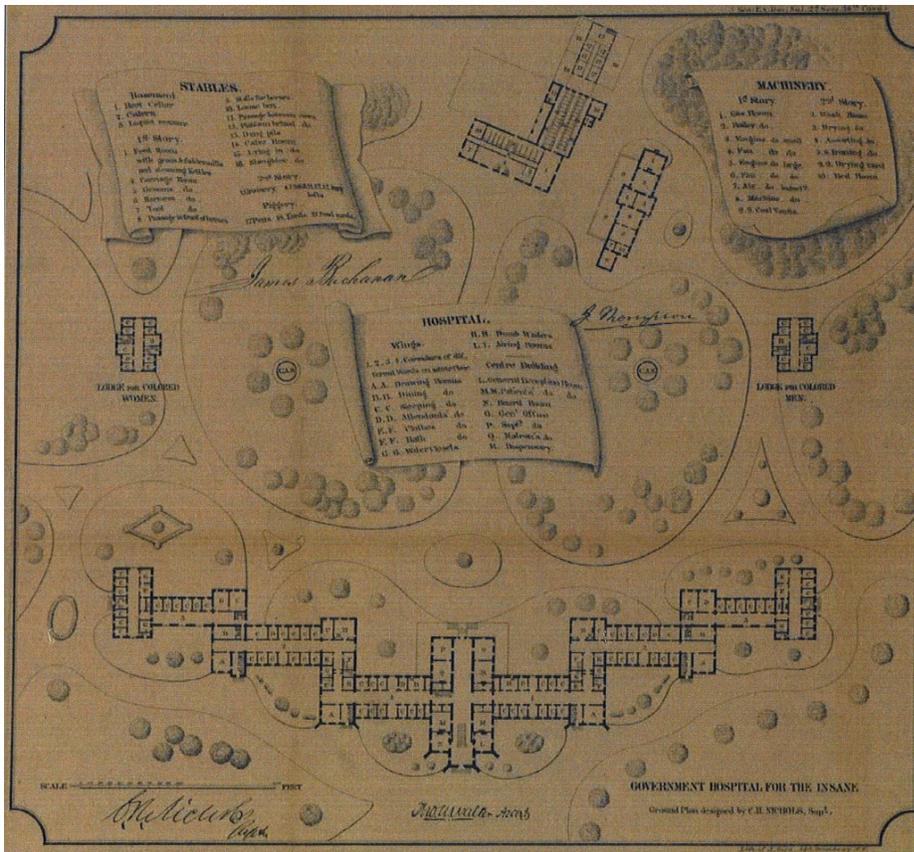
Figure 3. 1860 Ground Plan designed by Charles Nichols and signed by Architect Thomas U. Walter and President James Buchanan. Source: Library of Congress.

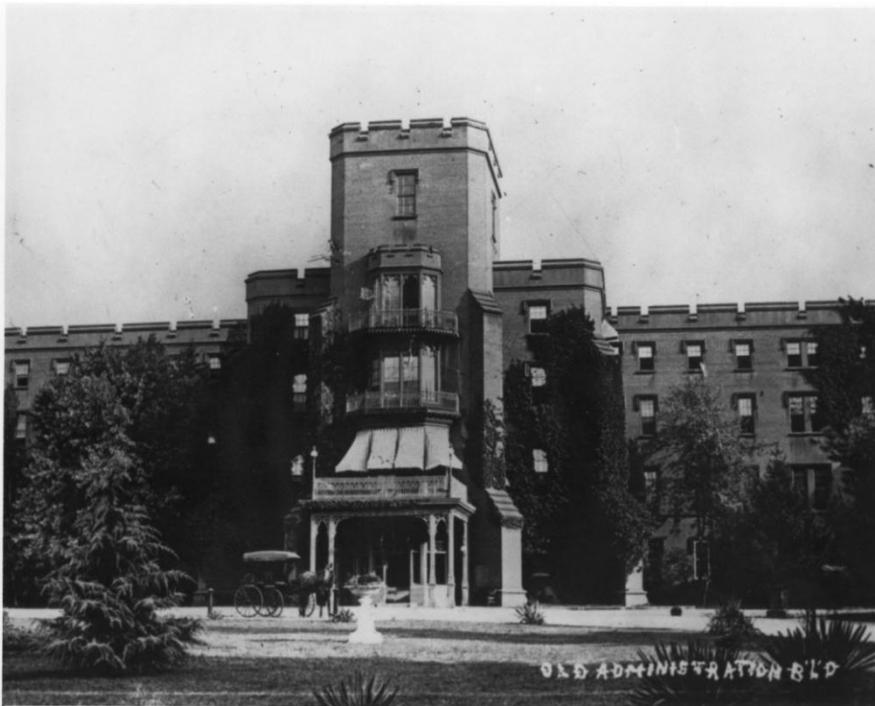
*Figure 7. View from the north of the Center Building with porte cochère, balconies, and fourth floor additions to side wings, circa 1889. Source: GSA archives, image DC0066SE0P003.*

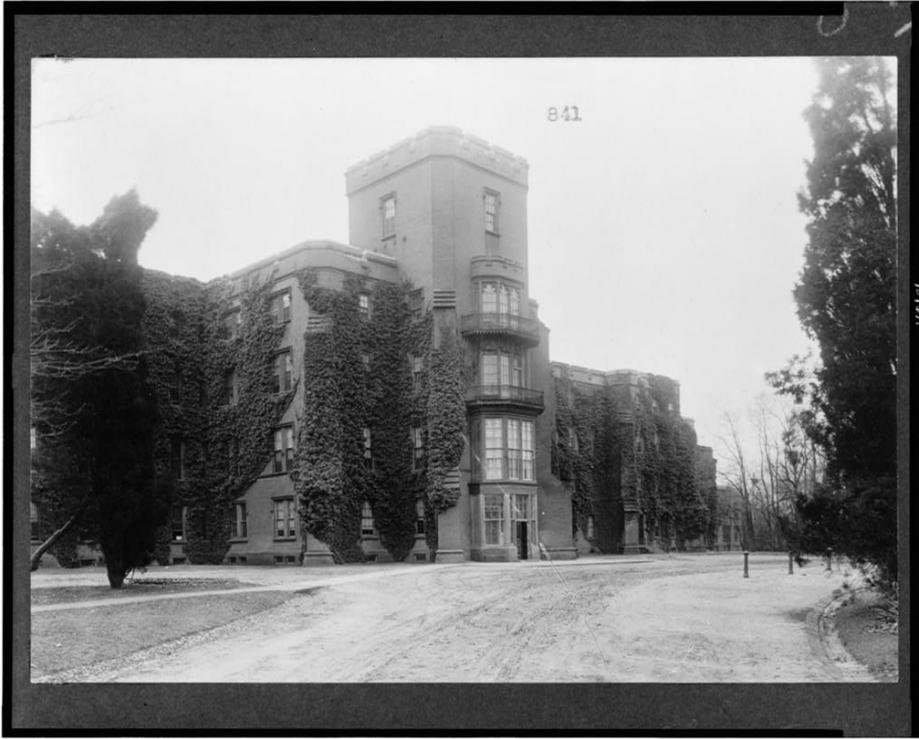
*Figure 30. North facade of the Center Building following the dismantlement of the porte cochère, between 1908 and 1932. Source: National Photo Company archives at the Library of Congress.*

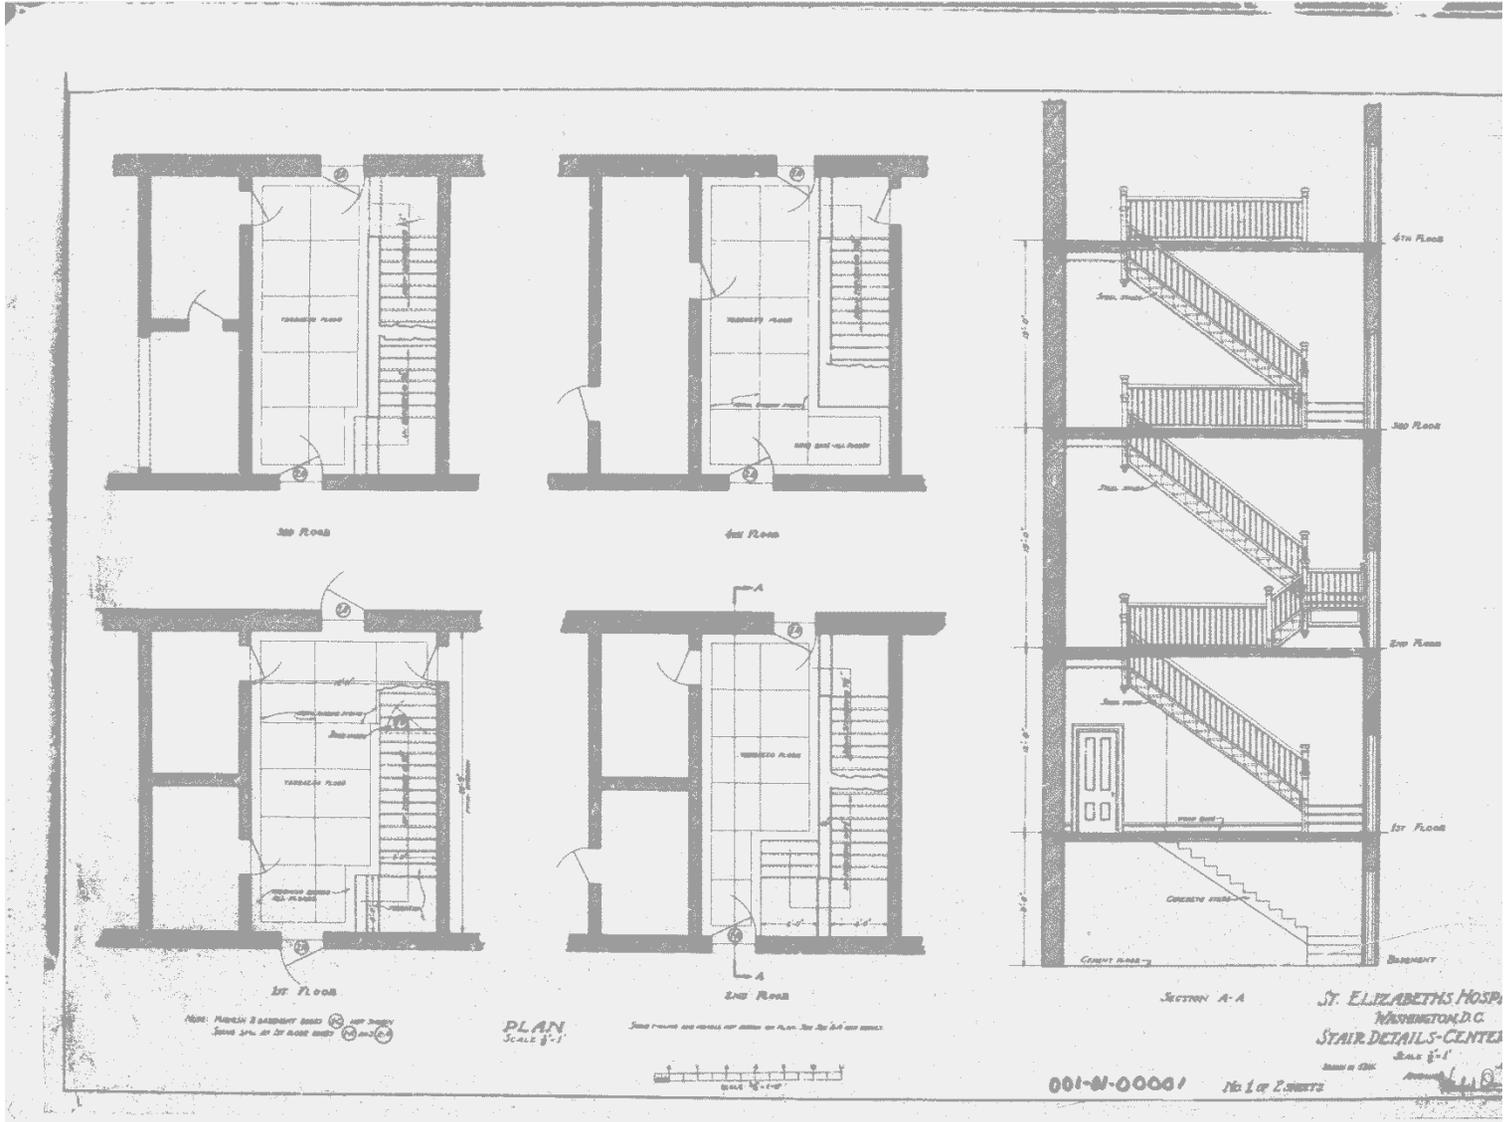
Figure 33. Stairwell renovation at the center Building, 1938. Source: GSA archives, image DC0066SE0109.

Due to its dilapidated condition, Dawes was demolished in 1965. Other projects initiated in 1967 aimed to improve security and safety. Metal-framed screen doors and windows were installed throughout the Center Building and stairwells were renovated to incorporate code compliance handrails.<sup>49</sup>

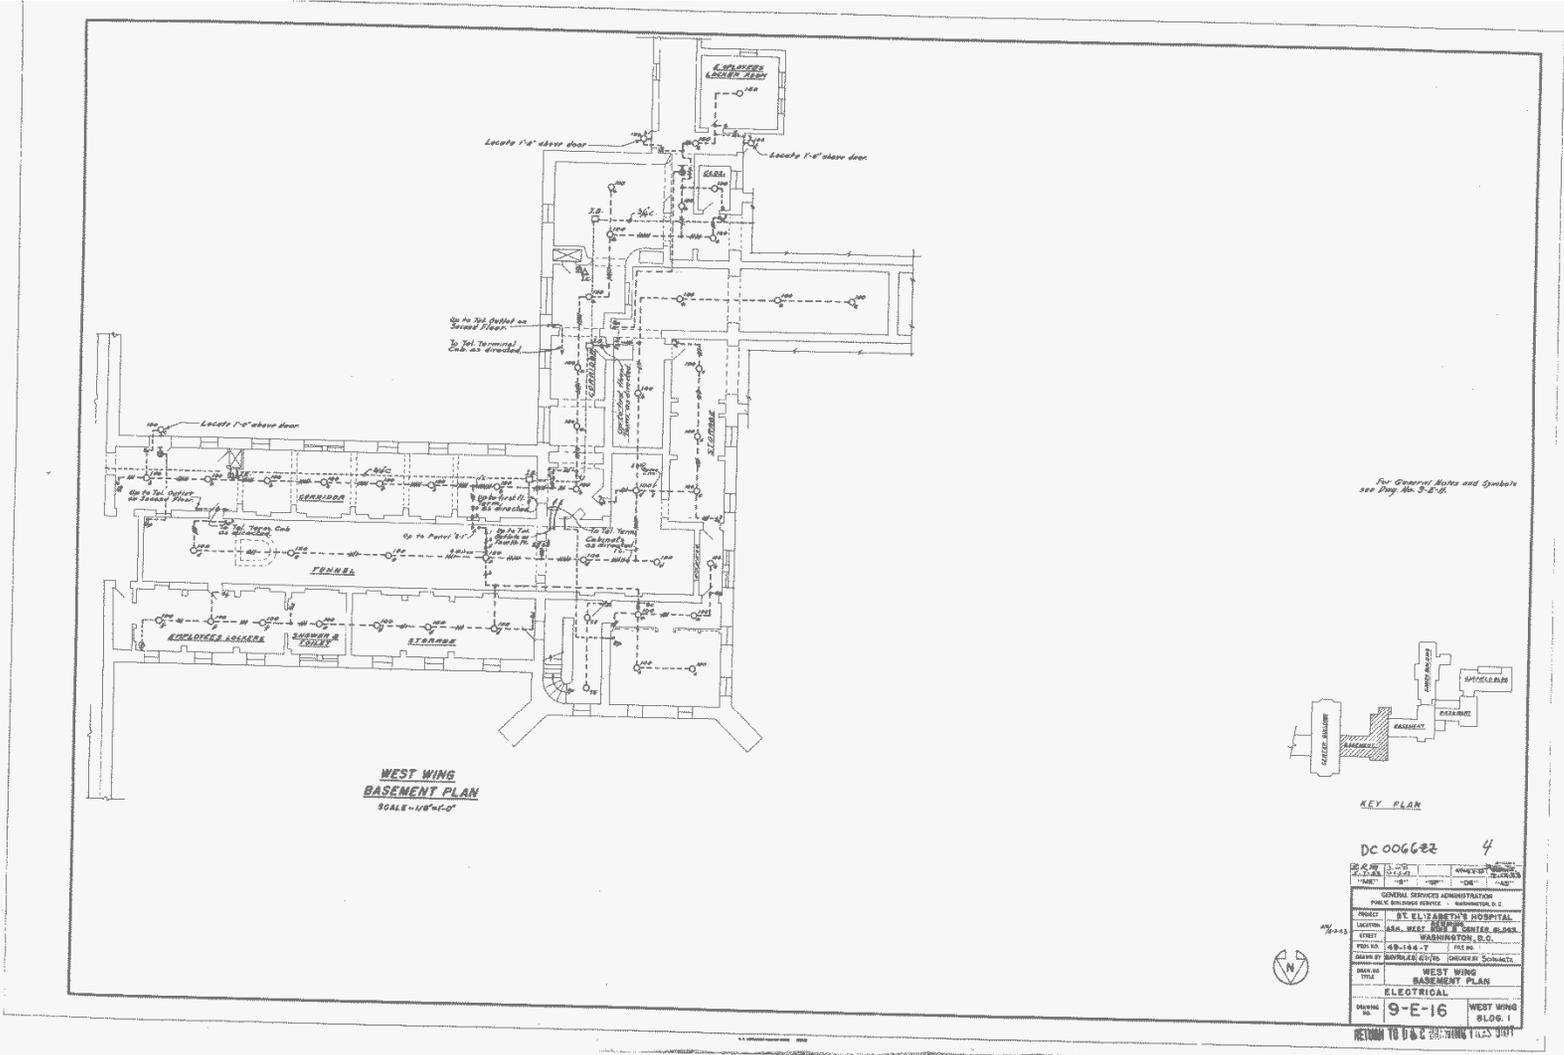
Figure 34. Basement plan of the west wing of the Center Building outlining improvements to the electrical system, 1953. Source: GSA archives, image DC0066SE0004.

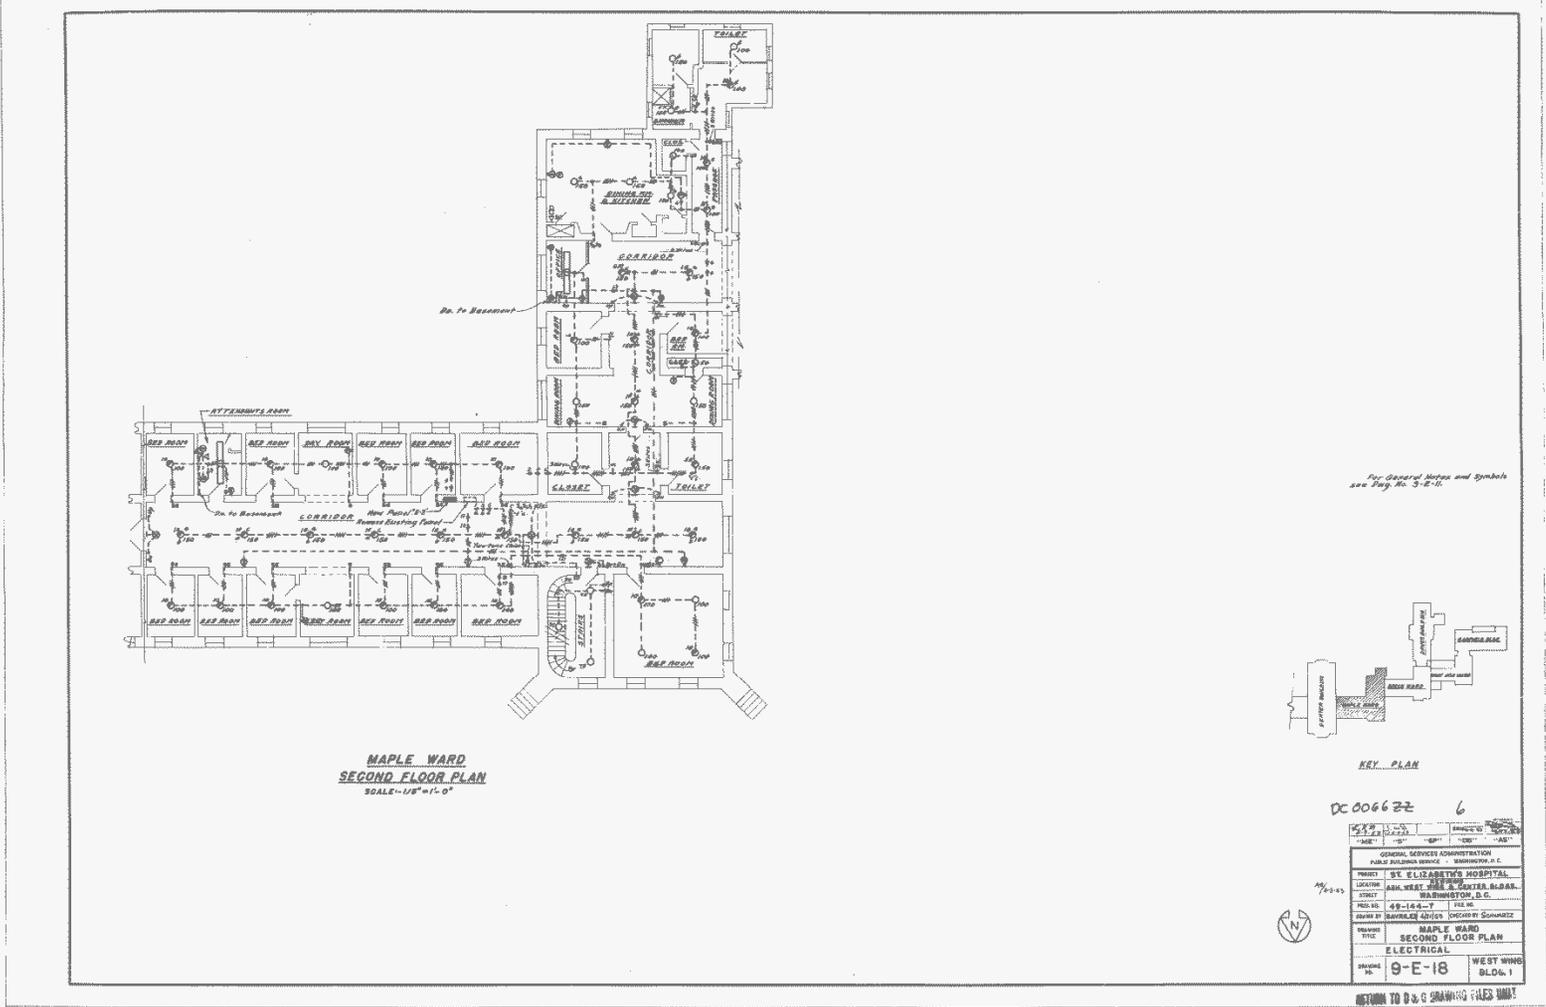
Figure 36. Second floor plan of the west wing of the Center Building, Maple ward, outlining improvements to the electrical system, 1953. Source: GSA archives, image DC0066SE0006.

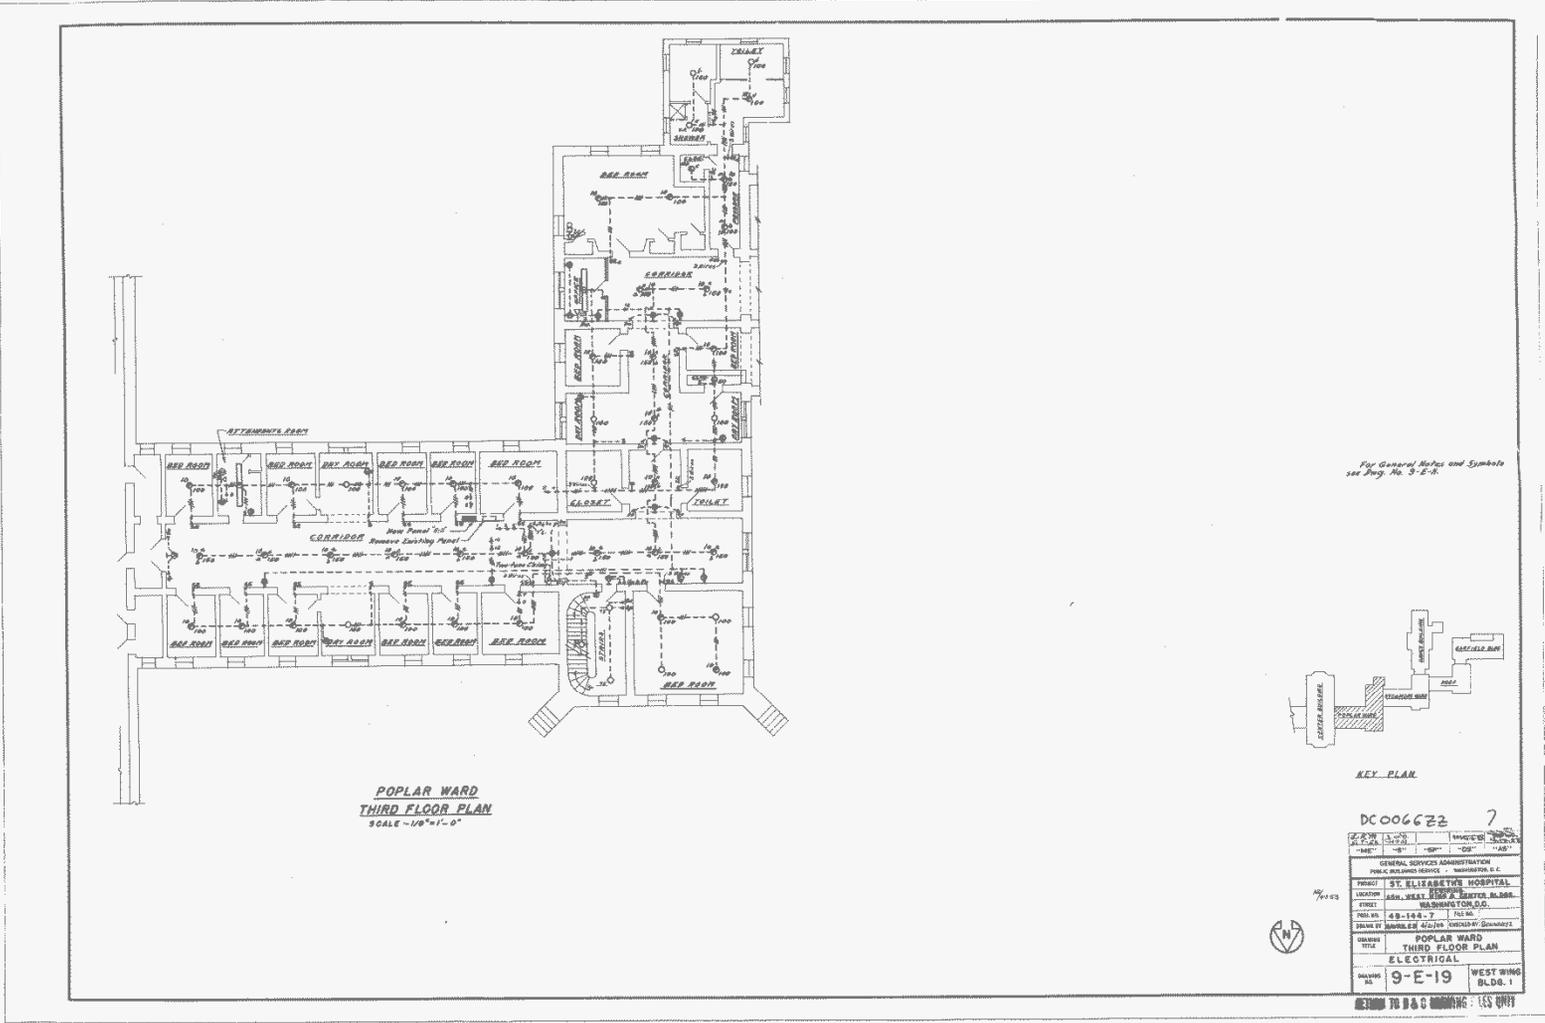
Figure 37. Third floor plan of the west wing of the Center Building, Poplar ward, outlining improvements to the electrical system, 1953. Source: GSA archives, image DC0066SE0007.

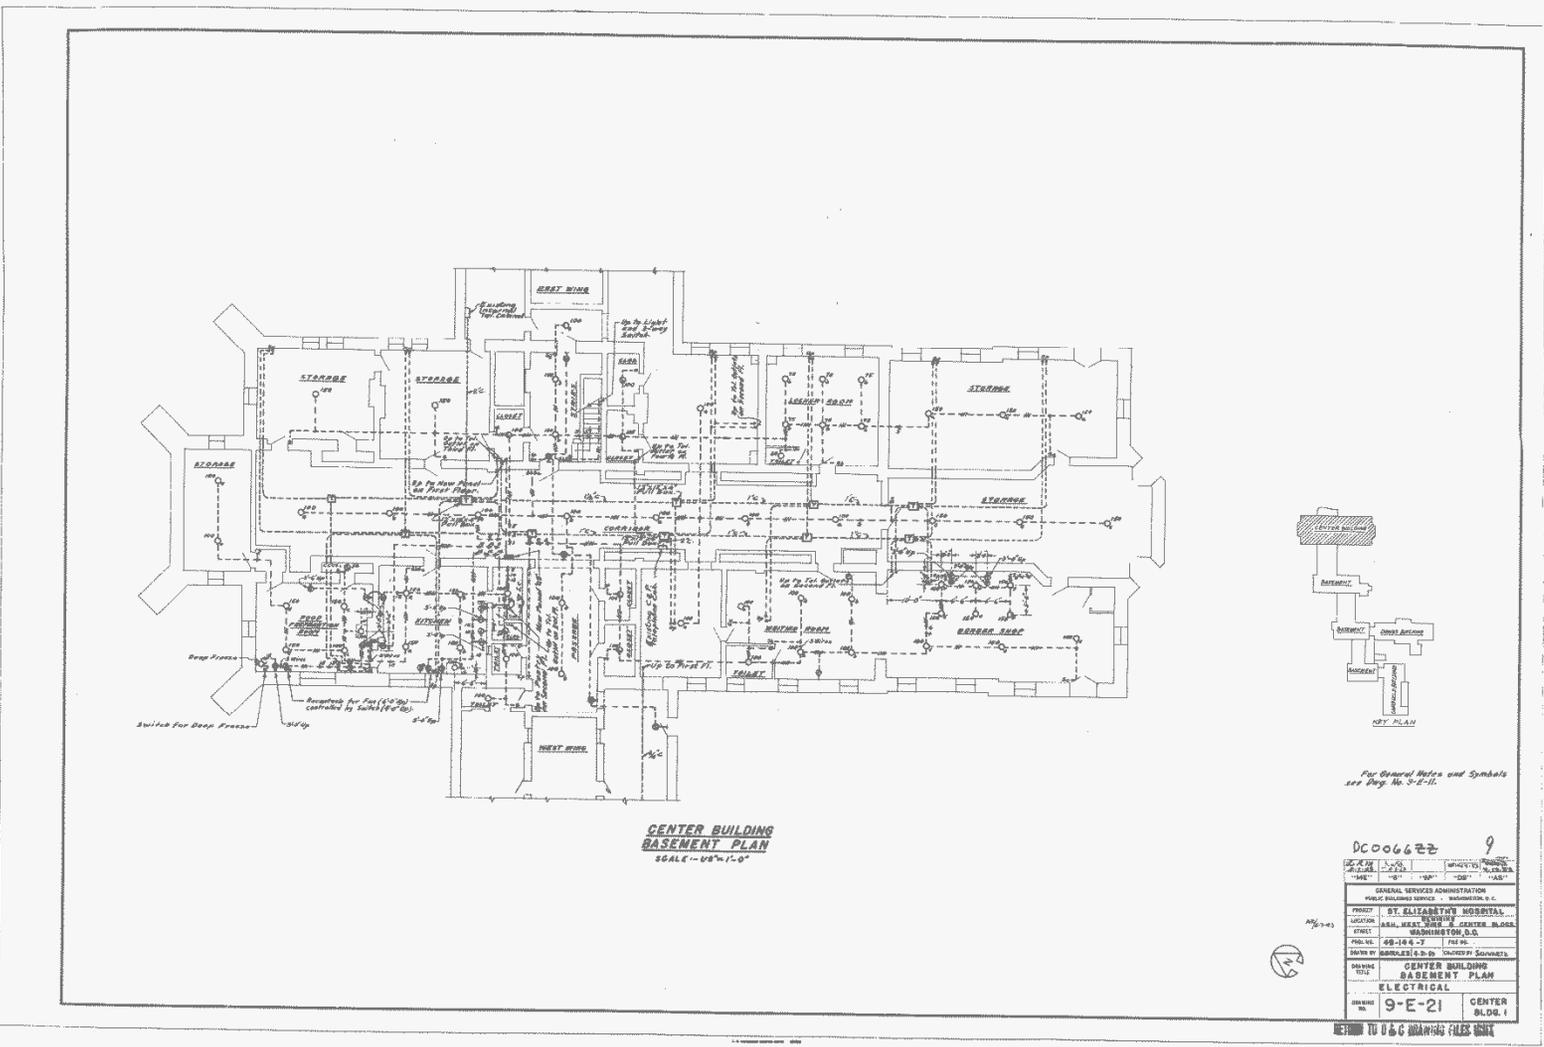
Figure 39. Basement plan of the Center Building outlining improvements to the electrical system, 1953. Source: GSA archives, image DC0066SE0009.

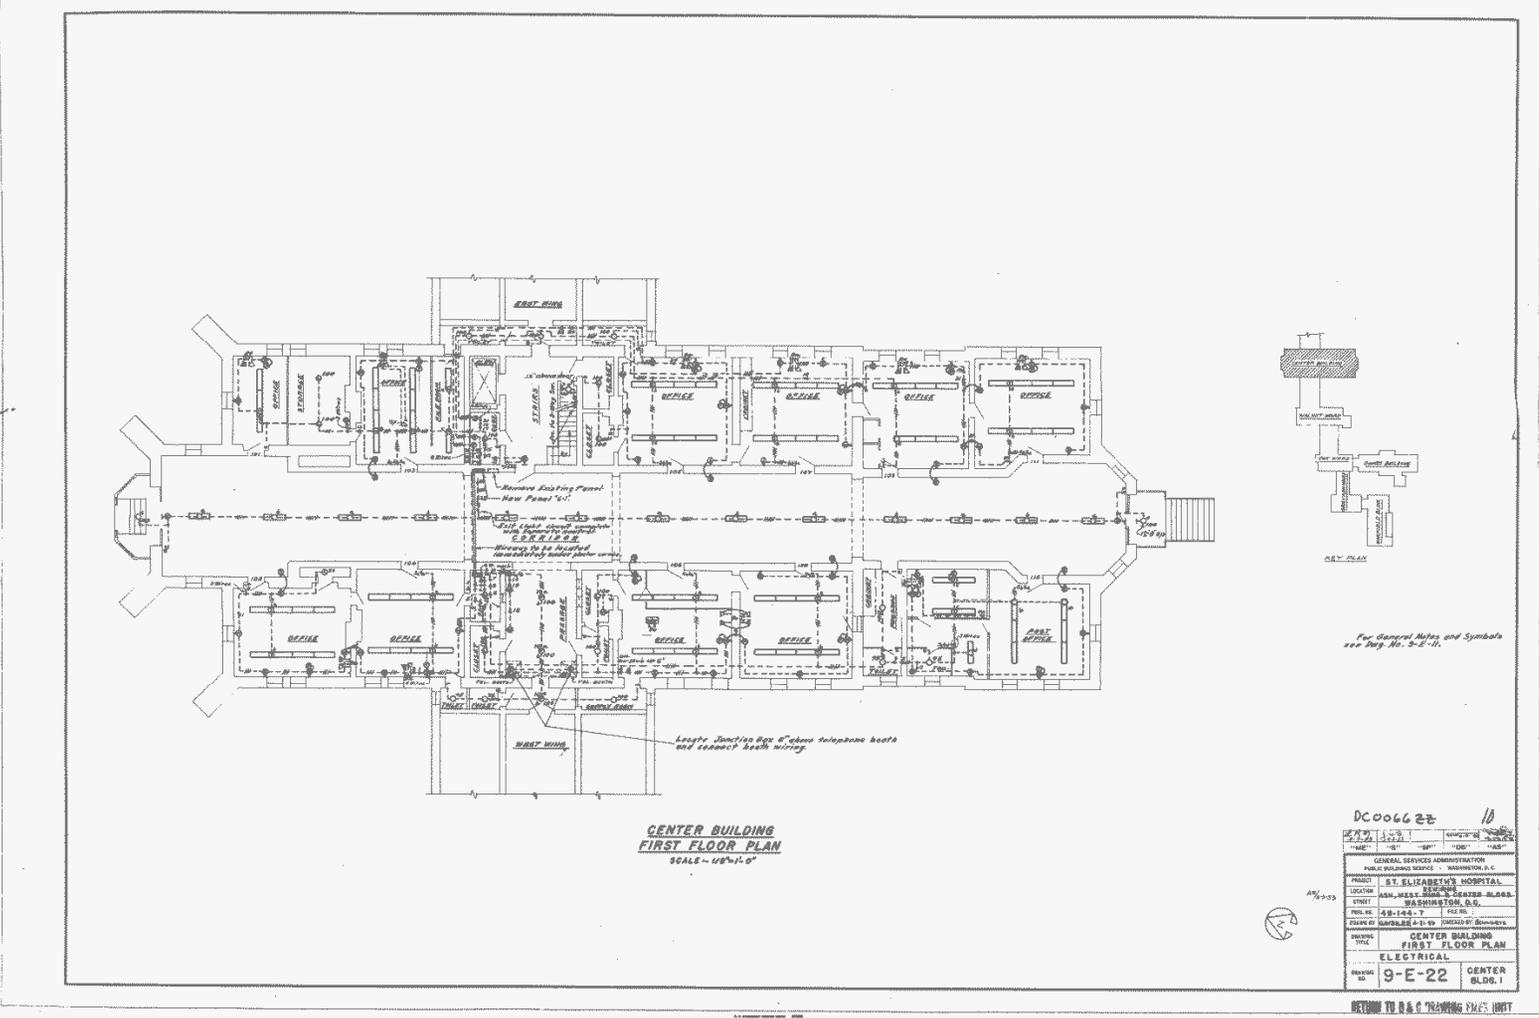
Figure 40. First floor plan of the Center Building outlining improvements to the electrical system, 1953. Source: GSA archives, image DC0066SE0010.

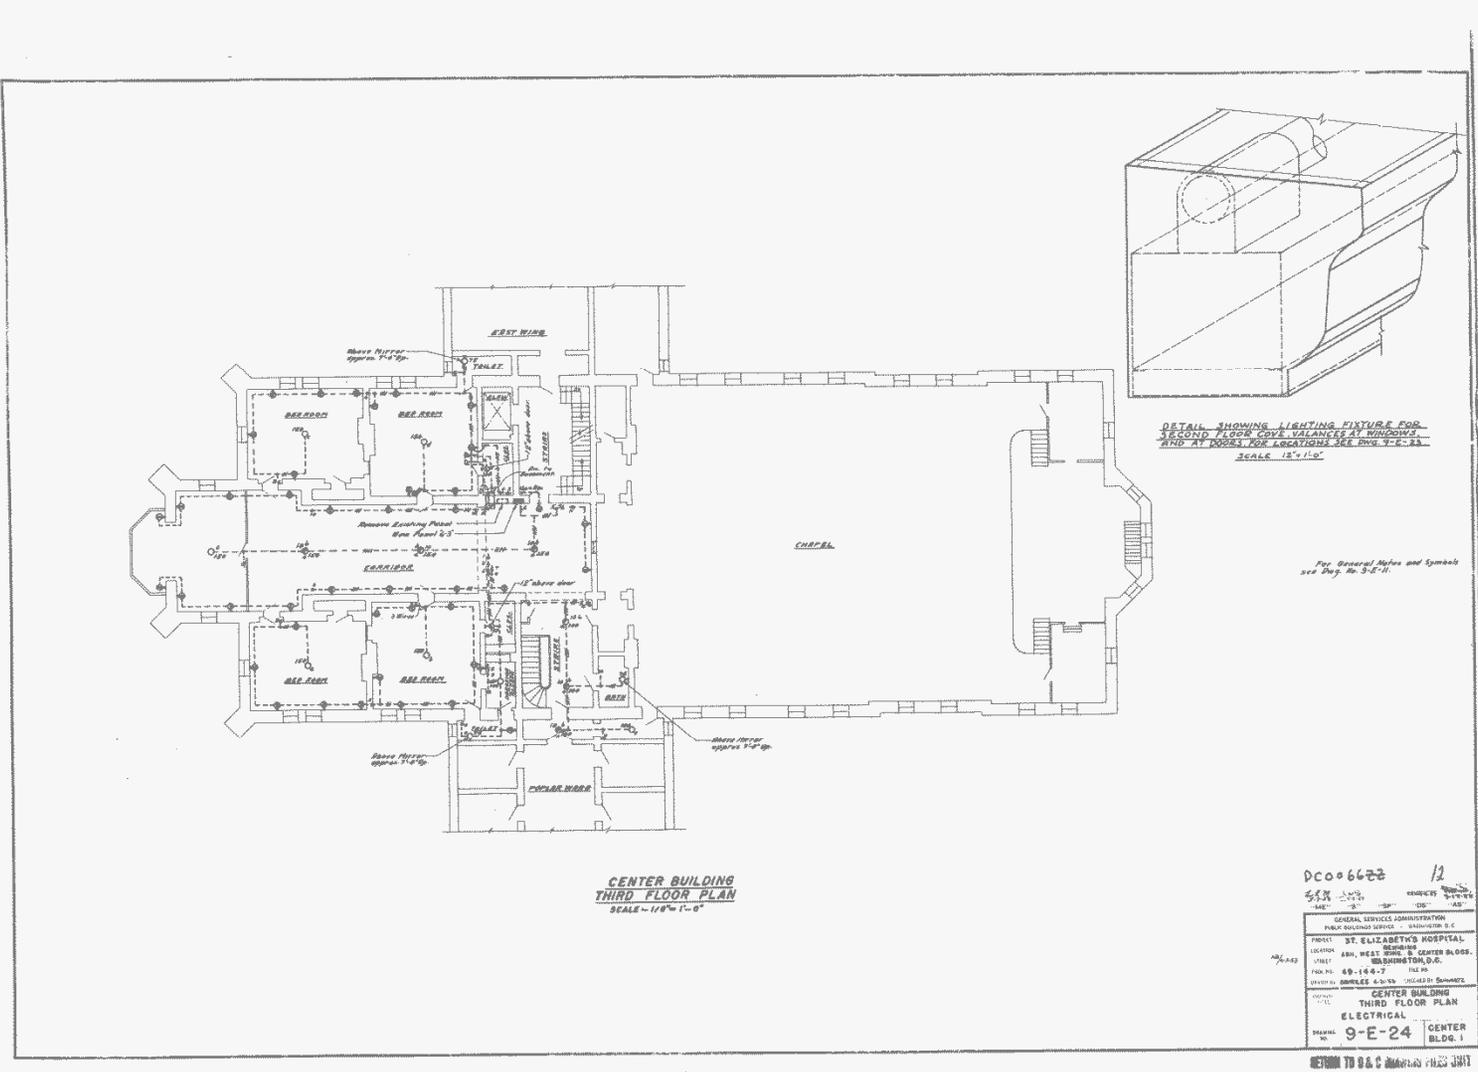
Figure 42. Third floor plan of the Center Building outlining improvements to the electrical system, 1953. Source: GSA archives, image DC0066SE0012.

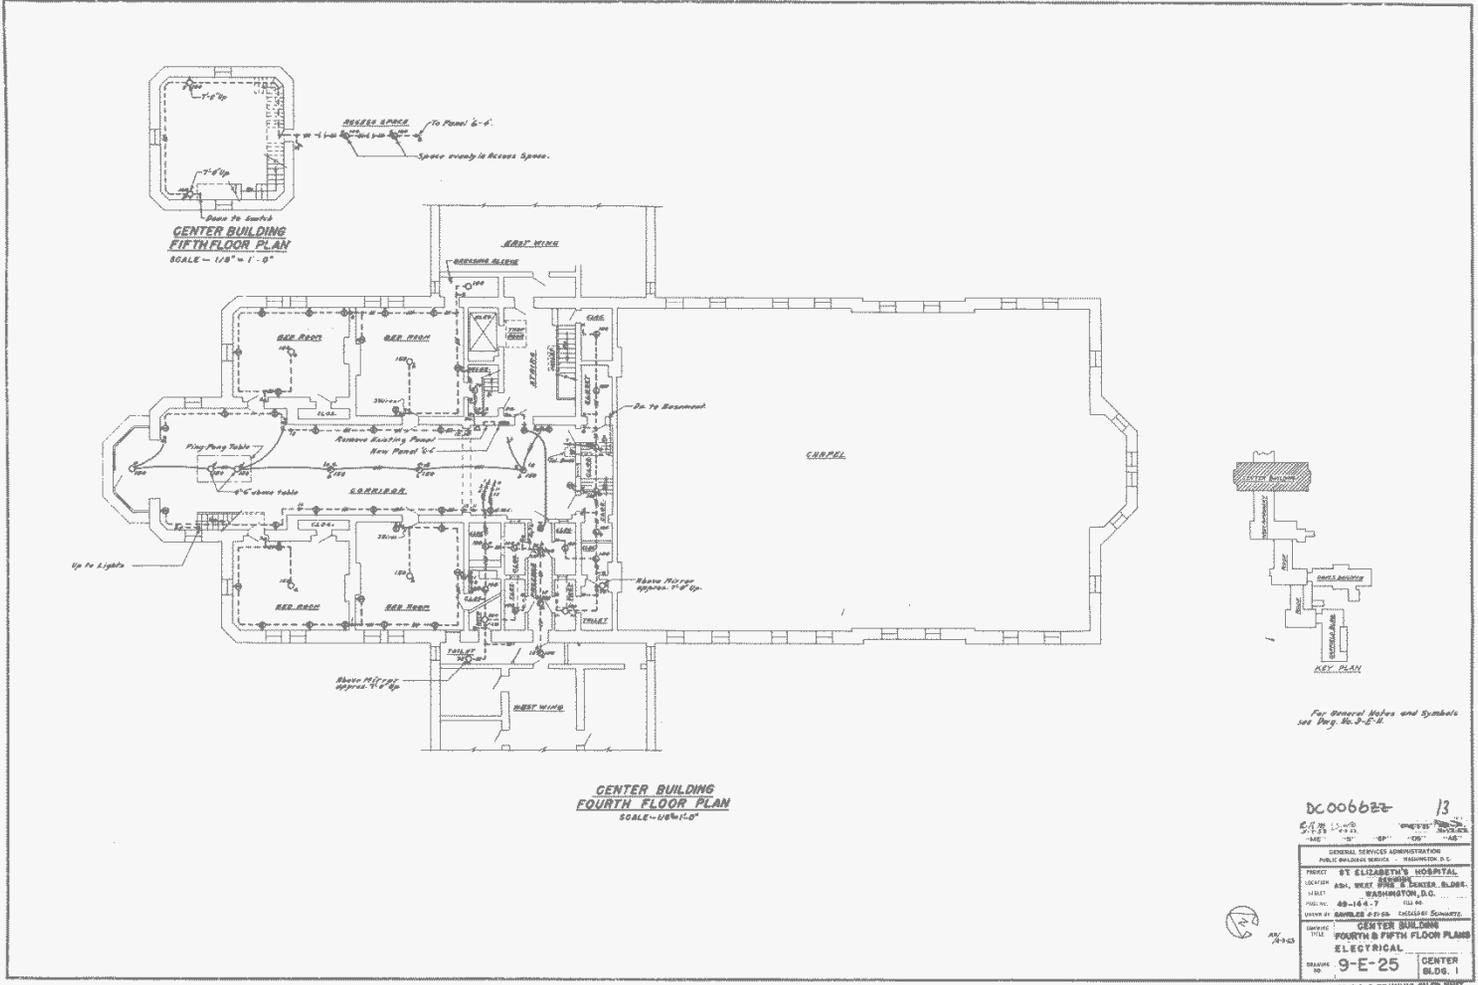
Figure 43. Fourth floor plan of the Center Building outlining improvements to the electrical system, 1953. Source: GSA archives, image DC0066SE0013.

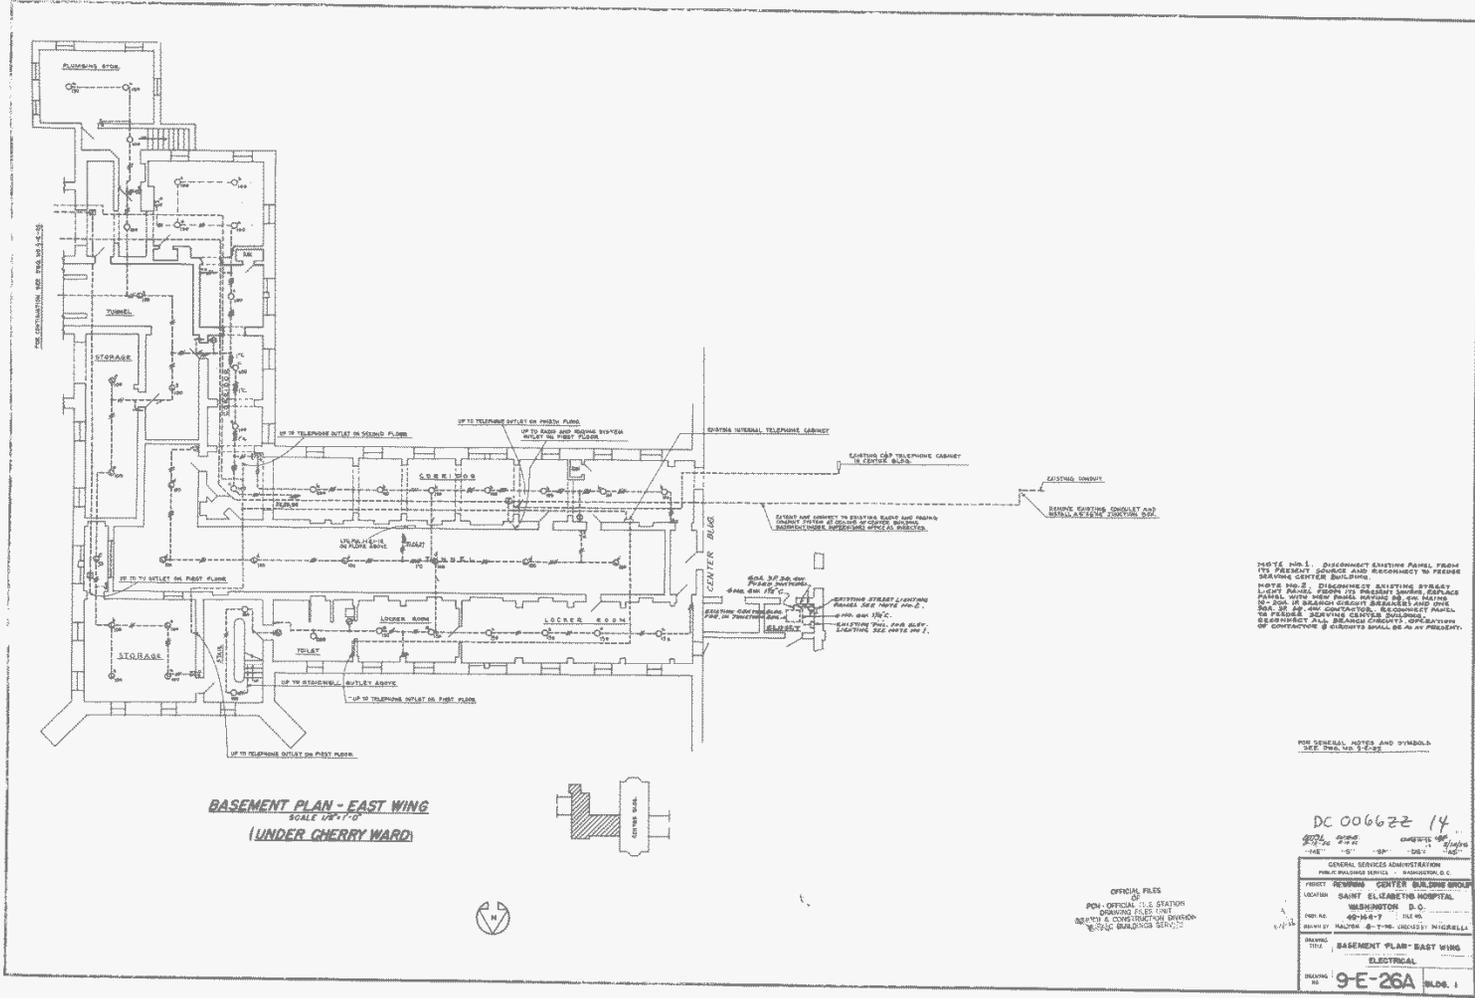
Figure 44. Basement plan of the east wing of the Center Building outlining improvements to the electrical system, 1953. Source: GSA archives, image DC0066SE0014.

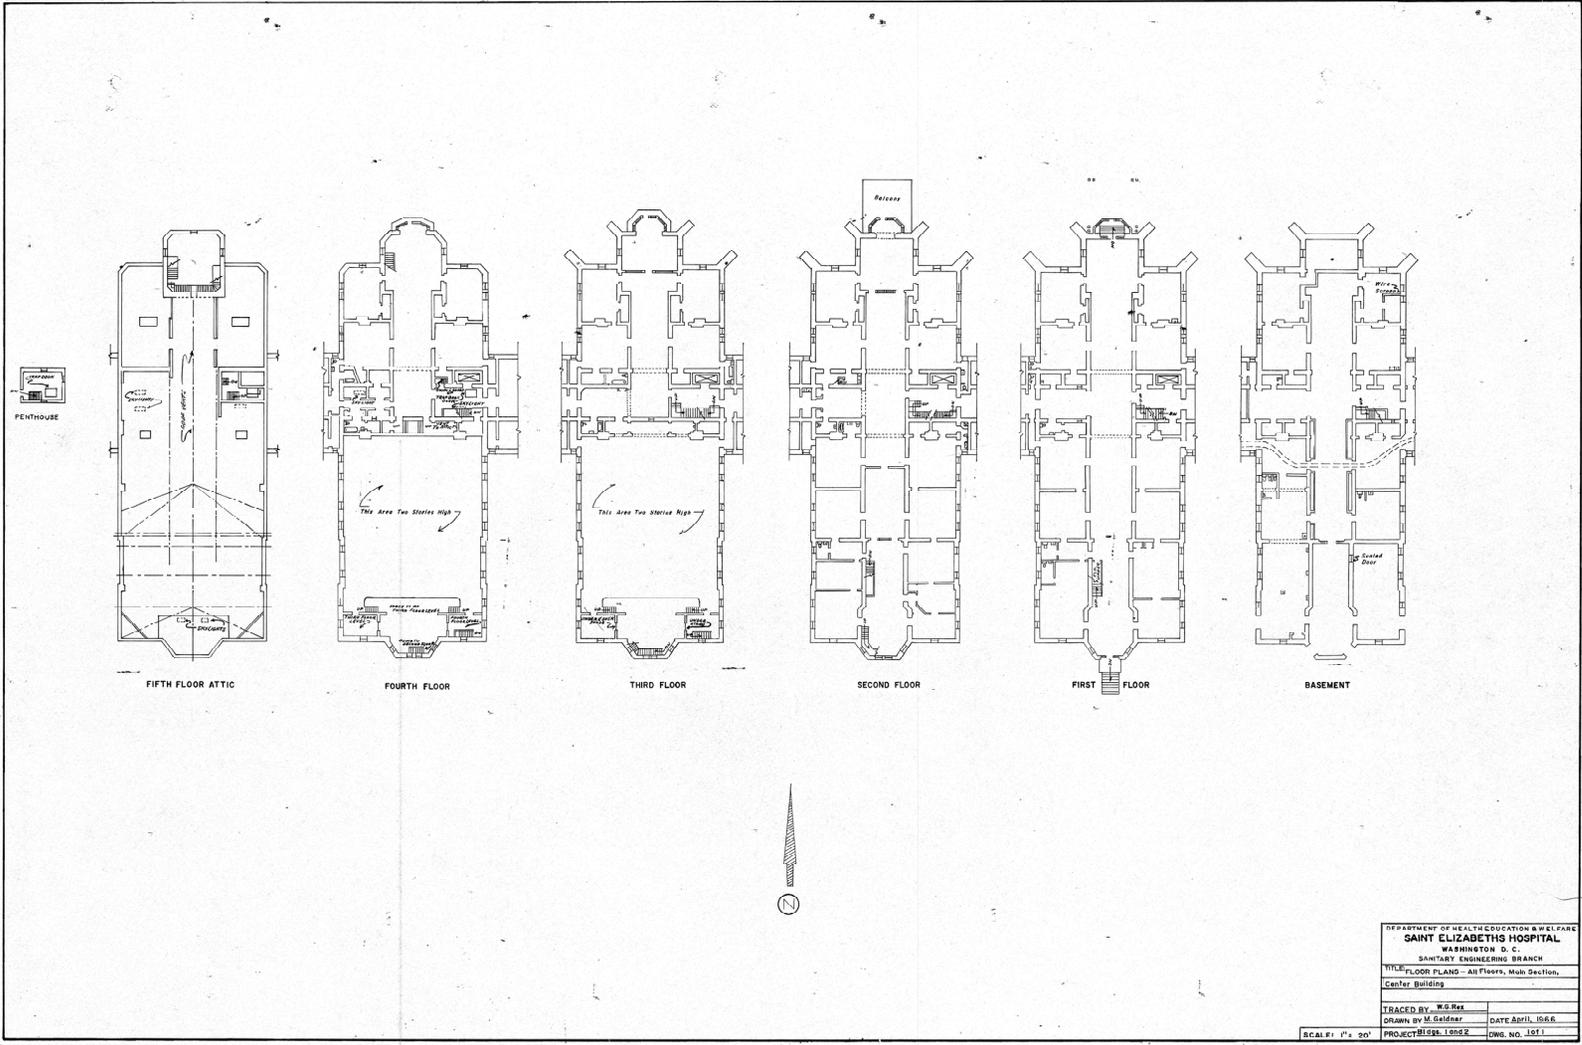
Figure 47. Floor plans of the Center Building, 1966. Source: GSA archives, image DC0066SE0132.

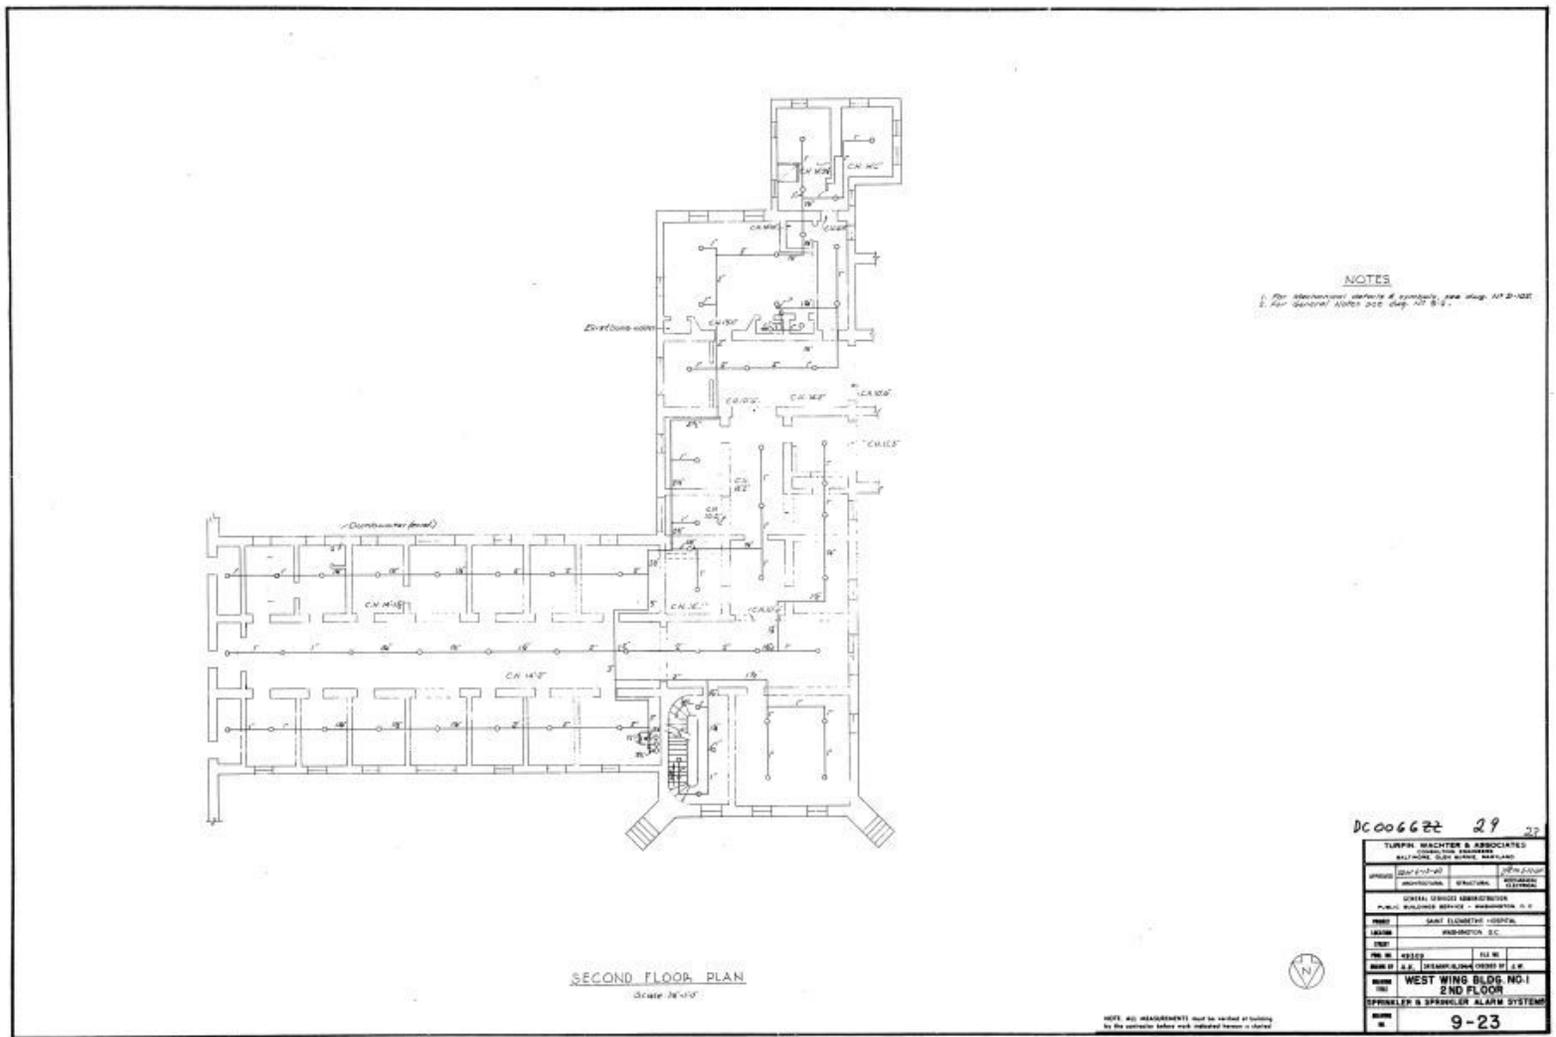
Figure 50. Second Floor Renovation Plans, West Wing, 1964. Source: GSA archives, image DC0066SE0029.

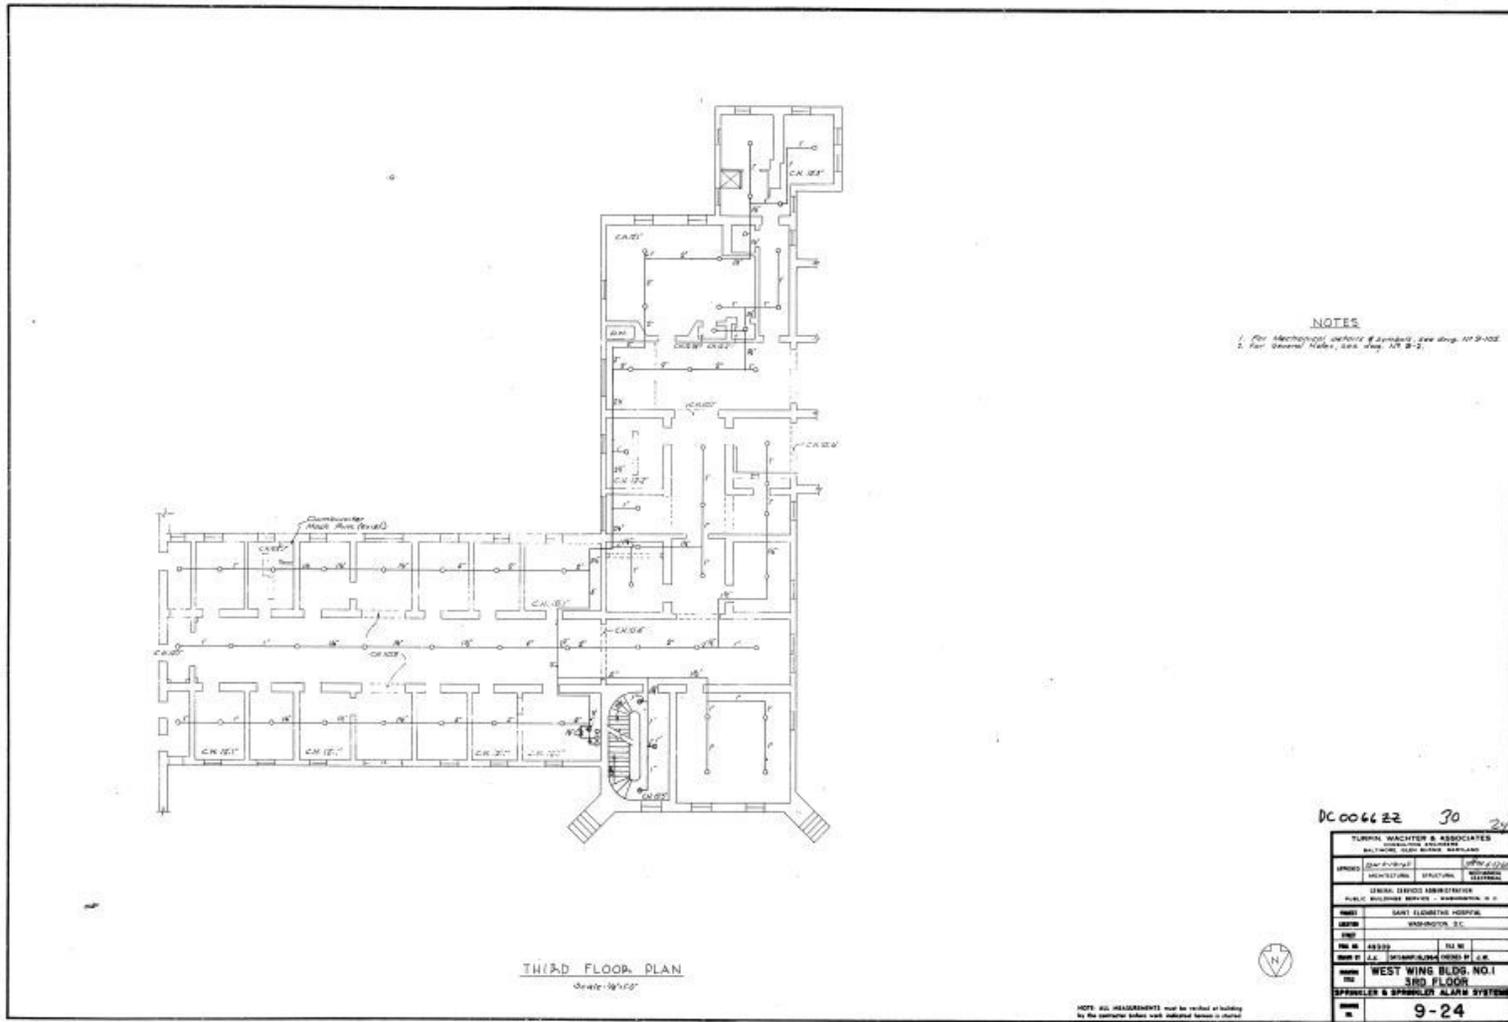
Figure 51. Third Floor Renovation Plans, West Wing, 1964. Source: GSA archives, image DC0066SE0030.
