ST. ELIZABETHS HOSPITAL, EAST WING
(Building No. 4)
539-559 Cedar Drive, Southeast
Washington
District of Columbia

HABS DC-349-Y
HABS DC-349-Y

ST. ELIZABETHS HOSPITAL, EAST WING (BUILDING 4)

HABS NO. DC-349-Y

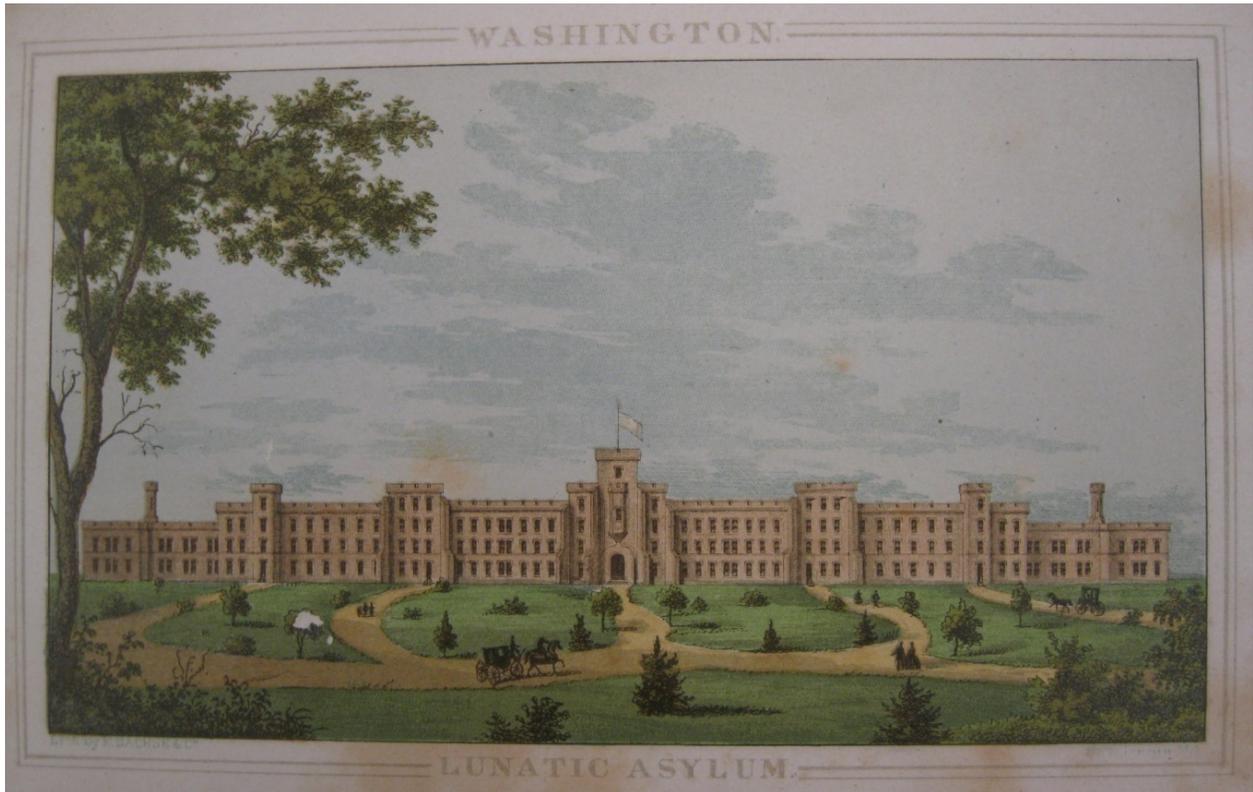
Figure 1. Rendering of the St. Elizabeths Hospital, 1860. Source: National Archives, Record Group 418.

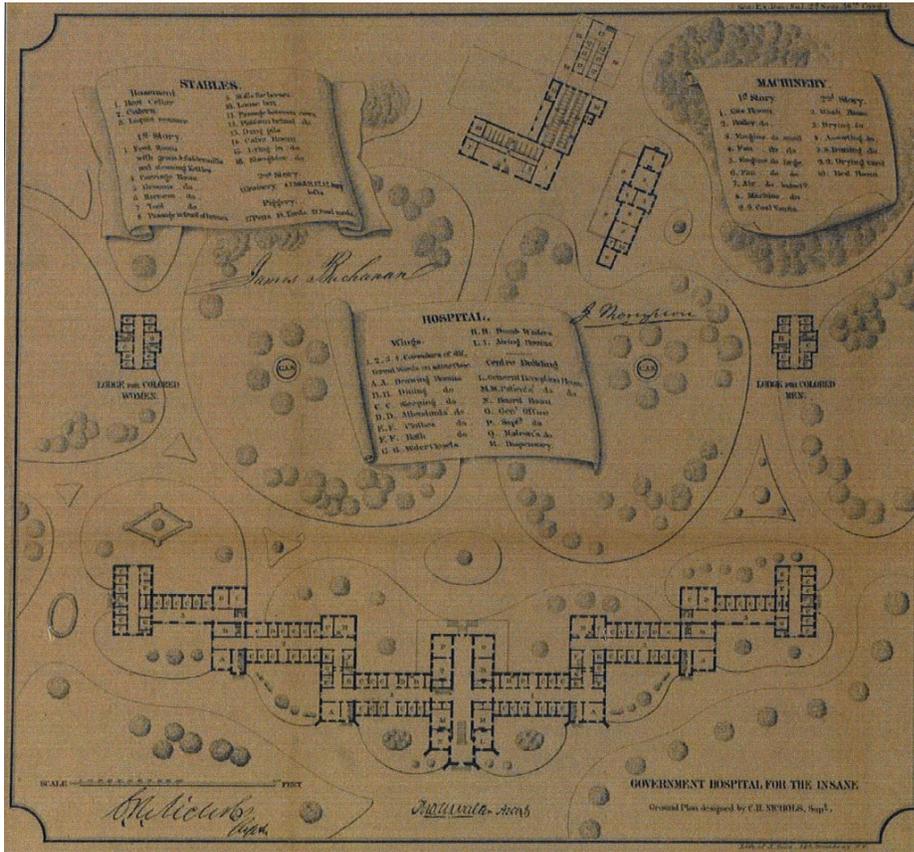
Figure 3. 1860 Ground Plan designed by Charles Nichols and signed by Architect Thomas U. Walter and President James Buchanan. Source: Library of Congress.

5. Original plans and construction: As outlined by the Kirkbride plan, the original design for the Center Building was composed of a four-story Center Building, with attached wings stepping down to three and two-story buildings. Superintendent Charles Nichols opted to complete the project through a series of orchestrated phases of construction. Construction started with the West Wing with the intent that, upon substantial completion of that portion of the building, patients most urgently in need of care would be the first admitted. The rest of the hospital could then be constructed with minimal disruption or relocation of patients. Furthermore, by completing the side wings, Nichols could ensure that additional funding would be provided by Congress until construction of the entire Center Building group was completed.

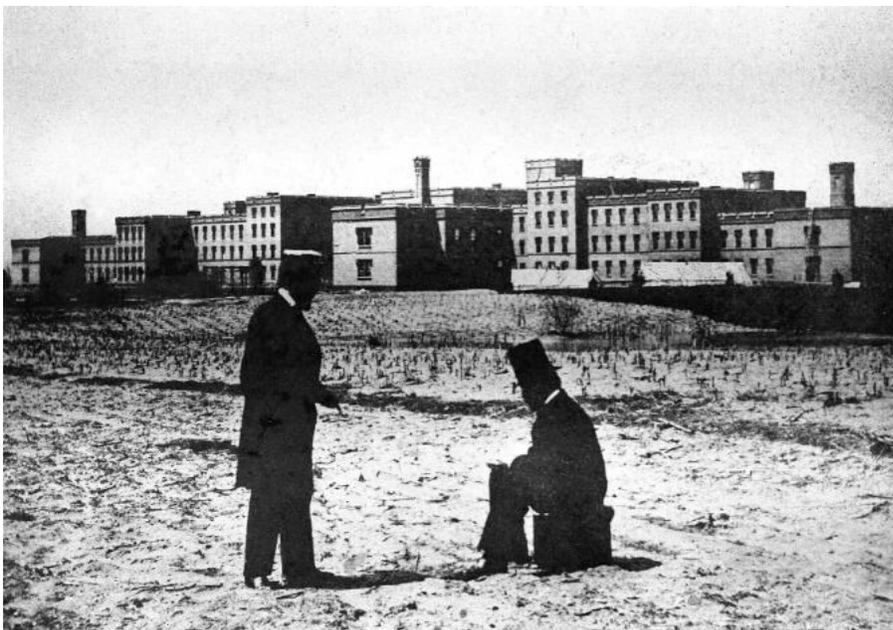
Figure 4. Archival photograph from the southeast of the Center Building group, Detached Nurses Home, and West Lodge (no longer extant), 1860. Source: GSA archives, image DC0066SE0P035.

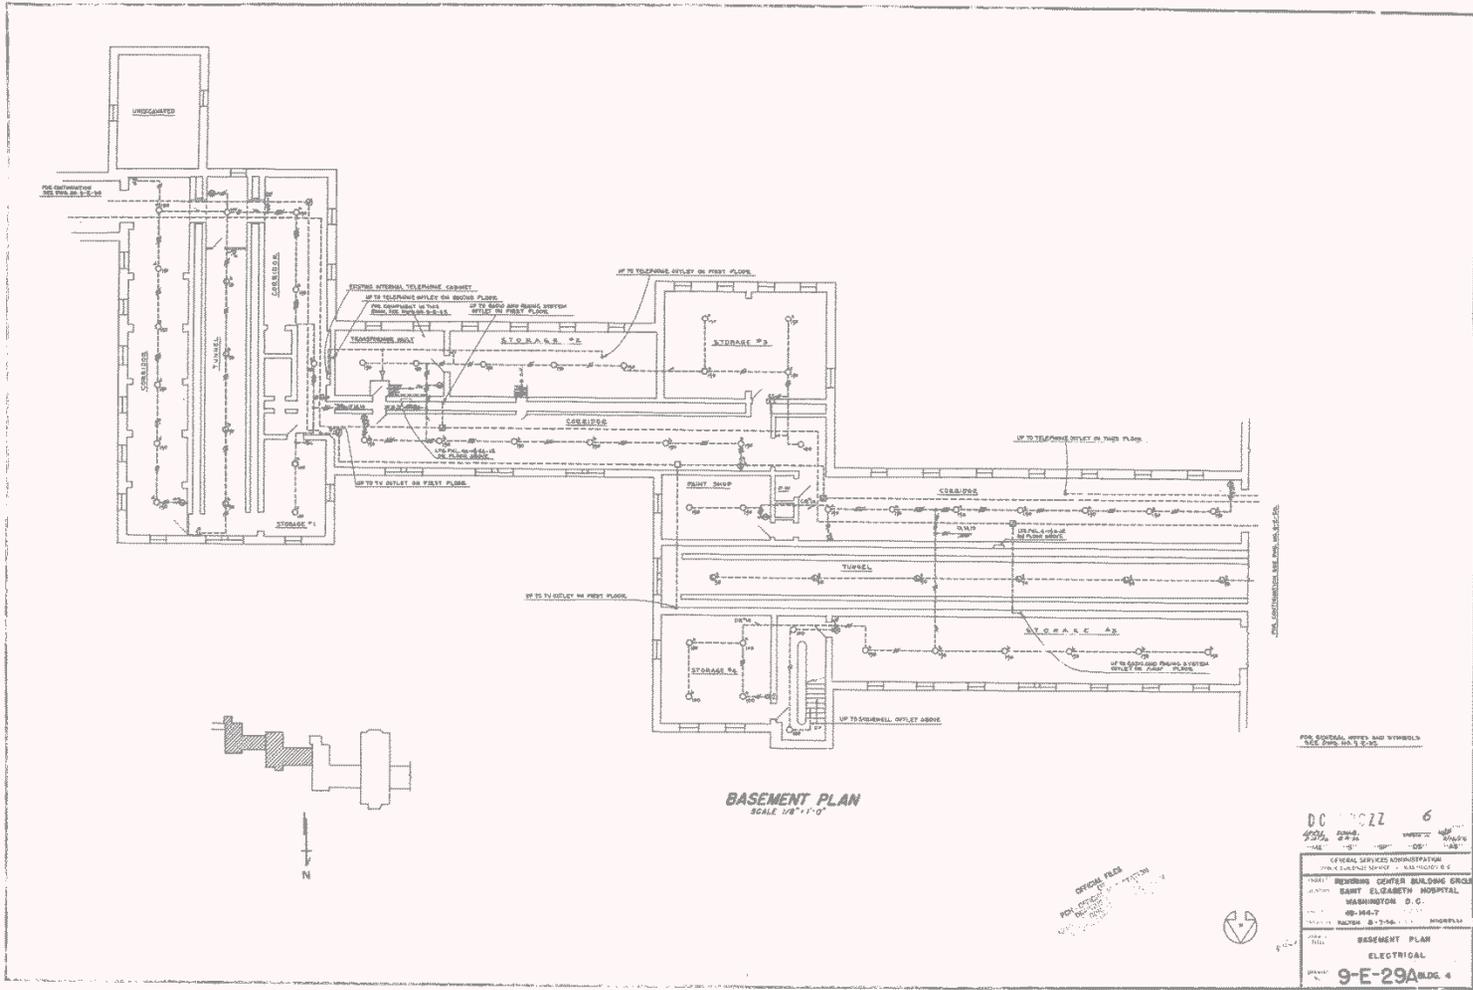
Figure 5. Basement plan of the East Wing outlining electrical system improvements, 1956. Source: GSA archives, image DC0080SE0006.

Electrical improvements to the Center Building and West Wing were planned in 1953, immediately following the transfer of the west campus to the Department of Health, Education and Welfare, and completed by 1955.³⁰

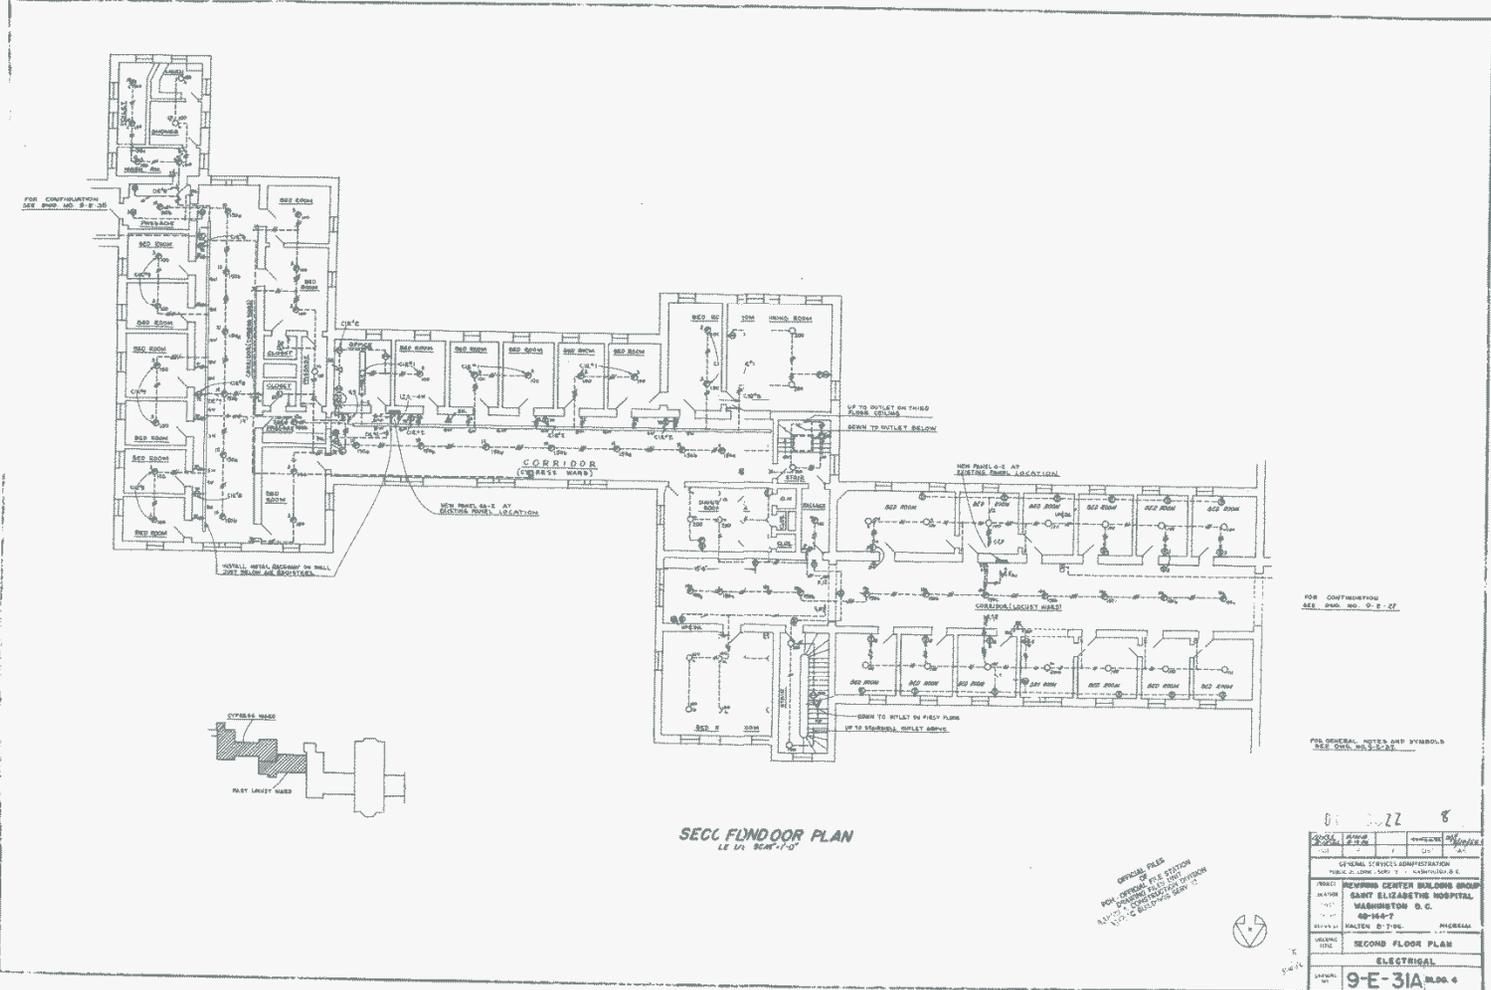
Figure 7. Second floor plan of the East Wing outlining electrical system improvements, 1956. Source: GSA archives, image DC0080SE0008.

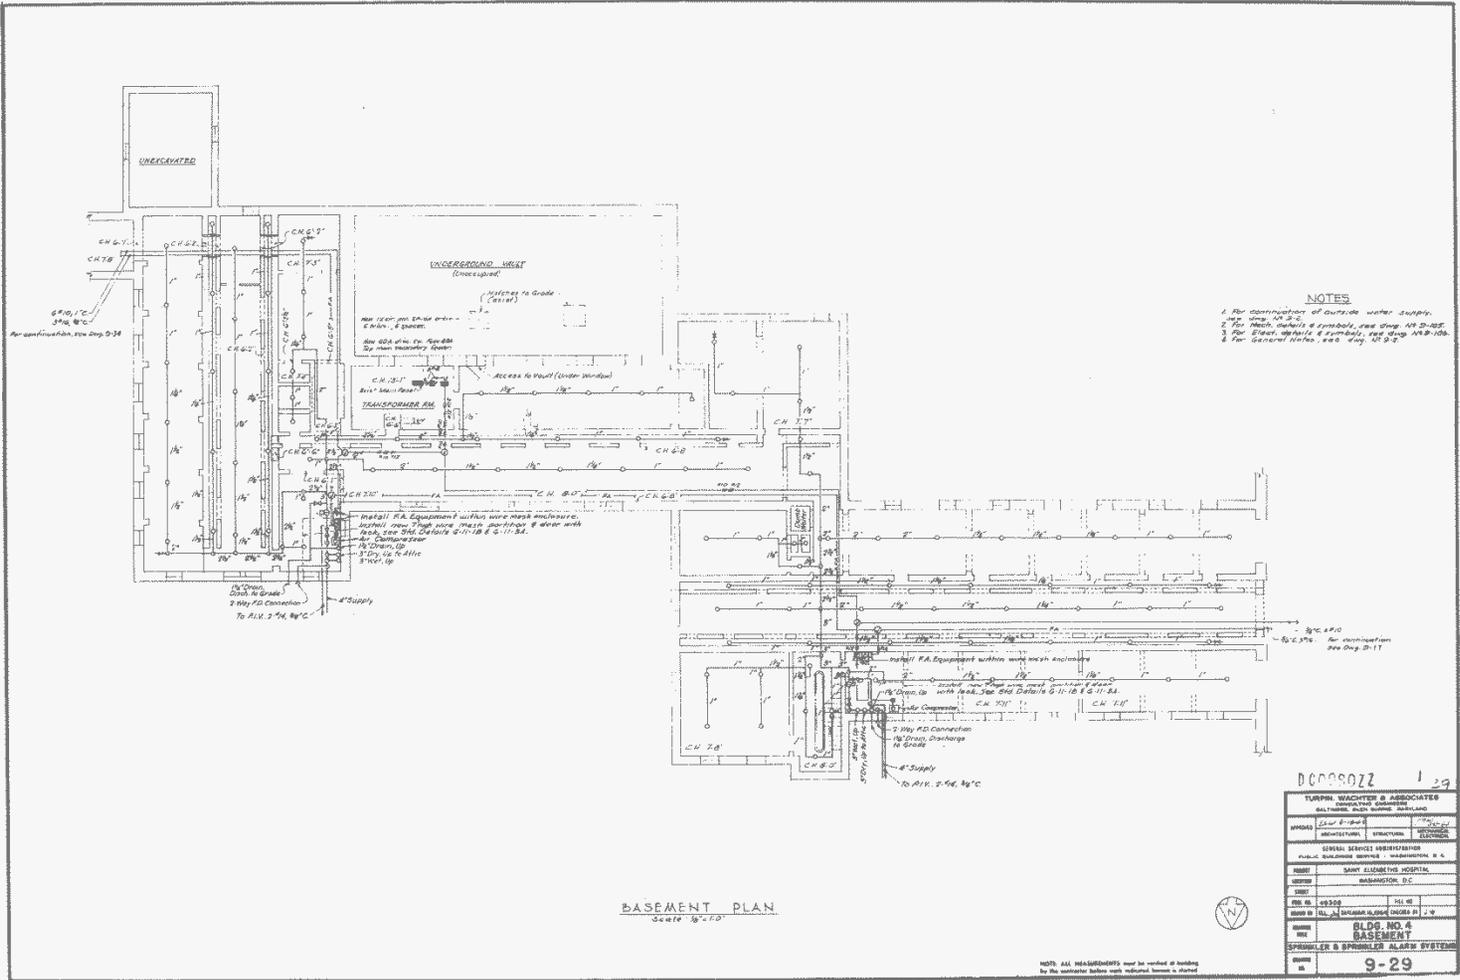
Figure 8. Basement plan of the East Wing outlining fire suppression system improvements, 1964. Source: GSA archives, image DC0080SE0001.

In 1963, an \$865,000 appropriation was made for the installation of sprinkler systems in non-fire-resistant buildings. The suppression unit consisted of surface-mounted sprinklers and was installed in every room. That same year, a study of the existing plumbing and electrical systems was initiated. The study led to the appropriation of funds for a multi-million-dollar building facilities modernization project. Plans for building alterations were generated between 1963 and 1965 and included the replacement of electrical wiring and outlets, upgrades to lavatory and plumbing systems, and the installation of fluorescent light fixtures. All additions were surface-mounted. Construction began in 1966 and continued through 1970.³¹

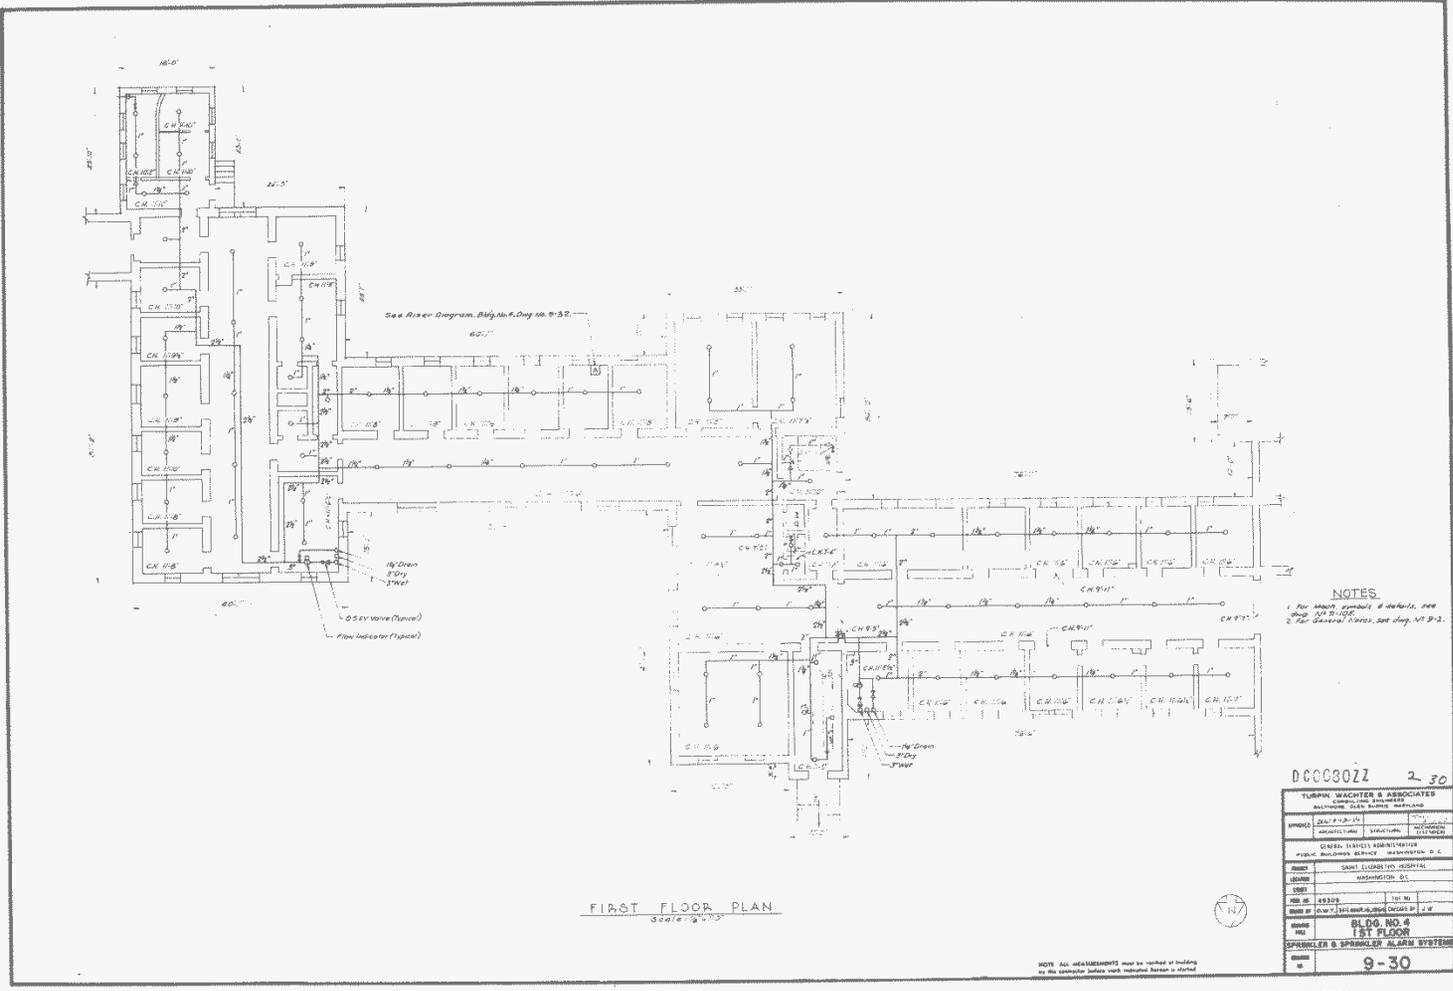
Figure 9. First floor plan of the East Wing outlining fire suppression system improvements, 1964. Source: GSA archives, image DC0080SE0002.

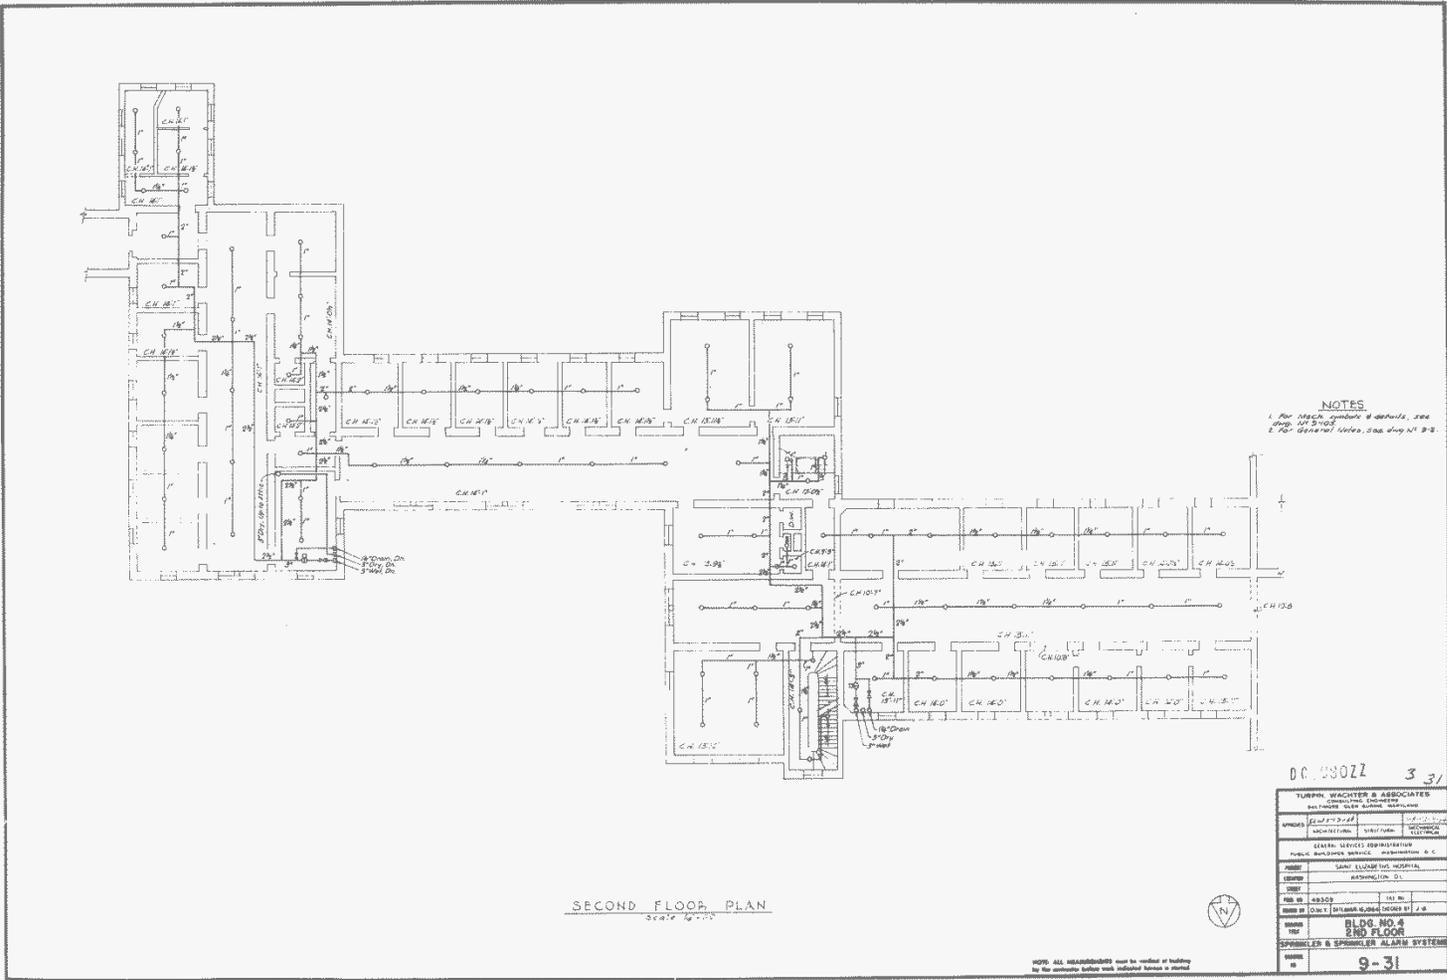
Figure 10. Second floor plan of the East Wing outlining fire suppression system improvements, 1964. Source: GSA archives, image DC0080SE0003.

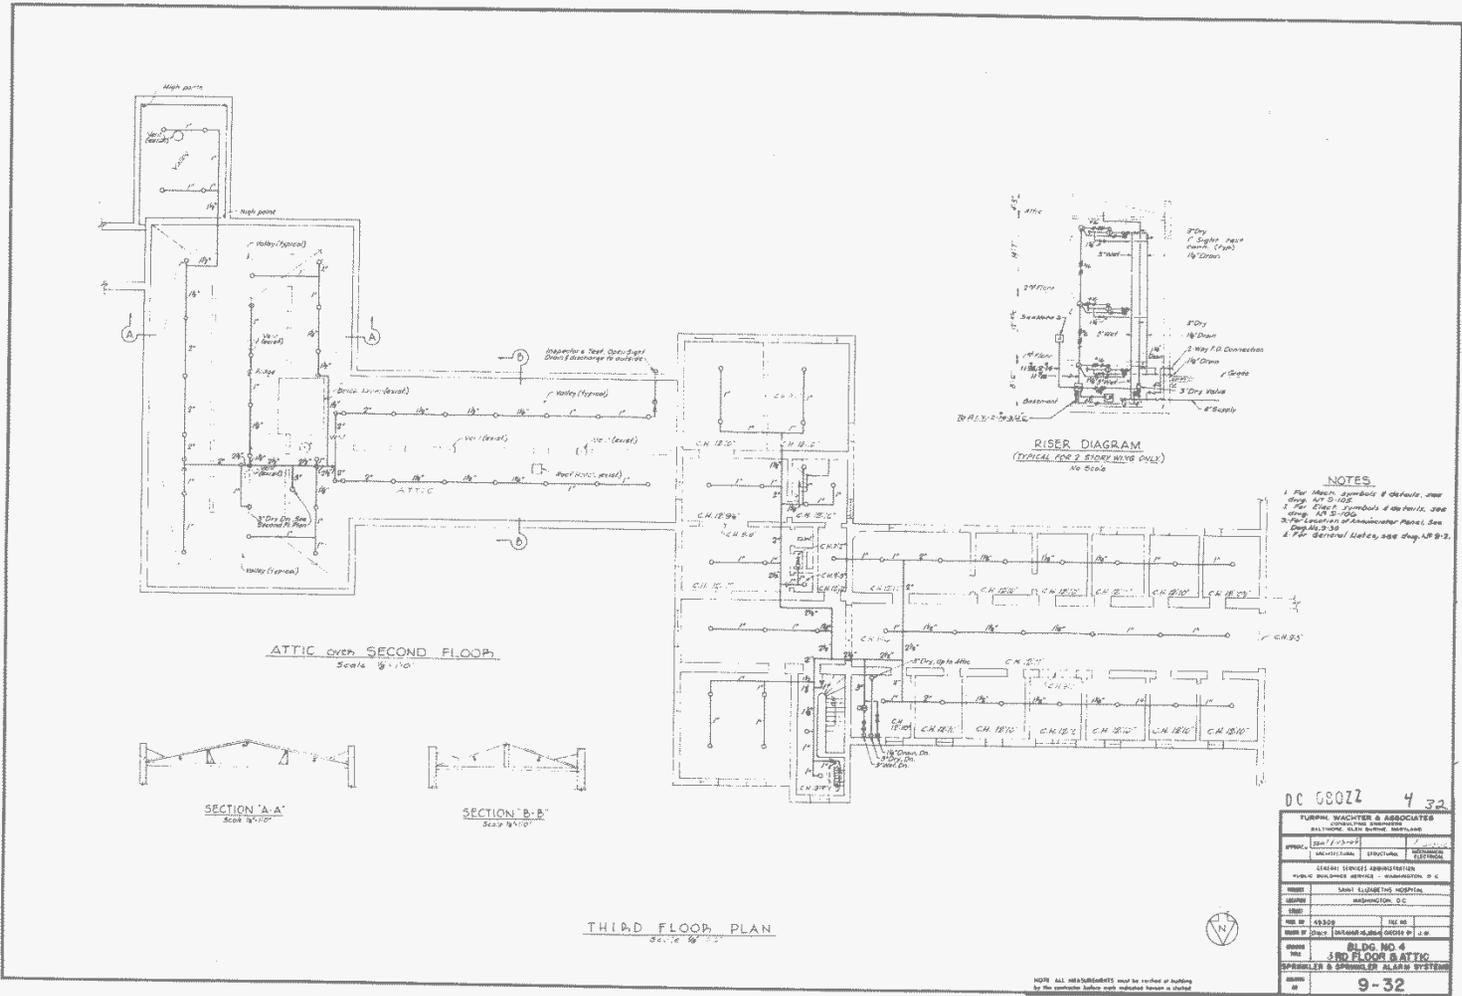
Figure 11. Third floor plan of the East Wing outlining fire suppression system improvements, 1964. Source: GSA archives, image DC0080SE0004.

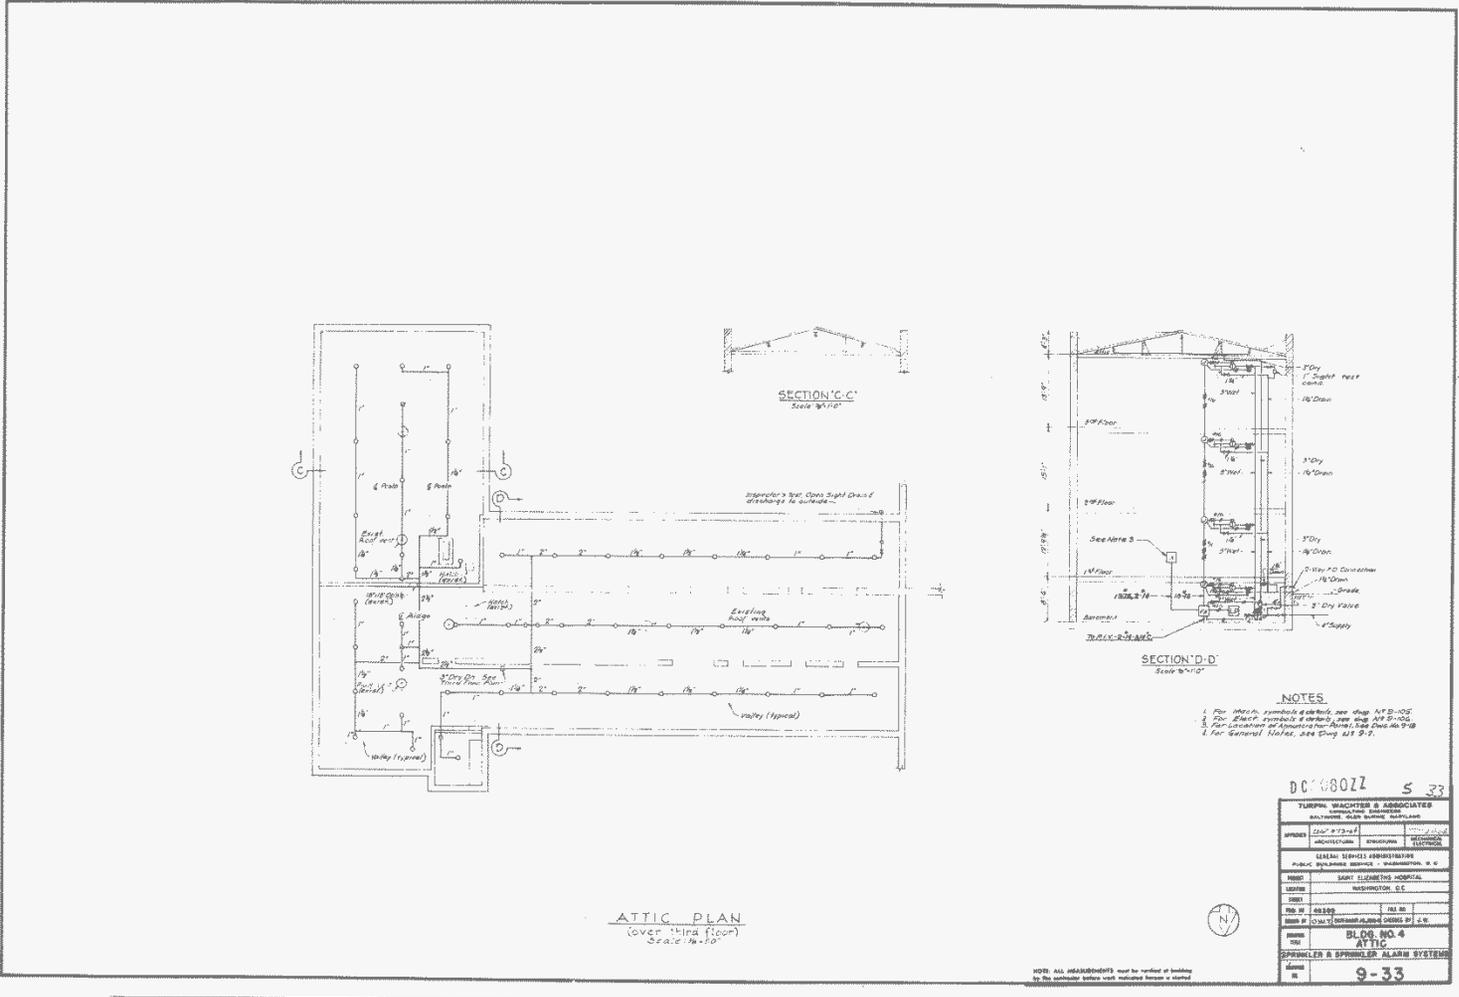
Figure 12. Attic plan of the East Wing outlining fire suppression system improvements, 1964. Source: GSA archives, image DC0080SE0005.

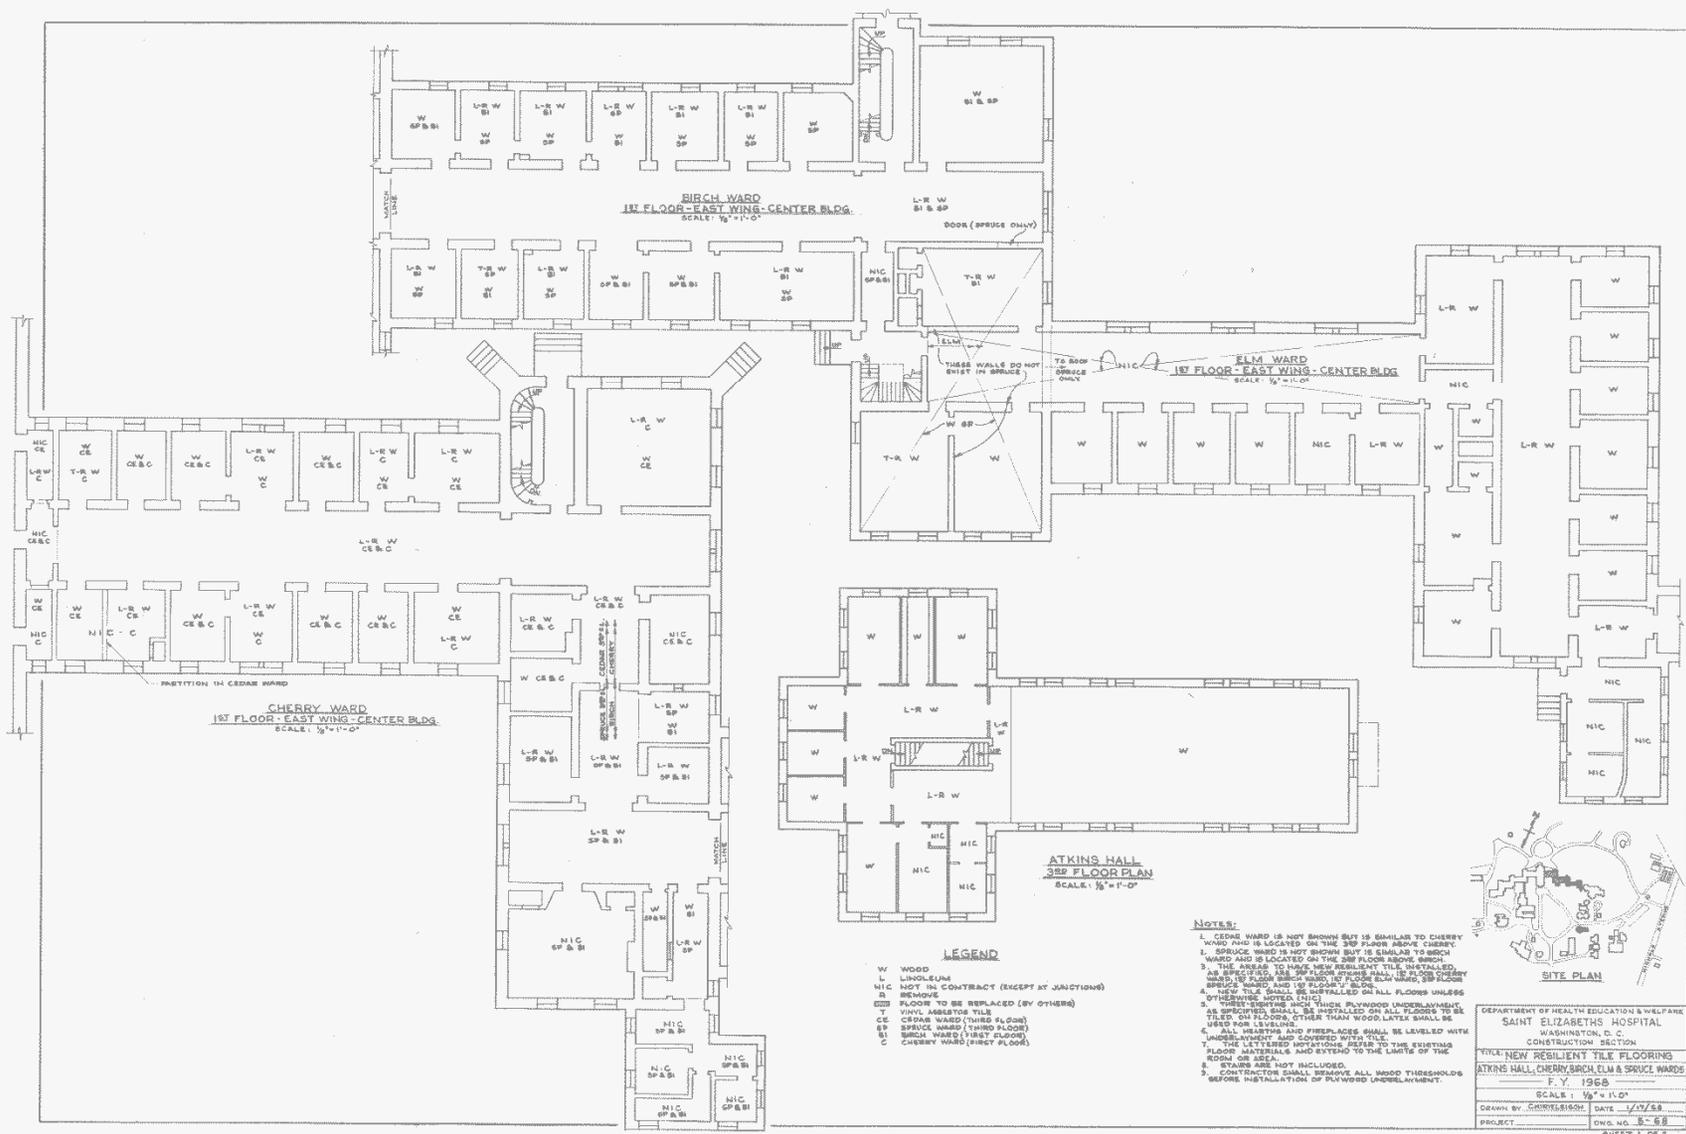
Figure 13. First floor plan of the East Wing outlining new floor covering installation, 1968. Source: GSA archives, image DC1343SE0104.

In 1969, historic wood flooring was repaired and replaced and existing linoleum and carpeting was removed throughout the Center Building group. The floor was structurally reinforced with steel framing and resilient flooring was laid. Sheet vinyl was installed in corridors and vinyl-asbestos tile was installed over repaired wood flooring or plywood underlayment in all other areas.³⁵

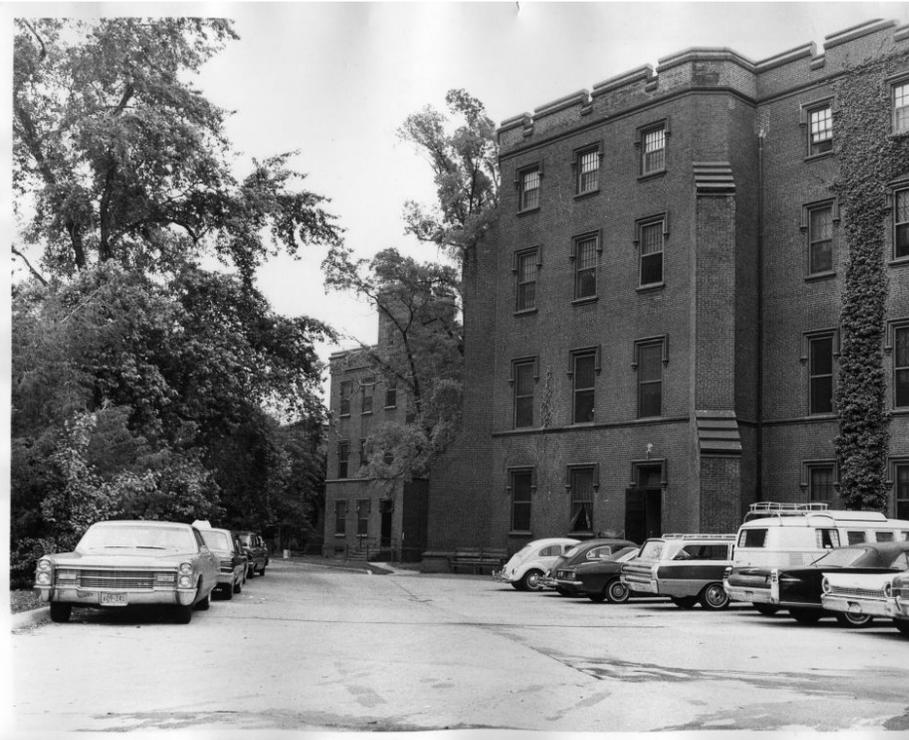
Figure 14. The north elevation of the East Wing, 1968. Source: GSA archives, image DC0080SE0P001.

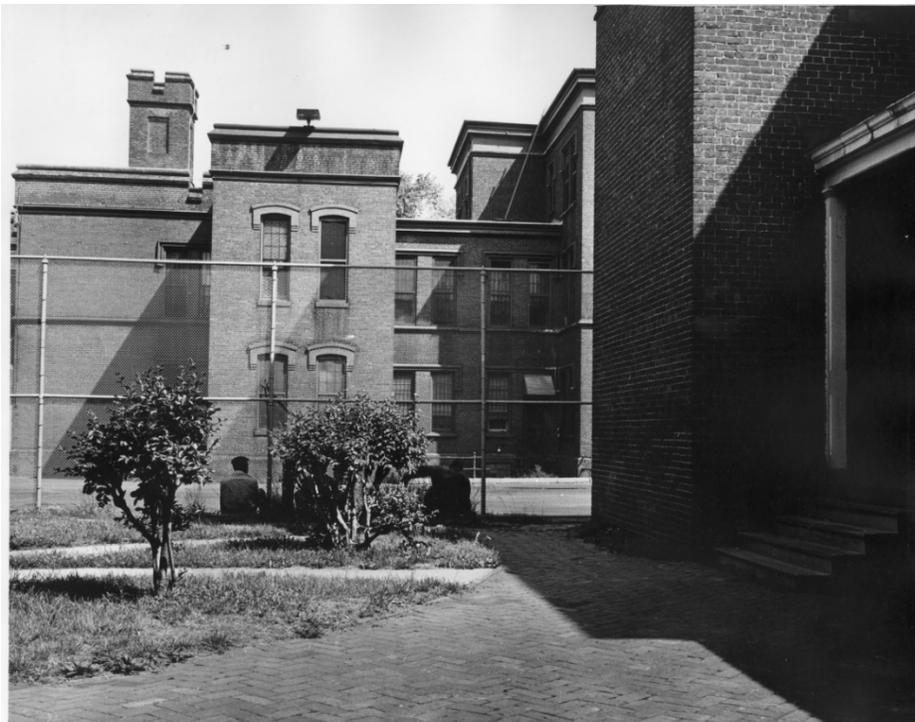
Figure 15. The south elevation of the connecting link between the East Wing (left side of image) and Pine (right), 1968. Source: GSA archives, image DC0179SE0P001.

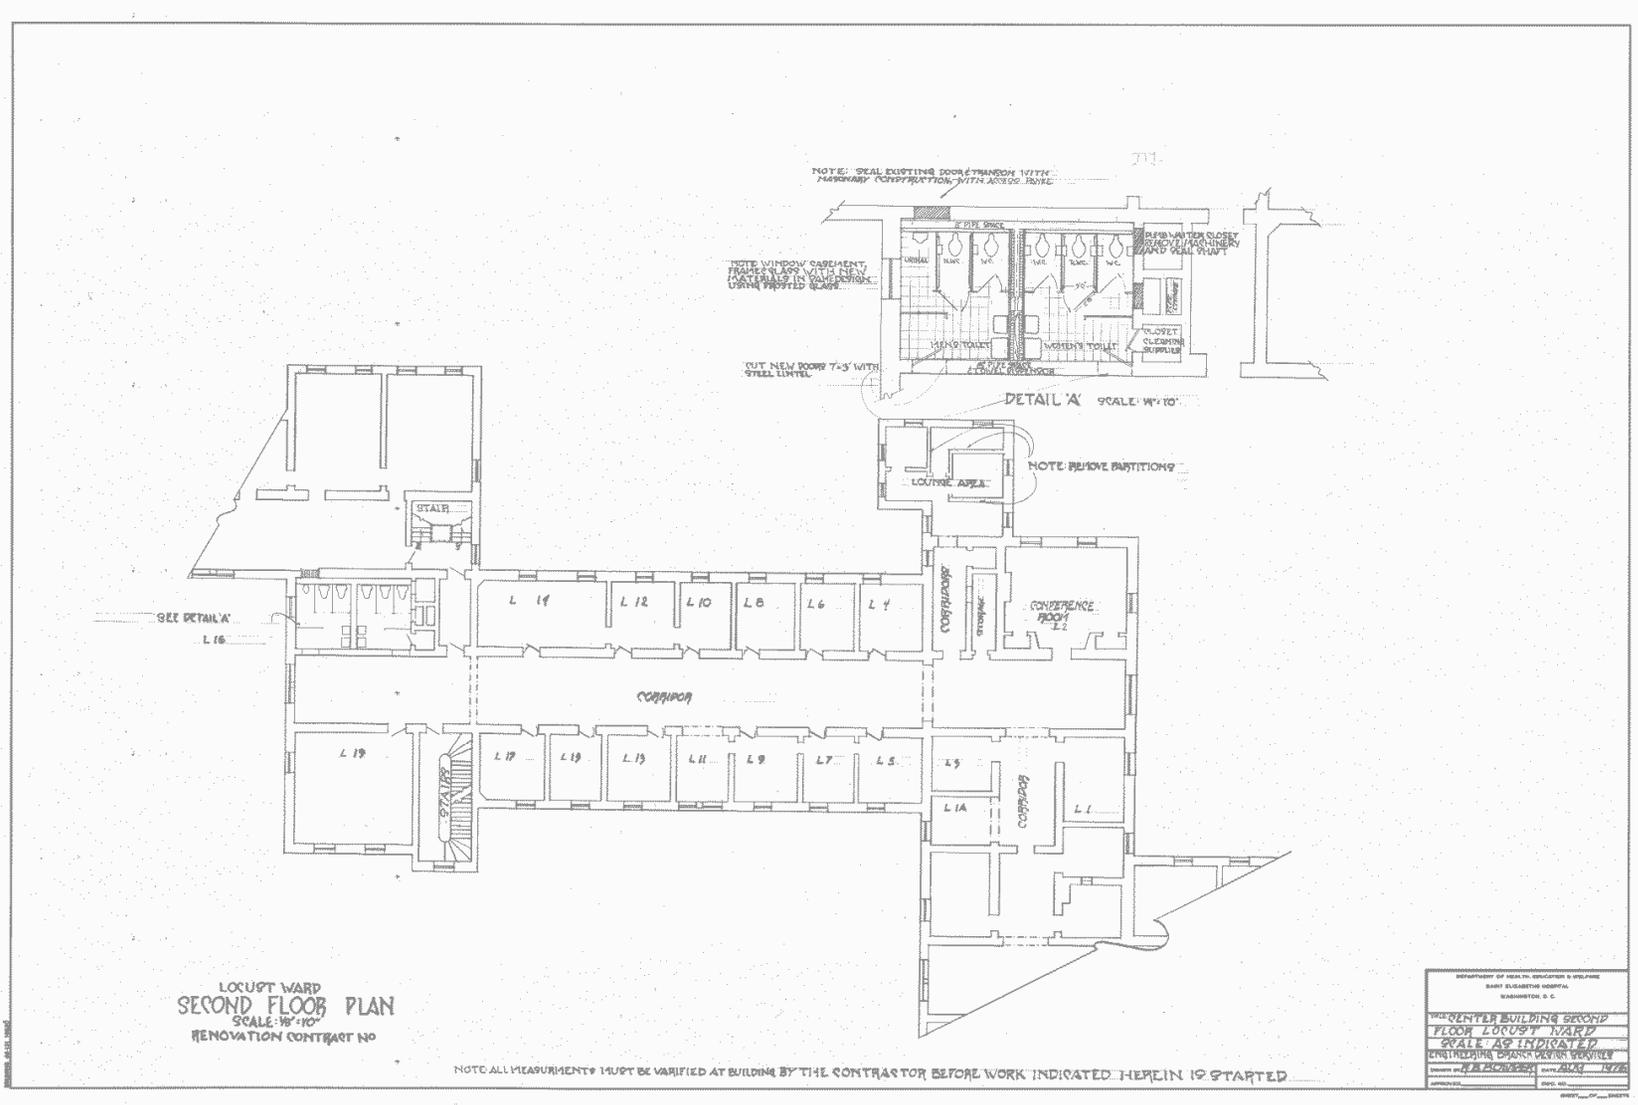
Figure 16. Second floor plan of East Wing outlining bathroom addition, 1976. Source: GSA archives, image DC0080SE0108.
