ST. ELIZABETHS HOSPITAL, DETACHED KITCHEN  
(Building No. 34)  
562-572 Redwood Drive, Southeast  
Washington  
District of Columbia

HABS DC-349-AR  
*HABS DC-349-AR*

### ST. ELIZABETHS HOSPITAL, DETACHED KITCHEN (BUILDING 34)

HABS NO. DC-349-AR

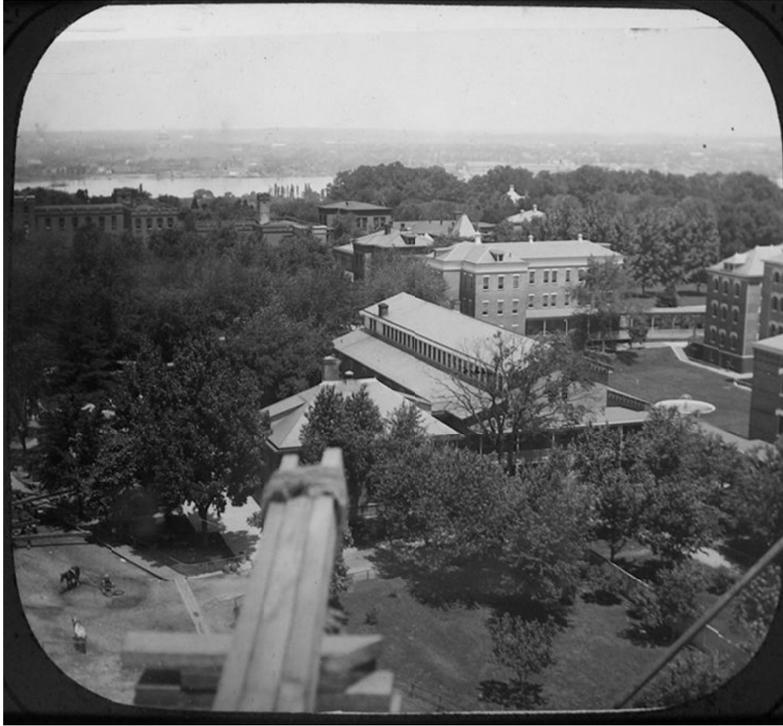
Figure 2. View from south of Detached Kitchen and Dining Hall, from the top of the campus water tower, early 1900s. Source: GSA archive, image DC1472SE0P083.

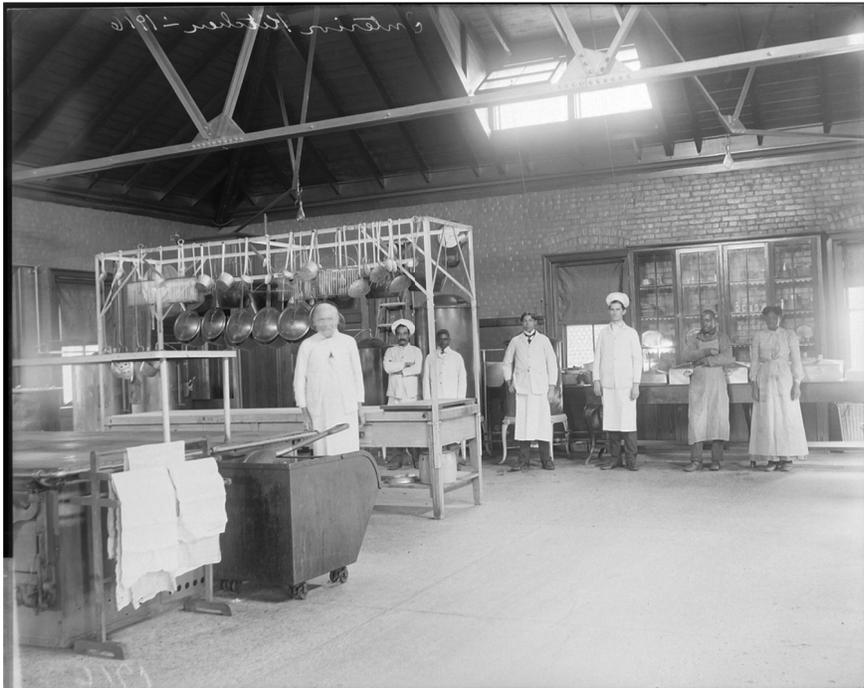
Figure 3. View of the interior of the kitchen with staff, 1916. Note that in this view, the original paired multi-panel wood doors leading to the Detached Dining Hall are visible at left. Source: GSA archive, image DC1453SE0P001.

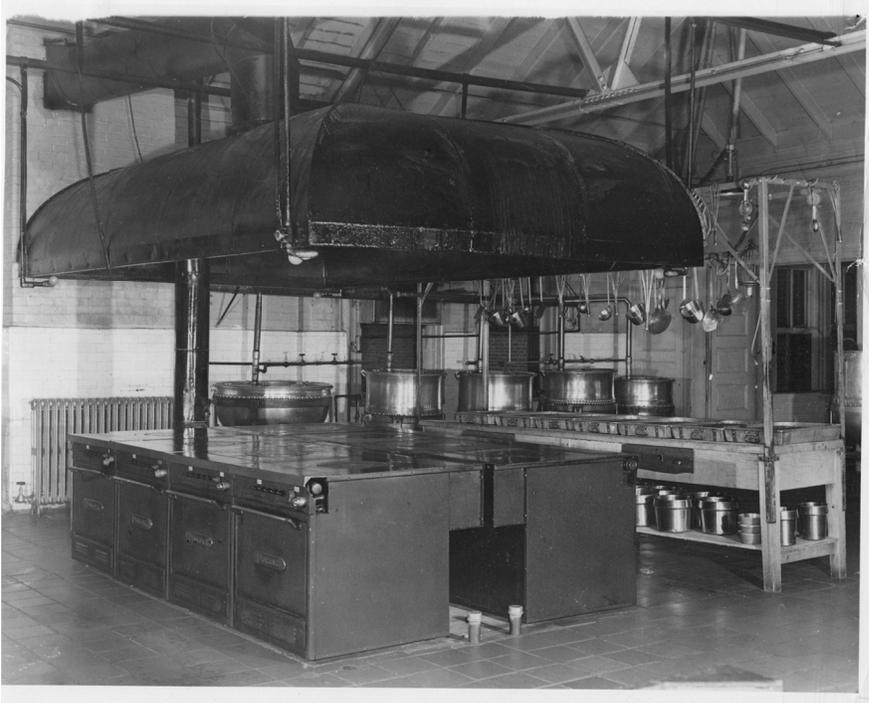
*Figure 4. An undated interior view of the kitchen showing ceramic tile floors, ceramic tile wall cladding, and Vulcan gas ranges under a new exhaust hood. Source: GSA archive, image DC1453SE0P004.*

6. Alterations and additions: In 1922, the concrete flooring was replaced by a new “asphalt floor.”<sup>9</sup> The floors were replaced again in 1932. Clay tile was installed throughout the first floor kitchen space. The *Report by the Public Buildings Administration* and an undated archival photograph support the change in flooring material and also indicate that a white glazed tile wainscot was added. Based on physical evidence, it is assumed that the wall tile was applied at the same time as the flooring.<sup>10</sup>

3. Flooring: Throughout the first floor, flooring consists of areas of 9-inch-square red ceramic tiles in a grid pattern, and areas of 6-inch-square red ceramic tiles in a running bond pattern. The ground floor spaces exhibit a combination of materials, including terrazzo floors, asbestos tiles, and hexagonal tiles.

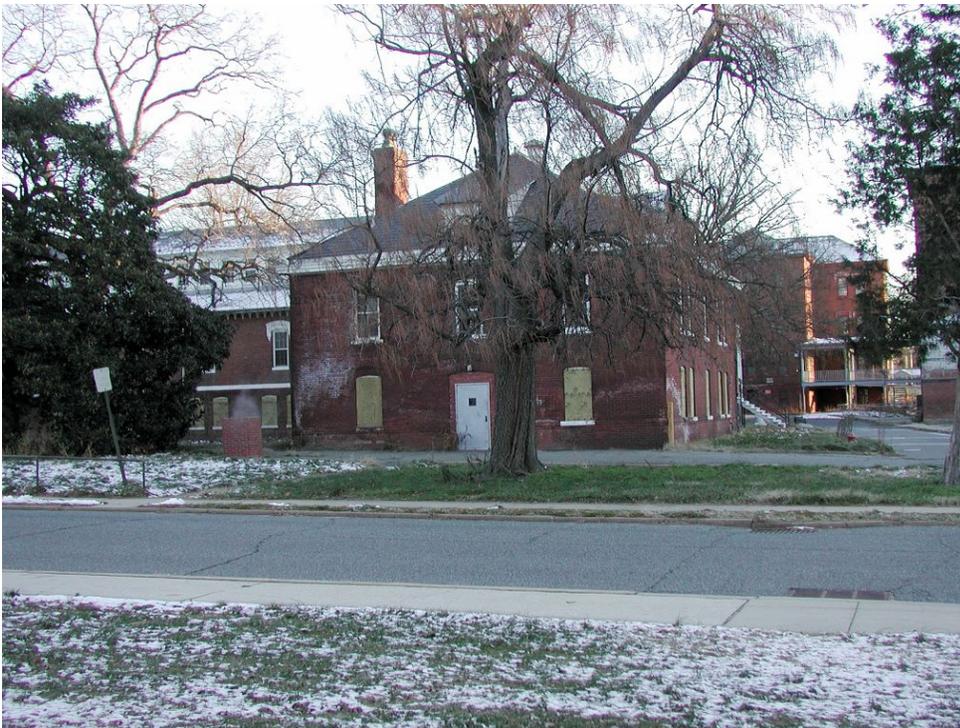
*Figure 5. View of west facade from west in 2003. Source: GSA archive, image DC1453SE0P008.*

Between 1945 and 2003, the wood-framed entrance door and transom on the west facade were removed and replaced with a small metal door. The original door opening was partially infilled to accommodate the smaller retrofit door.<sup>14</sup>

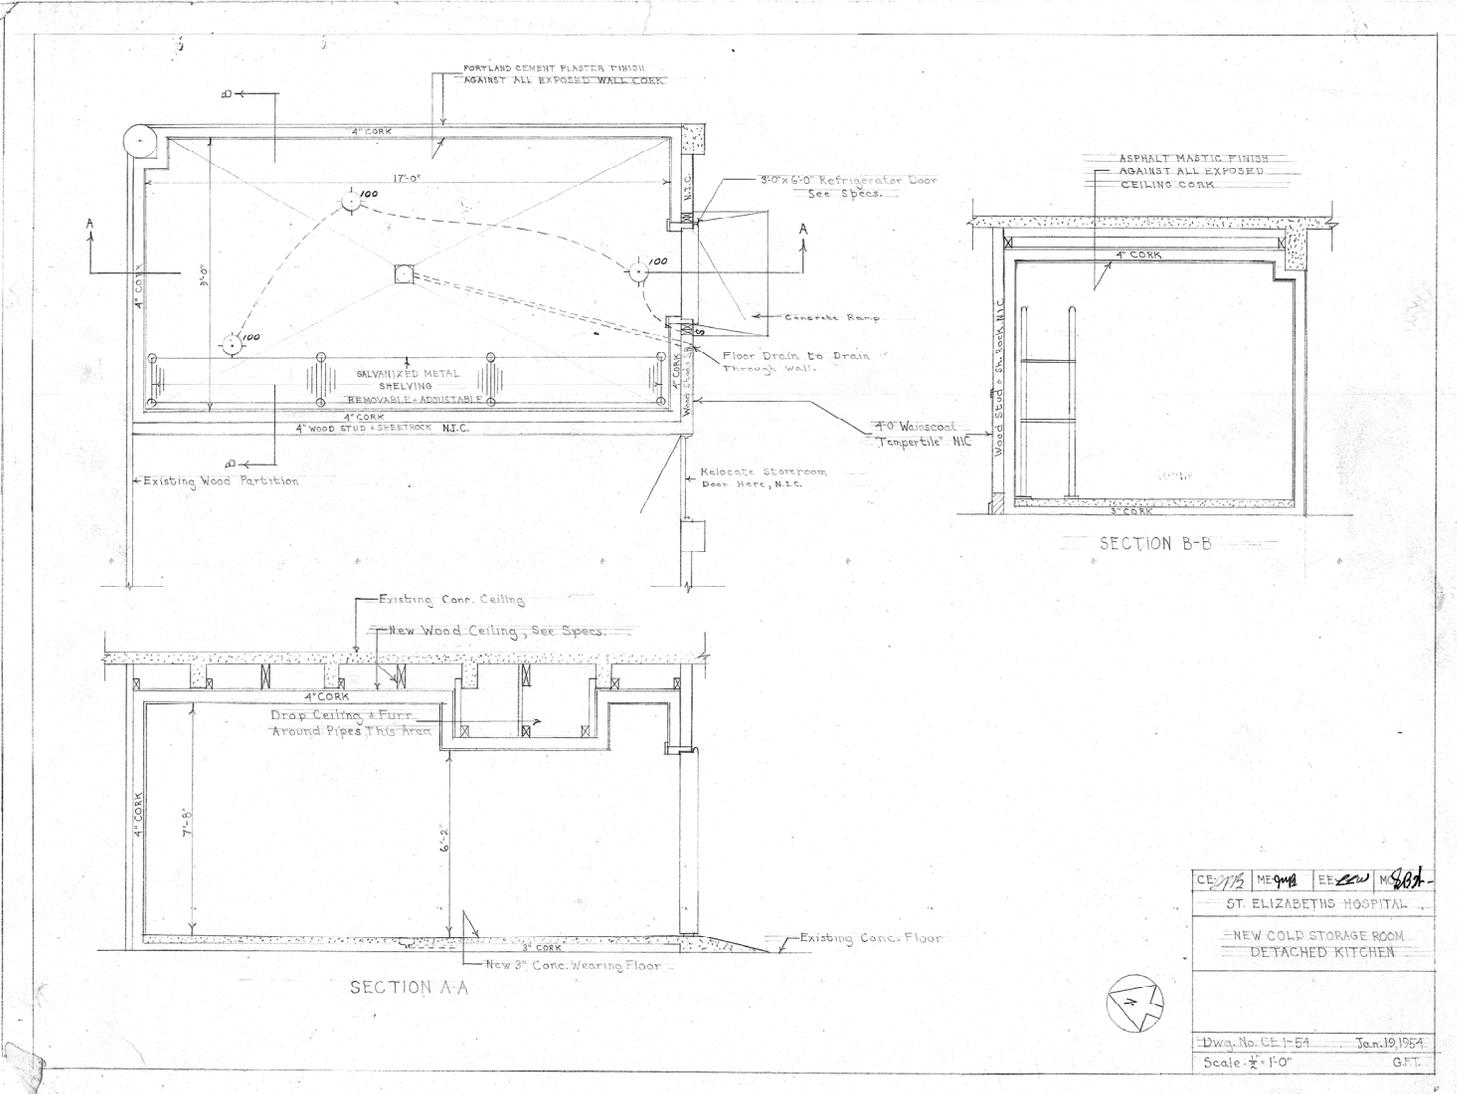
Figure 6. 1954 construction drawing for the cold storage room at the basement level. Source: GSA archive, image DC1453SE0104.

Construction documents from 1954 outline the installation of a new cold storage unit on the ground floor of the building. The wood-framed room was constructed on the existing concrete floors and had a cork insulated lining.<sup>12</sup>
