ST. ELIZABETHS HOSPITAL, GENERAL KITCHEN
(Building No. 45)
2700 Martin Luther King Jr. Avenue, Southeast, Golden Raintree
Drive, Southeast
Washington
District of Columbia

HABS DC-349-BC
HABS DC-349-BC

ST. ELIZABETHS HOSPITAL, GENERAL KITCHEN (BUILDING 45)

HABS NO. DC-349-BC

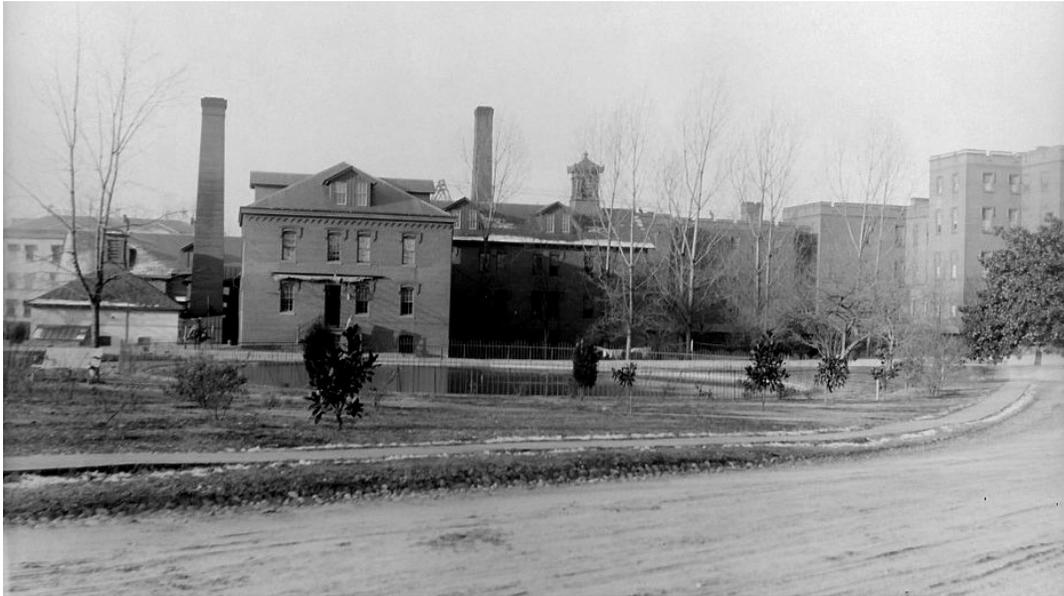
Figure 1. View of the east elevation of the General Kitchen addition shortly after the completion of the addition, 1892. Source: GSA archives, image DC1336SE0P003.

6. Alterations and additions: In 1892, a two-story with basement addition to the General Kitchen was completed. The brick structure with slate tile hip roof and projecting gable roof dormers was situated east of the original north wing. The extension had six-over-six double-hung windows, corbelled brick drip molds, and a metal cornice over a corbelled brick blind arcade. An exterior entrance consisting of a cast iron staircase, brick landing, and awning was located on the east elevation.

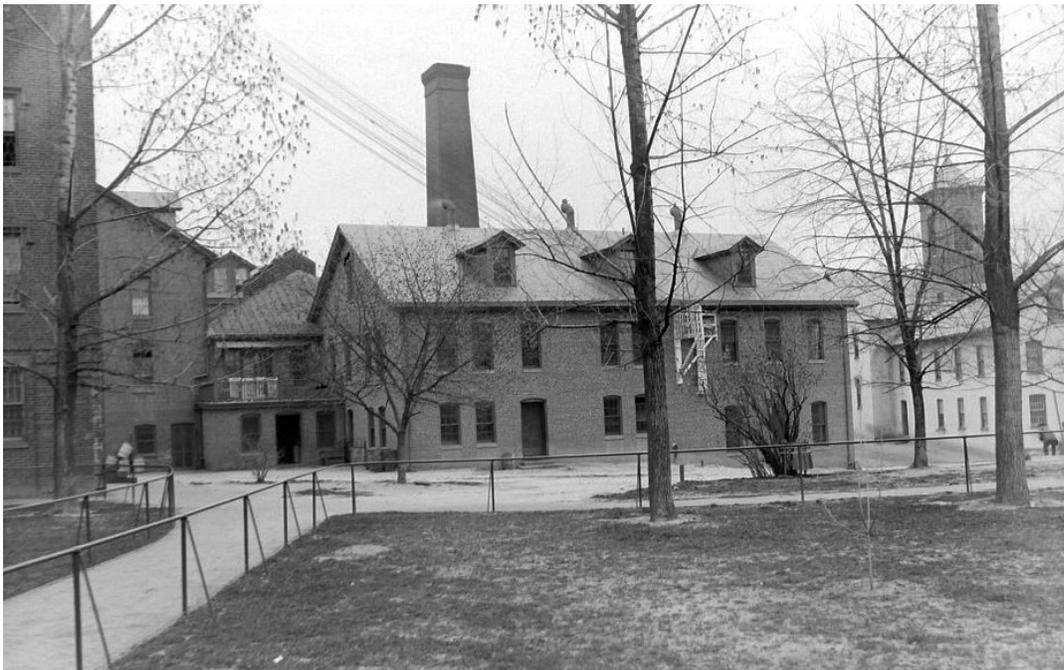
Figure 2. The west elevation of the General Kitchen, 1898. Source: GSA archives, image DC1336SE0P002.

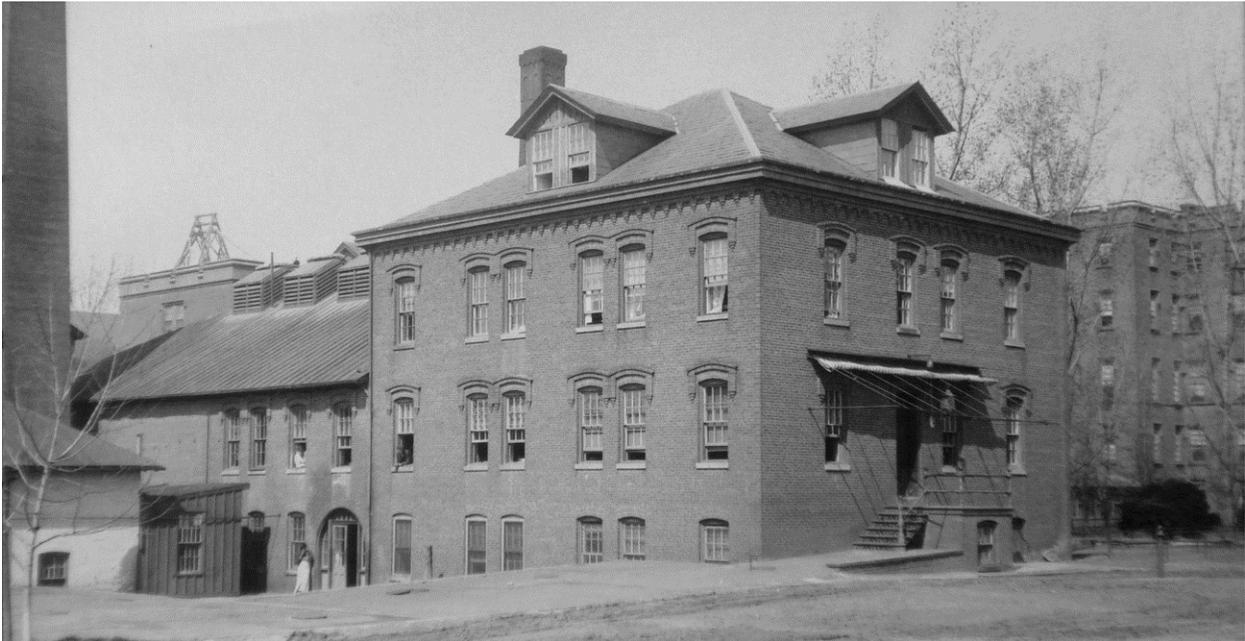
Figure 3. The southeast corner of the General Kitchen addition, 1898. Source: National Archives, image 418-H-52.

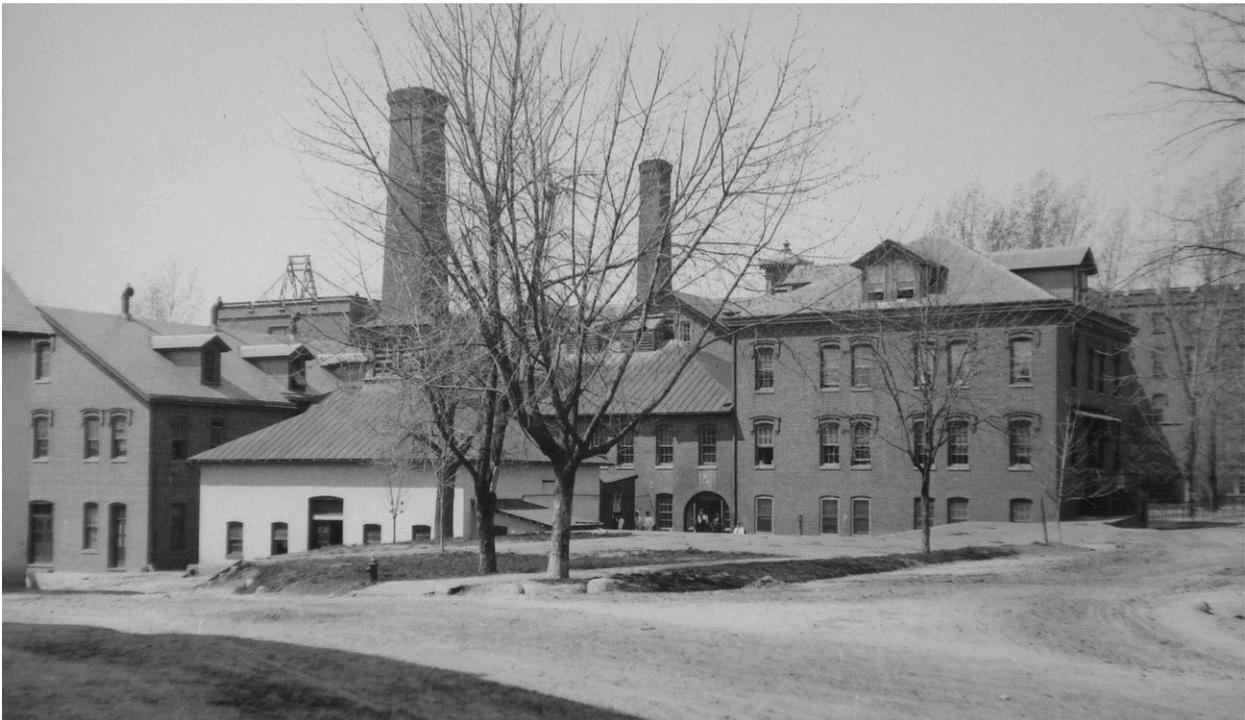
Figure 4. The south elevation of the General Kitchen and addition, 1898. The old Boiler House (in the foreground on the left side) was constructed in 1876 and razed in circa 1900. Source: National Archives at College Park, image 418-H-54.

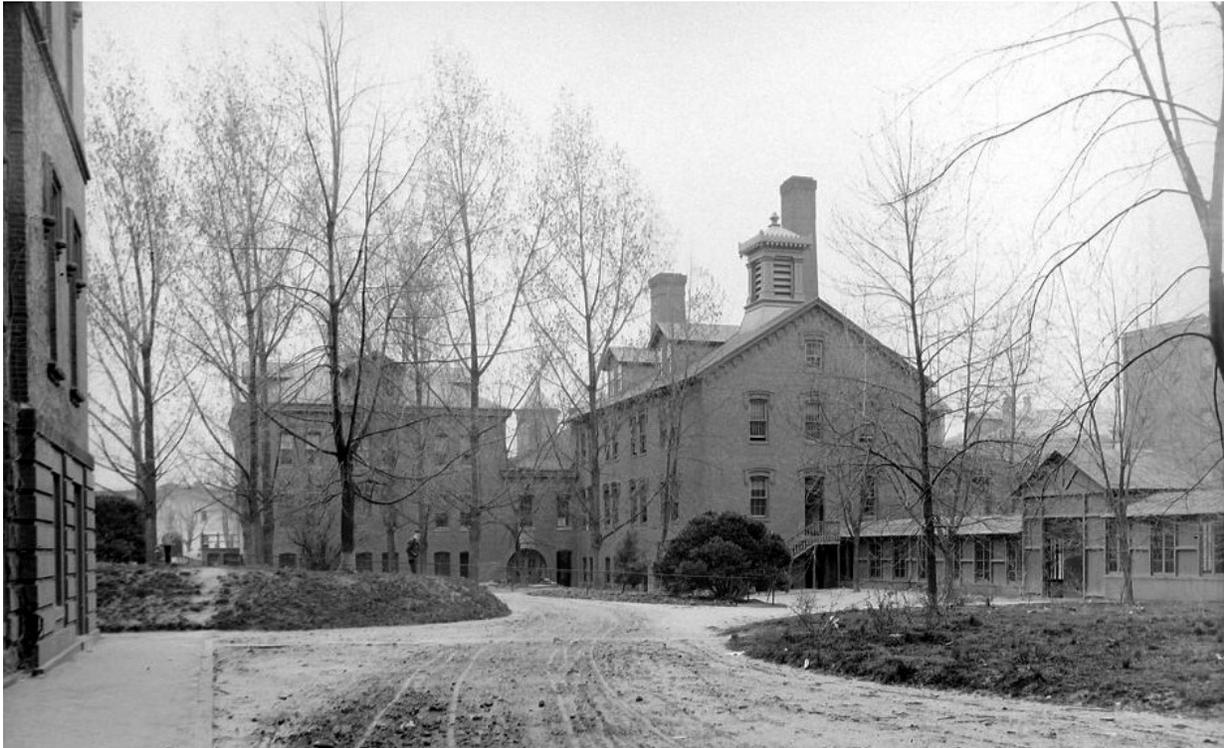
Figure 5. The General Kitchen addition is located behind the trees, the Bakery building is in the foreground, 1898. Source: GSA archives, image DC1458SE0P004.

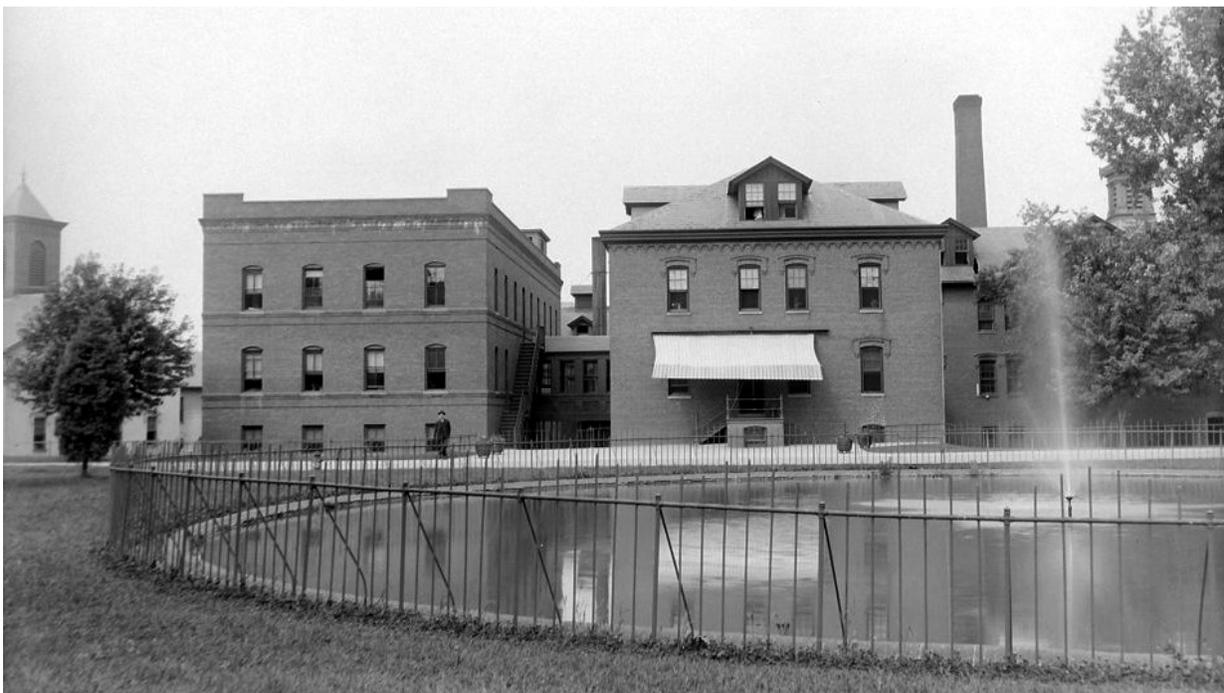
Figure 6. View of the east elevation of the General Kitchen addition and Old Storeroom, 1906. Source: GSA archives, image DC1458SE0P002.

The Old Storeroom (Building 44) was completed in 1900. The building was situated south of the General Kitchen and had a direct connection to the second floor level of the General Kitchen through two new connecting corridors, one located on the south elevation of the north wing and one positioned on the east elevation of the west wing. The enclosed connecting corridors had tin gable roofs, window openings with double-hung windows, and paneled metal cladding.¹²

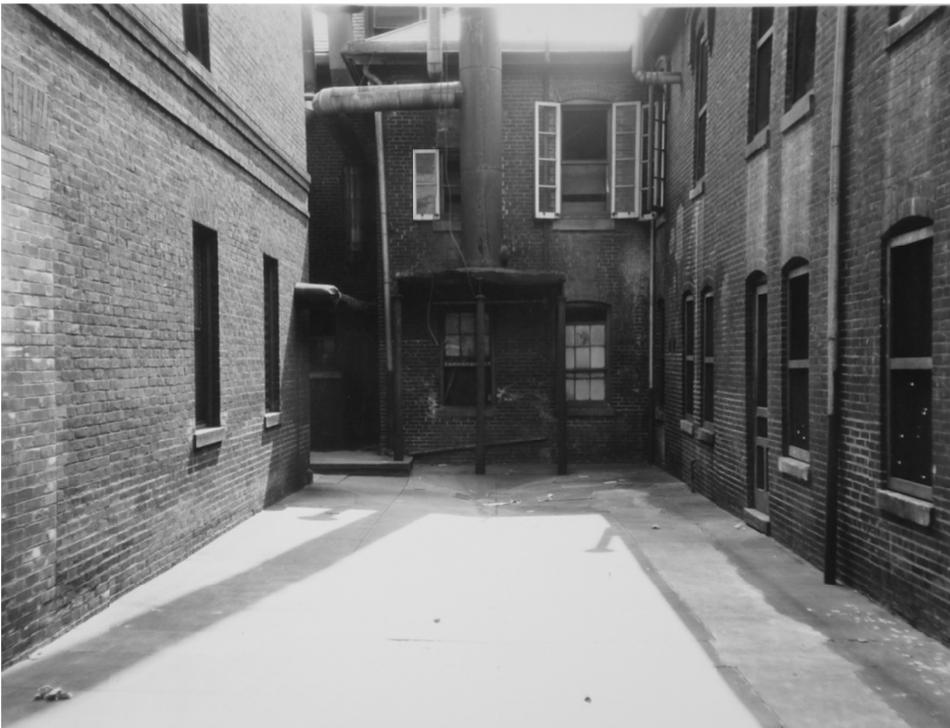
Figure 8. Image of the storage area of the General Kitchen. The Old Storeroom is seen on the left, 1935. Source: National Archives, image 418-P-247.

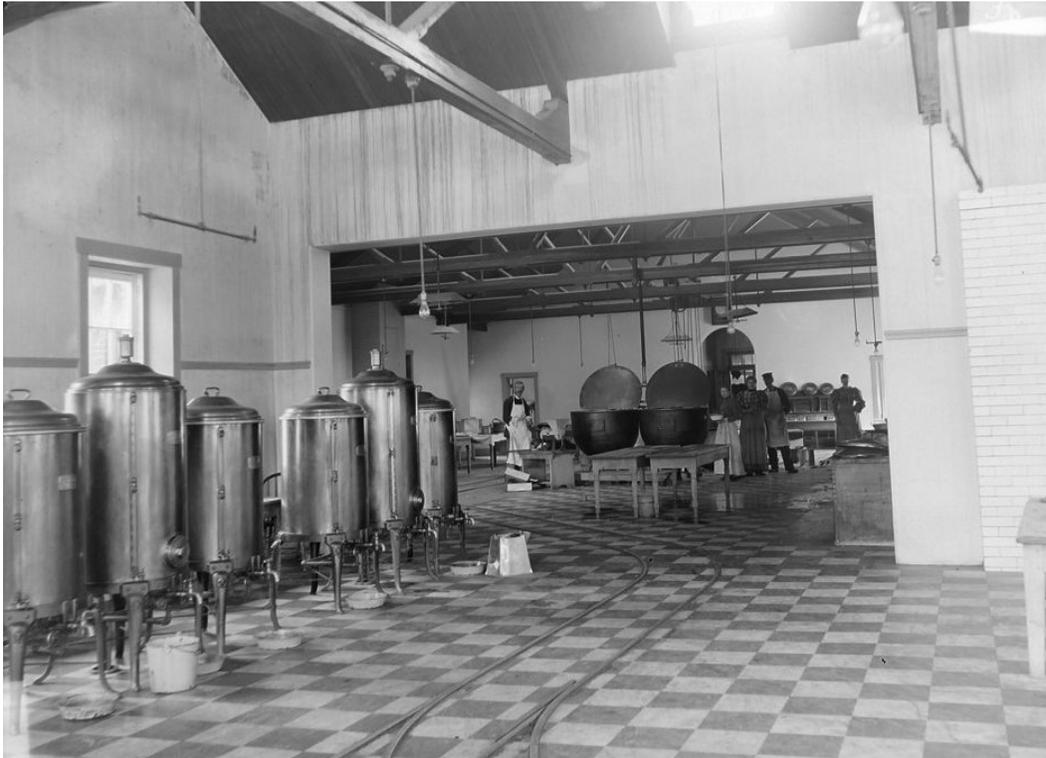
Figure 9. An interior view of the second floor of the General Kitchen looking west from the north wing, 1898. Source: GSA archives, image DC1336SE0P001.

An employee dining hall and residence for the culinary department were located on the second floor.⁹ A small storage structure was attached to the north end of the east elevation.¹⁰

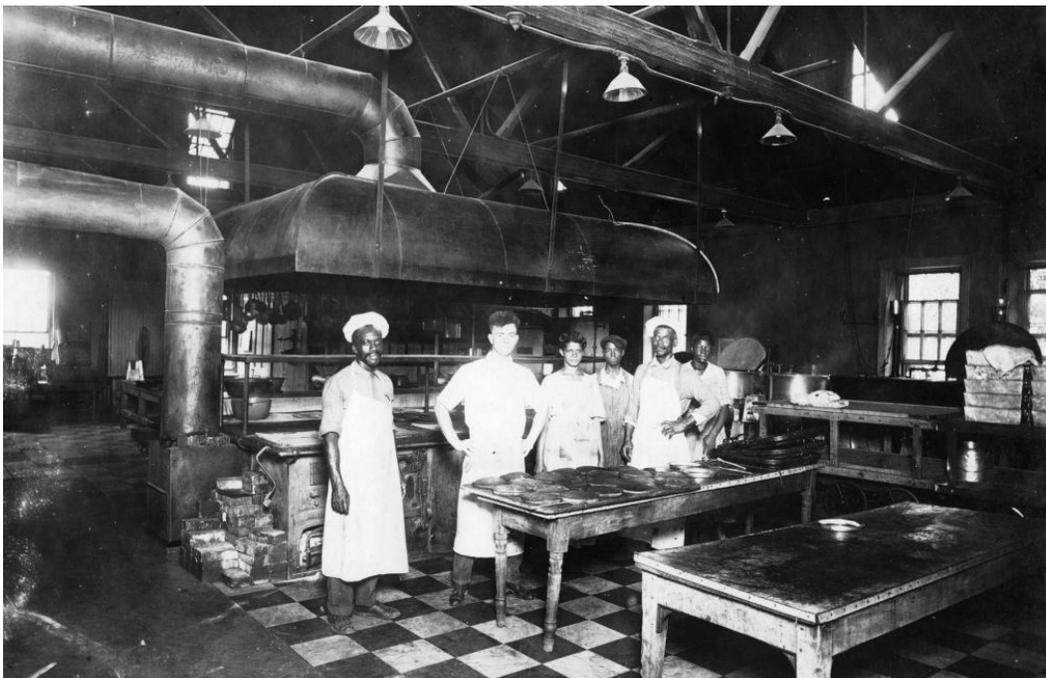
Figure 10. Interior view of the west wing of the General Kitchen, 1915. Source: GSA archives, image DC1336SE0P007.
