ST. ELIZABETHS HOSPITAL, BAKERY
(Building No. 46)
2700 Martin Luther King Jr. Avenue, Southeast, Golden Raintree
Drive, Southeast
Washington
District of Columbia

HISTORIC AMERICAN BUILDINGS SURVEY

ST. ELIZABETHS HOSPITAL, BAKERY (BUILDING 46)

HABS NO. DC-349-BD

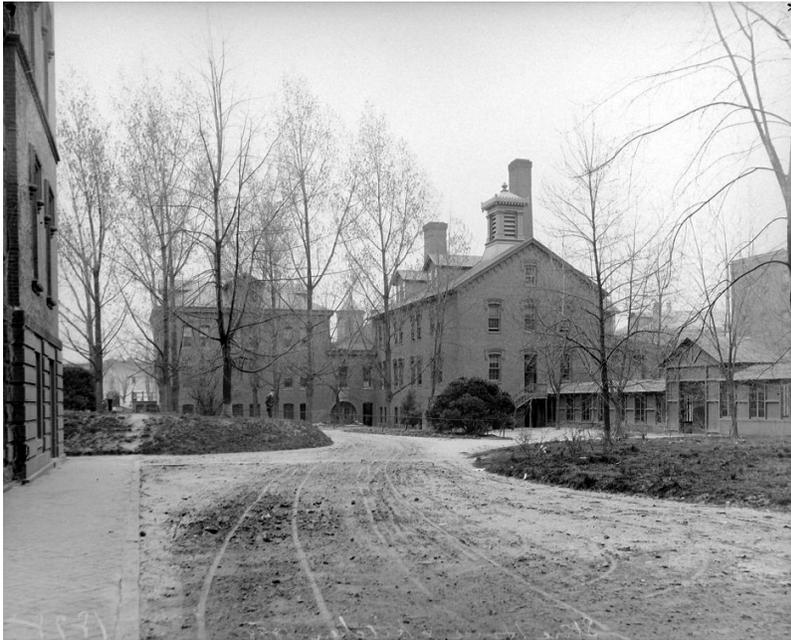
Figure 1. View of the original Bakery building (left side of image) with covered breezeway connecting to the West Wing (Building 3), 1898. Note ventilation stack on roof of 1878 portion of the Bakery. Source: GSA archives, image DC1458SE0P004.

¹² A site map from the 1895 *Annual Report* indicates that construction of the breezeway was underway. An archival photograph from 1898 depicts the completed passageway.

¹³ A shadow of the one-story shed roof addition is seen in an 1898 archival photograph. There is no reference made to an existing one-story structure in the 1910 construction documents.

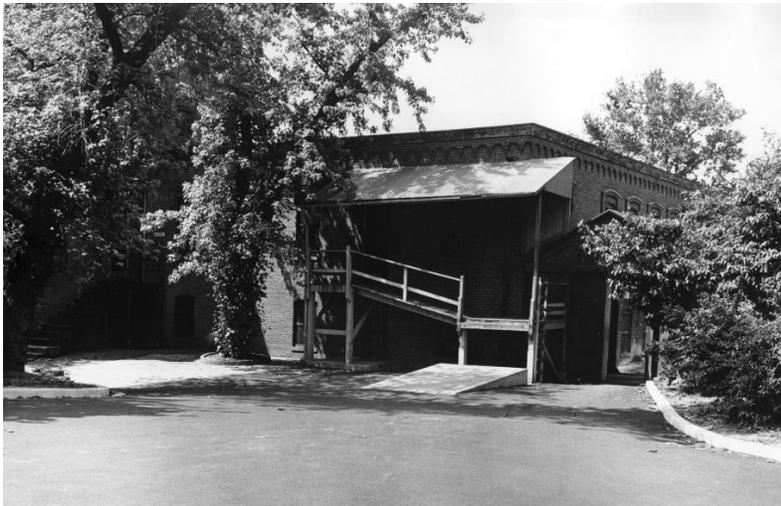
Figure 2. North end of the east facade of the Bakery, 1968. Source: GSA archives, image DC1459SE0P001

By 1968, a wood-framed loading ramp with wood-framed shed roof had been constructed along the east facade of the Bakery extension.¹⁹ The ramp provided access to the second floor level of the Bakery. The lower landing of the ramp was approximately 5 feet above grade and was accessed from a metal ladder or small concrete ramp located at the foot of the landing.²⁰

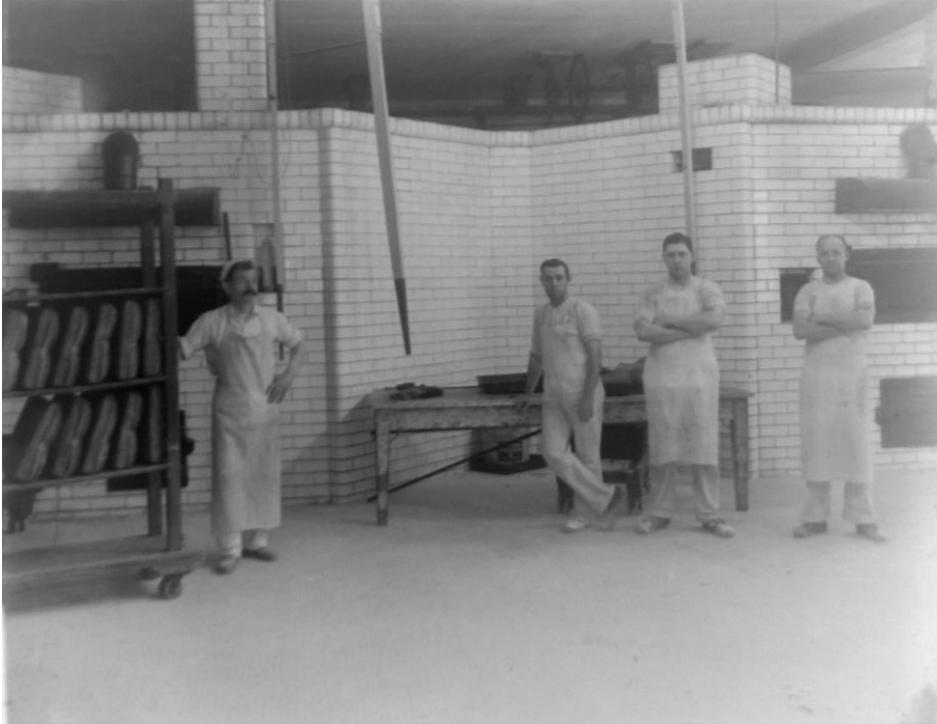
Figure 3. An interior view of the Bakery extension as it appeared in 1917. Source: GSA archives, image DC1459SE0P002.

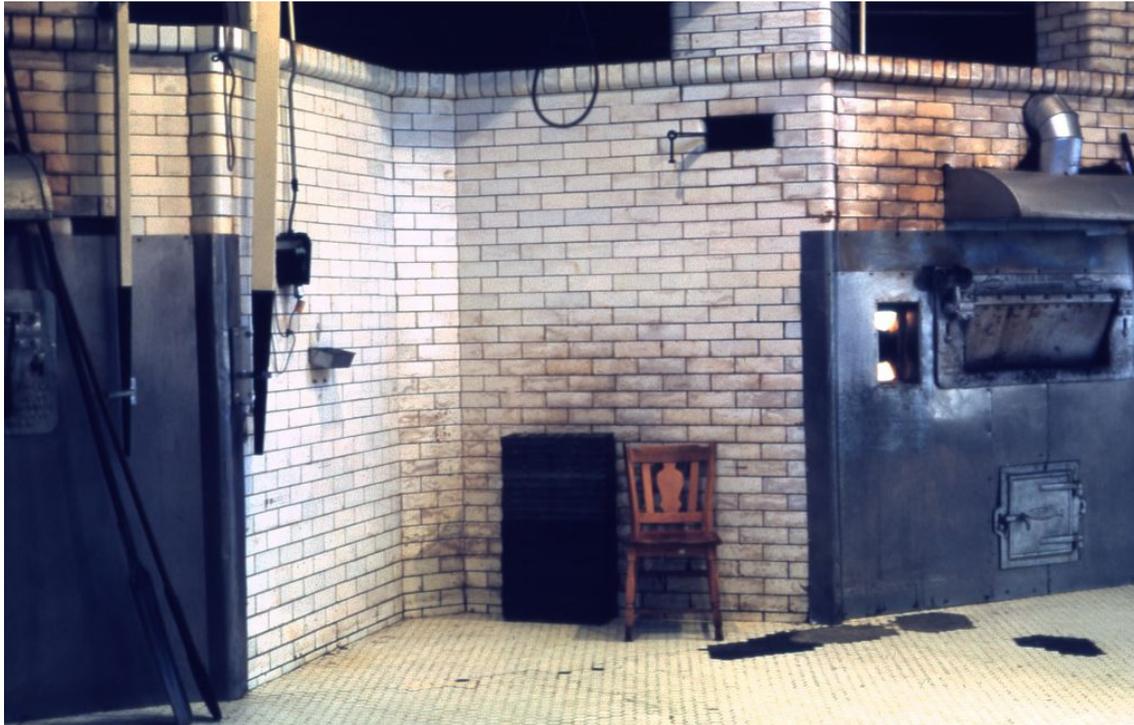
Figure 5. View of the bakery ovens as they appeared in 1964. Source: GSA archives, image DC1459SE0P007.

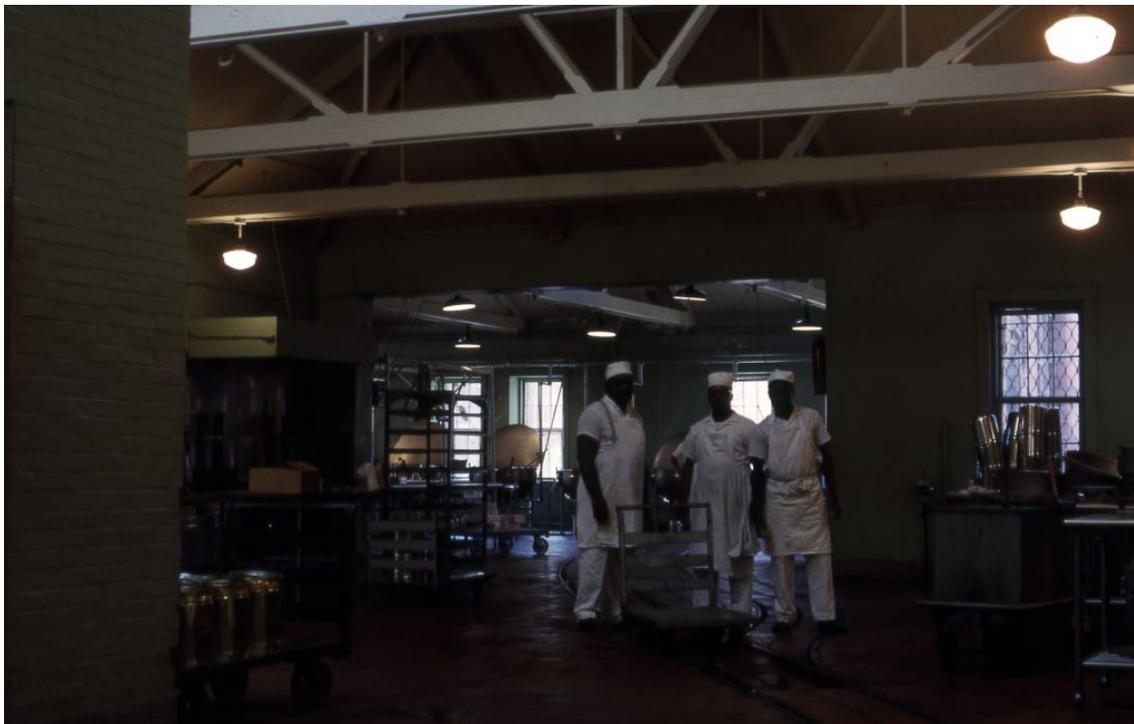
Figure 6. The interior of the original Bakery building looking west into the Bakery extension, 1964. Source: GSA archives, image DC1459SE0P006.

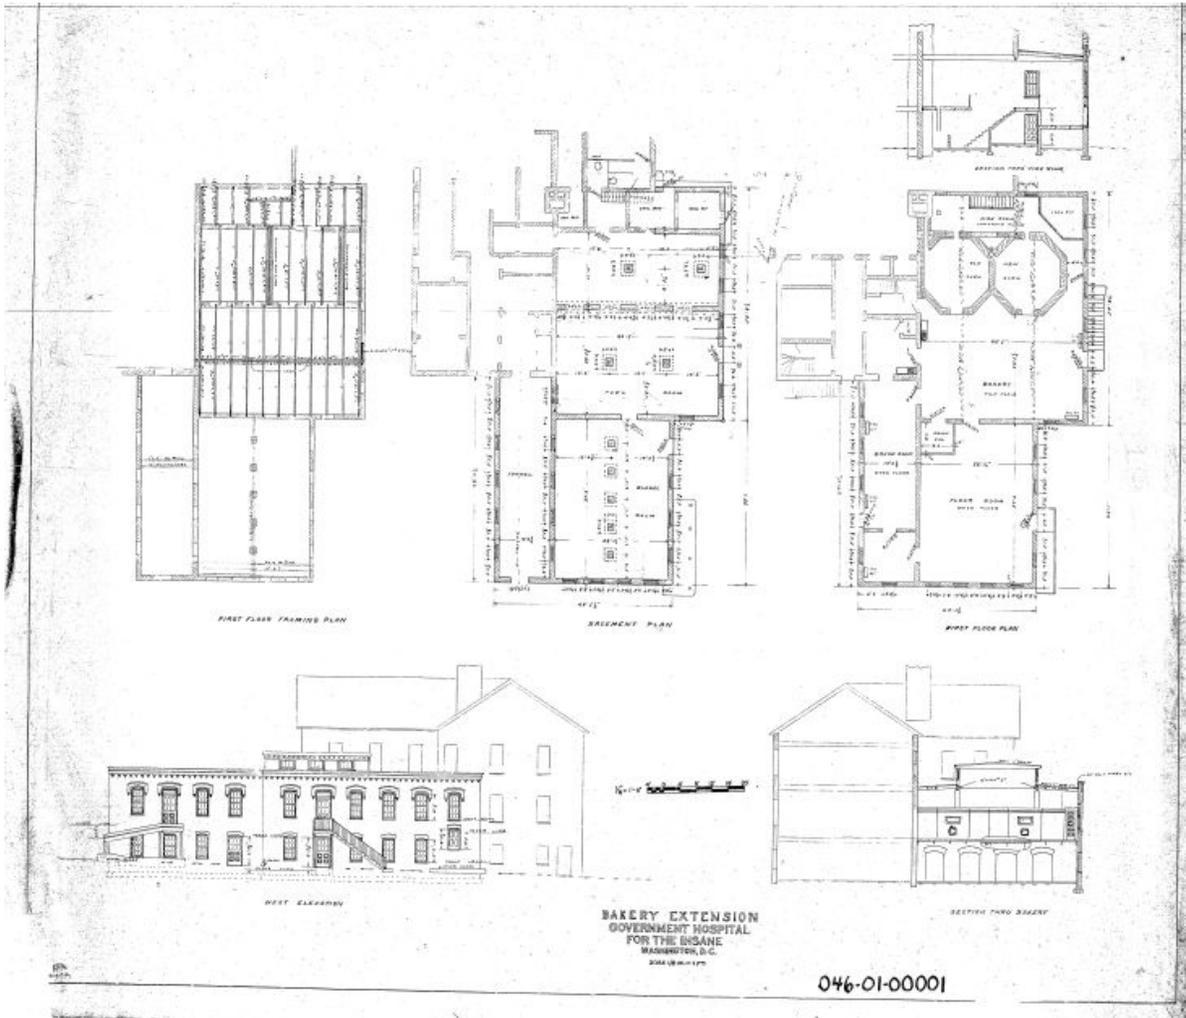
Figure 8. Construction documents for the 1910 Bakery extension. Source: GSA archives, image DC1459SE0001.

Prior to 1910, the one-story shed roof portion of the original Bakery was razed.¹³ In 1910, an addition was constructed to enlarge the Bakery building. The extension was constructed along the north and west facades of the existing Bakery and replaced the south portion of the covered breezeway linking the Bakery to the Center Building. The extension consisted of two sections, a north and west component, offset 12 feet from one another. The Bakery extension had corbelled brick drip molds over window and door openings and a corbelled brick blind arcade with cast iron cornice. The north portion had a flat roof covered with slag while the west section had a compound monitor roof. The Bakery extension provided storage for flour and bread and housed the new ovens. Upon completion of the addition, all baking functions were relocated to the new extension.

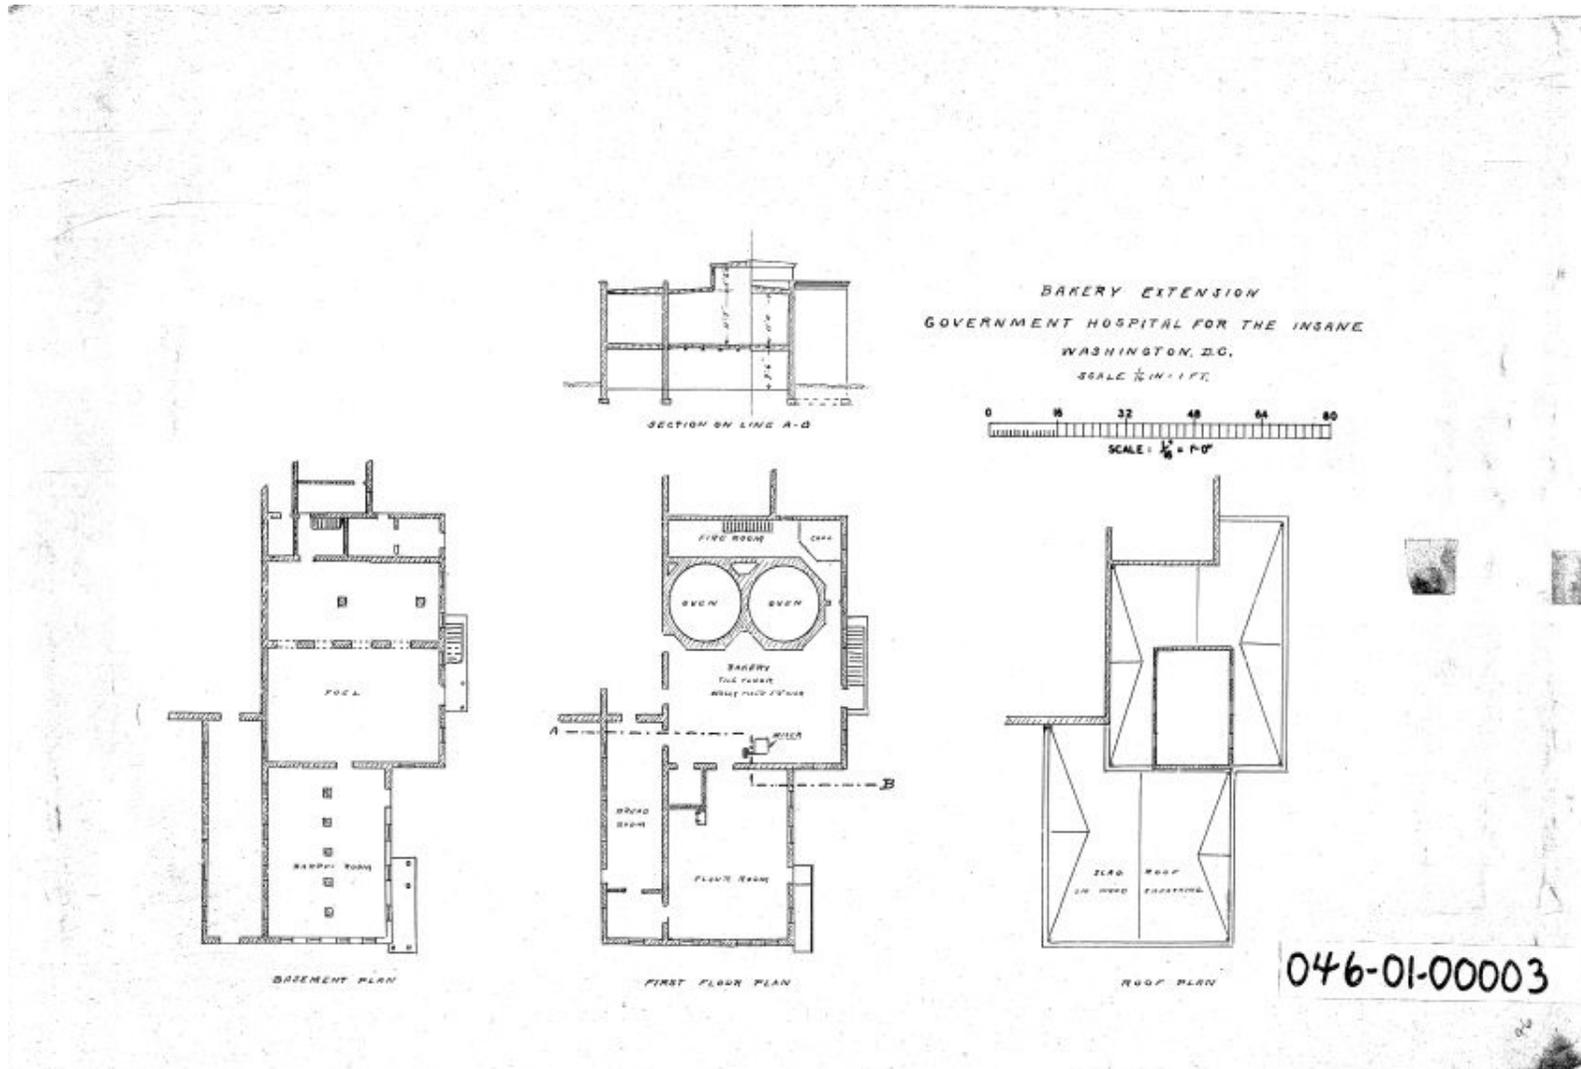
Figure 9. Plans for the 1910 Bakery extension. Source: GSA archives, image DC1459SE0002.
