ST. ELIZABETHS HOSPITAL, MECHANICAL AND ELECTRIC
SHOPS
(Building No. 12)
2700 Martin Luther King Jr. Avenue, Southeast, Holly Street,
Southeast
Washington
District of Columbia

HABS DC-349-BG
HABS DC-349-BG

ST. ELIZABETHS HOSPITAL, MECHANICAL AND ELECTRICAL SHOPS (BUILDING 12)

HABS NO. DC-349-BG

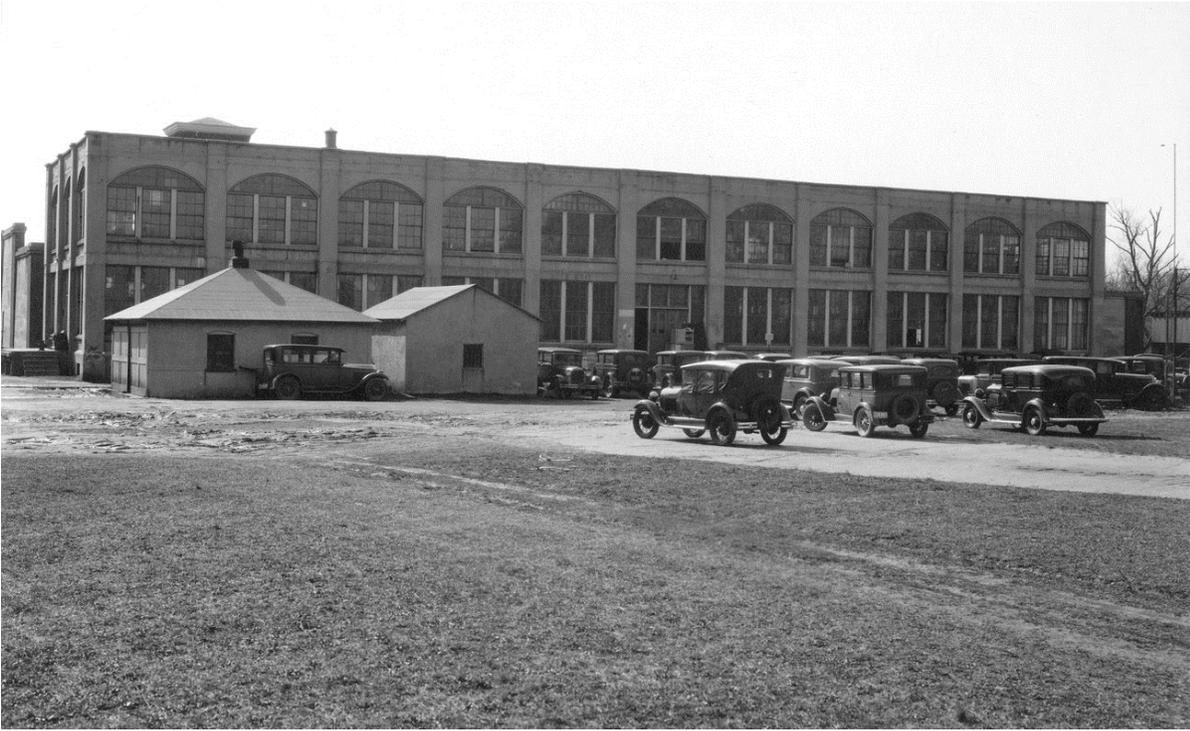
Figure 3. View from the north of the Mechanical and Electrical Shops, circa 1930s. Source: GSA archives, image DC0158SE0P002.

4. Builder, contractor, suppliers: Not known
5. Original plans and construction: The Mechanical and Electrical Shops building was constructed as a two-story, rectangular, steel-framed, exposed concrete structure just north of the wall surrounding Howard Hall (now demolished). The structure was defined by a series of repeating bays. Each bay included three double-hung windows on the first level and three double-hung windows on the second level. Arched transom windows were present above the second floor windows. The building was constructed using patient labor.⁴
6. Alterations and additions: After 1937 but prior to 1955, a one-story addition was constructed on the west end of the Mechanical and Electrical Shops. This addition was a concrete block structure with a flat roof and a brick chimney.⁵ The building received a new tar and gravel roof in 1942.⁶

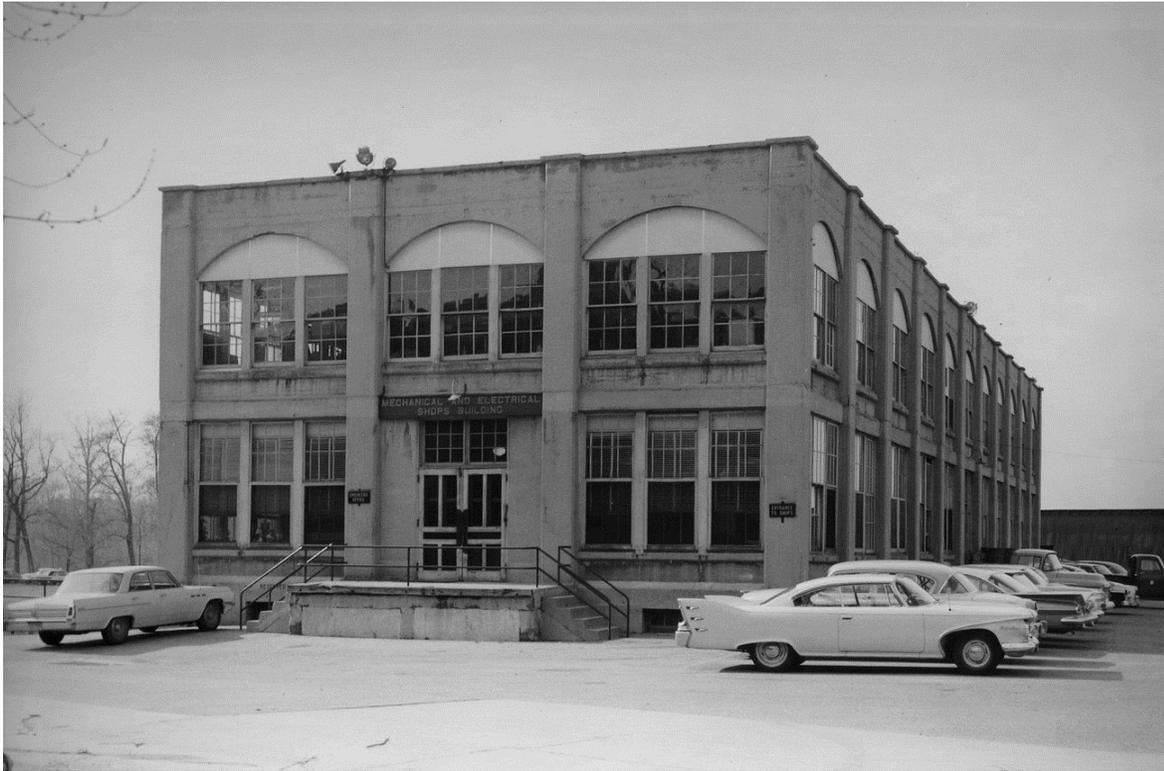
Figure 5. The east end of the building, 1964. Source: GSA database, image DC0158SE0P004.

In 1955, handrails were installed on the interior and exterior stairs. The elevator was replaced and electrical upgrades were made to the building. The building was again re-roofed in 1960.⁷ After 1945 but prior to 1964, the arched transom windows at the second floor were removed and replaced with cement board infill panels. During the same period the eight-panel entry doors were replaced with four-panel doors.⁸ Later, after 1968 but before 1983, several of the original windows were removed. The openings were partially infilled with concrete masonry units and smaller double-hung windows were installed. The entry doors were also removed and replaced with metal-framed doors. The entire structure was painted during the same period.⁹

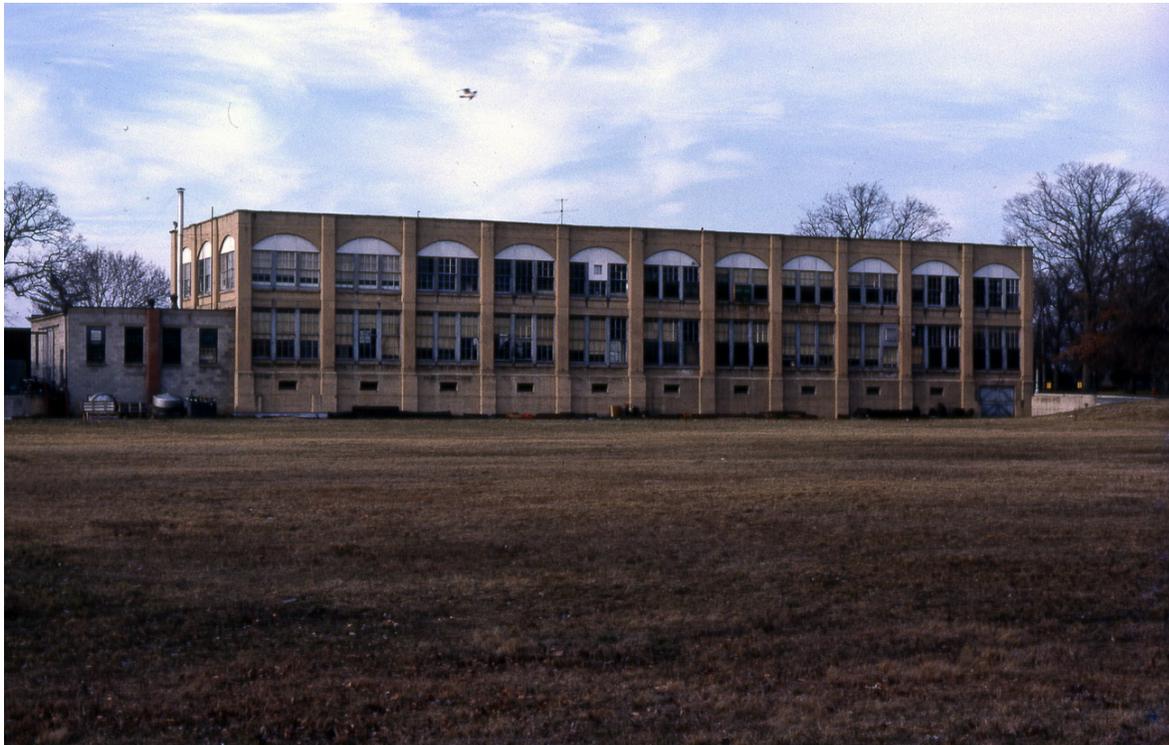
Figure 6. View from the south, 1964. Source: GSA database, image DC0158SE0P003.

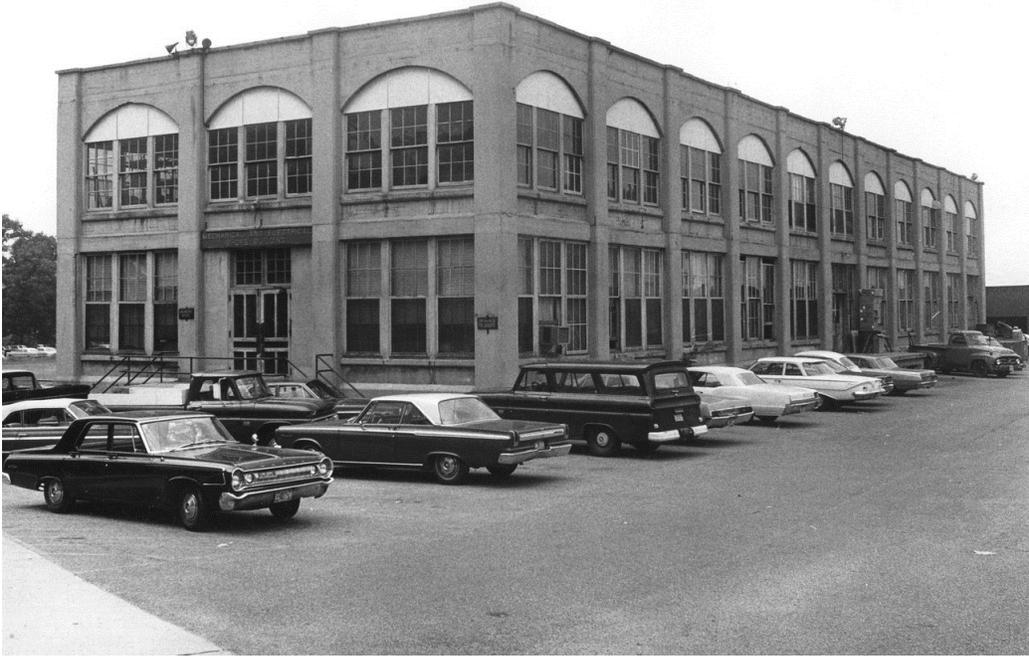
Figure 7. View from the northeast, 1968. Source: GSA database, image DC0158SE0P001.

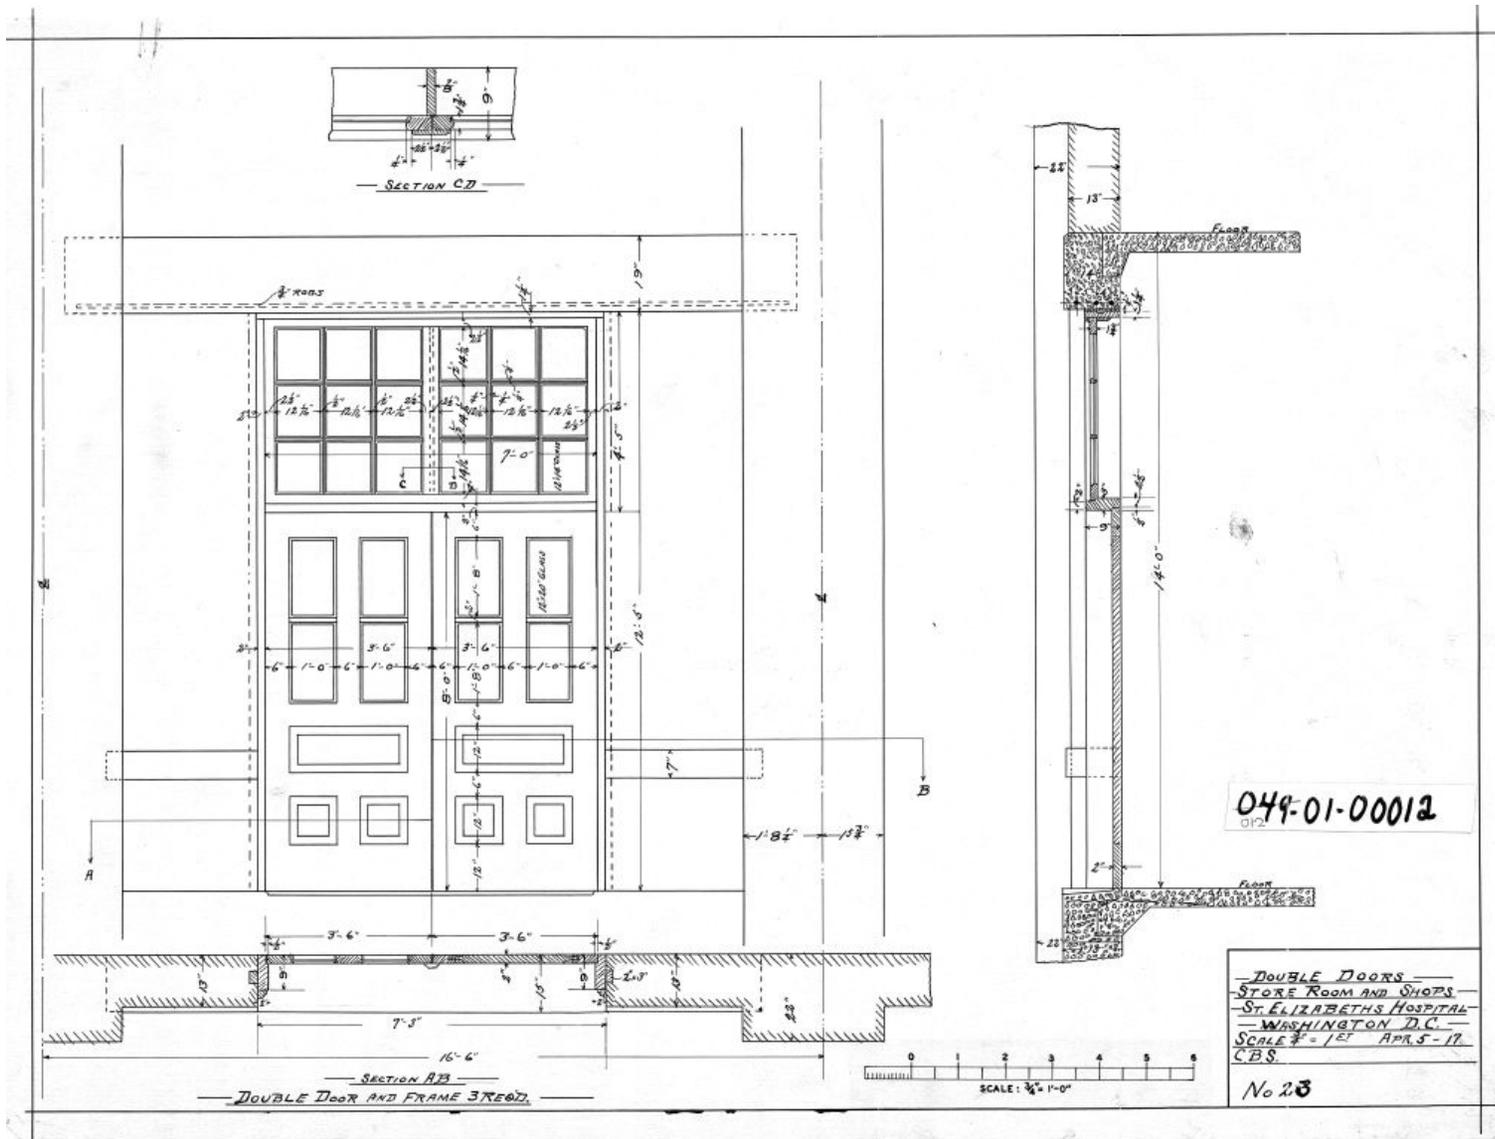
Figure 11. Original exterior door drawing. Source: GSA archives, image DC0158SE0105.

6. Chimneys: There is a brick chimney at the north wall of the west one-story addition.
7. Openings:
 - a. Doorways and doors: The exterior entrance doors are non-original hollow-core metal doors in metal frames. At the east elevation main entrance, the original door opening has been reduced in size with concrete masonry.

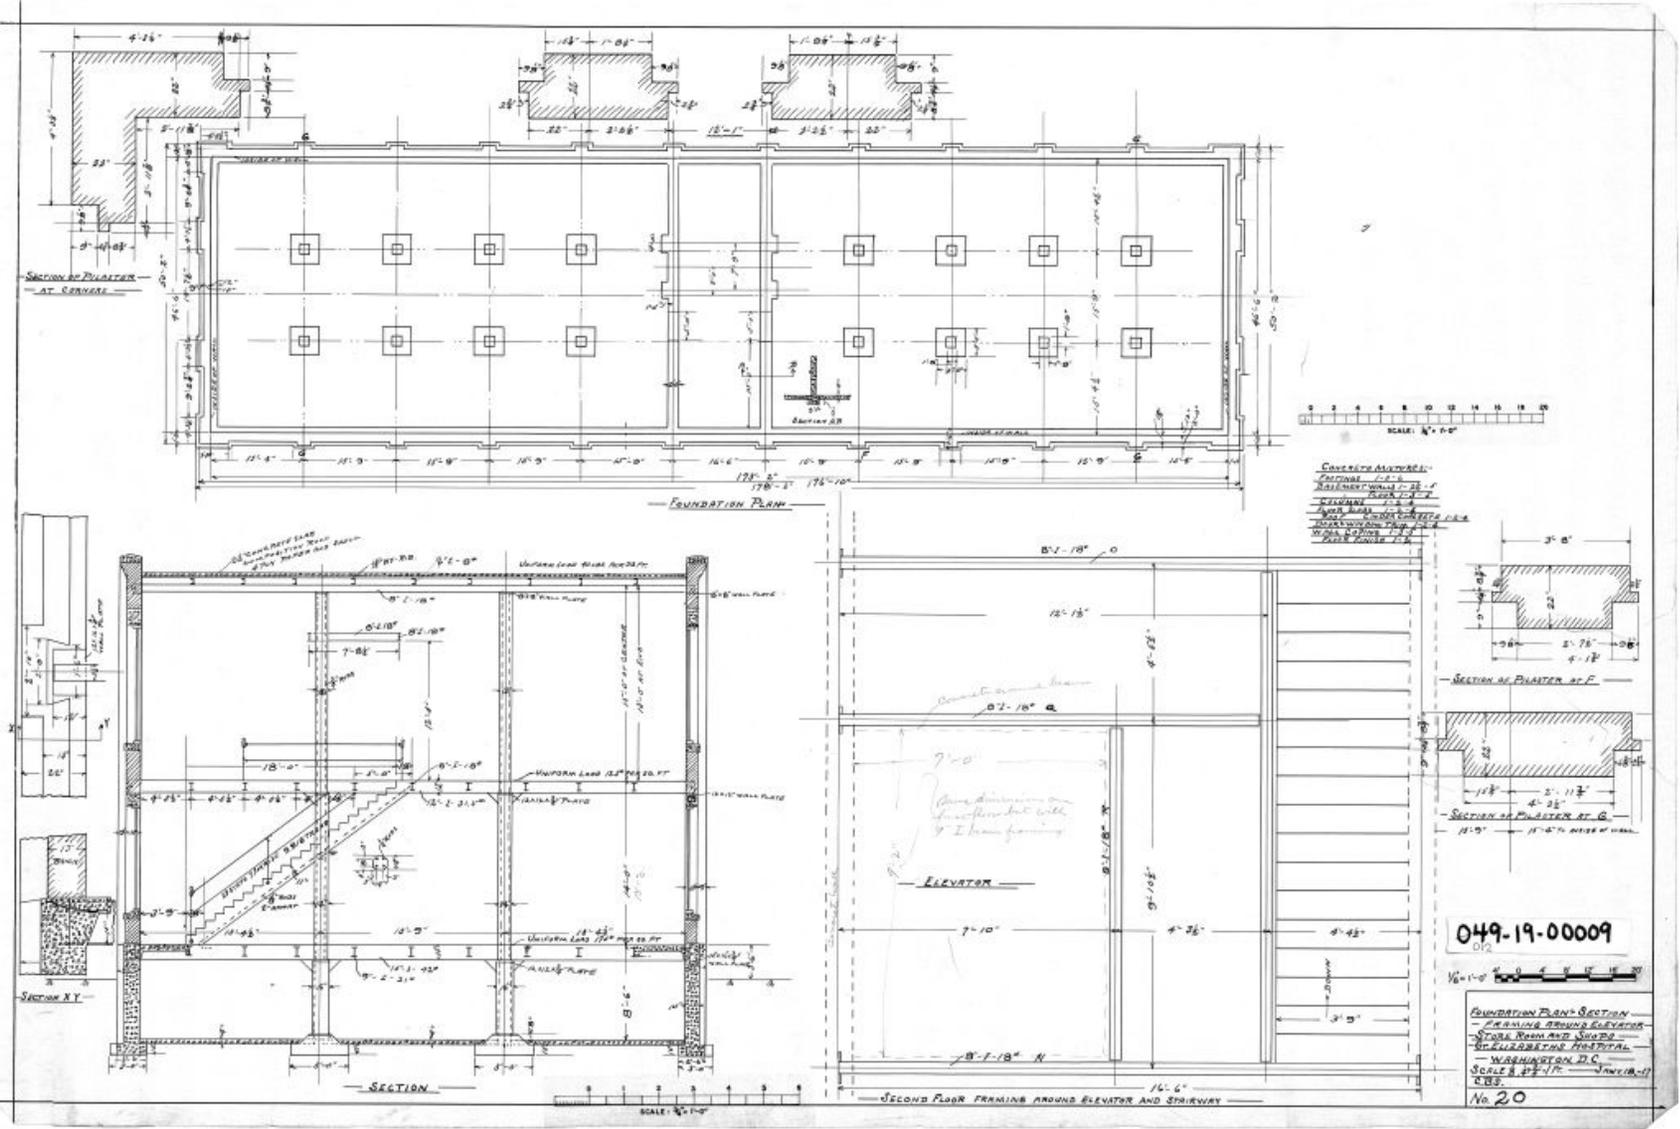
Figure 12. Original structural drawing. Source: GSA archives, image DC0158SE0111.

4. Structural system, framing: The building has a concrete and steel structure, with reinforced concrete floors and roof structures supported by exterior walls and interior columns. The concrete walls have a series of arched openings around the building perimeter that are filled in with concrete masonry. The floor and roof slabs bear on steel framing supported by interior columns and the exterior walls. The concrete floors are cast around the steel beams and are reinforced with expanded steel diamond mesh.
