ST. ELIZABETHS HOSPITAL, INCINERATOR  
(Building No. 123)  
2700 Martin Luther King Jr. Avenue, Southeast, Ash Street, Southeast  
Washington  
District of Columbia

HABS DC-349-BR  
*HABS DC-349-BR*

### ST. ELIZABETHS HOSPITAL, INCINERATOR (BUILDING 123)

HABS NO. DC-349-BR

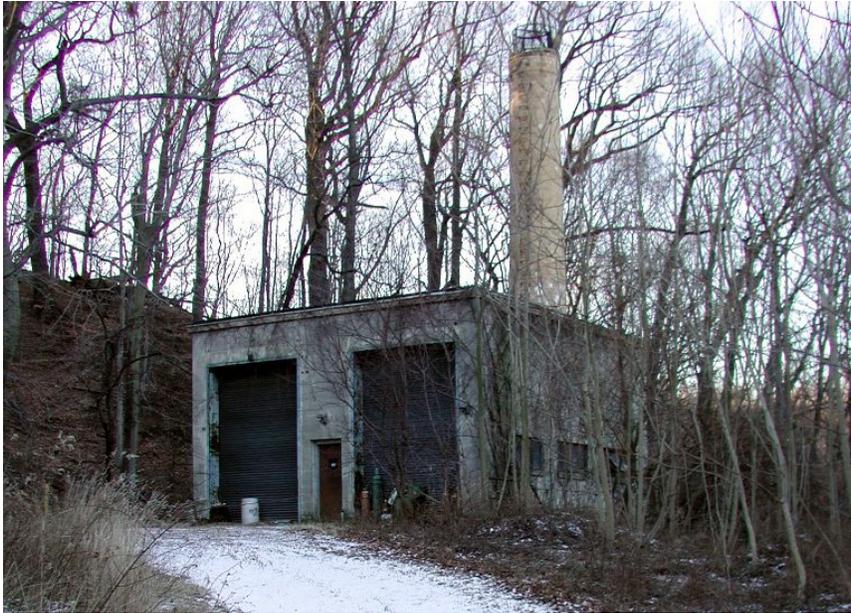
*Figure 1. Incinerator in 2003. Source: GSA archives, image DC0147SE0P001.*

2. Condition of fabric: At the time of the field survey for the Historic Structure Reports/Building Preservation Plans project in 2009, the Incinerator was in fair to poor condition. The roof was severely deteriorated and missing the roof monitor. The interior and exterior face of the walls exhibited water staining and efflorescence. Most of the window glazing was broken and interior finishes were missing or severely deteriorated.

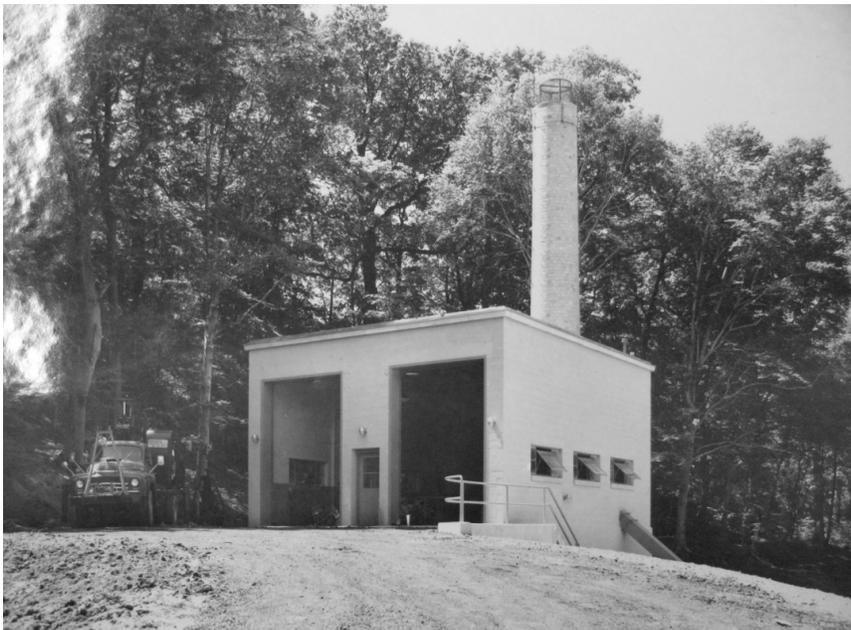
*Figure 2. View of Incinerator, May 22, 1958. Source: St. Elizabeth Hospital Health Science Library archive.*
