Robinson House (Carpenter Park Log House)  
Walter S. Carpenter State Park  
South side of Pleasant Hill Road approximately  
.1 mile east of junction with Route 896 (New London Road)  
Newark  
White Clay Creek Hundred  
New Castle County  
Delaware

HABS No. DE-241

ARCHITECTURAL DATA FORM

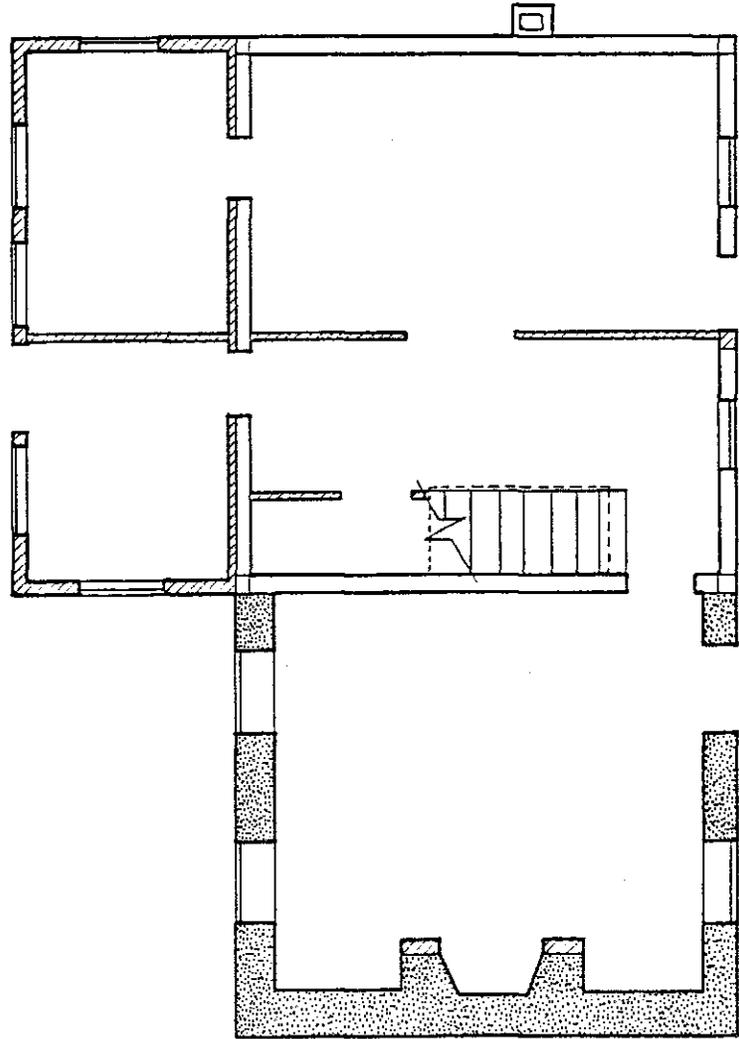
FIRST FLOOR PLAN

- PERIOD 1 LOG
  - ▒ PERIOD 2 STONE
  - ▨ PERIOD 3 FRAME
- LOCATION OF PERIOD 1 HEARTH

STYLE (IF APPROPRIATE)		
MATERIAL OF CONSTRUCTION (INCLUDE STRUCTURAL SYSTEMS) Period 1: V-notched hewn log with wood slab and clay chinked interstices and whitewashed exterior, stud gables with common rafter roof. Period 2: rubble stone. Period 3: dimension sawn frame.		
SHAPE AND DIMENSIONS OF STRUCTURE (SKETCHED FLOOR PLANS ON SEPARATE PAGES ARE ACCEPTABLE) Period 1: one-room plan. Period 2: enlarged to hall-parlor plan. Period 3: leanto added.		
EXTERIOR FEATURES OF NOTE Period 1: The original exterior finish included whitewashing the exposed logs, chinking utilizing construction scrap pressed into sand tempered clay, front and rear sill logs dropped into the foundation masonry. Also, frame gables clad with average 9" face vertical mill sawn 1" thick rabbet-edged siding.		
INTERIOR FEATURES OF NOTE (DESCRIBE FLOOR PLANS, IF NOT SKETCHED) The interior of the building was largely gutted and refurbished in the mid 20th century. Evidence for original stair and chimney placement in the Period 1 dwelling was obliterated.

MAJOR ALTERATIONS AND ADDITIONS WITH DATES Period 1 plan enlarged in the mid 19th century into the Period 2 hall-parlor arrange- ment; Period 3 subdivided Period 1 plan, added leanto, and reworked entire structure.		
PRESENT CONDITION AND USE Vacant		
OTHER INFORMATION AS APPROPRIATE The Carpenter Park Log House has been the subject of parkwide cultural resource plan deposited in the Delaware Bureau of Archaeology and Historic Preservation.		
SOURCES OF INFORMATION (INCLUDING LISTING ON NATIONAL REGISTER, STATE REGISTERS, ETC.) For parallel information see Barbara Clark Smith, <u>After The Revolution</u> (New York: Pantheon, 1985) especially chapter on Springer family in Delaware.		
COMPILER, AFFILIATION Bernard Herman, Center for Historic Architecture and Engineering, University of Delaware		DATE 4/1/1986
