FORT BENNING, VETERINARY HOSPITAL COMPLEX HOSPITAL &
BARRACKS

HABS GA-2426-A

HISTORIC AMERICAN BUILDINGS SURVEY

VETERINARY HOSPITAL COMPLEX, Veterinary Hospital and Barracks (Building No. 265)

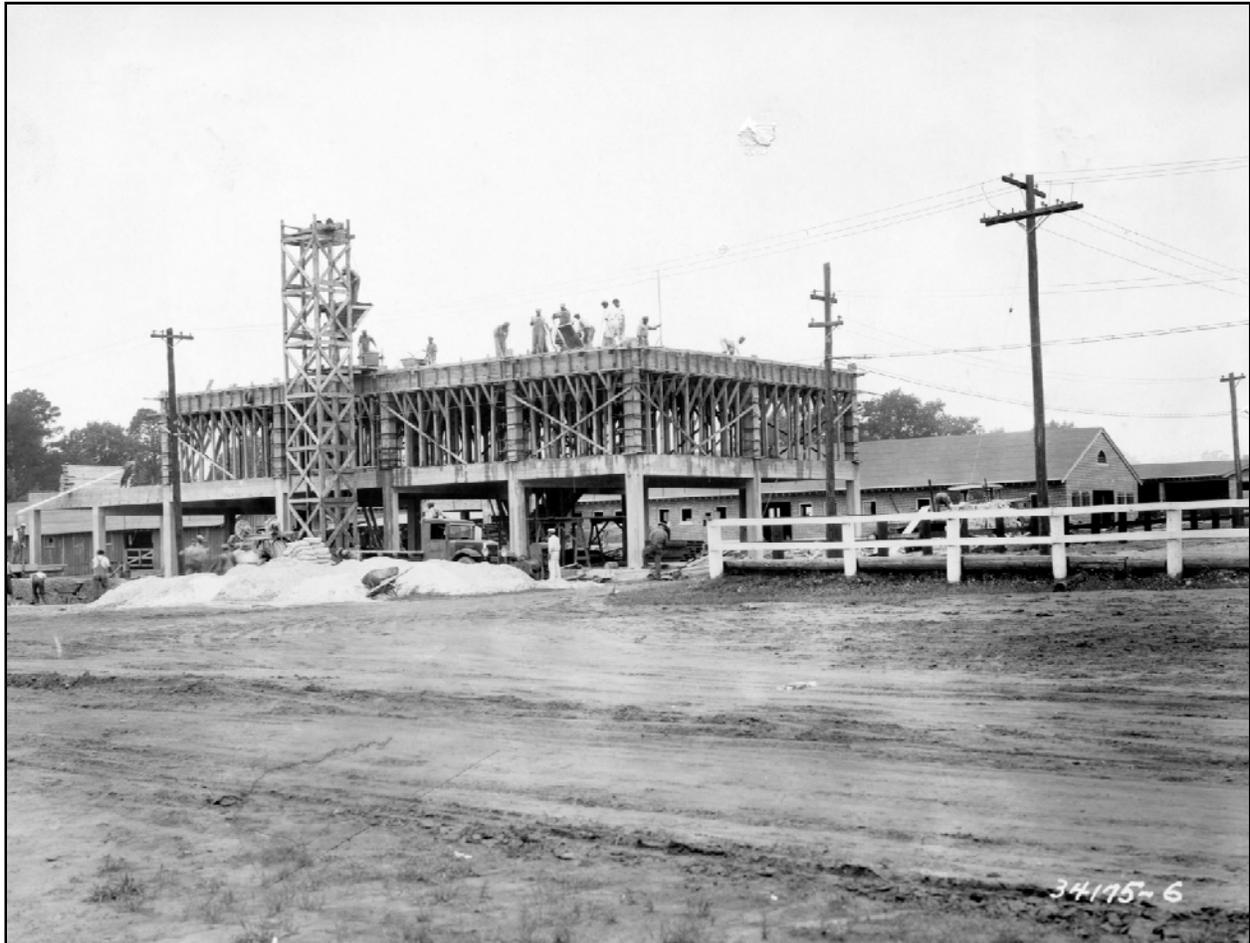
View of Veterinary Hospital and Barracks, Building No. 265, under construction, facing southwest. Original photograph on file at the National Infantry Museum, Fort Benning Military Reservation, Columbus, Georgia (Folder 1/4/49:Buildings – Veterinary Hospital and Office).

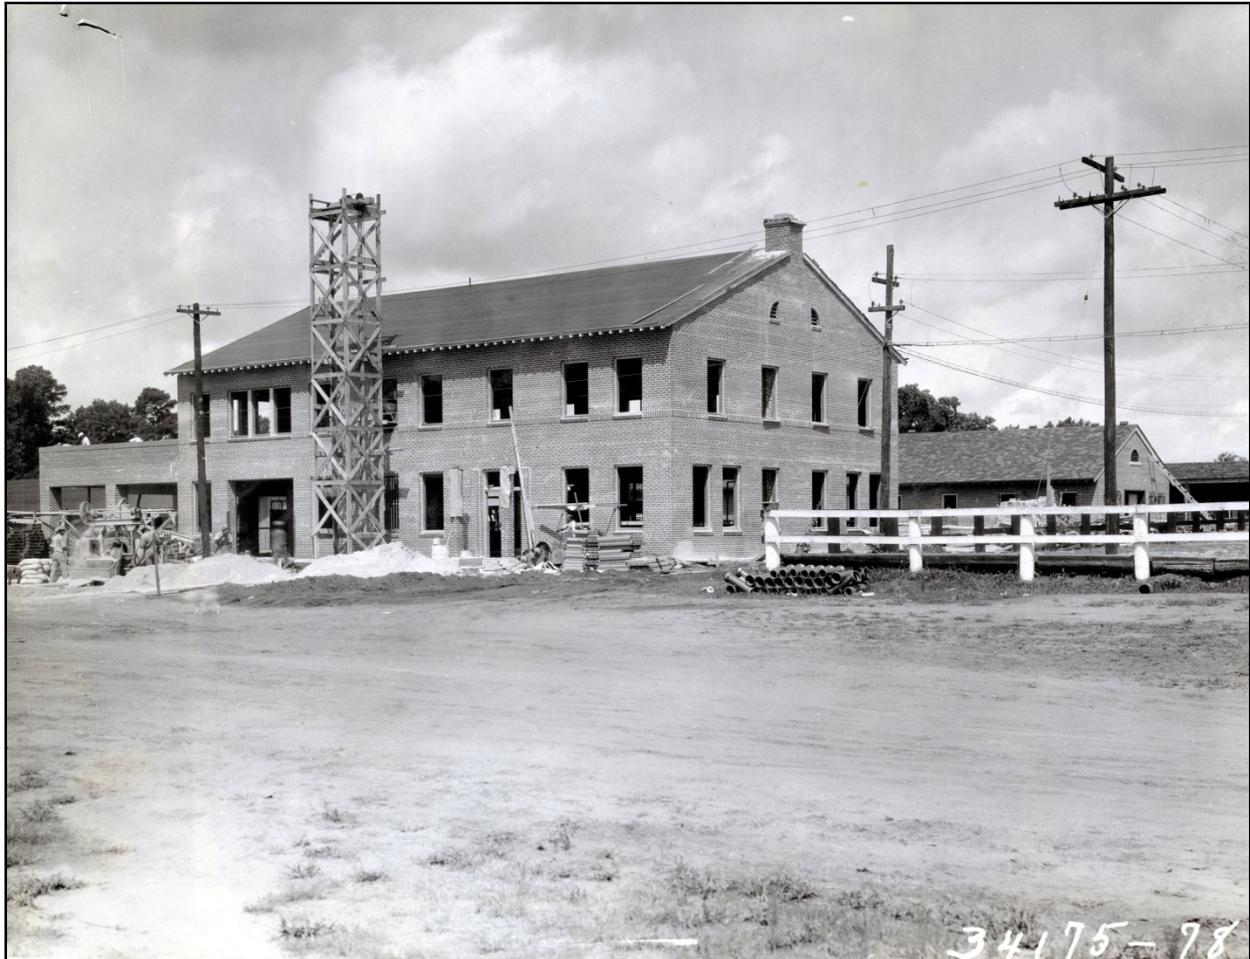
View of Veterinary Hospital and Barracks, Building No. 265, under construction, facing southwest. Original photograph on file at the National Infantry Museum, Fort Benning Military Reservation, Columbus, Georgia (Folder 1/4/49:Buildings – Veterinary Hospital and Office).

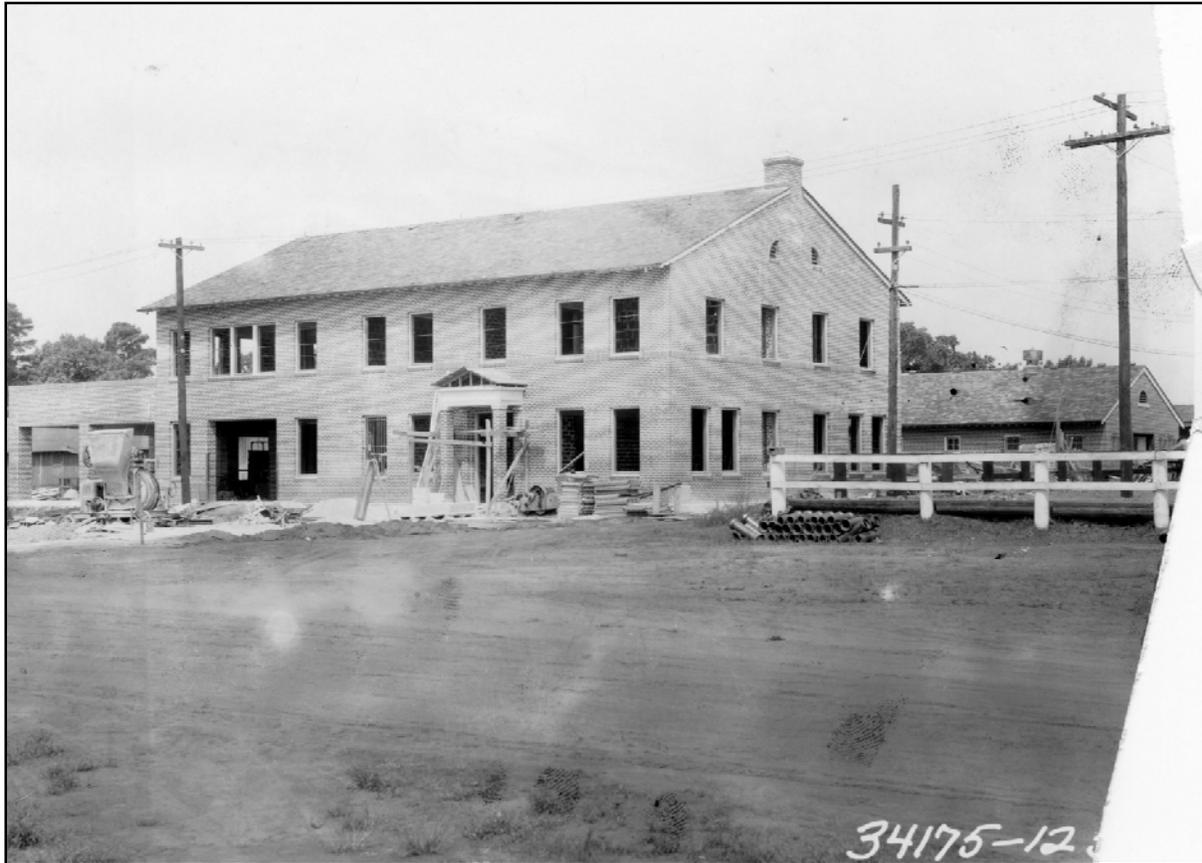
View of Veterinary Hospital and Barracks, Building No. 265, facing southwest. Original photograph on file at the National Infantry Museum, Fort Benning Military Reservation, Columbus, Georgia (Folder 1/4/49:Buildings – Veterinary Hospital and Office).

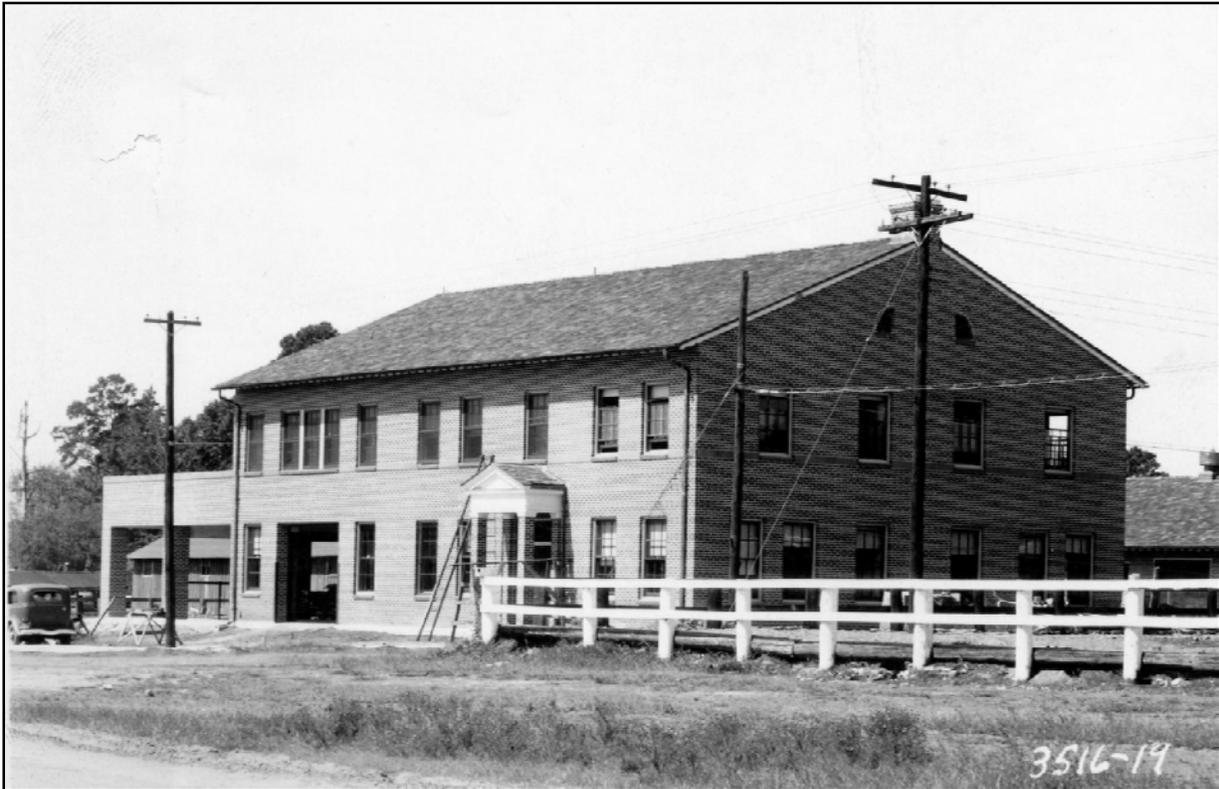
View of Veterinary Hospital and Barracks, Building No. 265, facing southwest. Original photograph on file at the National Infantry Museum, Fort Benning Military Reservation, Columbus, Georgia (Folder 1/3/30:Buildings Headquarters Fire Depot).

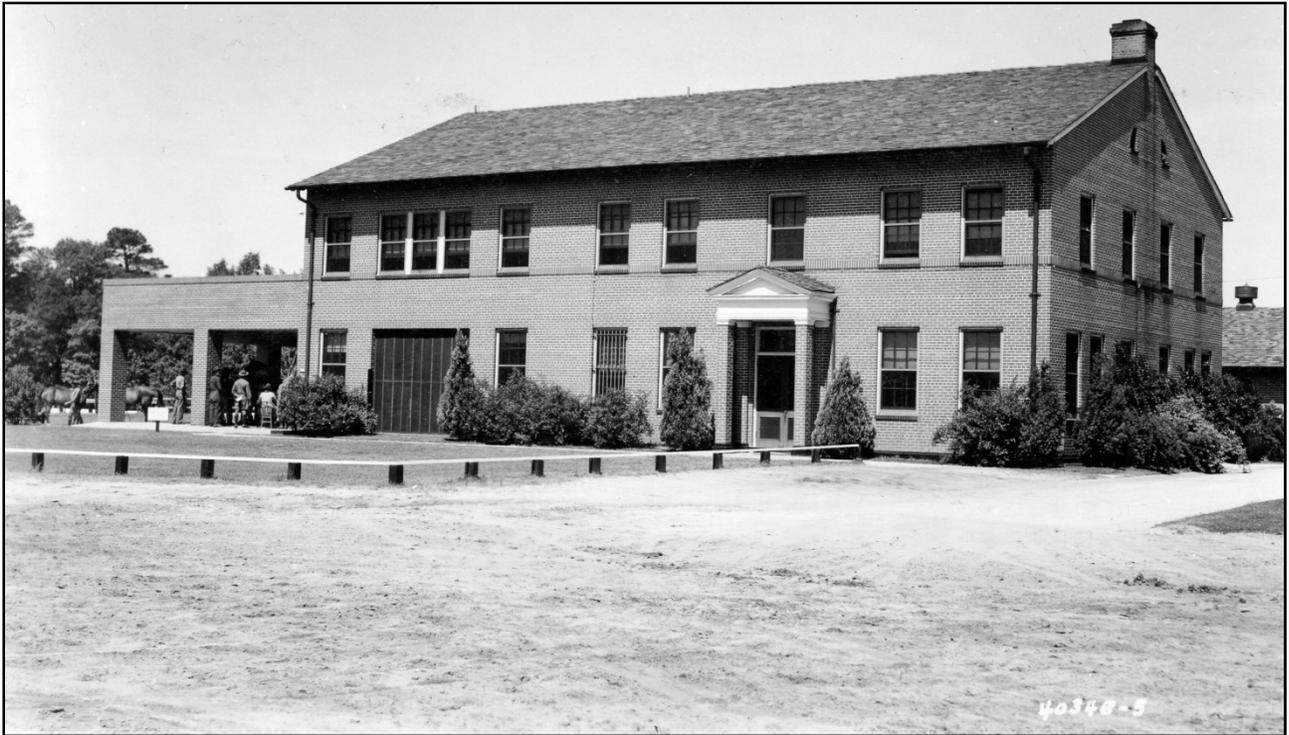
View of Veterinary Hospital and Barracks, Building No. 265, facing southwest. Original photograph on file at the National Infantry Museum, Fort Benning Military Reservation, Columbus, Georgia (Folder 1/4/49:Buildings – Veterinary Hospital and Office).

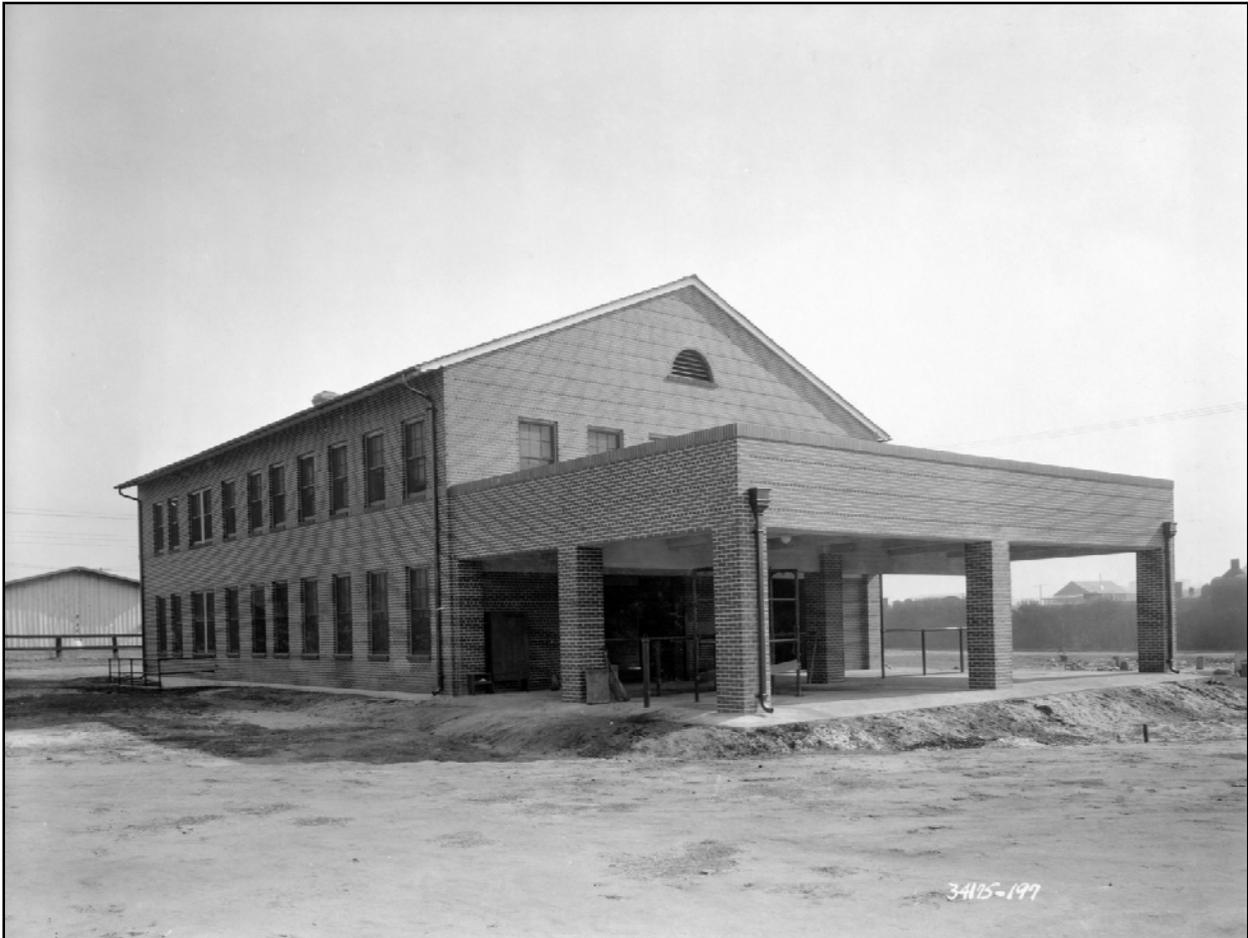
View of the northwest rear and southwest side of Veterinary Hospital and Barracks, Building No. 265, facing northeast. Original photograph on file at the National Infantry Museum, Fort Benning Military Reservation, Columbus, Georgia (Folder 1/4/49:Buildings – Veterinary Hospital and Office).

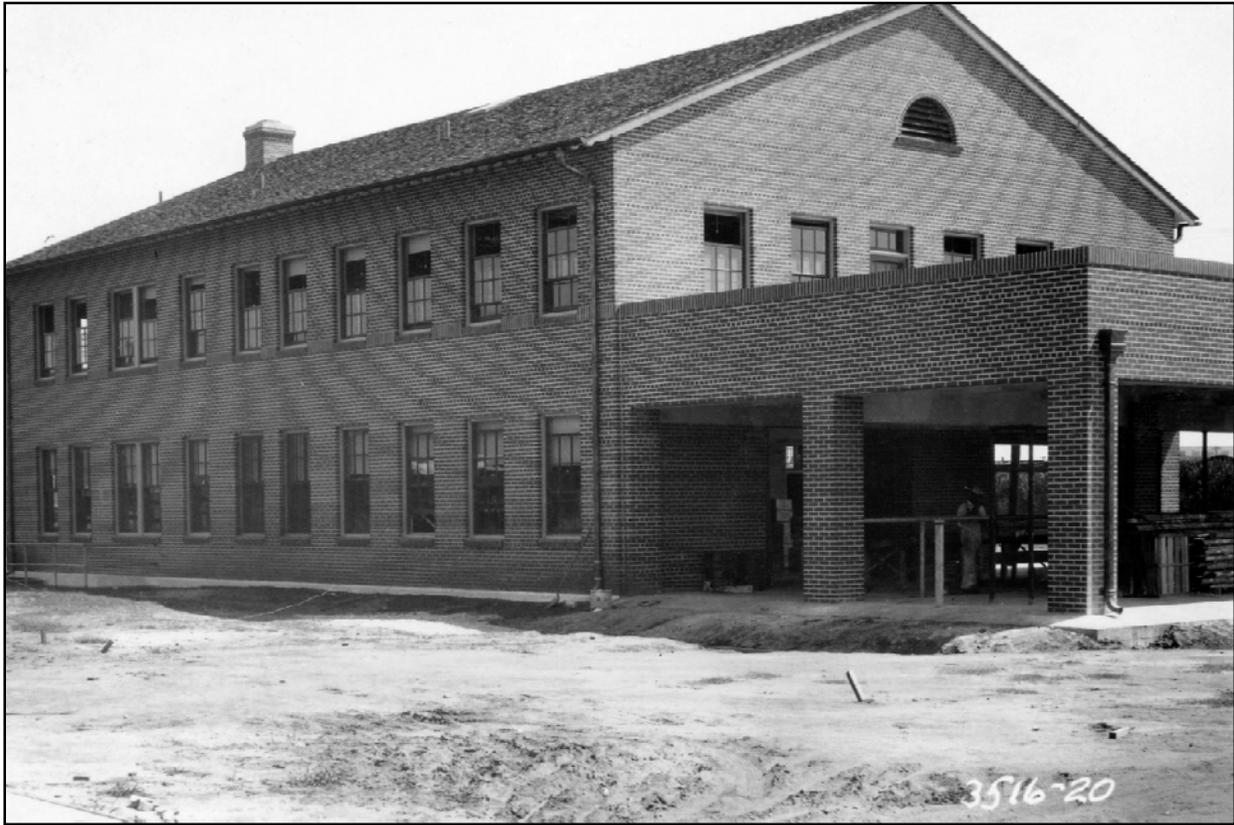
View of the northwest rear of Veterinary Hospital and Barracks, Building No. 265, facing northeast. Original photograph on file at the National Infantry Museum, Fort Benning Military Reservation, Columbus, Georgia (Folder 1/3/30:Buildings Headquarters Fire Depot).

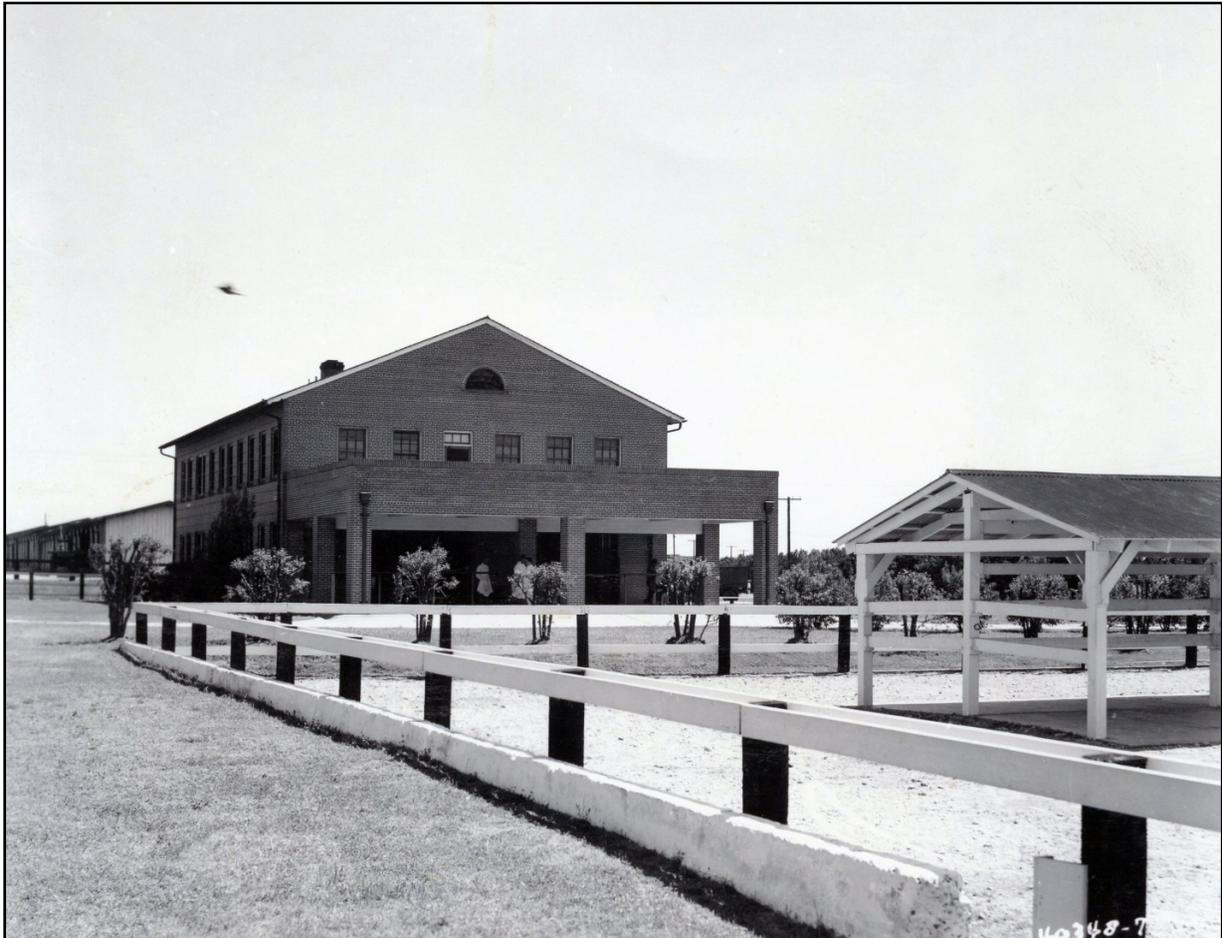
View of Veterinary Hospital and Barracks, Building No. 265, with paddock in foreground, facing northeast. Original photograph on file at the National Infantry Museum, Fort Benning Military Reservation, Columbus, Georgia (Folder 1/4/49:Buildings-Veterinary Hospital and Office).

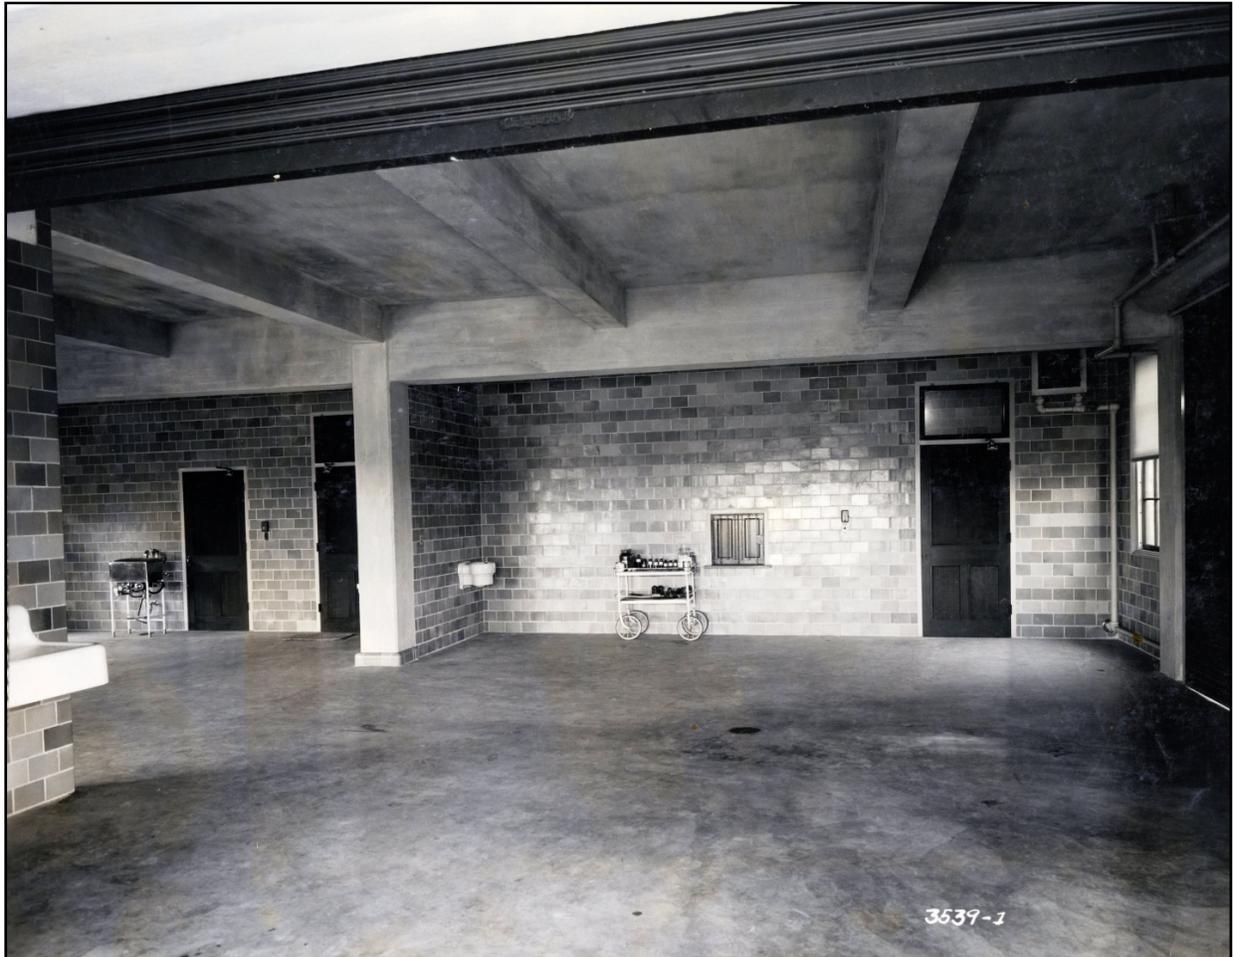
View of dressing room, facing northeast. Original photograph on file at the National Infantry Museum, Fort Benning Military Reservation, Columbus, Georgia (Folder 1/4/49:Buildings – Veterinary Hospital and Office).

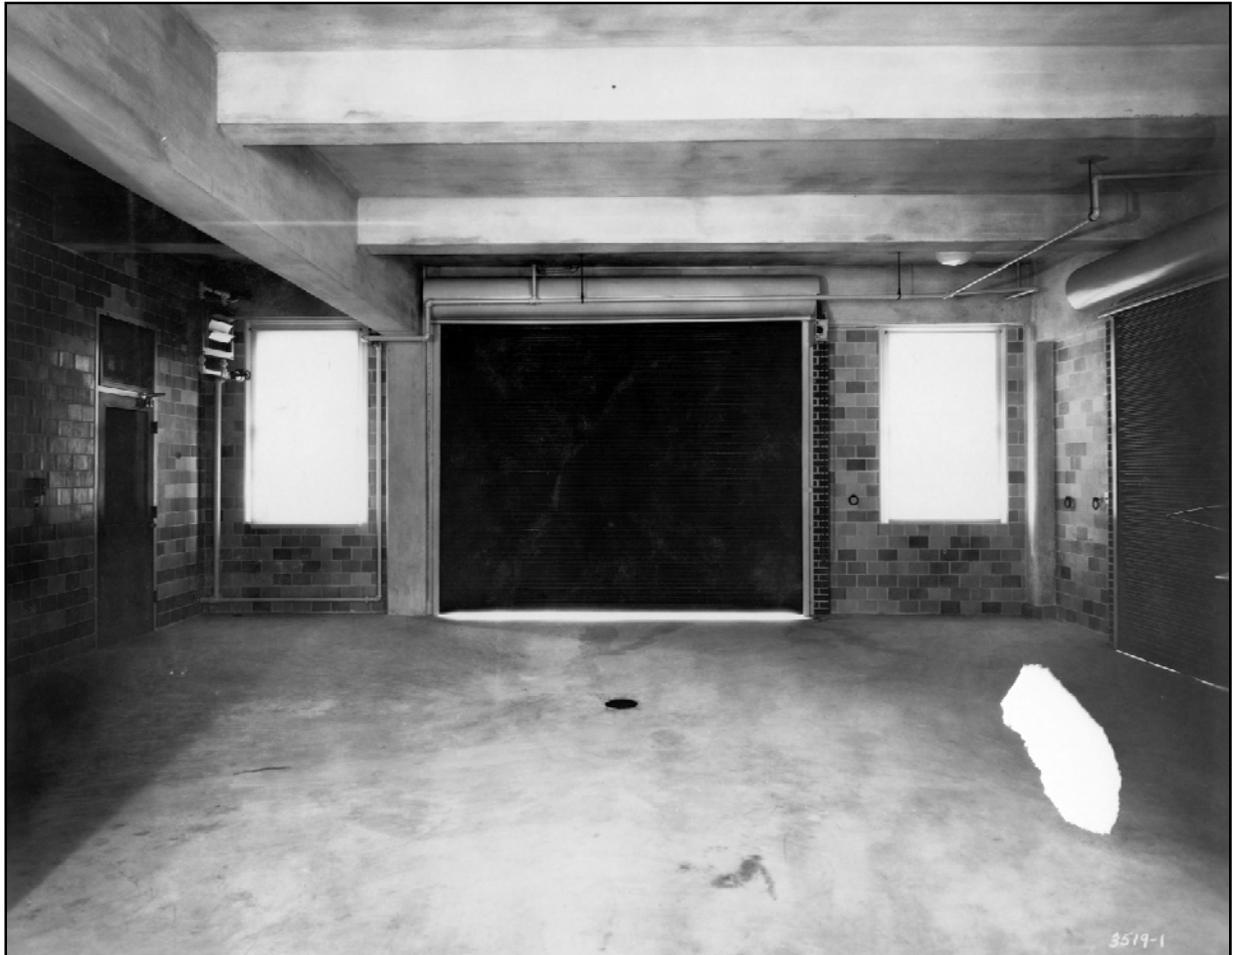
View of dressing room with detail of original rolling door on southeast front wall, facing southwest. Original photograph on file at the National Infantry Museum, Fort Benning Military Reservation, Columbus, Georgia (Folder 1/4/49:Buildings – Veterinary Hospital and Office).

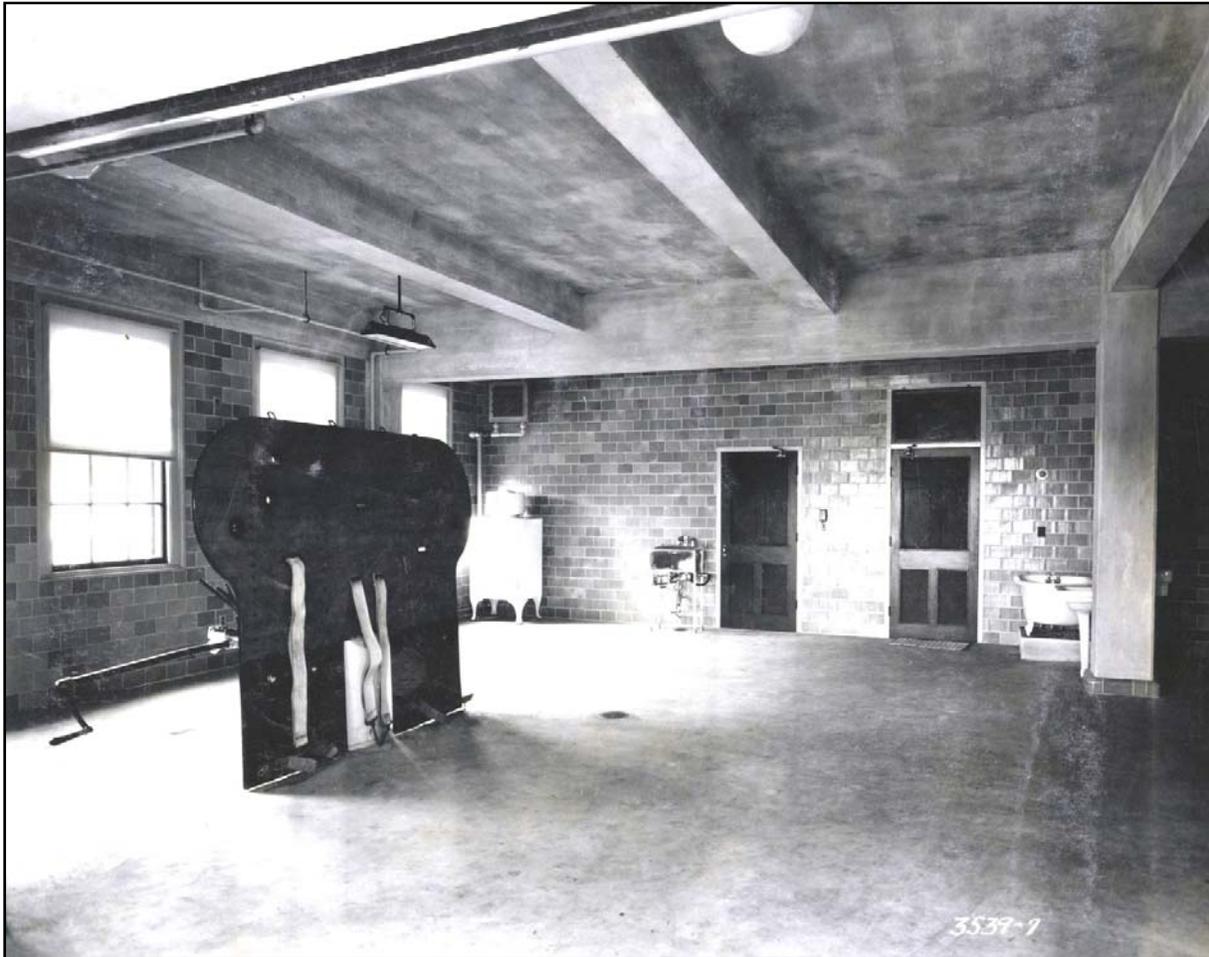
View of operating room, facing north-northeast. Original photograph on file at the National Infantry Museum, Fort Benning Military Reservation, Columbus, Georgia (Folder 1/4/49:Buildings – Veterinary Hospital and Office).

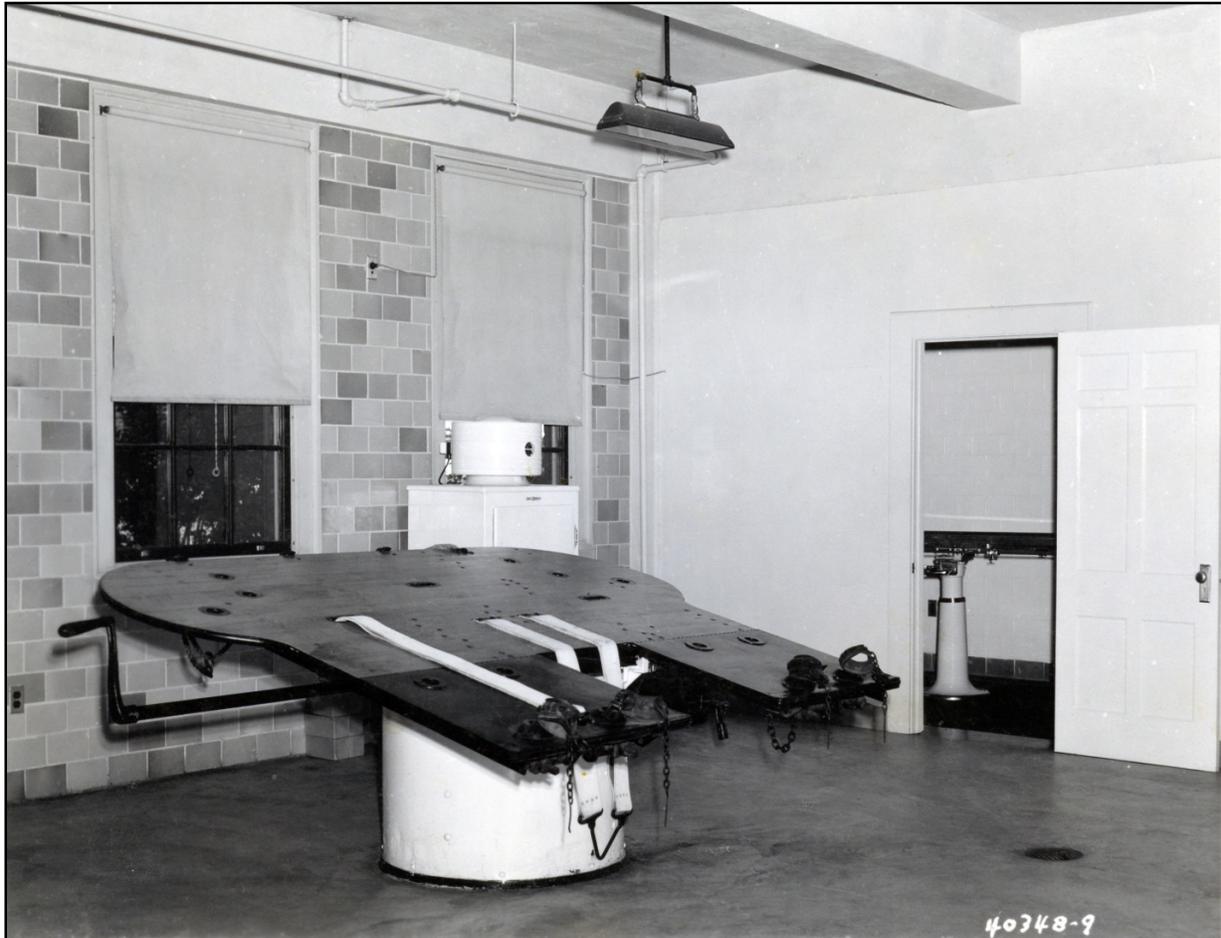
View of operating room with horse operating table, facing north-northeast. Original photograph on file at the National Infantry Museum, Fort Benning Military Reservation, Columbus, Georgia (Folder 1/3/48:Live Stock Area).

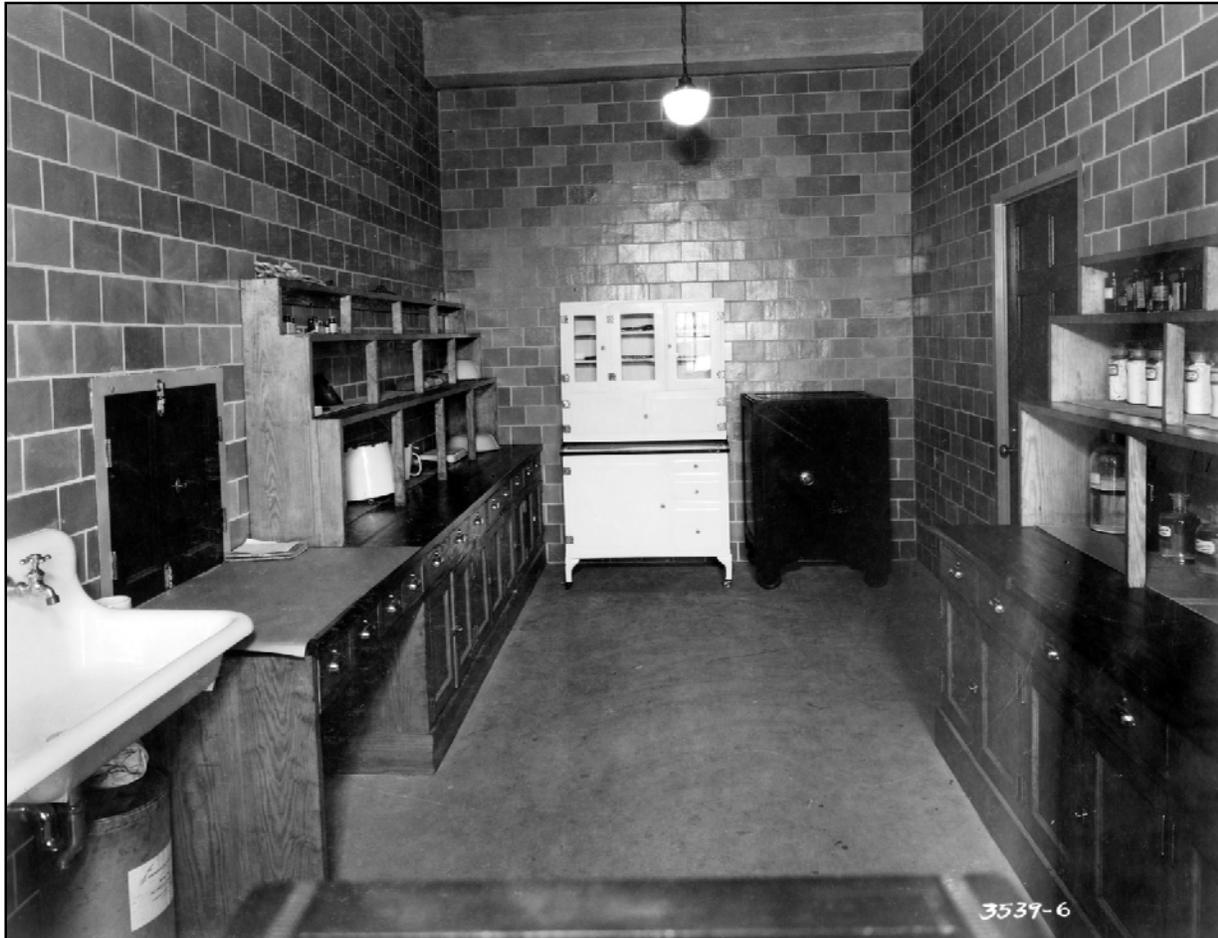
View of pharmacy, facing southwest. Original photograph on file at the National Infantry Museum, Fort Benning Military Reservation, Columbus, Georgia (Folder 1/4/49:Buildings – Veterinary Hospital and Office).

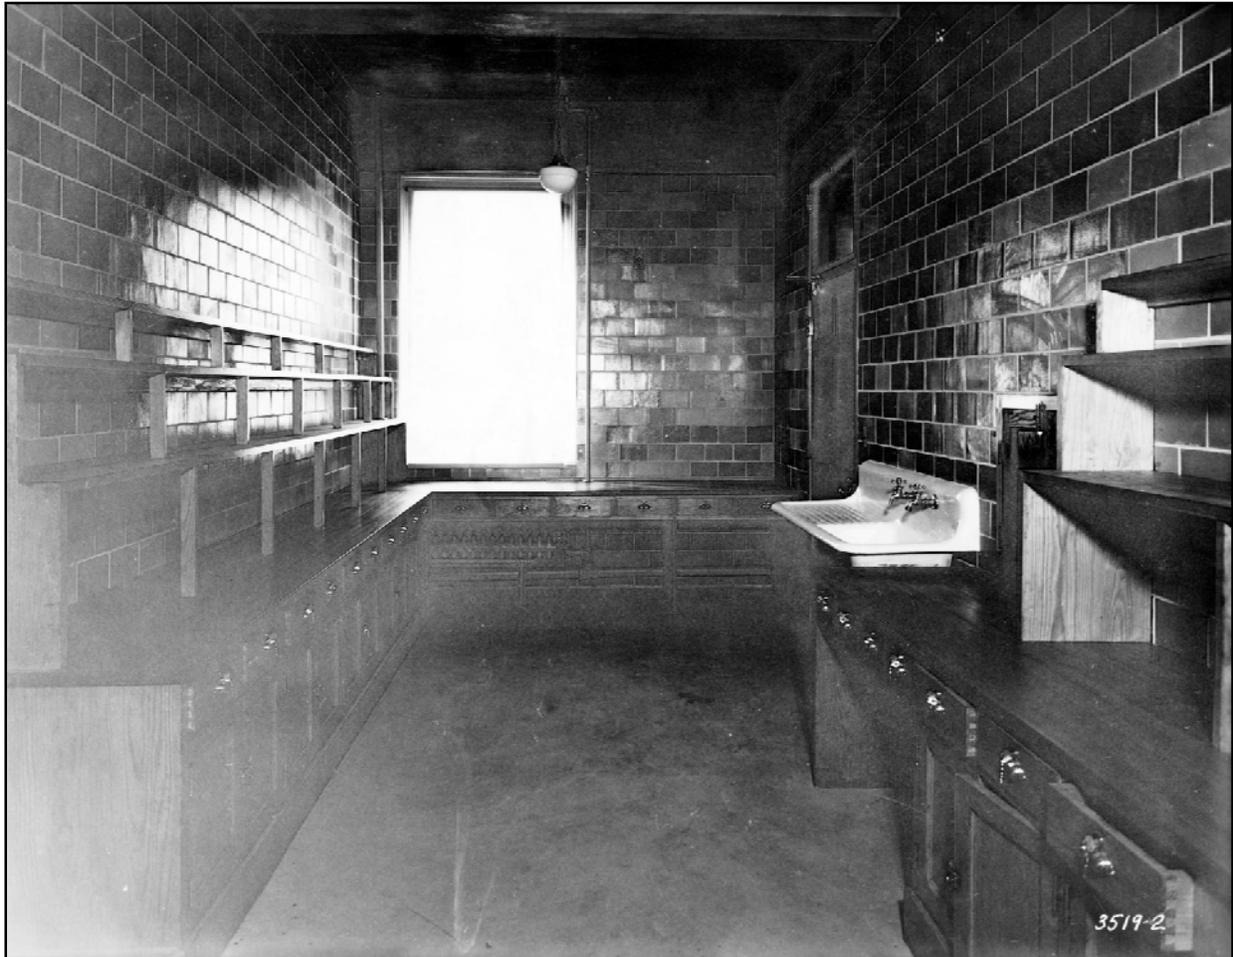
View of pharmacy, facing southwest. Original photograph on file at the National Infantry Museum, Fort Benning Military Reservation, Columbus, Georgia (Folder 1/4/49:Buildings – Veterinary Hospital and Office).

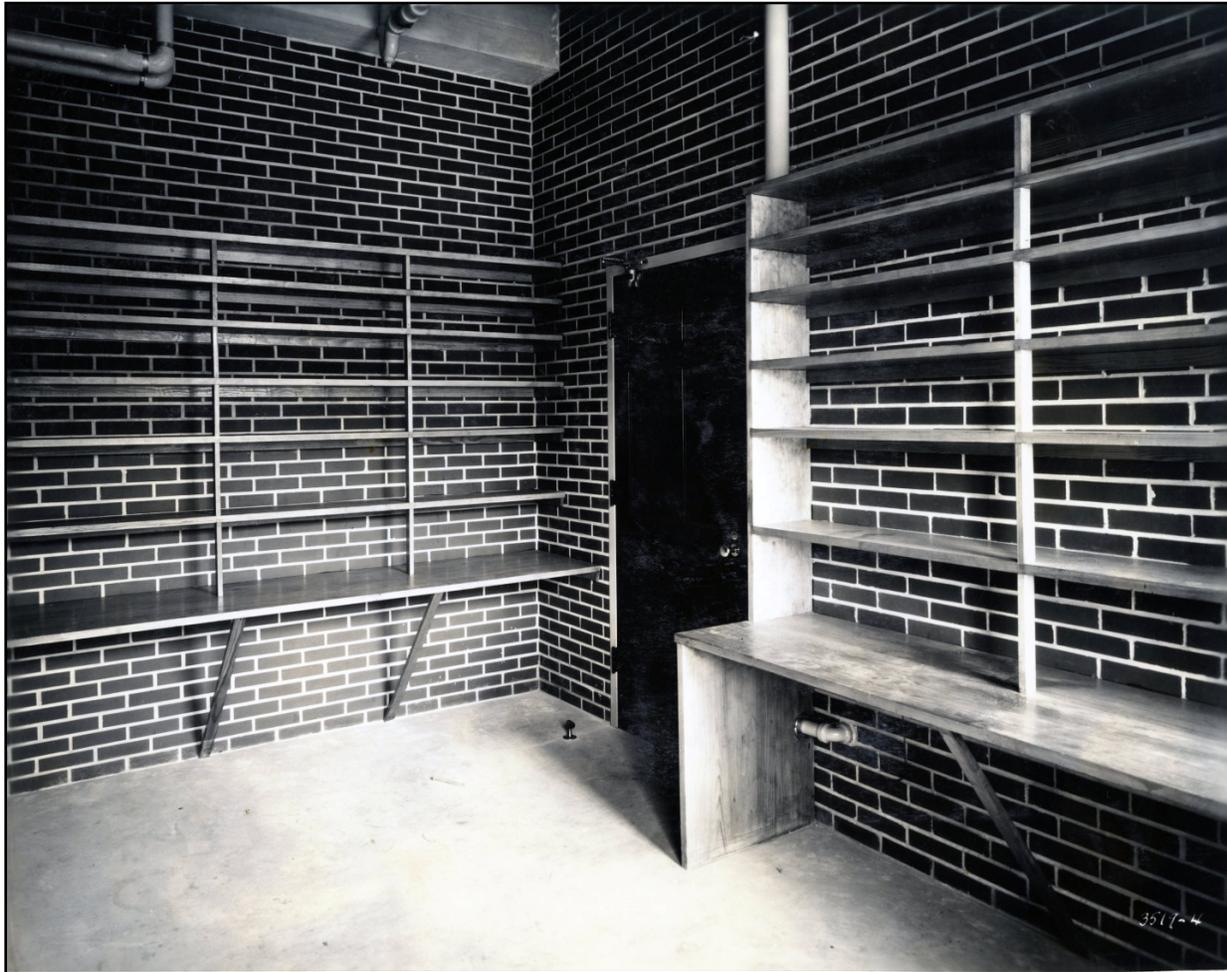
View of original shelving and wall finish. Original photograph on file at the National Infantry Museum, Fort Benning Military Reservation, Columbus, Georgia (Folder 1/4/49:Buildings – Veterinary Hospital and Office).
