GEORGE SPANGERBERGER FARMSTEAD , CHICKEN HOUSE
2012 W. Illinois Ave.
South Hutchinson Vicinity
Reno County
Kansas

HABS No. KS-77-D

GEORGE SPANGERBERGER FARMSTEAD, CHICKEN HOUSE

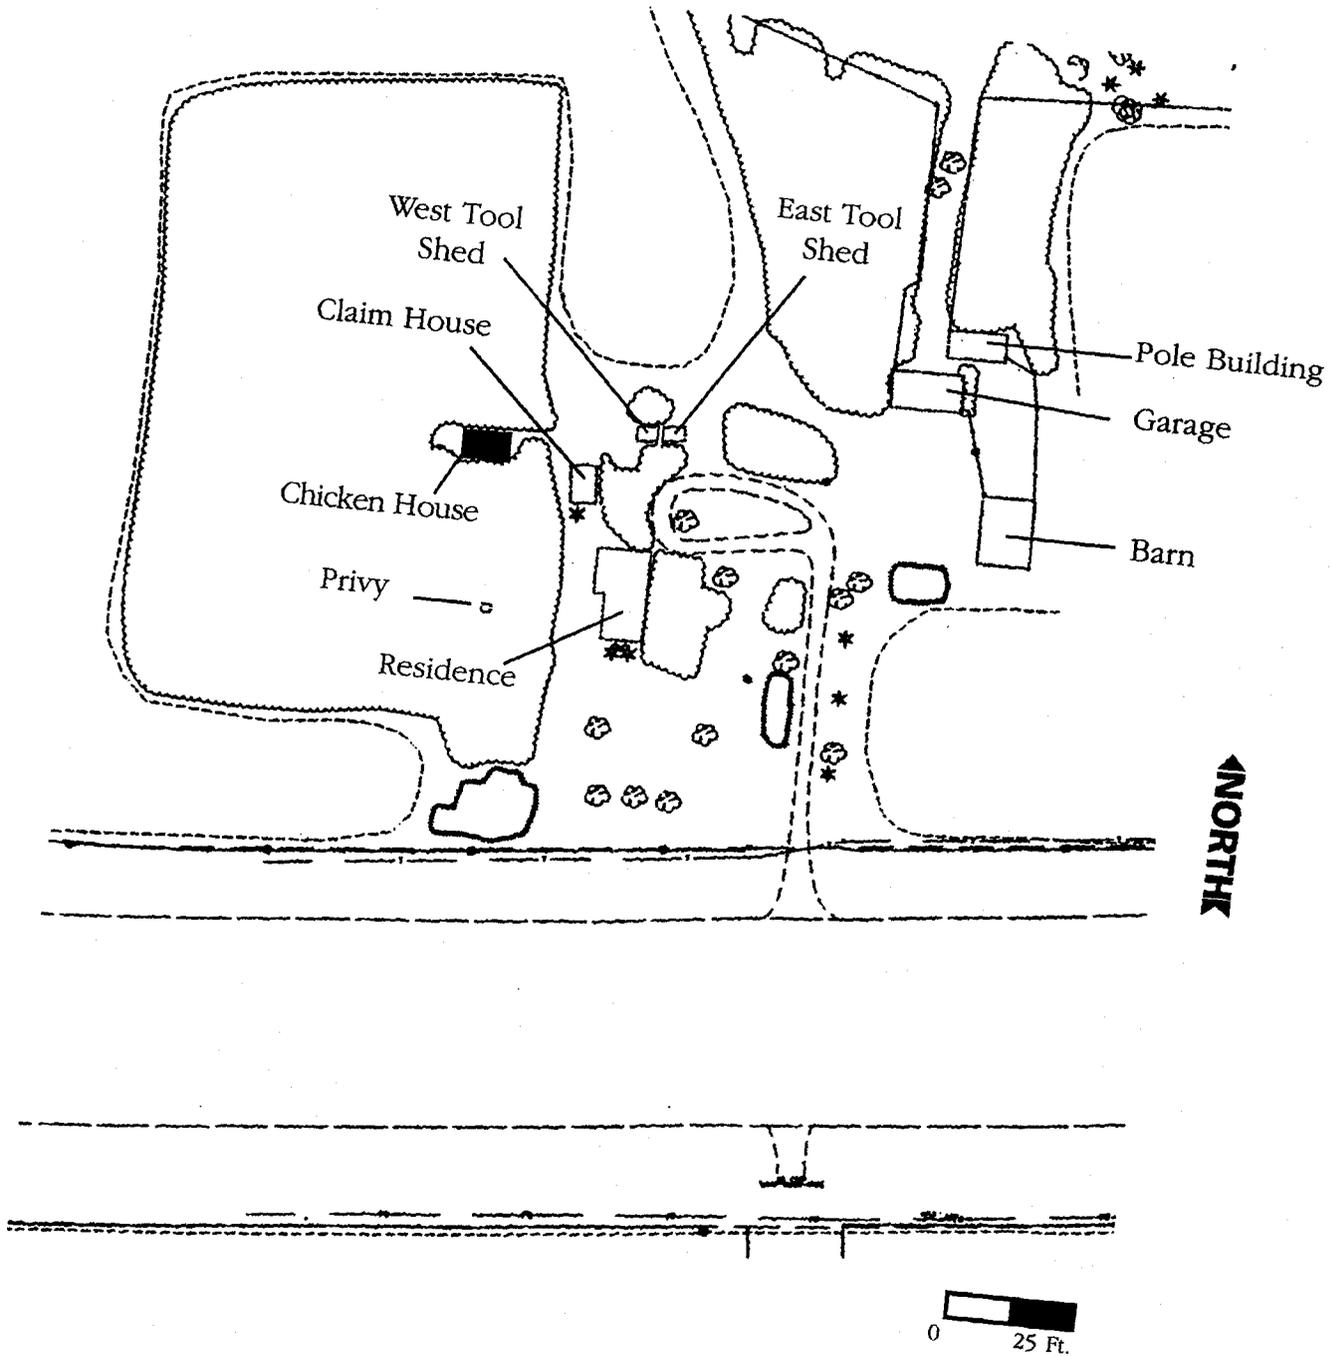
SITE PLAN SHOWING THE LOCATION OF THE
GEORGE SPANGERBERGER FARMSTEAD, CHICKEN HOUSE.

- Description: The George Spangerberger Farmstead chicken house is located 73' northwest of the residence, 34' northwest of the claim house, 28' north of the privy, and 74' southwest of the west tool shed. This rectangular wood building measures approximately 16' x 28', and features an asphalt shingle, asymmetrical gable roof. The walls are constructed of horizontal boards. The exterior of the north wall has been covered with plywood and battens. The building appears to rest directly on the ground surface. The chicken coop has a Z-brace vertical board access door on the east wall near the southeast corner. Two six-light fixed windows remain in the deteriorating south facade. The south side of the chicken house consisted of five bays, one of which was probably a doorway. There are no other doors or windows in the exterior walls. A fenced yard or pen extends south from the chicken house. A picket gate opening is located along the east side of this fenced area adjacent to the southeast corner of the chicken house.

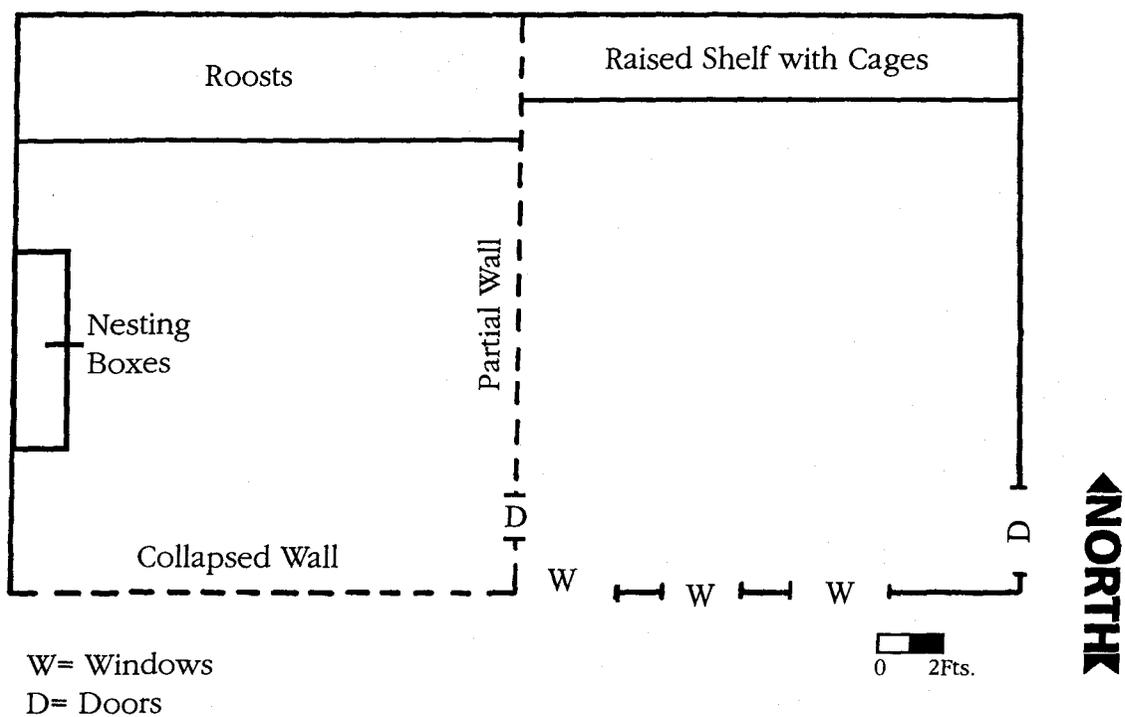
FLOOR PLAN OF THE GEORGE SPANGERBERGER FARMSTEAD, CHICKEN HOUSE.

- The interior of the chicken house is divided into two rooms of approximately equal size by a north-south interior wall. A door way connecting the two rooms is situated near the south end of this interior wall. In the west room two slanted wood roosts are attached to the interior of the north wall and four frame and metal nesting boxes are attached to the west wall in this room. A slanted wood shelf on the north wall of the east room supports a line of wood frame and chicken wire cages. The floors of both rooms are dirt.
