BRASSFIELD DEPOT (Riney-B Depot)
1964 Brassfield Road
Brassfield
Madison County
Kentucky

HABS No. KY-265

WRITTEN HISTORICAL AND DESCRIPTIVE DATA

REDUCED COPIES OF MEASURED DRAWINGS

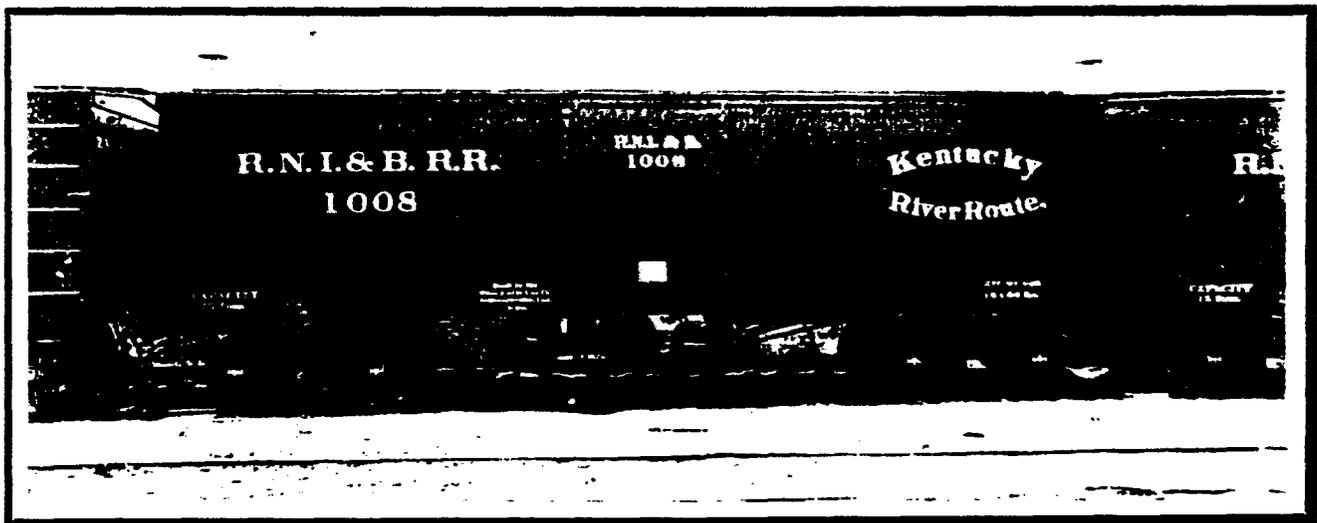
Exhibit A.1: Builder's photograph taken in September, 1890 of Richmond, Nicholasville, Irvine & Beattyville Railroad boxcar #1008 at the Ohio Falls Car Company's manufacturing plant in Jeffersonville, Indiana.

The nickname "Riney-B" is an acronym referring to the initials of the company which originally constructed and operated the railroad, the Richmond, Nicholasville, Irvine & Beattyville Railroad Company. Photographs of rolling stock taken in 1890 show the initials "R.N.I.&B." prominently displayed on the sides of boxcars, stock cars, and other equipment.¹ (See Appendix A, Exhibits A.1 and A.2)

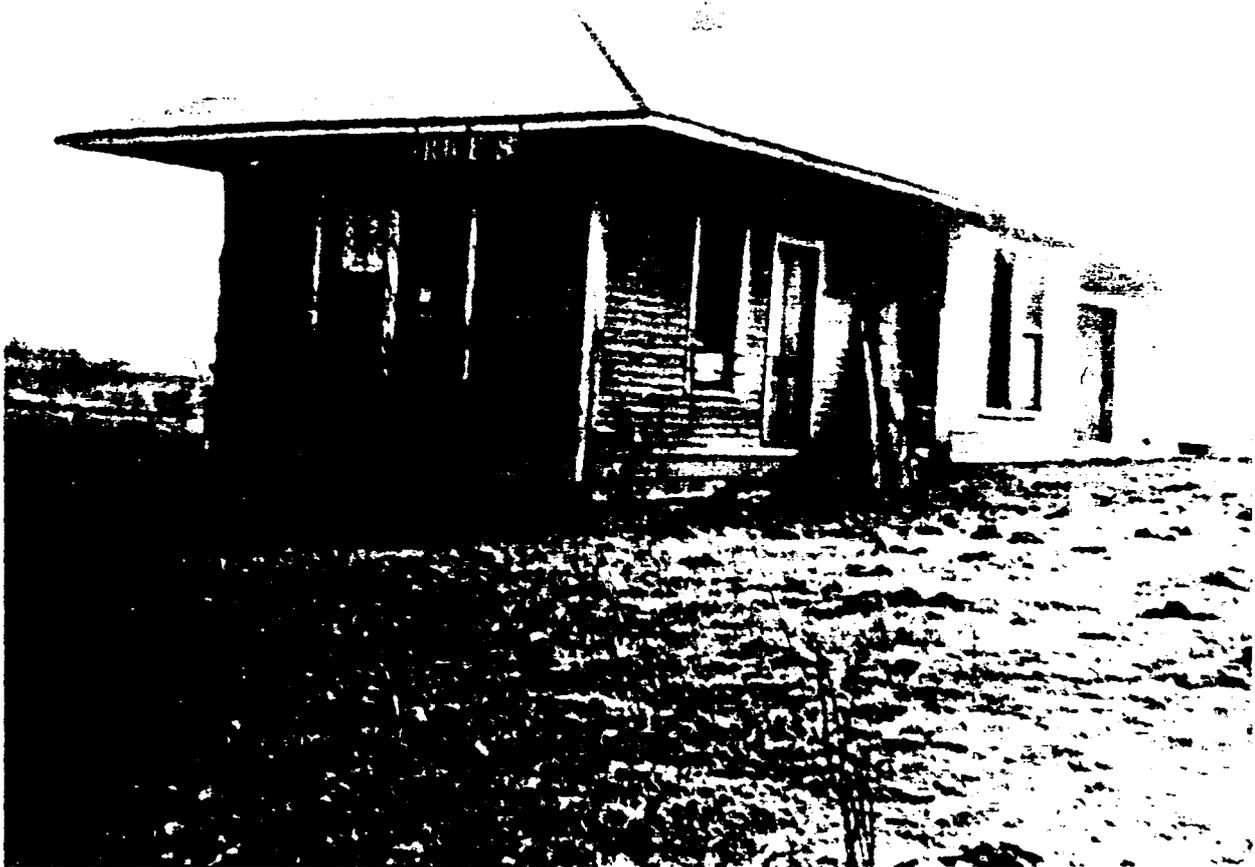
Exhibit A.3: The Rice Station Depot following abandonment in 1932. The depot is virtually identical to the Brassfield and Valley View Depots.

Examination of historical photographs indicates that the Brassfield depot is basically identical to the Rice Station depot, located seven miles to the east on the R.N.I.&B. (See Appendix A. Exhibit A.3) The Valley View depot, the only other remaining station building, is also nearly identical to the Brassfield depot, although the widths vary slightly. Apparently the railroad built "standard" buildings, adjusting the size of the depot to suit the needs of each community and varying minor architectural details to avoid monotony. This was a fairly common practice which reduced the time and cost of construction due to repetition and familiarity, and produced buildings with a strong "family" identity.

Physical evidence indicates that the southern chimney is the only original chimney, located in the wall between the passenger waiting room and the agent's office. This is supported by historical photographs of the Rice Station Depot which show a single chimney in the same location. (See Appendix A, Exhibit A.3) The south chimney is constructed of red brick, supported on a small stone foundation, and is in fair condition, probably due to high brick and mortar quality. The ridge tile project in either direction from this chimney and all of the roof tiles and flashings are neatly executed. In the attic, the spacing of the roof trusses has been adjusted to allow penetration of the chimney. Stove thimbles in the passenger waiting room and agent's office indicate the original locations of the two stoves that provided heat for the depot.

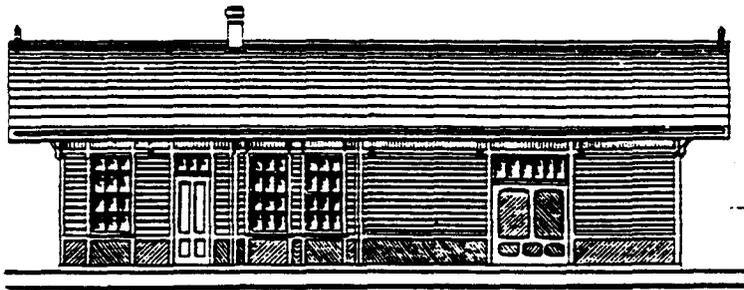
FIG. 425.—FRONT ELEVATION, CLASS "E."

Exhibit B.1: Front Elevation, End Elevation, Cross Section, and Ground Plan of a "Class E" combination depot as constructed by the Minnesota & Northwestern Railroad and illustrated in 1893.

The Brassfield Depot bears a striking resemblance to a combination depot illustrated in *Buildings and Structures of American Railroads*, a standard reference work published in serial form in the *Railroad Gazette* in 1891, and later released as a book in 1893.⁸ (See Appendix B, Exhibit B.1)

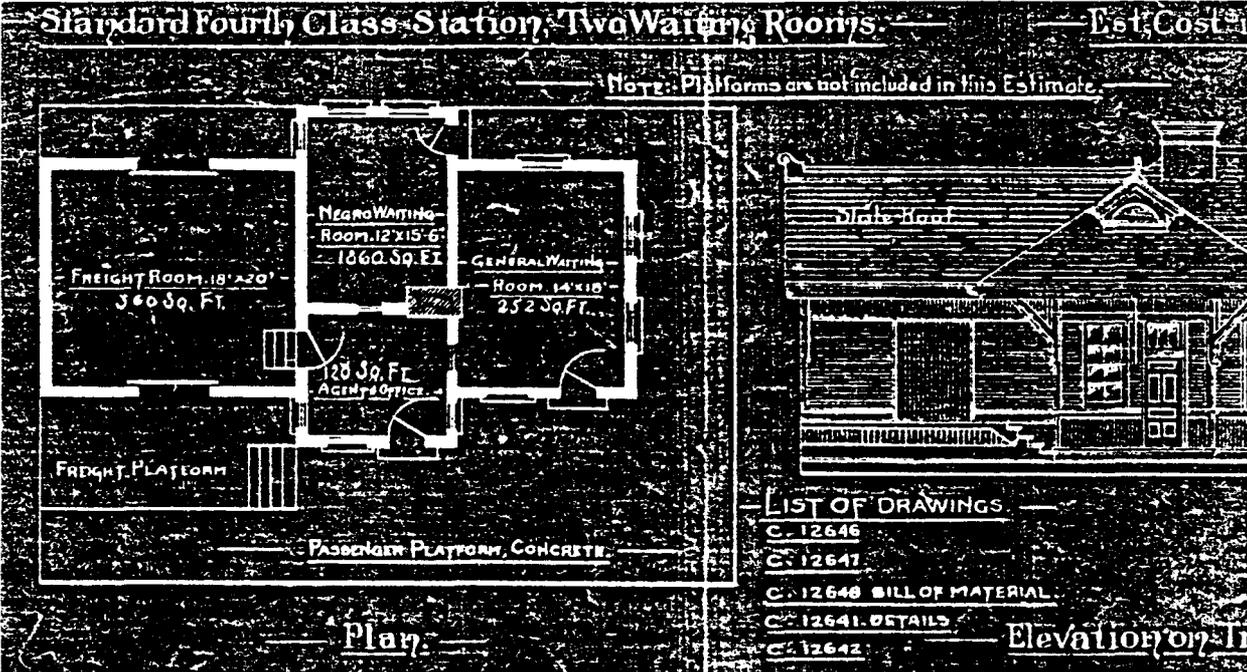
Exhibit B.2: Plan and Elevation on Track of a Standard Fourth Class Station as constructed by the Louisville & Nashville Railroad in 1911.

It can be said for certain that the Brassfield Depot is not a replacement depot designed and constructed by the Louisville & Nashville Railroad, which purchased the line in 1909 and began operation in 1910. As early as the mid-1890s the Louisville & Nashville adopted standard designs for all buildings. Drawings of the Hopkinsville and Owensboro, Kentucky depots published in 1893, as well as the Richmond, Kentucky depot published in 1895, all indicate adherence to a standard set of architectural details and forms.^{10,11} A comparison between the Louisville & Nashville's standards as published in 1911, and the Brassfield Depot clearly indicates that the Brassfield Depot is not a Louisville & Nashville structure.¹² (See Appendix B, Exhibit B.2) The Versailles Depot, built by the Louisville & Nashville in 1912 and one of the few depots built along the line after the Louisville & Atlantic was purchased in 1909, rigidly adheres to these standards.
