Marine Biological Laboratory, Supply Building HABS No. MA-1251-A
111 Water Street
Marine Biological Laboratory
~~Weeds Hole~~/Falmouth
Barnstable County
Massachusetts

HISTORIC AMERICAN BUILDINGS SURVEY

MARINE BIOLOGICAL LABORATORY,
Supply Building

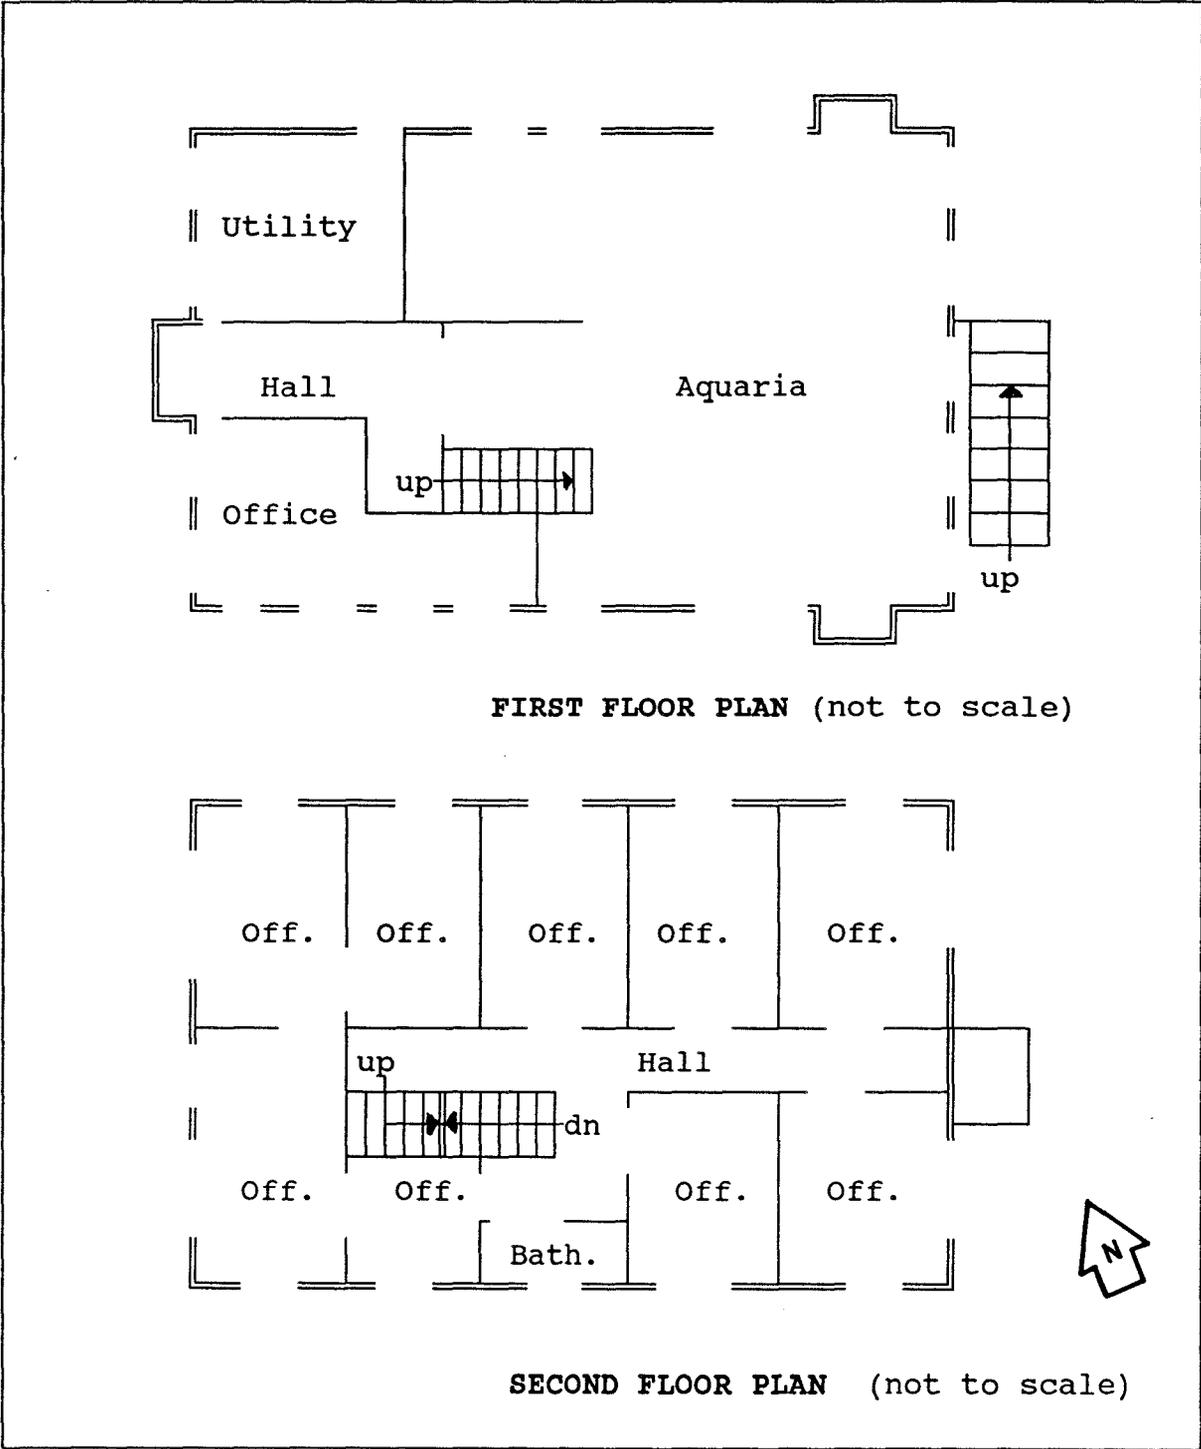
Floor Plan Sketches

1. Floor plans: The first floor has an irregular floor plan encompassing aquaria, laboratory, and utilities rooms. The second floor has a central hall flanked with offices. Please refer to sketch plans.
