THOMAS FARM, HOUSE  
(Araby)  
Monocacy National Battlefield  
4632 Araby Church Road  
Frederick  
Frederick County  
Maryland

### THOMAS FARM, HOUSE (Araby)

HABS No. MD-1251-A

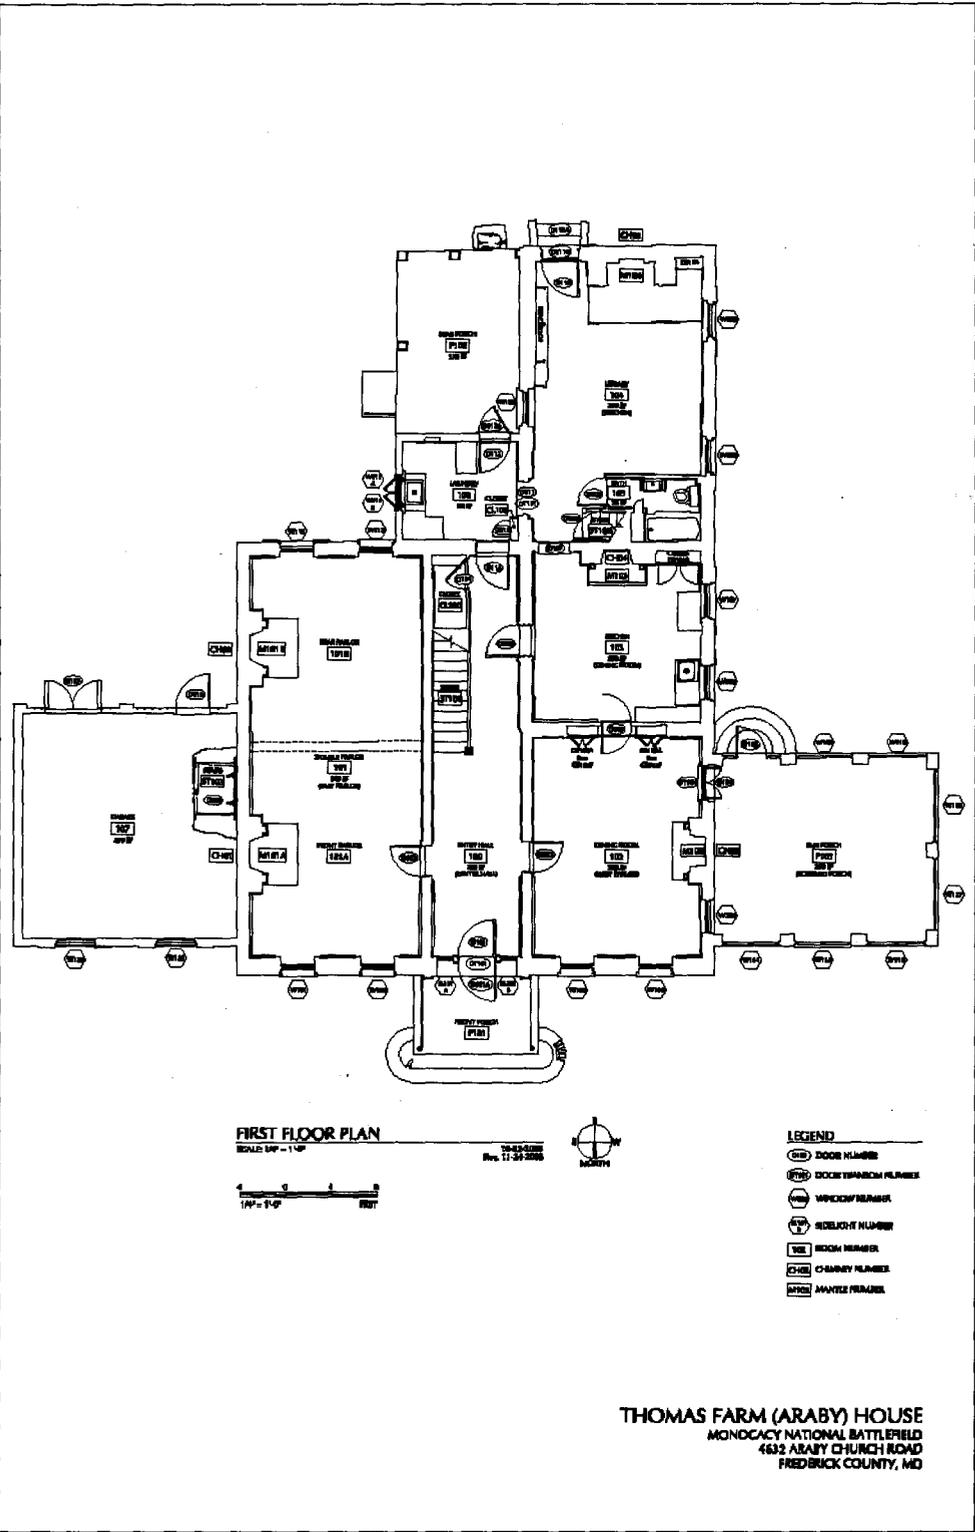
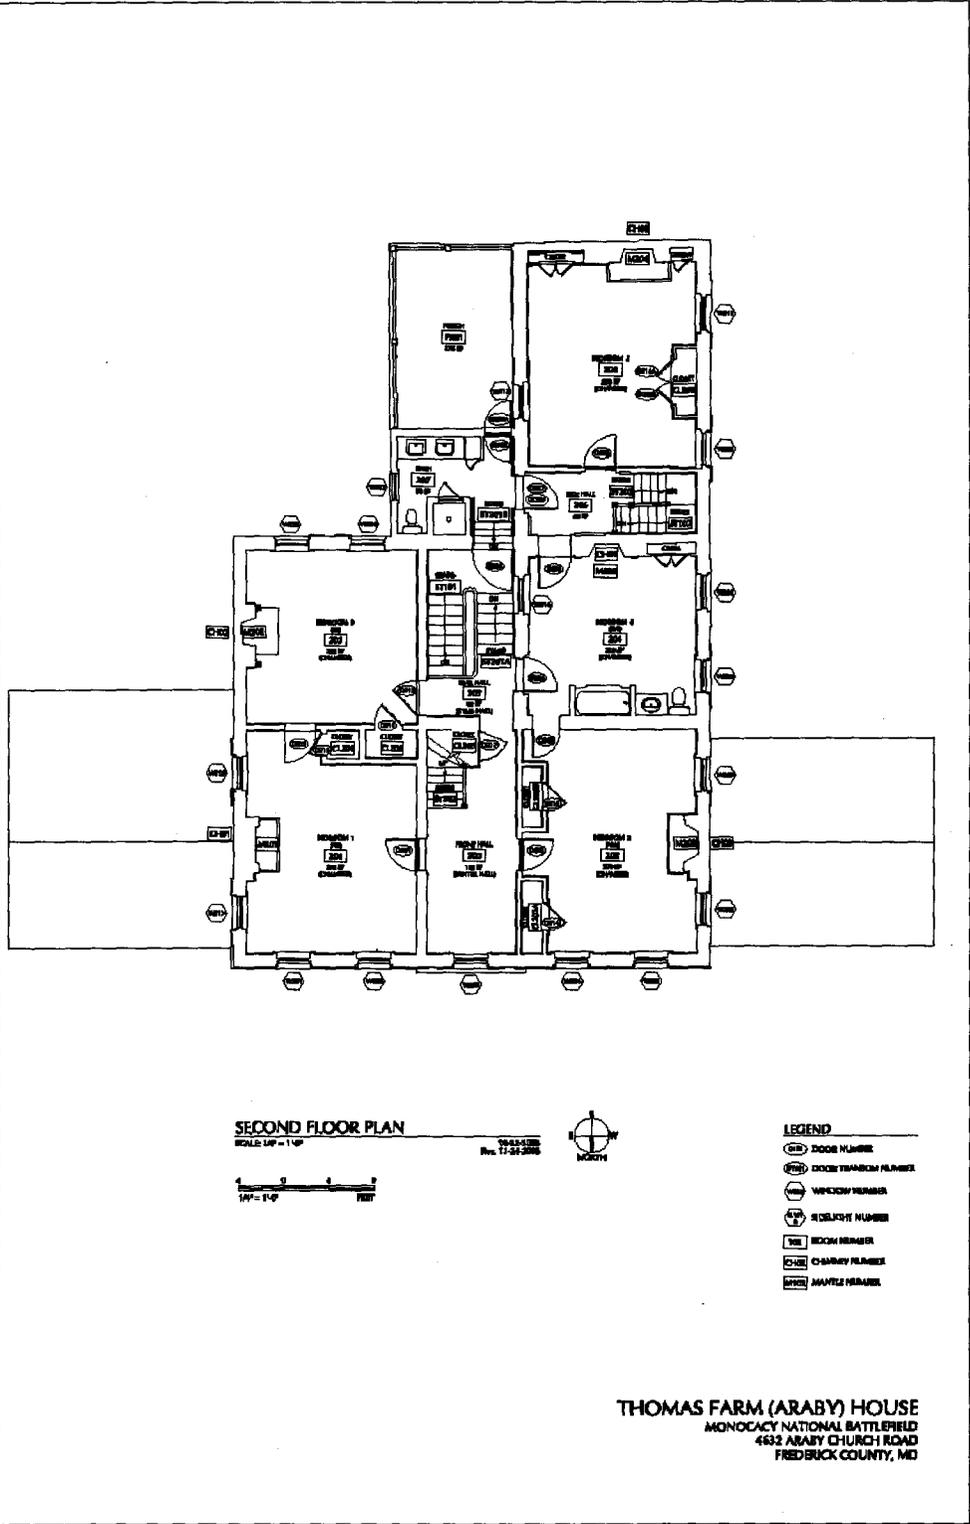
Drawings depicting the floor plans of the Thomas House with the rooms, windows, doors and fireplaces identified by number for the purposes of the HSR and referenced throughout the above text.

**Note:** Room, window, door, and fireplace numbering in this report corresponds to that in the HSR. Floor plans adapted from the HABS drawings and including those numerical notations are appended to this report.
