Nevada Test Site, Environmental  
Protection Agency Farm  
(Public Health Service Laboratory,  
Experimental Farm)  
Area 15, Yucca Flat, 10-2 Road near Circle Road  
Mercury Vicinity  
Nye County  
Nevada

HABS No. NV-28

## HISTORIC AMERICAN BUILDINGS SURVEY

### NEVADA TEST SITE, ENVIRONMENTAL PROTECTION AGENCY FARM

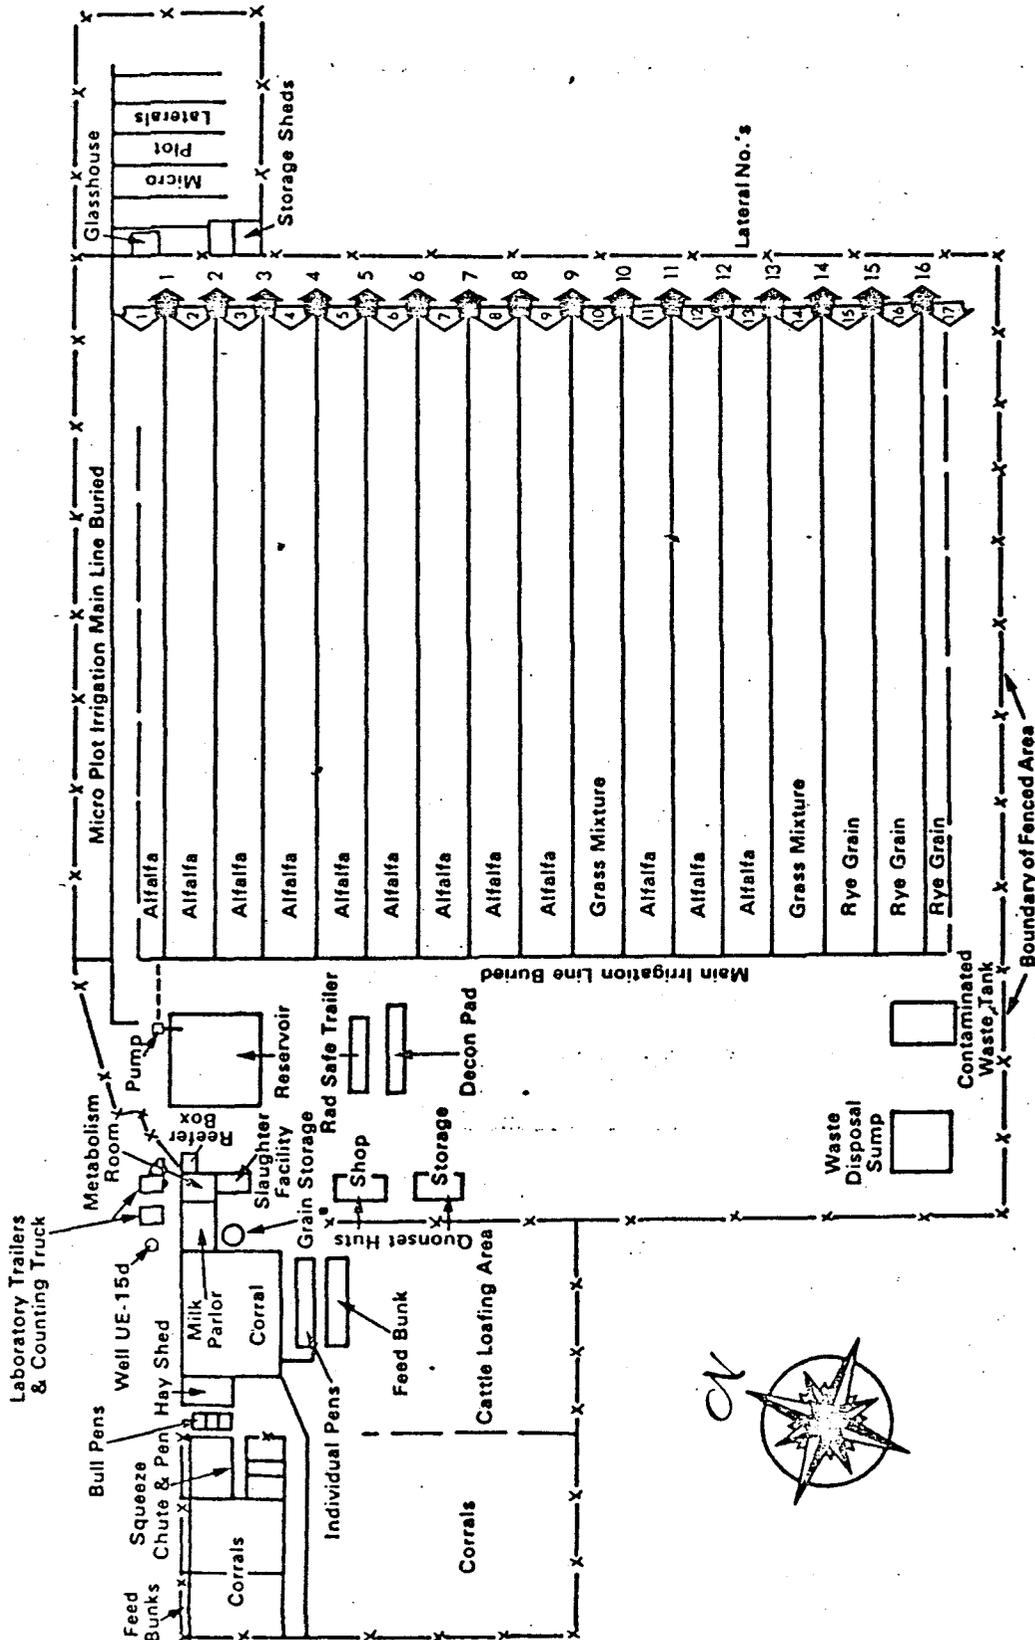
Figure 3. Layout of the EPA Farm on the Nevada Test Site.

1. Date of construction: Design and construction of the EPA Farm began in the spring of 1964 (Daley and Smith 1969:1). Thirty acres (12 hectares) were cleared near Well 15d for the project. This area was selected because of its water supply, and also because of its location downwind from weapons tests and reactor releases (USPHS n.d.). The power and water systems were installed which involved extending the existing power lines, digging a million-gallon (3,785,300 liter) reservoir, and laying irrigation lines. That fall, scientists planted 16 acres (6.5 hectares) of forage crops, mostly alfalfa. During the spring of 1966, the main laboratory/dairy building (Building 15-06) was completed. Subsequently, at least 11 structures were added (which still stand today) including a small greenhouse (aka glasshouse), a double storage shed, two silos (for grain storage), two quonset huts, four shelters (three single and one double) and a guyed, skeletal steel weather tower. The dates that these were added is unknown but some documentation indicates all were in place by the time Building 15-06 was modified to include a slaughter facility. That wing was added in 1973. In addition, temporary structures included a horse trailer beneath the double roof shelter and a small mobile-home structure that served as the Rad-Safe trailer. Other features include a rad-waste sump, rad-waste tank, and holding pens. A hay shed was located west of Building 15-06 but only the poles remain today. Figures 1 and 2 provide location information. Figure 3 provides a site layout.

5. Original plans and construction: Site 26NY8441, the EPA Farm, is a roughly "T-shaped" area of 30 acres, spreading down an alluvial fan of gravelly, sandy loam, bounded at the north, east and west by 7,000-foot (2,134-meter) peaks. The average elevation of the site is 4,580 feet (1,395 meters) and the average land slope is 2-4 percent to the southeast (Daley and Smith 1969:1). The northwest portion of the site contains the main structures--milking, laboratory and slaughter facility, shop, storage and silos-- as well as corrals, pens, shelters and other features for handling and containing cattle. A 1,000,000 gallon reservoir is centered along the northern border of the site, while the crop areas are to the east. These consisted of 16 acres of forage crops and 5 acres (2 hectares) of micro plots. A small parking lot is adjacent to the laboratory.

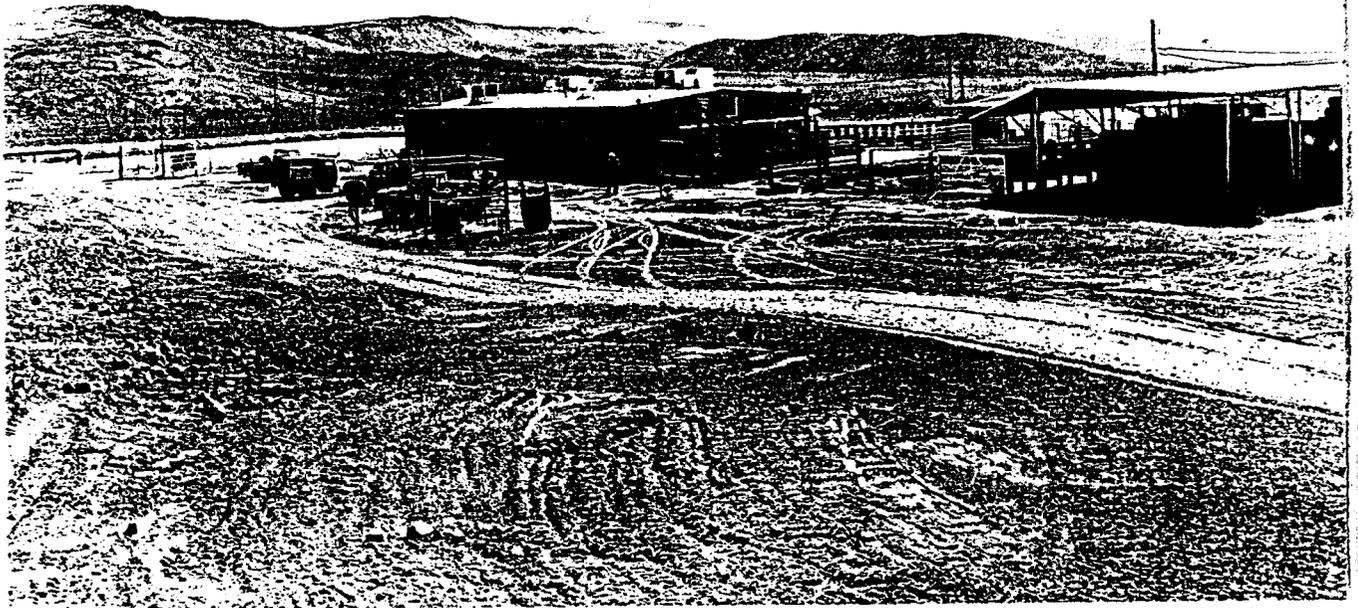
Picture No. 2  
EPA Photograph Archives  
No. 304-9-21-66-BIO

Overview of Building 15-06

1. Overall dimensions:
  - a. Building 15-06 is actually two separate buildings joined together. Both sections appear to be manufactured metal buildings clad with ribbed steel siding with a baked-on finish. Some interior rooms were inaccessible due to safety concerns over potential radioactive contamination, but these can be described from photographs and drawings. The larger, older east-west portion of the L-shaped building has a shallow gable with sliding doors. The western end served as a milking parlor and contains a milker's work pit, milking stalls, and a milk room. Laboratory facilities (now contaminated) storage, and toilet and shower facilities are also located in this older portion of the building. The north-south wing is taller and has an overhead rolling metal door on the south end and protruding hoists. This 1973 addition consists of an abattoir and a "hot" slaughter room, presumably for the slaughter of contaminated animals. These two spaces have suspended acoustical ceilings, fluorescent lighting, concrete floors, and gypsum board walls. Building 15-06 stands at the center of the EPA Farm's northern boundary. A concrete apron extends to the south and west, and a silo is centered on the southern portion of the apron. Remnants of holding areas, in poor condition, stand to the west of the structure; a parking area lies to the north, and the dry reservoir lies to the east.

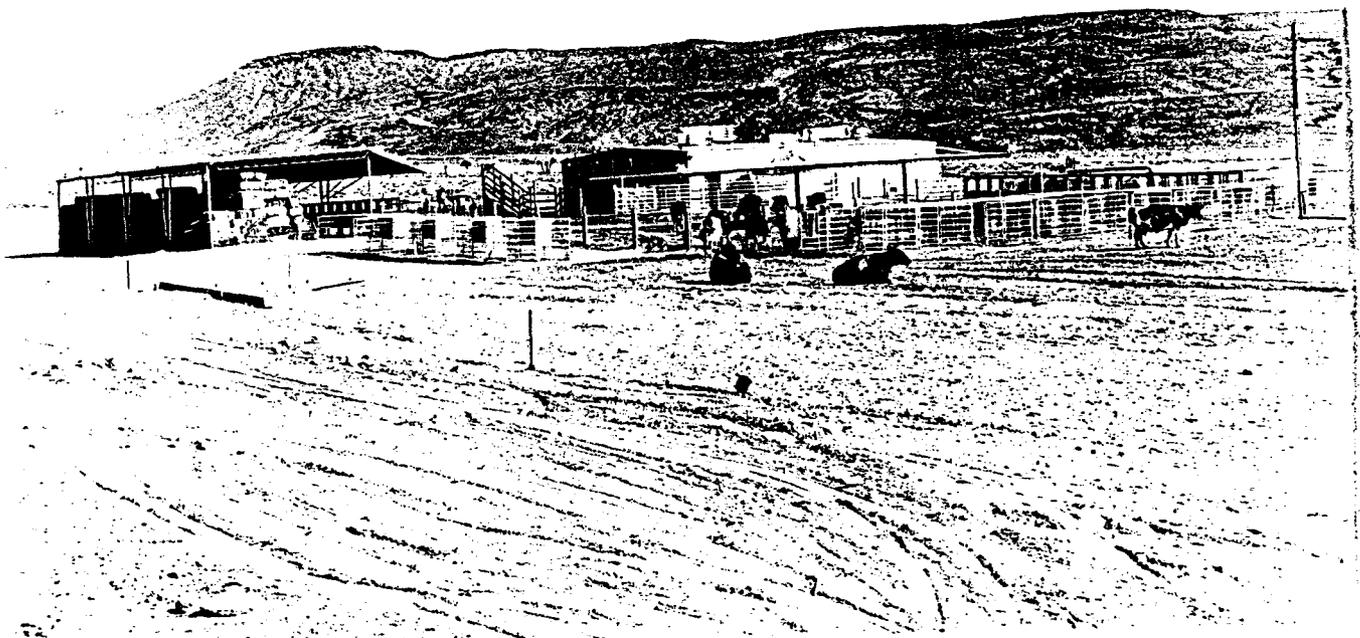
Picture No. 3  
EPA Photographic Archives  
No. 290-9-21-66-BIO

Overview of Building 15-06

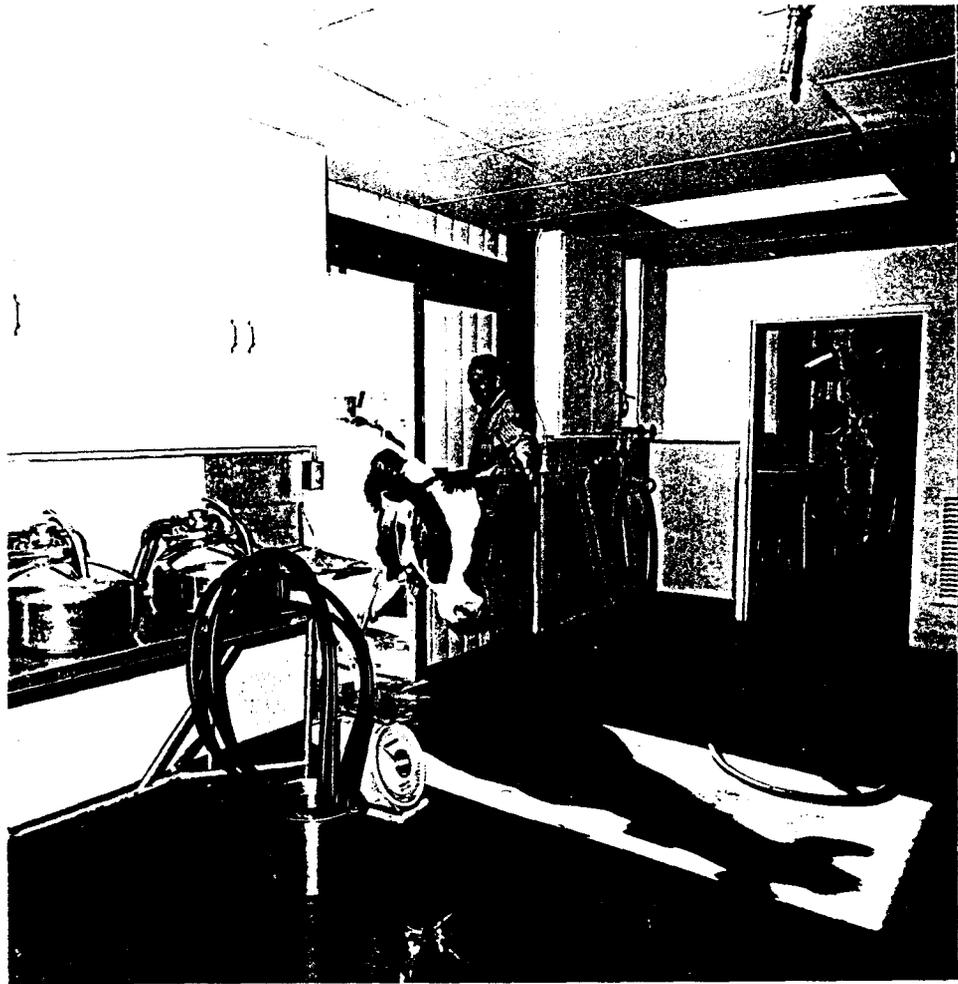
Picture No. 4  
EPA Photographic Archives  
No. 151-4-24-69-BIO-A

Interior of Building 15-06, View: North-Northwest  
1969

1. Floor plans:
  - a. Basements: None.
  - b. First floor: Building 15-06 is divided into 10 rooms and one corridor by skeletal wood frame walls sheathed in gypsum wall board. The walls separating the hot slaughter area are more elaborate (see above description). The quonsets, storage shed, greenhouse and silos have no divisions. It is unknown whether or not the interior of the Rad-Safe trailer is divided.

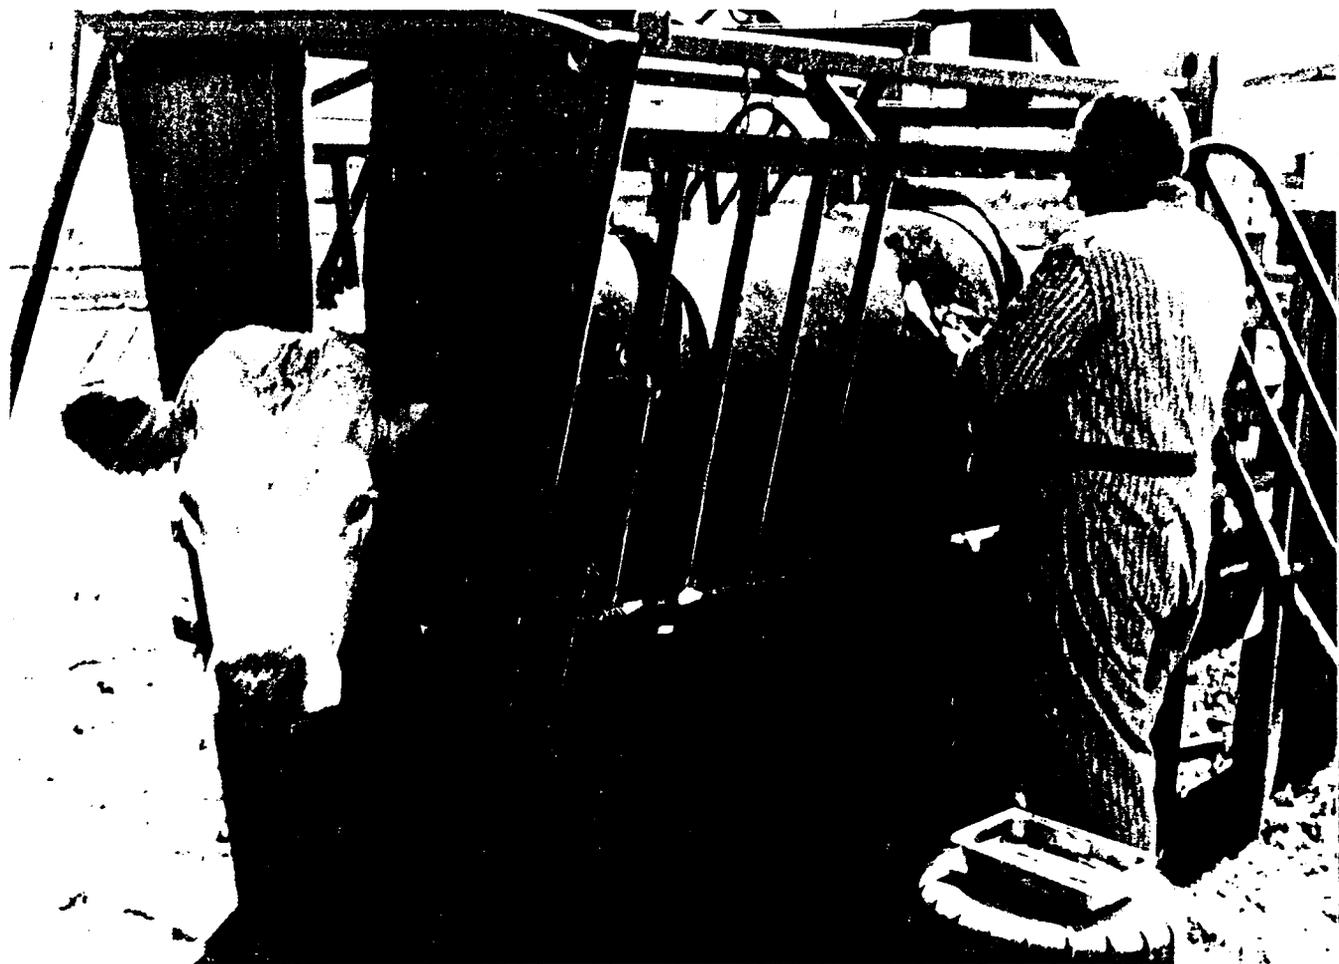
Picture No. 5  
EPA Photographic Archives  
No. 234C-8-13-70-BIO

Cow in cow holder

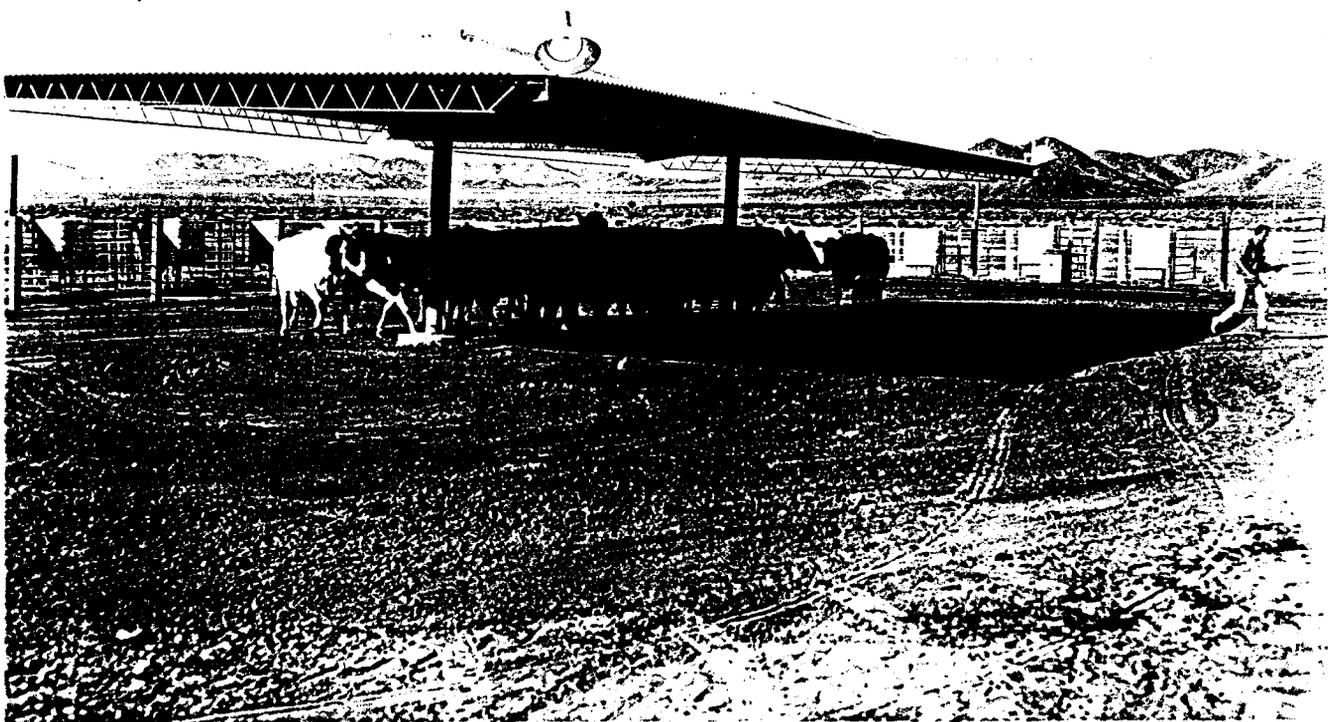
Picture No. 8  
EPA Photographic Archives  
No. 289-9-21-66-BIO

Cows under double shelter

- f. There are three single and one double shelter units, all of which are located in the former corral area. Each unit is a 25-foot (7.6-meter) square module constructed in 1965; the modules consist of a corrugated metal roof on metal beams supported on a central, cylindrical square pole. The structural members for the double unit are open-web truss joists, and those for the single units are solid-steel I beams.

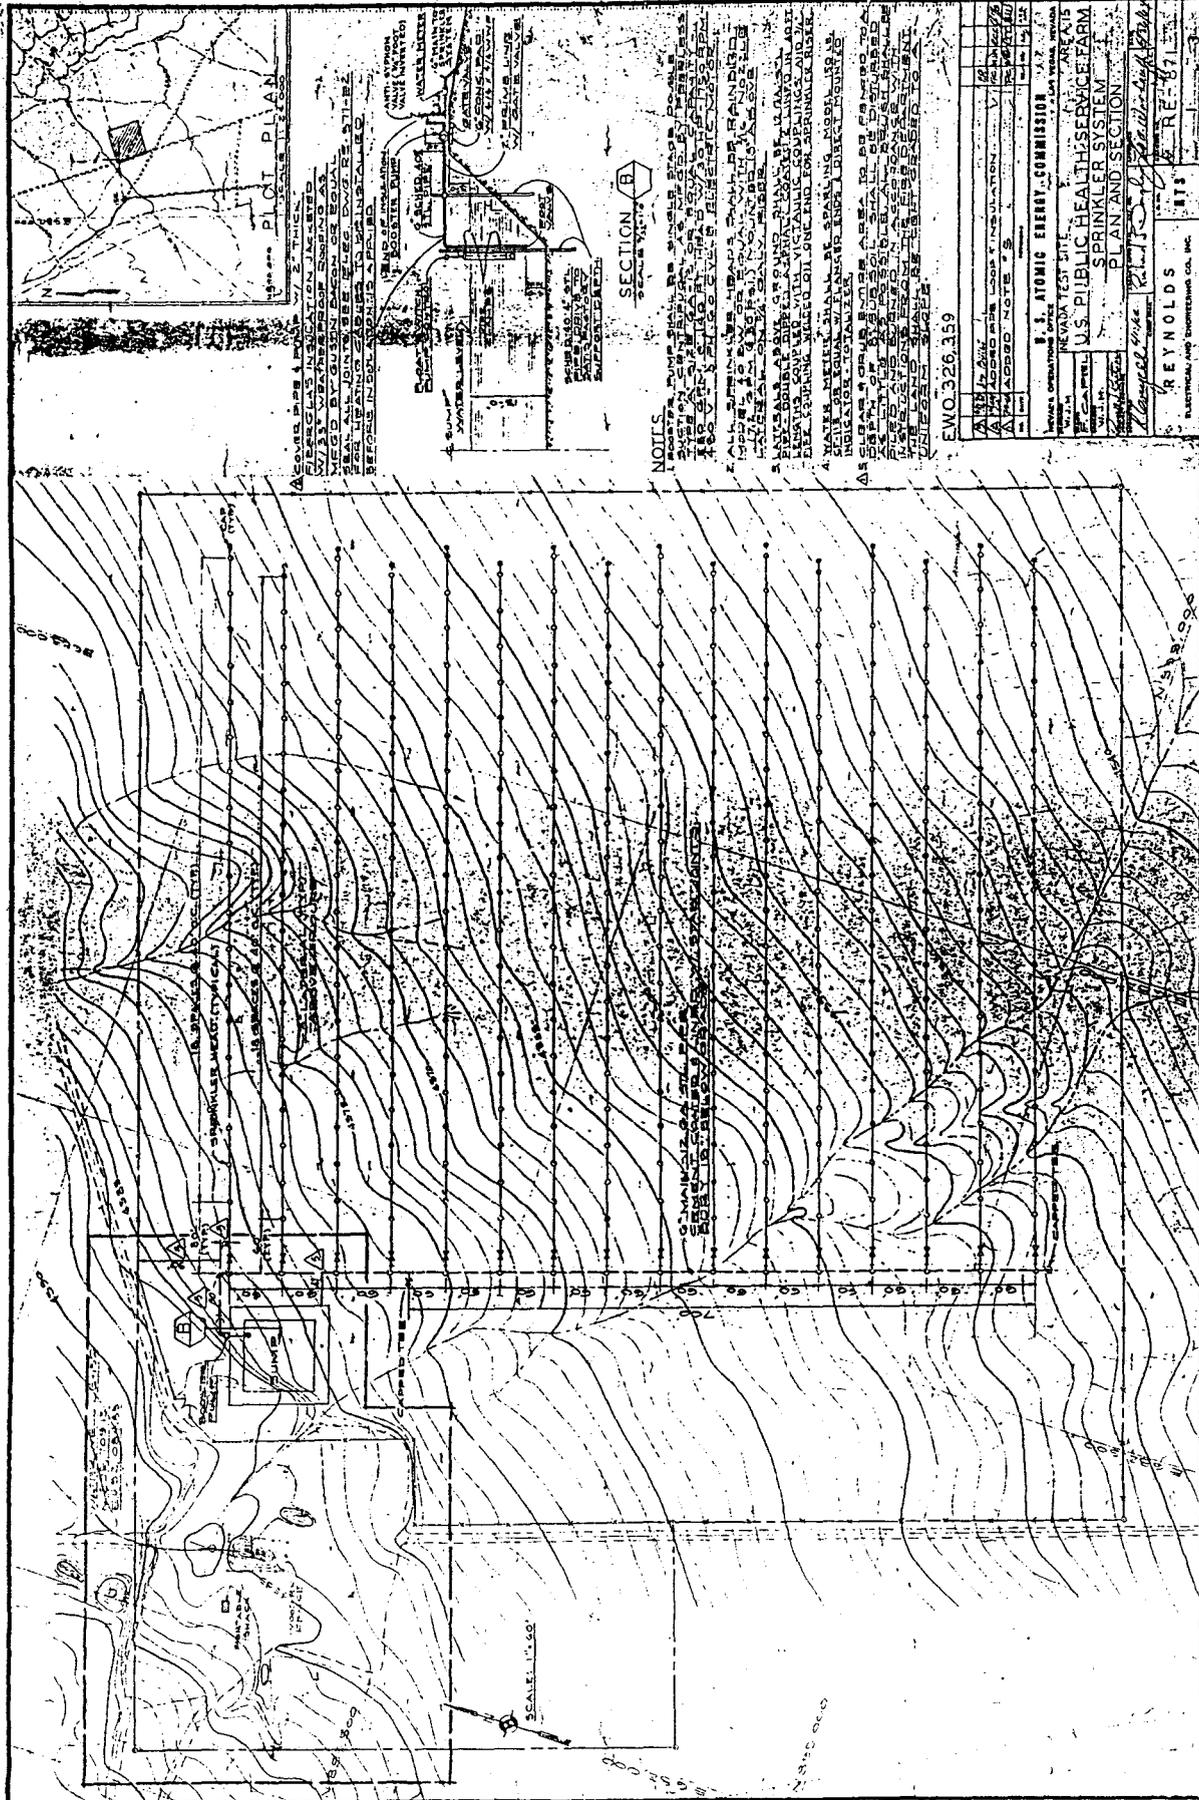
**PLOT PLAN**

Plot plan of EPA Farm featuring irrigation system.

The irrigation system consists of the 5,400-foot-deep (1,646-meter-deep) Well UE-15d, a 1,000,000-gallon reservoir, and a sprinkler system. The well is located to the north of the main building. Water was pumped at 200 gallons (757 liters) per minute, then stored in the now-dry 1,000,000 gallon reservoir, located east of the main building. The reservoir is approximately

The sprinkler lines extend from the reservoir pump east to the growing areas. Initially, the water lines consisted of 960 linear feet (293 linear meters) of 5-inch (12.7-centimeters) aluminum main line, 12,800 linear feet (3,901 linear meters) of 3-inch (7.6-centimeters) aluminum lateral line, and 256 sprinkler heads. This equipment serviced the main 16-acre forage-growing area. The main line runs from the storage pond to the northwest corner of the plot, and then south to the southwest corner. Sixteen lateral lines extend east. The system extends to the microplot area at the northeast corner of the EPA Farm.

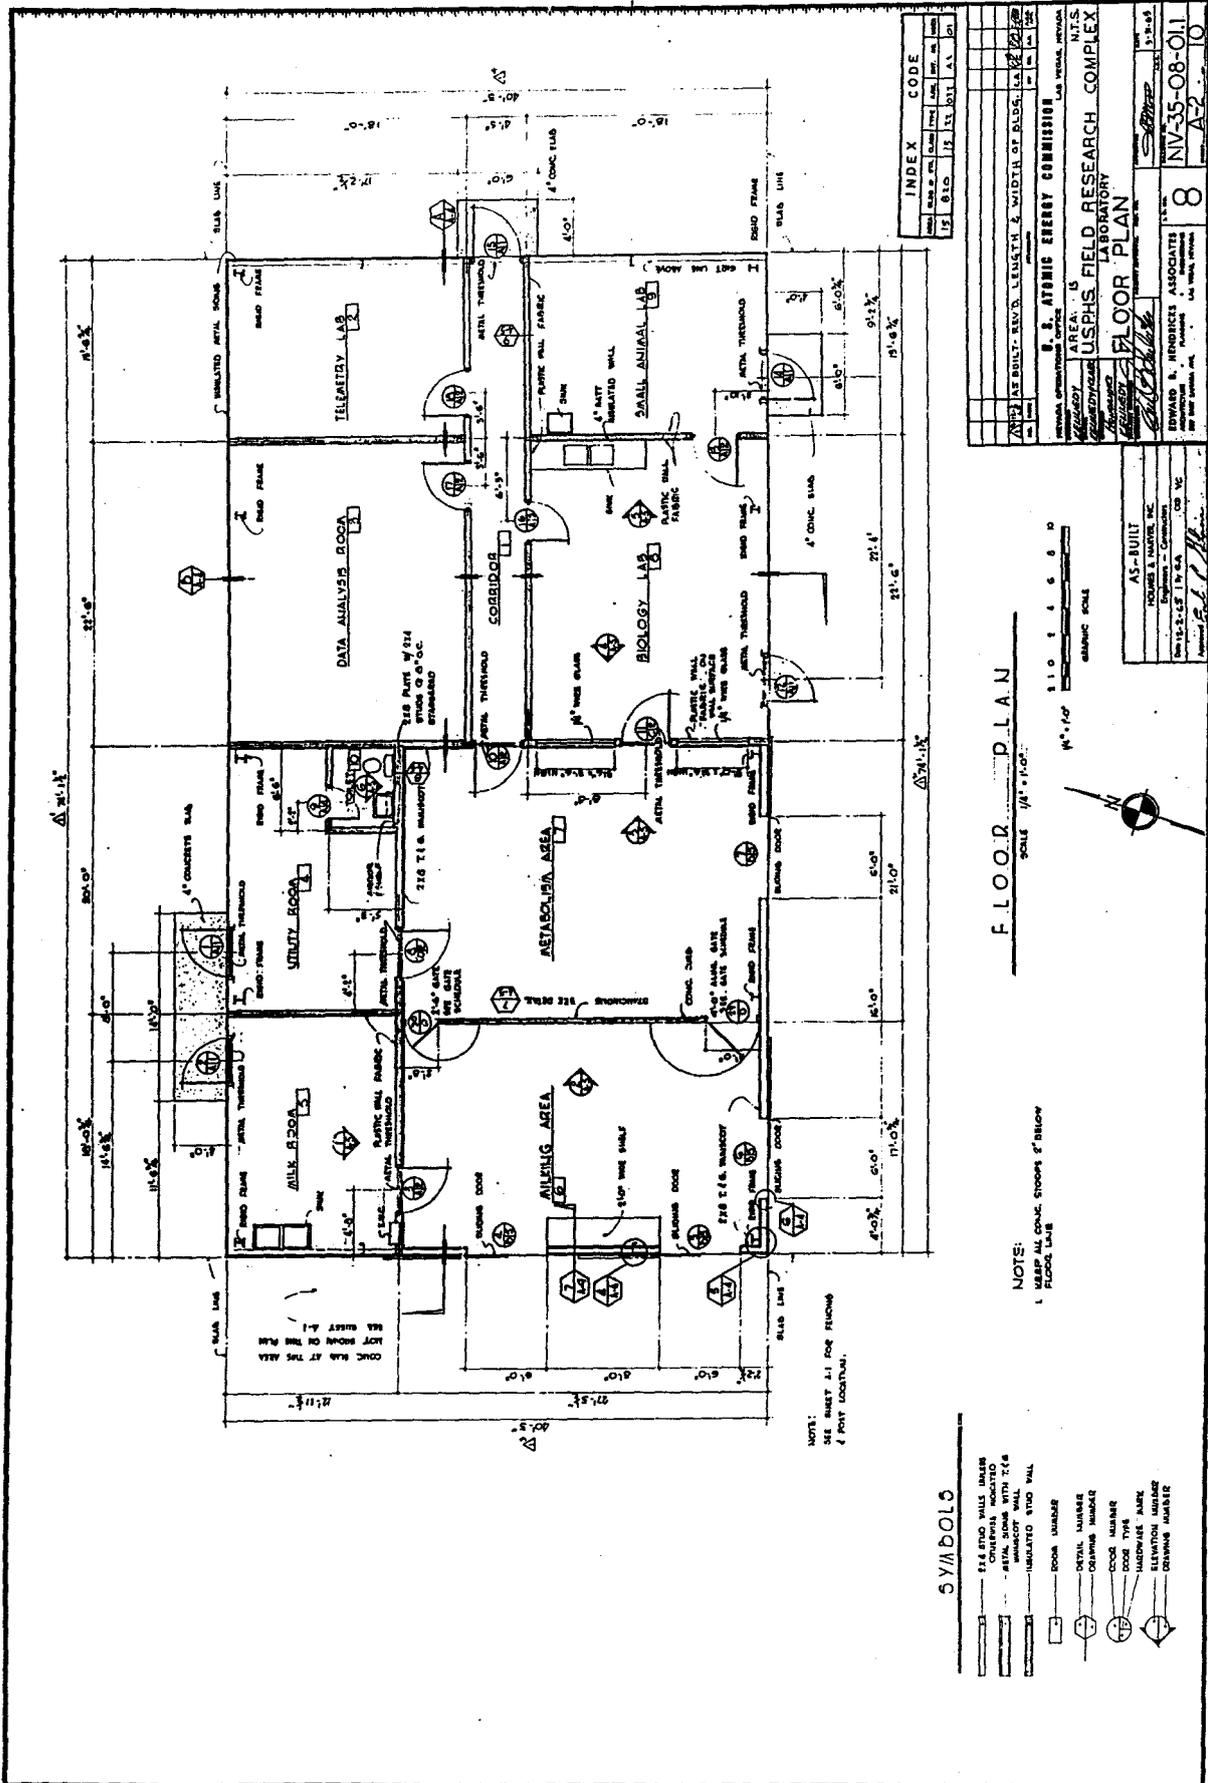
Floor plan of Building 15-06 (prior to slaughter addition).

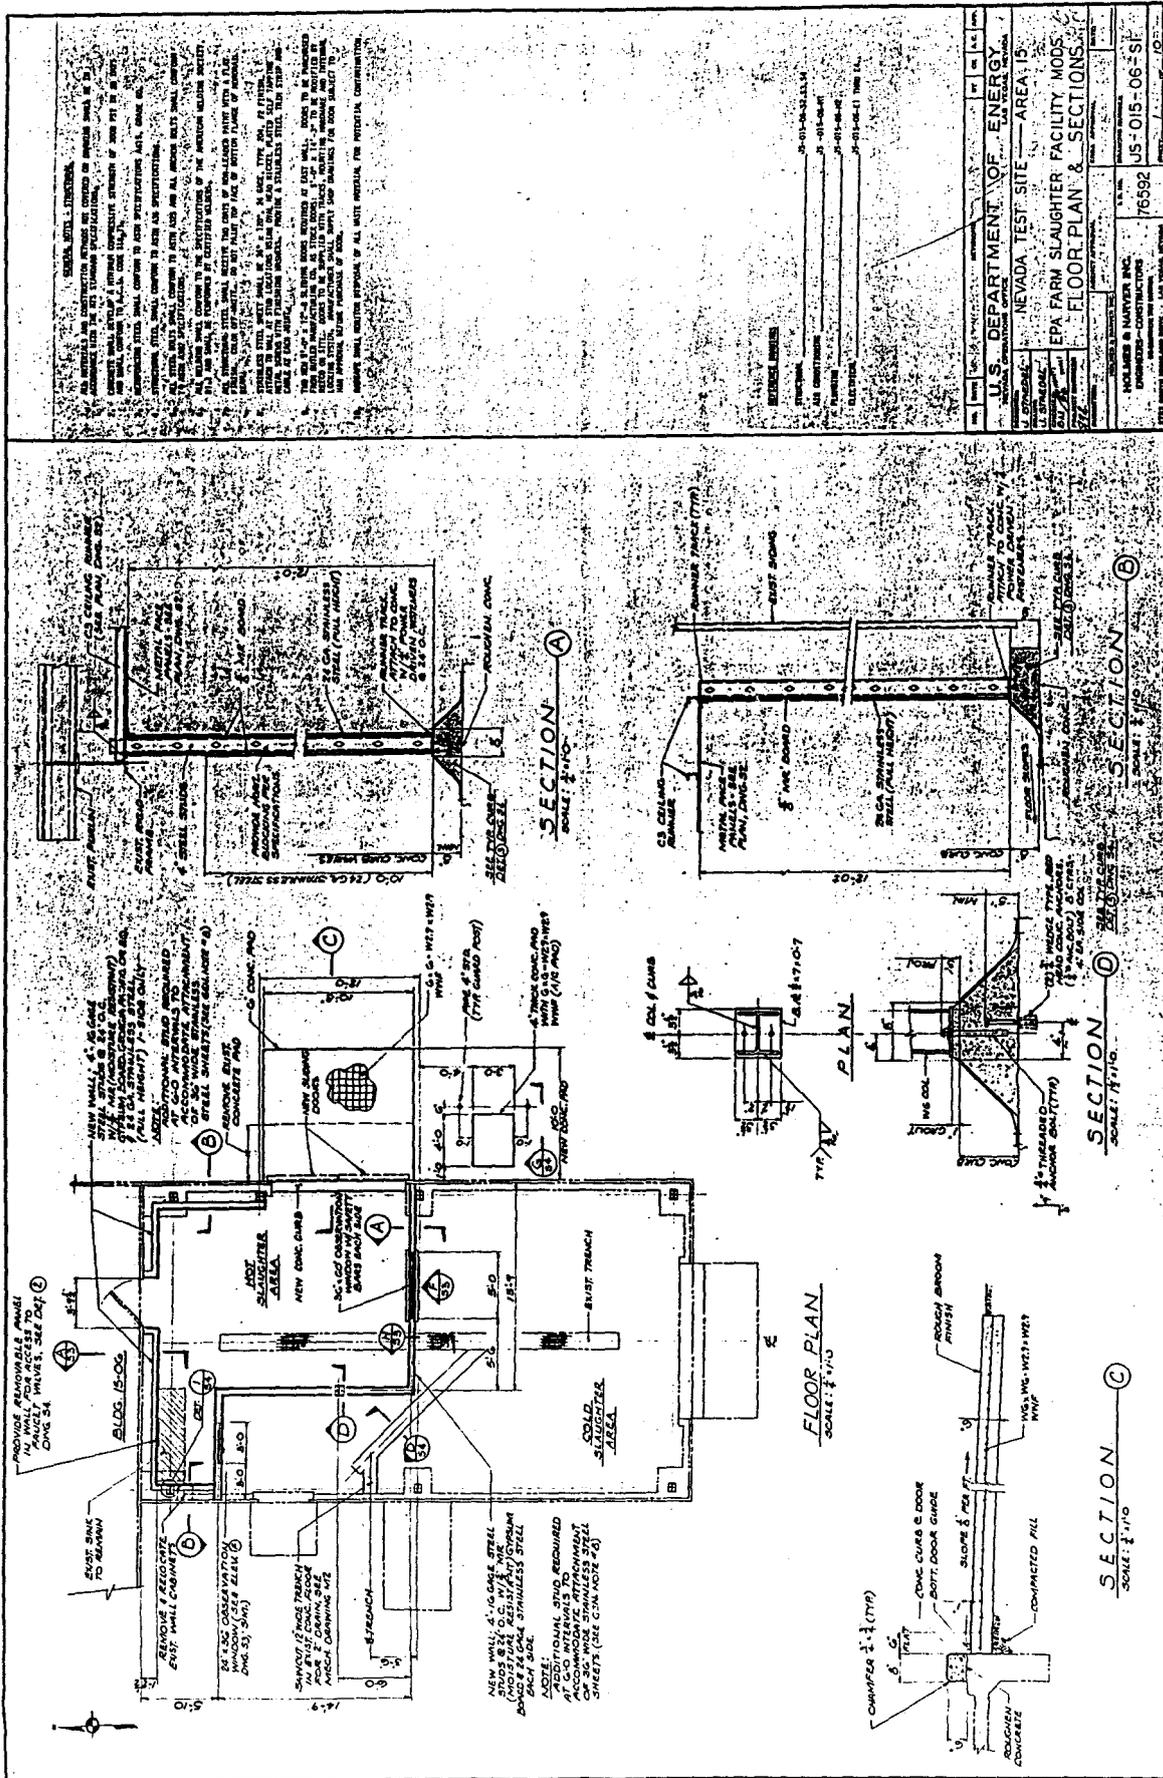
Floor plan of Building 15-06 slaughter addition.

3. Walls: Building 15-06 has gypsum wall boards on interior wall surfaces except in the slaughter addition where the hot slaughter area is separated from the rest of the facility by walls created by using 4-inch, 16-gage steel studs @ 24-inches o.c., with 5/8-inch moisture resistant gypsum board, and 24-gage stainless steel sheathing. The quonset huts, storage shed, greenhouse, and silos have unfinished walls. The interior of the Rad-Safe trailer was not examined.
