Bureau of Mines Boulder City Experimental **HABS No.** NV-35-B
Station, Original Building (Bureau of
Mines Metallurgy Research Laboratory,
Machine Shop)
(Building No. 200)
Date Street North of U.S. Highway 93
Boulder City
Clark County
Nevada

BUREAU OF MINES BOULDER CITY EXPERIMENTAL STATION (Date Street Complex) ORIGINAL BUILDING (Machine Shop, Building No. 200)

Addendum to
Bureau of Mines Metallurgical Research Laboratory, Original Building
(Bureau of Mines Metallurgical Research Laboratory, Machine Shop)
(Building 200)

Date: September 2006

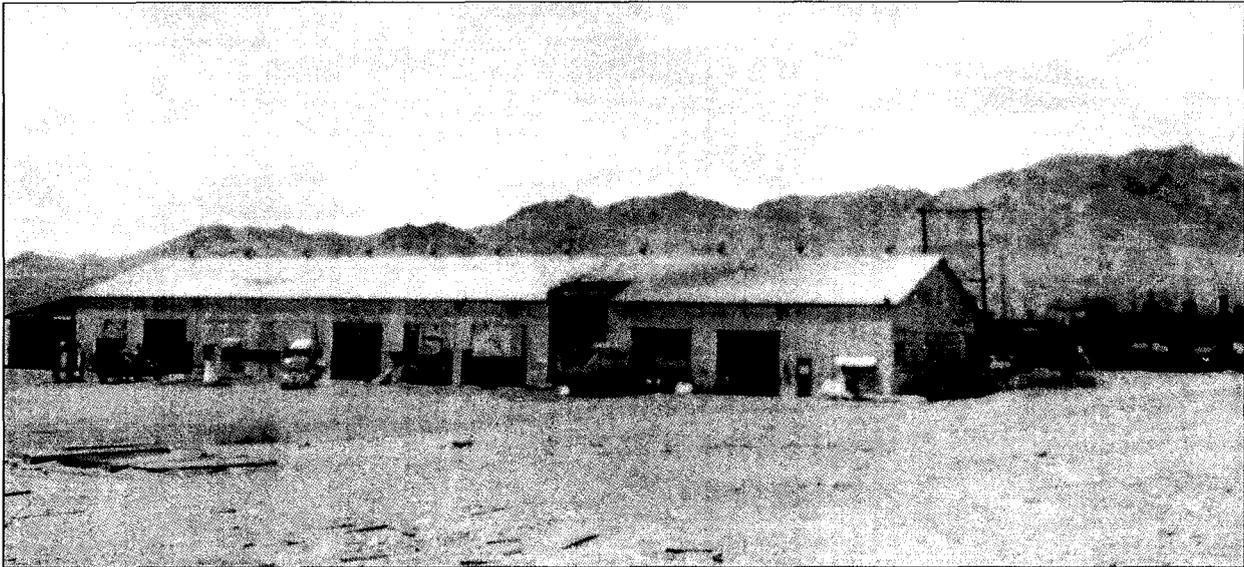
Figure 8. South facade of the former Six Companies Garage after the U.S. Bureau of Mines acquired the property, ca. 1936. Note addition to the east end of the original building (photograph courtesy of the Boulder City Museum and Historical Association, U.S. Bureau of Mines Collection, Photograph No. 0022:0266).

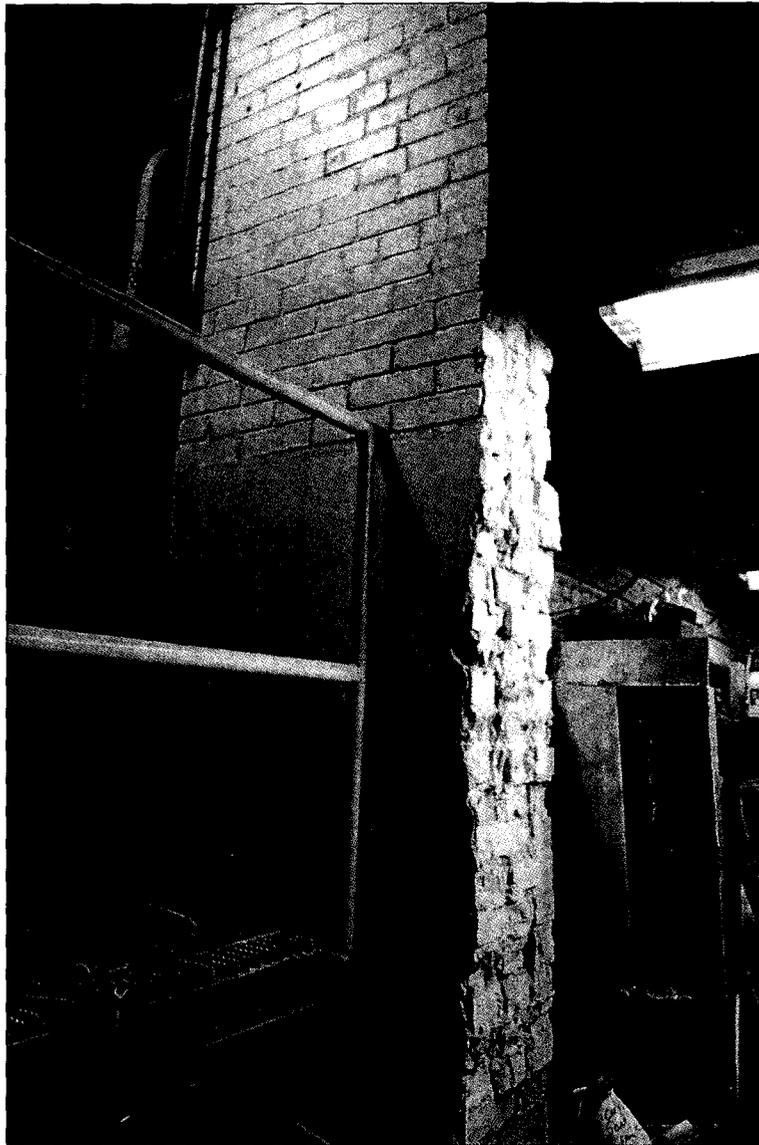
Figure 13. Partial partition wall along north wall of building, July 2005.

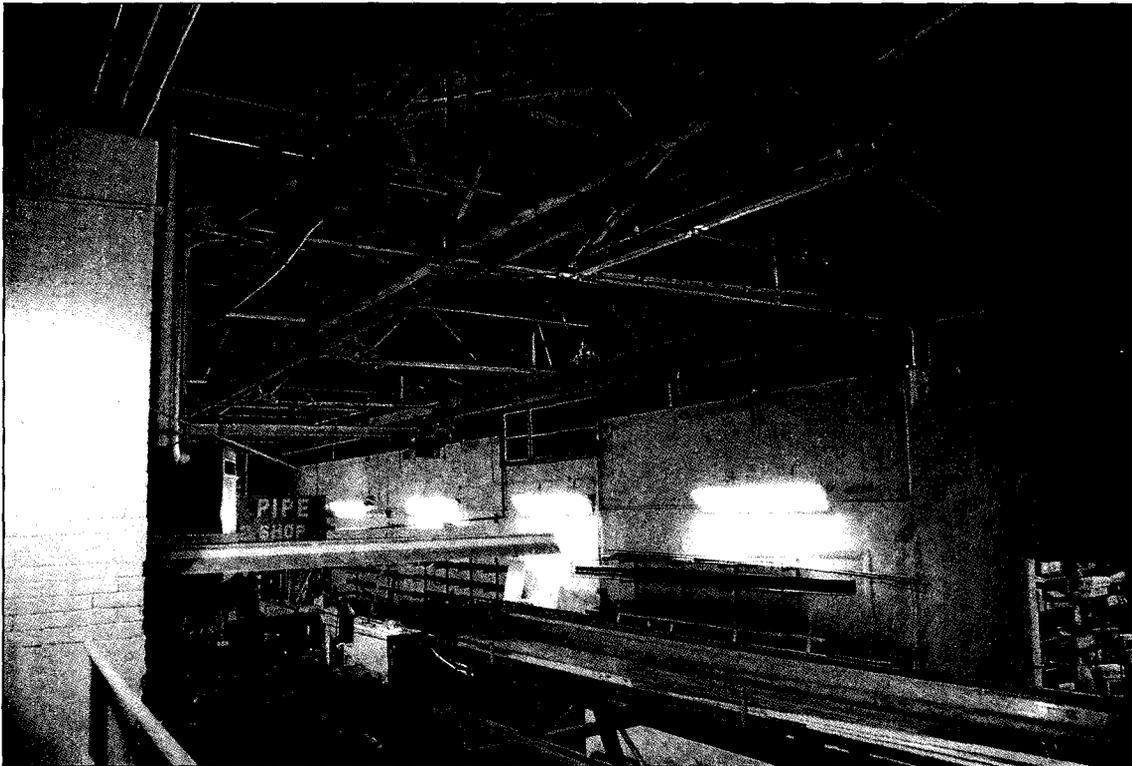
Figure 18. Interior partition wall separating the shop area and south addition office area, July 2005.

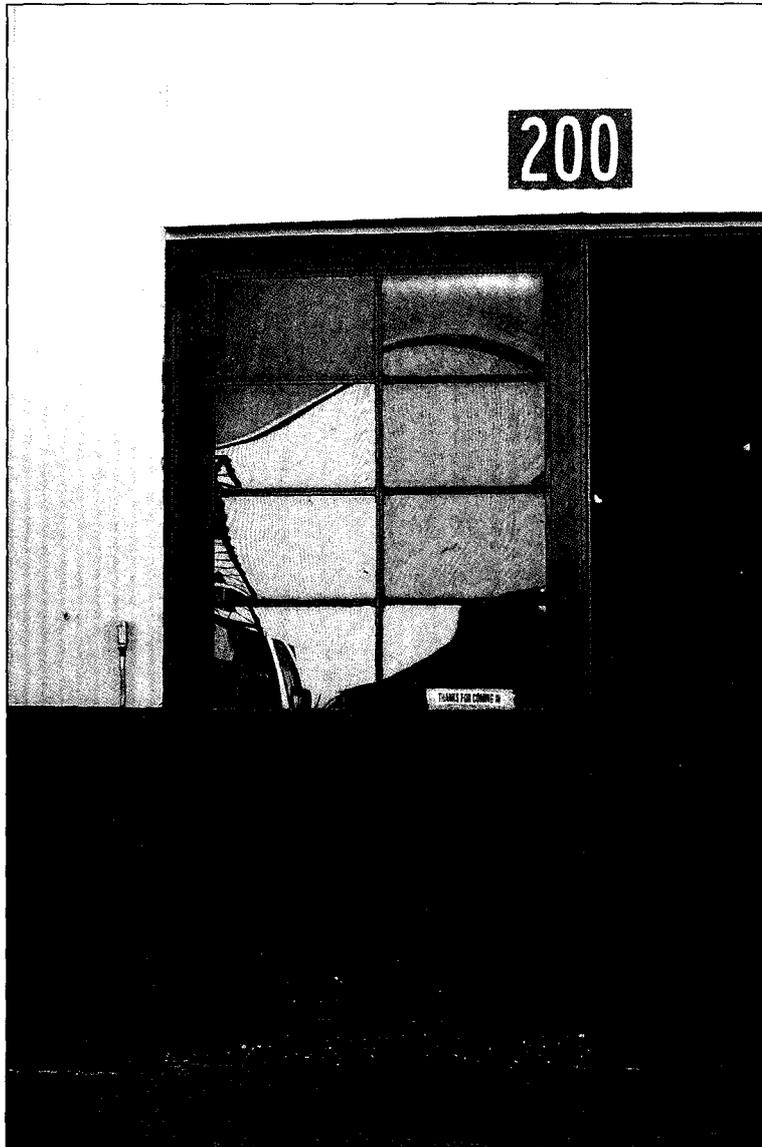
Figure 19. Main double doors on the west gable facade, July 2005.

The main double doors on the west gable facade are made of metal and open outwards. These can be fully opened, if needed, to lie flat against the exterior wall. These doors are 10'-0" high and 5'-0" wide and each contains a 5'-5"-tall, divided, glazed section (Figure 19).
