ADDENDUM TO:
ELLIS ISLAND, MAIN HOSPITAL
(U.S. Immigration Station, Island 2 Hospital)
Statue of Liberty National Monument
New York Harbor

ELLIS ISLAND, MAIN HOSPITAL
(U.S. Immigration Station, Island 2 Hospital)

HABS No. NY-6086-G

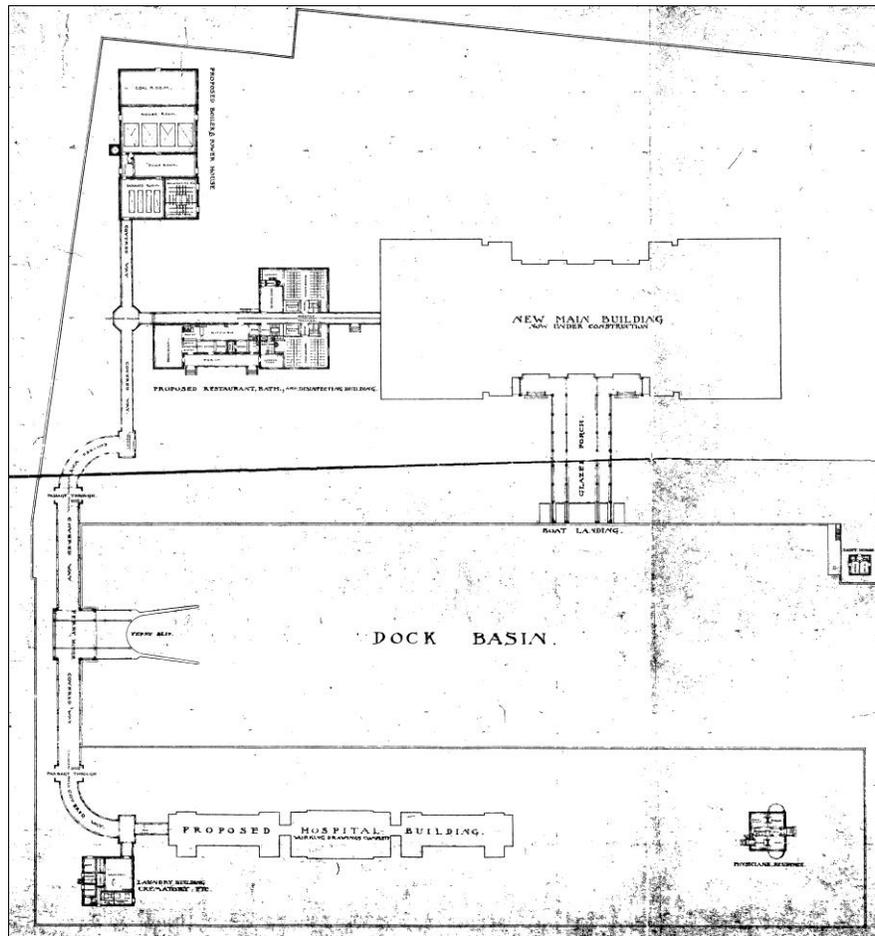
Figure 1: Original Site Plan with Proposed Hospital Building, Boring & Tilton, c. 1898.
Source: eTIC, Denver Service Center, National Park Service.

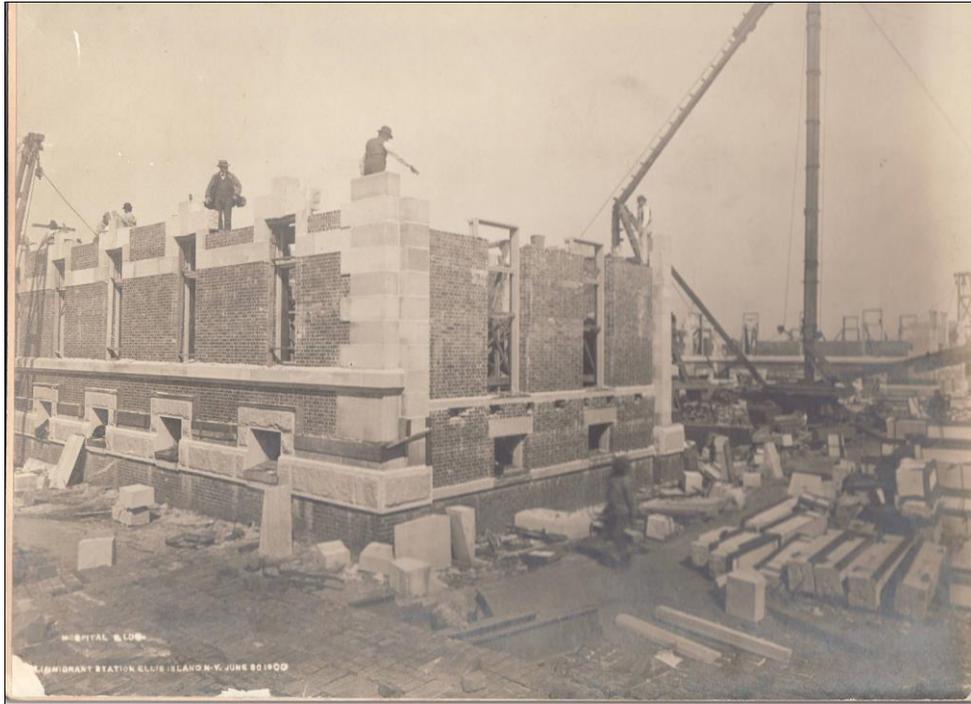
Figure 4: New Hospital (Hospital Building No. 1) Under Construction, 30 June 1900.
Source: Image 121-BCP-37D-19, Still Picture Branch, NARA II.

found around the island.¹⁸ Progress did move along swiftly. A letter sent to Supervising Architect James Knox Taylor on March 31 reported that the pile driving was nearly completion and seventy-five percent of the excavation was done.¹⁹ Just two weeks later the piles were finished and foundation work twenty percent underway.²⁰ Photographs from June 30, 1900 show the first floor walls being erected (Figure 4). A letter from this date to Taylor from his on-site construction superintendent described the progress, noting that the first story beams are in place and the first floor walls in various sections of the building complete to a height of between four and eleven feet.²¹

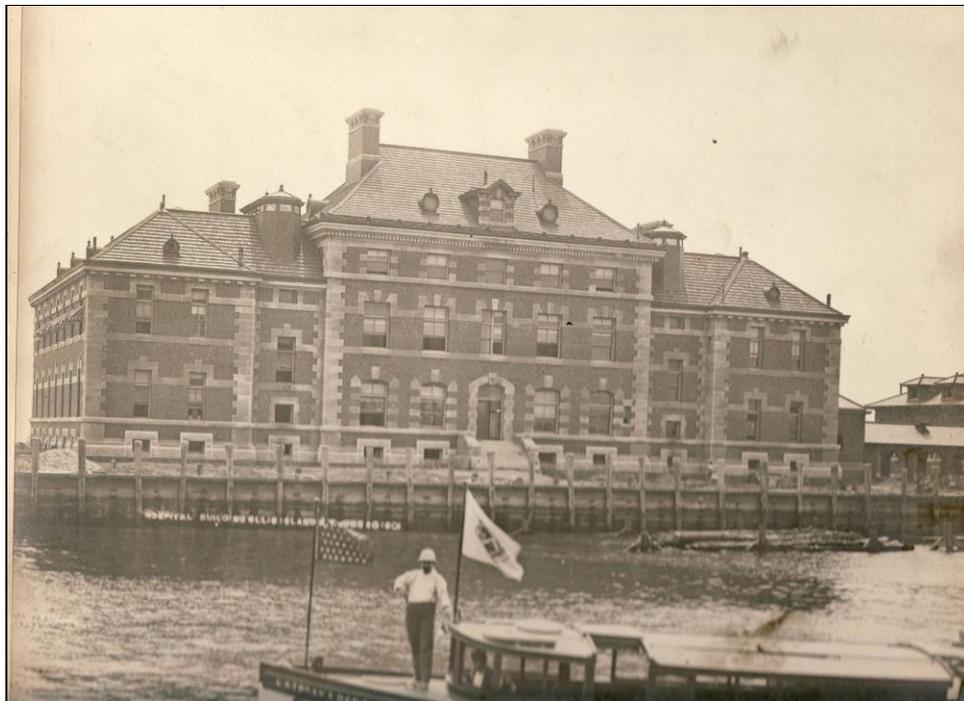
Figure 5: New Hospital (Hospital Building No. 1), 30 June 1901.
Source: Image 121-BCP-37D-4, Still Picture Branch, NARA II.

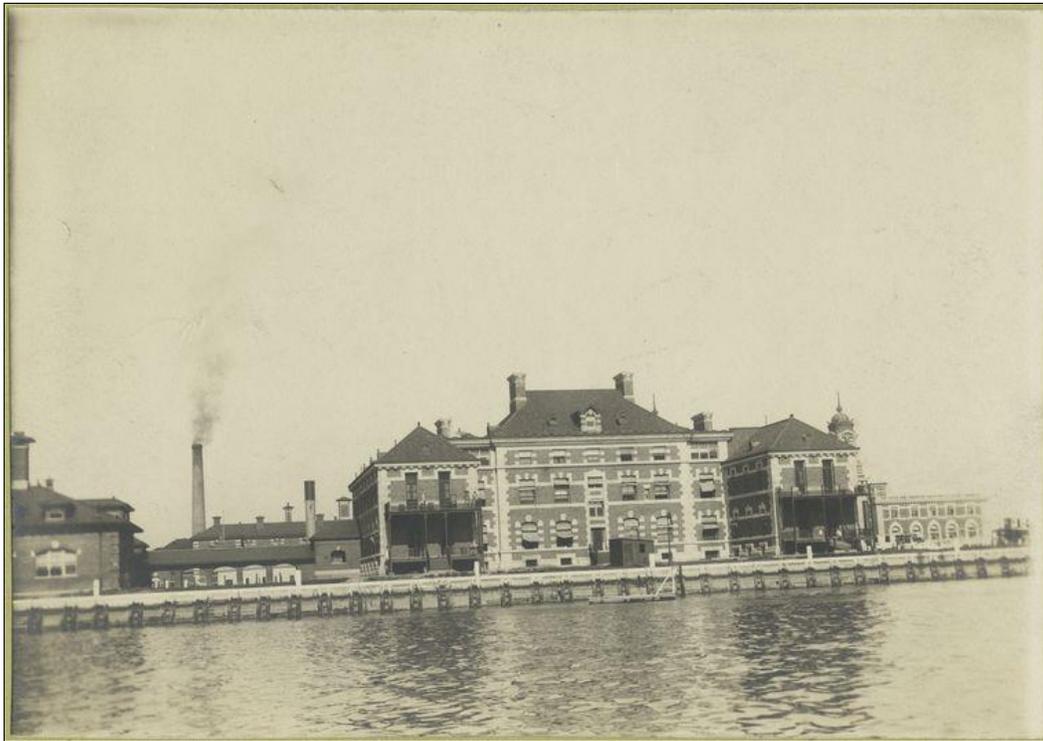
Figure 6: Rear View of Hospital Building No. 1, c. 1903.
Source: Image 416784, William Williams Collection, New York Public Library.

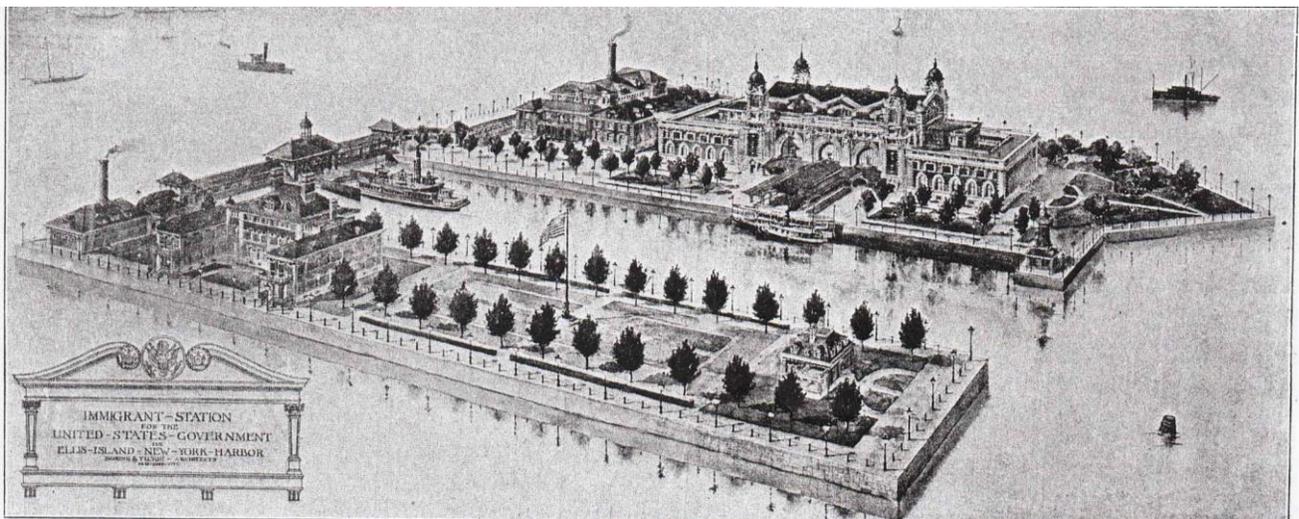
Figure 7: "Immigrant Station for the United States Government on Ellis Island, New York Harbor,"
Source: *Brickbuilder* 2, no. 7 (July 1902), 149.

rows of light standards, and formal paths with a flagpole at the center (Figure 7).²⁵ Photographs accompanying an article in *Architectural Record* later that year are focused closely on the new buildings, presumably because of the still raw condition of the landscape. Here the author praised the Beaux Arts grandeur of the Main Immigration Building, particularly its vast main hall. He compared the design problem here to a major railway station, with the need to accommodate large and sudden crowds of travelers. The newly opened Main Hospital on Island 2 was praised as “as plain as a charity hospital ought to be, . . . and the dignity that should attach to [its] ownership.”²⁶ The new immigration station was pronounced a “very distinct architectural success. The immigrant who gets his first notion of the New World from it will not get an unfair one, and the architects and our Uncle, their client, are alike to be congratulated.”²⁷

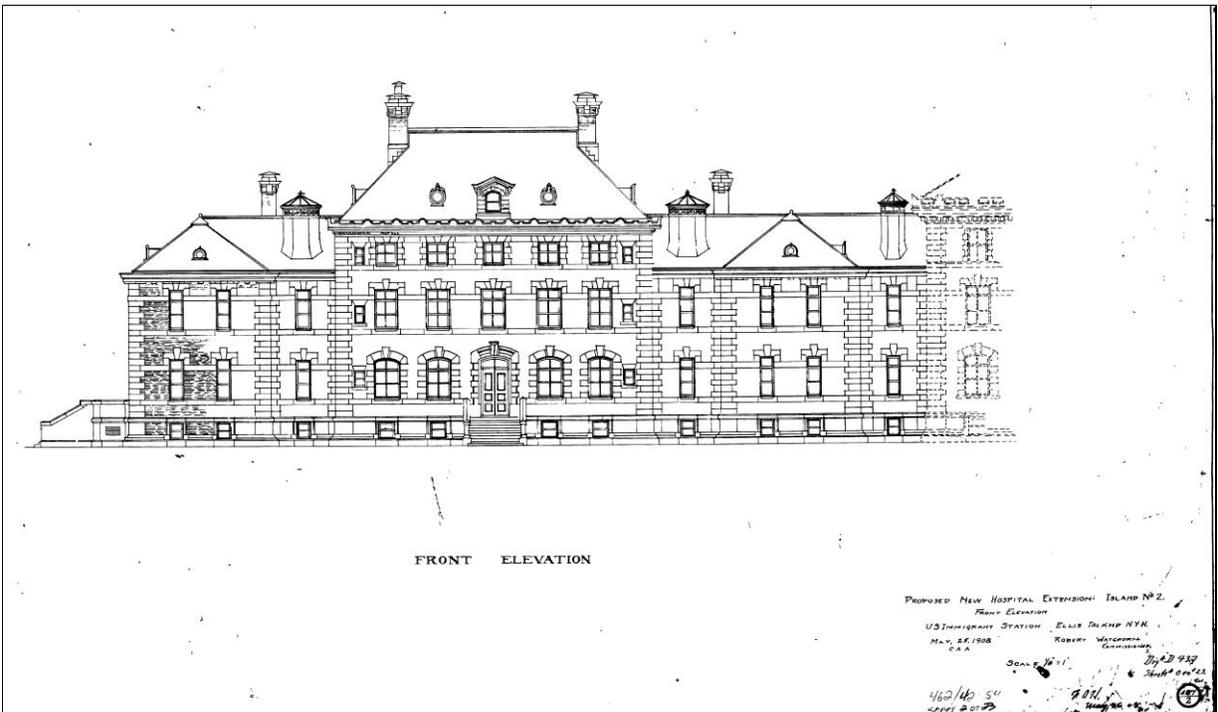
Figure 12: Front Elevation, Proposed New Hospital Extension (Hospital Building No. 2), 25 May 1908.
Source: eTIC, Denver Service Center, National Park Service.

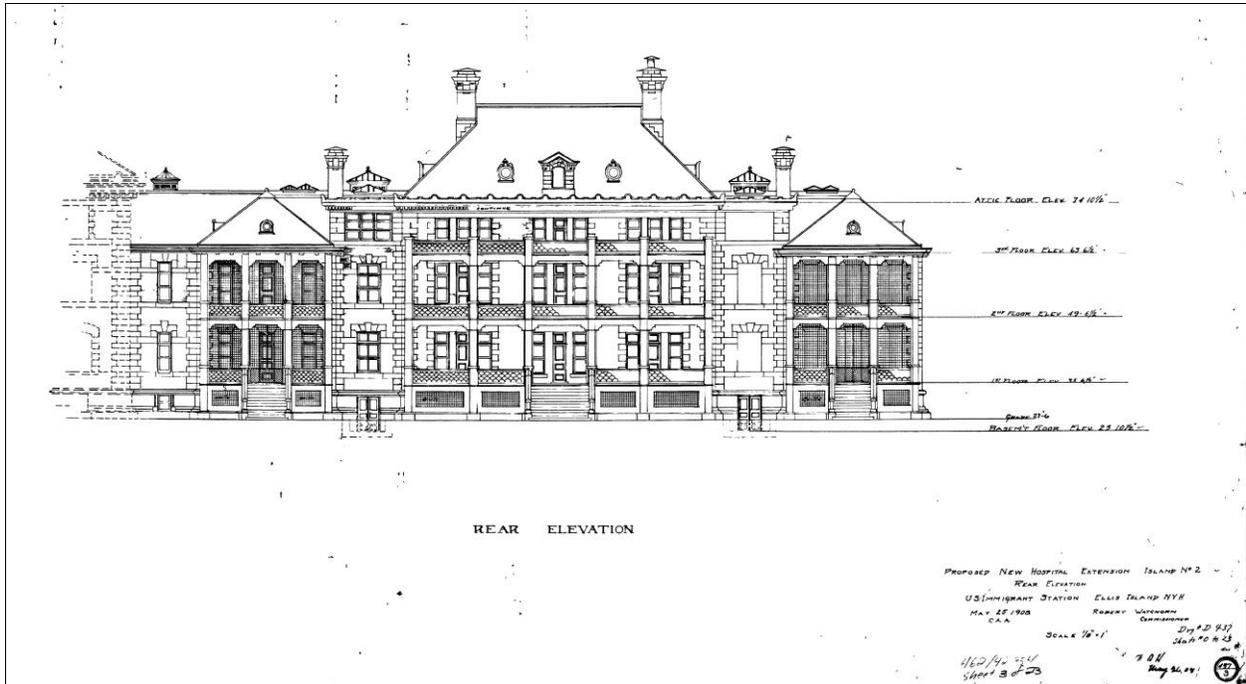
Figure 13: Rear Elevation, Proposed New Hospital Extension (Hospital Building No. 2), 25 May 1908.
Source: eTIC, Denver Service Center, National Park Service.

The rear elevation of Hospital Building No. 2 has a three-story porch across the center block. The porch is supported on a rusticated granite foundation and consists of a reinforced concrete floor and ceiling structure with tall brick piers. The concrete floor is scored in a checkerboard pattern of large squares with a wide border. The flat roof of the second floor porch serves the open third floor level. Each porch level has a brick balustrade with bricks laid in a perforated pattern and topped by a concrete rail. The porch is accessed at the center bay by a brick and concrete straight run stair with 14 steps. Sections of elaborate wrought iron grilles with a curved design remain at the basement level.

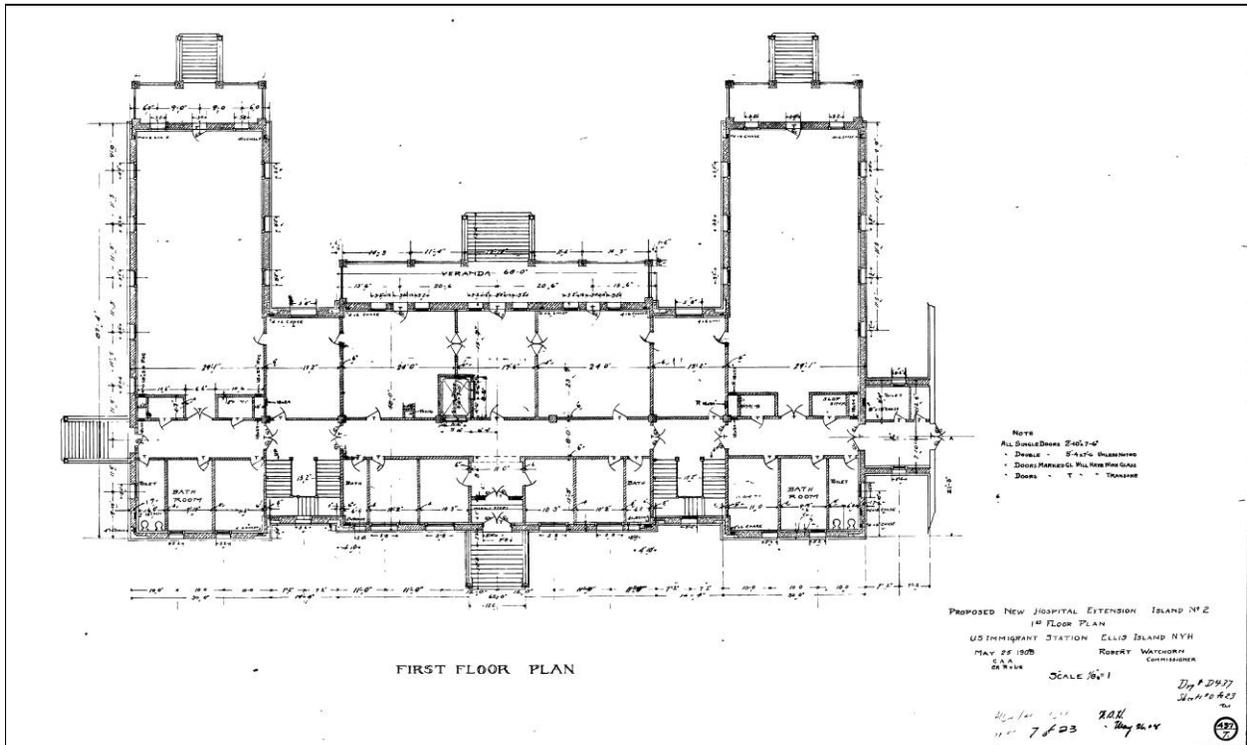
Figure 14: First Floor Plan, Proposed New Hospital Extension (Hospital Building No. 2), 25 May 1908.
Source: eTIC, Denver Service Center, National Park Service.

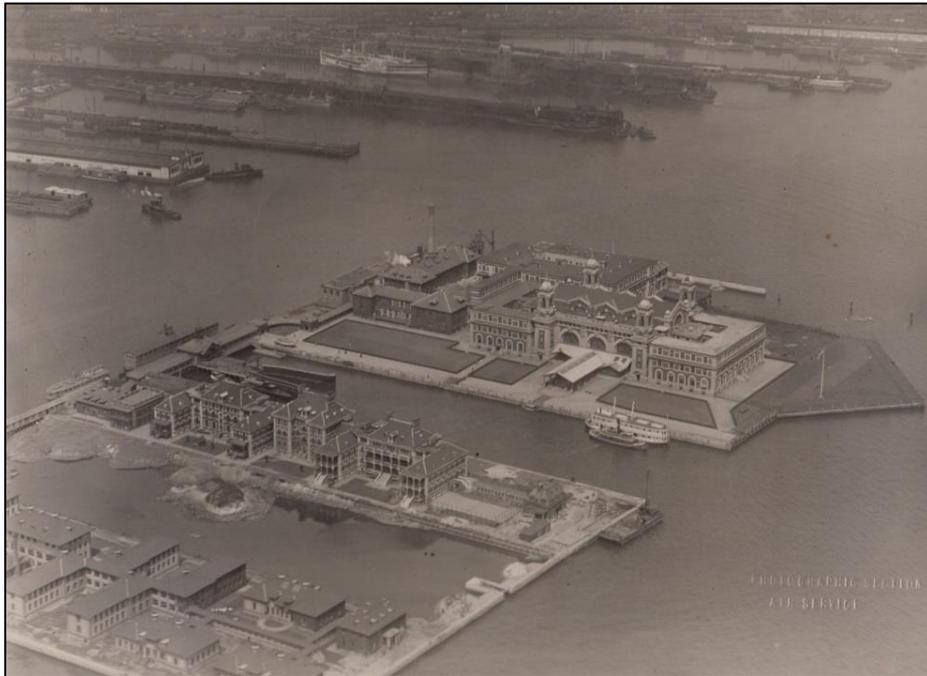
Figure 16: Seawall construction to fill the Hospital Ferry Basin, 20 October 1920.
Source: Image 18-AA-93-61, Still Pictures Branch, NARA II.

Overall Geddes was impressed with the medical care at Ellis Island, but he correctly noted that the buildings needed maintenance. The biggest change to the hospital areas in this period was gradual infill of the lagoon between Islands 2 and 3 in order to provide more recreation space for patients and staff. After repeated funding requests, work did begin, although it would not be completed until the 1930s.⁹⁷

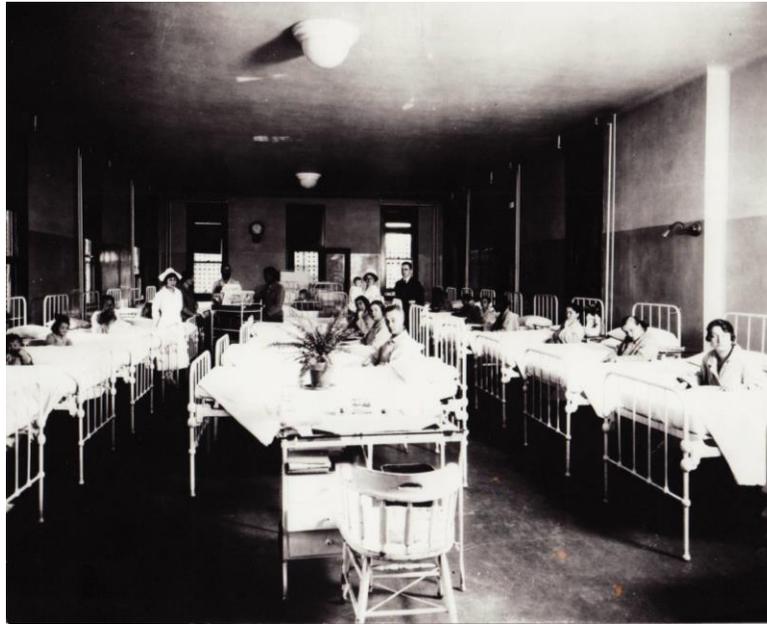
Figure 17: "Women's Ward," Main Hospital, c. 1925.
Source: Image 90-G-90-14, Still Pictures Branch, NARA II.

An undated photograph of the “Woman’s Ward” at Ellis Island likely shows one of the first floor rear ell wards in Hospital Building No. 2 during this period (Figure 17). Rows of iron beds line the walls between the windows while a nurses’ desk and additional bed sit in the center of the room. Early incandescent light fixtures are still in place, including scrolled wall sconces. The room is open and simple, with no decorations to collect unsanitary dirt except for a clock mounted on the wall near the porch door and a potted fern in a basket. Another similar but probably later view appears to show a female/pediatric ward, probably Ward No. 2 in Hospital Building No. 2 (Figure 18). The iron grilles over the porch are visible in the rear windows and the ceiling light fixtures have been replaced while some of the wall sconces remain. The ward is more crowded with several beds and cribs arranged in the center aisle.

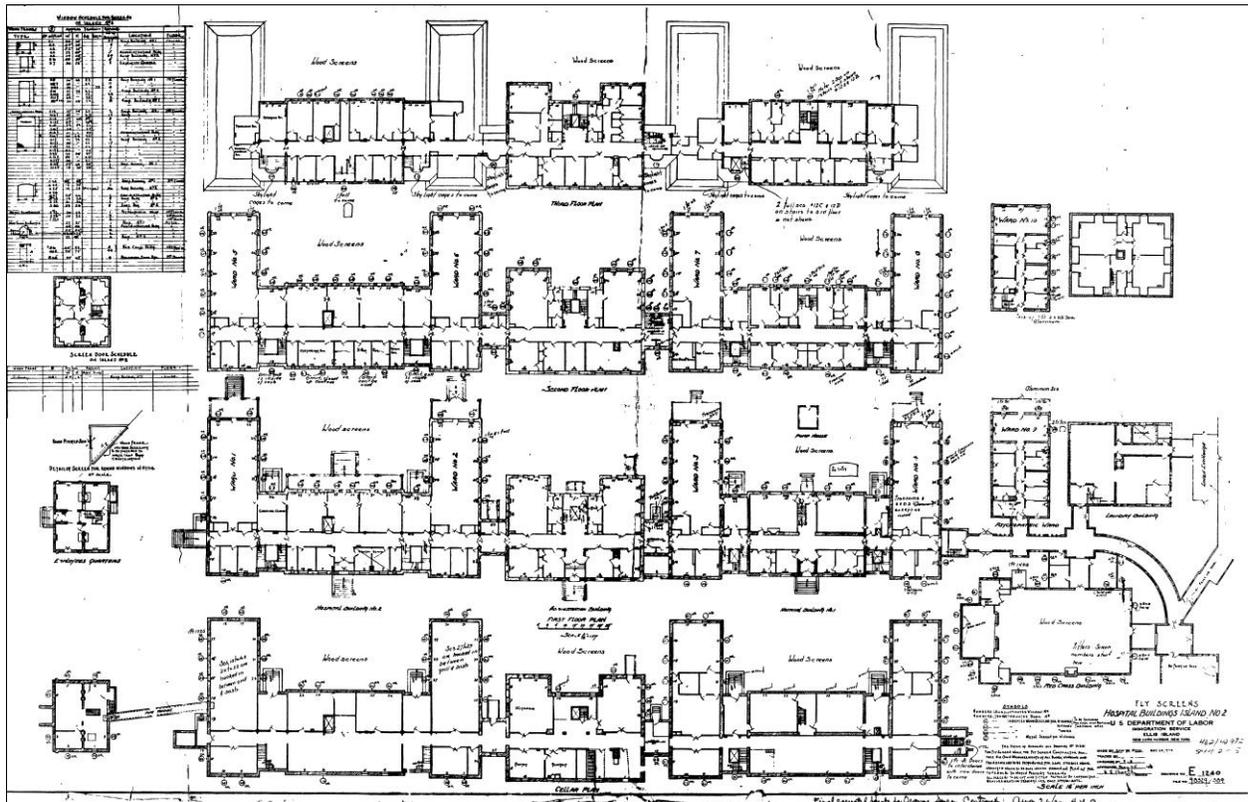
Figure 19: Main Hospital Floor Plans, 1932.
Source: eTIC, Denver Service Center, National Park Service.

A number of much needed repairs to lighting, roofs, plumbing and exterior and interior painting were finally funded in fiscal year 1931. Dr. Troie remarked that “the general equipment of the hospital and its betterment continued during the year, and at the present time I think it may be safely said that we have a fairly well equipped hospital which presents a satisfactory appearance, in spite of its age and its need for remodeling.”¹⁰⁴ He was hopeful that \$120,000 available to the Immigration Service for these hospital repairs would be used for that purpose in the coming year. Much of this work was done during fiscal year 1932 and 1933, and was extensive enough that Chief Medical Officer Lavinder complained to his superiors about the disruption caused by the contractor.¹⁰⁵ In spite of his great interest in having the repairs completed, accommodating the contractor was difficult in an already crowded hospital. Plans of the Island 2 hospital dated 1932 correspond to the completion of some of this work and illustrate the minor interior changes which had taken place over the years (Figure 19).¹⁰⁶

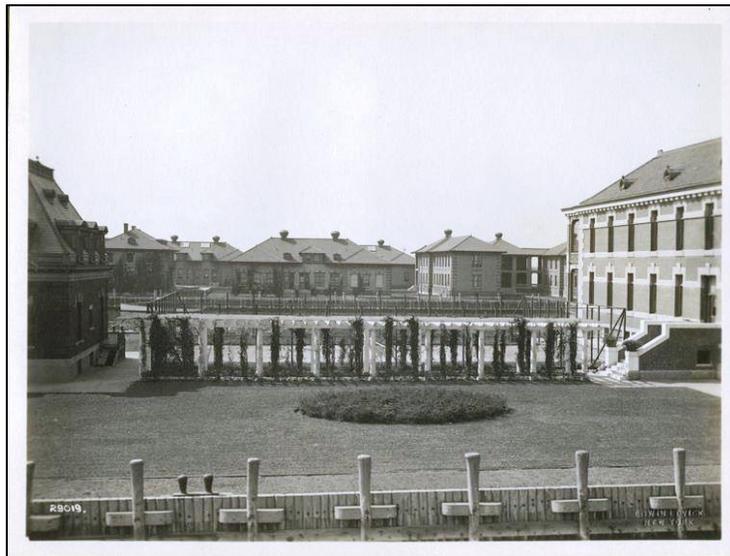
Figure 20: Aerial view Showing Landscaping of Hospital Recreation Courtyard, 11 March 1940.
Source: Image 18-AA-93-58, Still Pictures Branch, NARA II.
