ELLIS ISLAND, CONTAGIOUS DISEASE HOSPITAL STAFF HOUSE
(U.S. Immigration Station)
Statue of Liberty National Monument
New York Harbor
New York
New York County
New York

HABS NY-6086-R
HABS NY-6086-R

ELLIS ISLAND, CONTAGIOUS DISEASE HOSPITAL STAFF HOUSE

HABS No. NY-6086-R

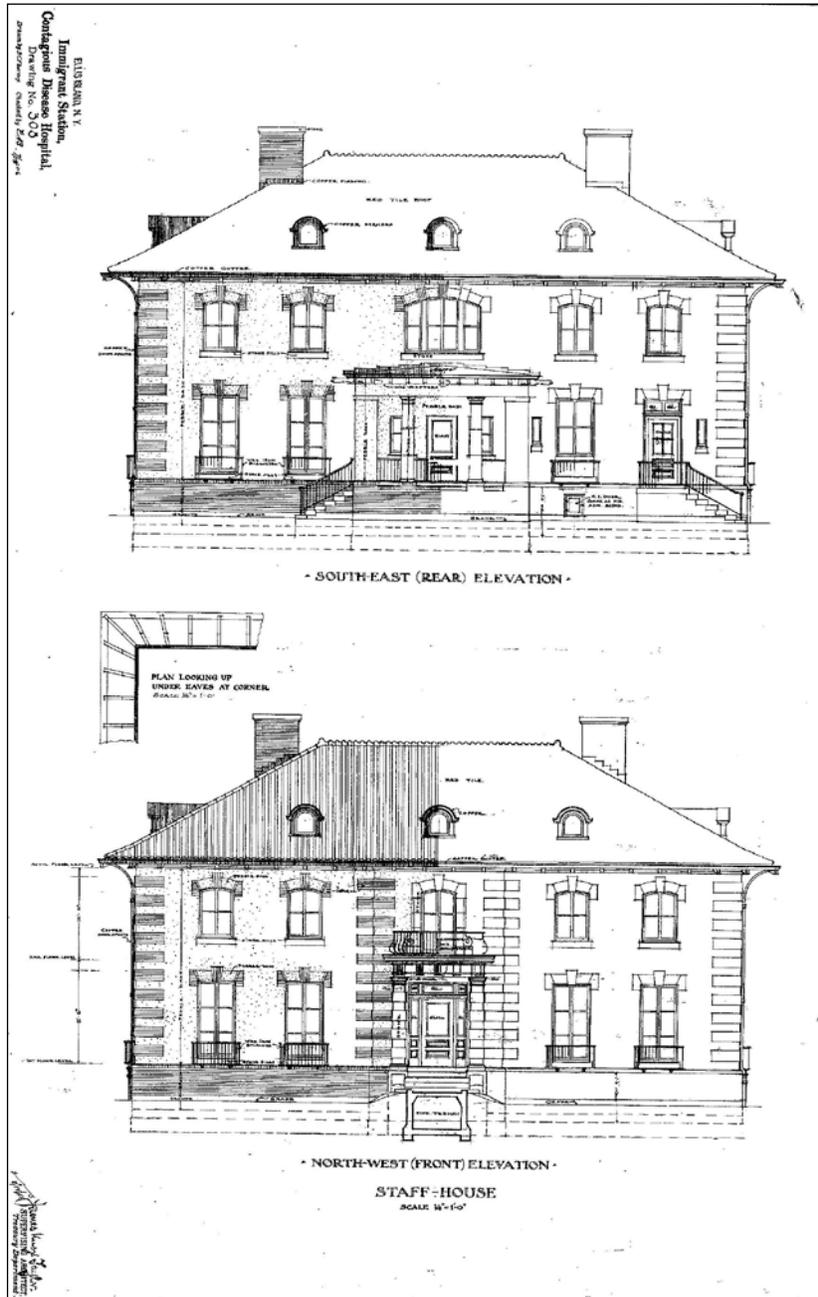
Figure 1: Office of the Supervising Architect, Contagious Disease Hospital Staff House – Front and Rear Elevations, Immigrant Station, Ellis Island, NY (18 August 1906)
(NPS Drawing No. 462/43,902D, Sheet 3 of 8)

on Island 3, including its detached Staff House. This drawing set includes elevations, floor, roof and foundation plans, sections and framing plans (Figures 1-3).¹

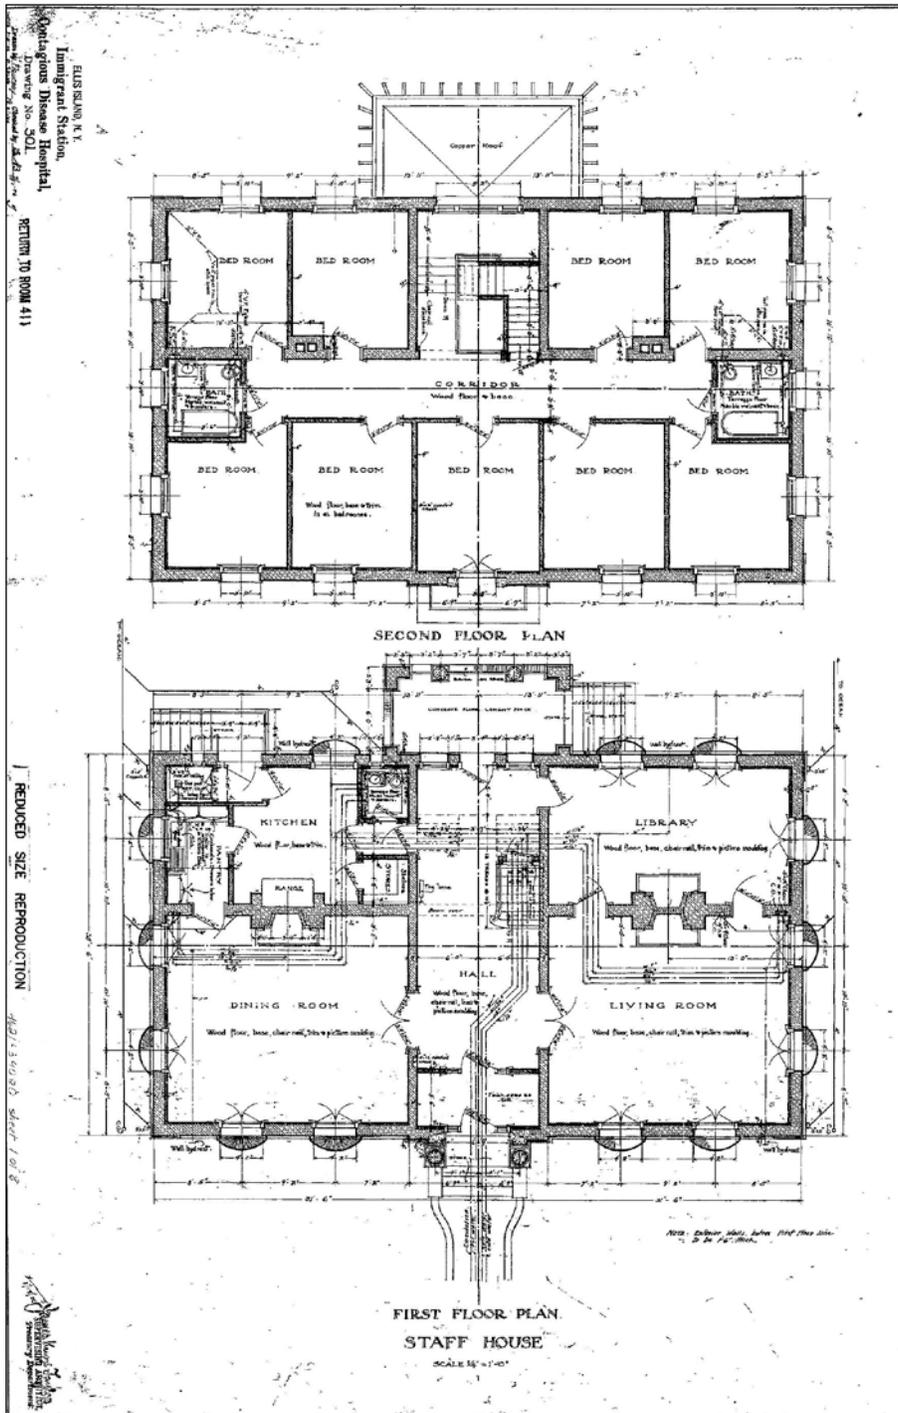
Figure 2: Office of the Supervising Architect, Contagious Disease Hospital Staff House – Floor Plans, Immigrant Station, Ellis Island, NY (18 August 1906) (NPS Drawing No. 462/43,902D, Sheet 1 of 8) Source: Technical Information Center, Denver Service Center, National Park Service

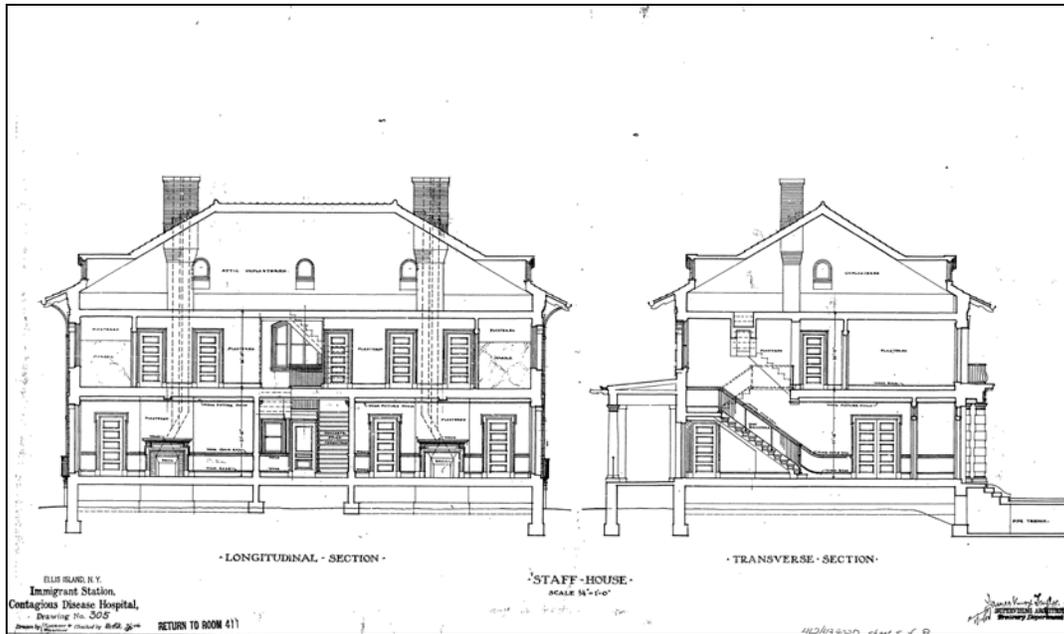
Figure 3: Office of the Supervising Architect, Contagious Disease Hospital Staff House – Sections, Immigrant Station, Ellis Island, NY (18 August 1906)
(NPS Drawing No. 462/43,902D, Sheet 5 of 8)
Source: Technical Information Center, Denver Service Center, National Park Service

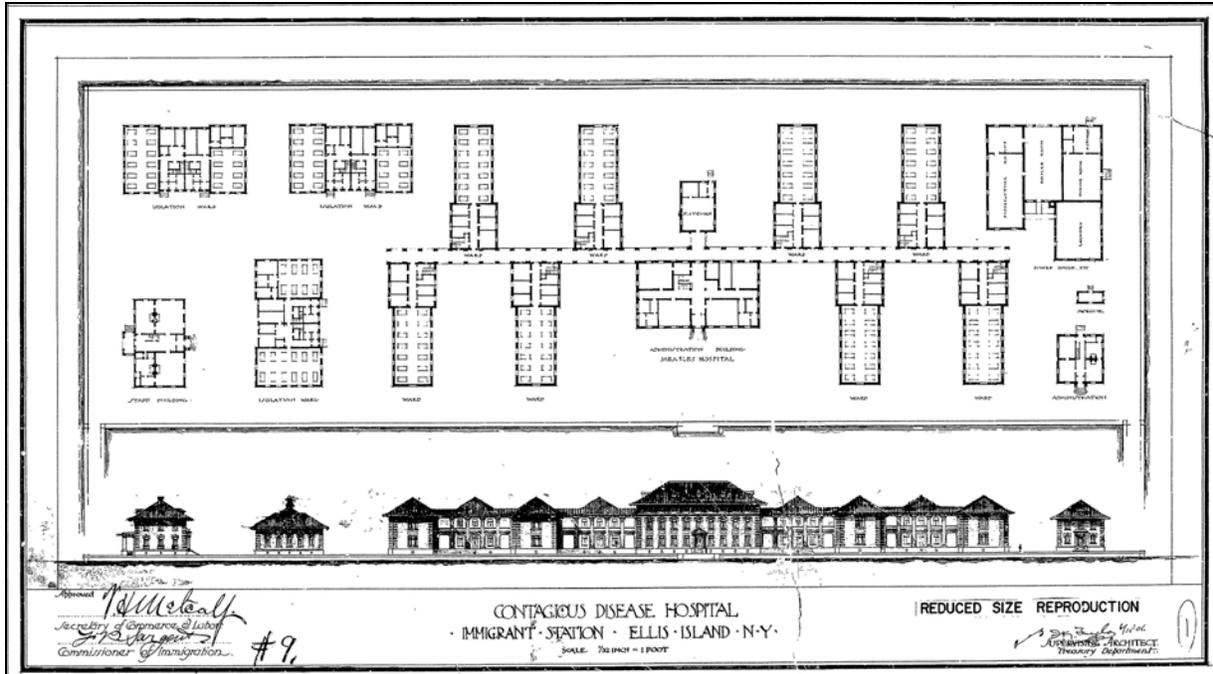
Figure 4: Office of the Supervising Architect, “Contagious Disease Hospital, Immigrant Station, Ellis Island, NY” (15 April 1906), (NPS Drawing No. 462/43,901 Sheet 1 of 1)
Source: Technical Information Center, Denver Service Center, National Park Service

It is unknown exactly which prints are referred to here, although two drawings signed by Taylor showing the hospital largely as constructed survive -- a “General View” birds-eye rendering of the entire complex and another showing the complex in both plan and elevation (Figure 4).²⁴ Commissioner General Sargent replied that he would return the plans with suggestions after conferring with the Surgeon General.²⁵ In June 1906 the “sketch plans” were approved by the Secretary of Commerce and Labor and the Office of the Supervising Architect could prepare architectural drawings.²⁶

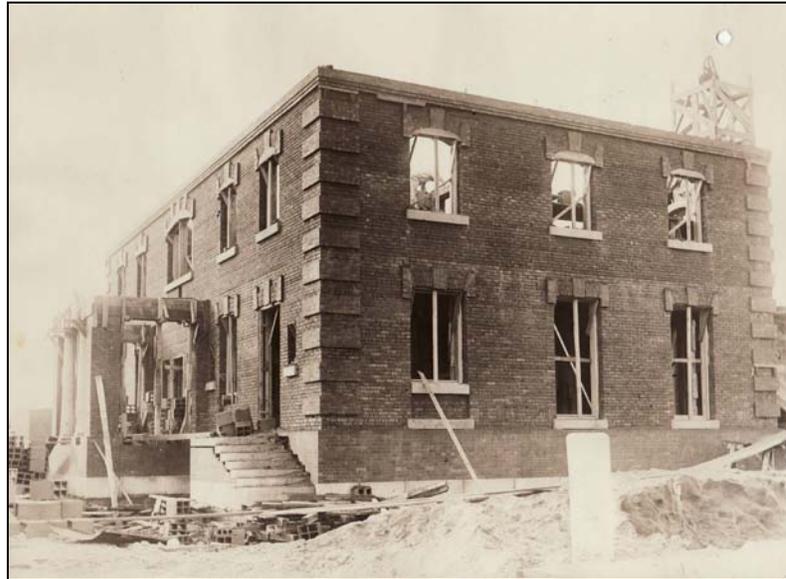
Figure 5: “Staff House Looking Southwest,” (16 December 1907),
(Photograph No. 121-BCP-38AI-22E),
Source: Record Group 121-BCP – Records of the Public Building Service,
Photographs of the Construction of Federal Buildings, 1885-1954,
Still Picture Branch, NARA, College Park, MD

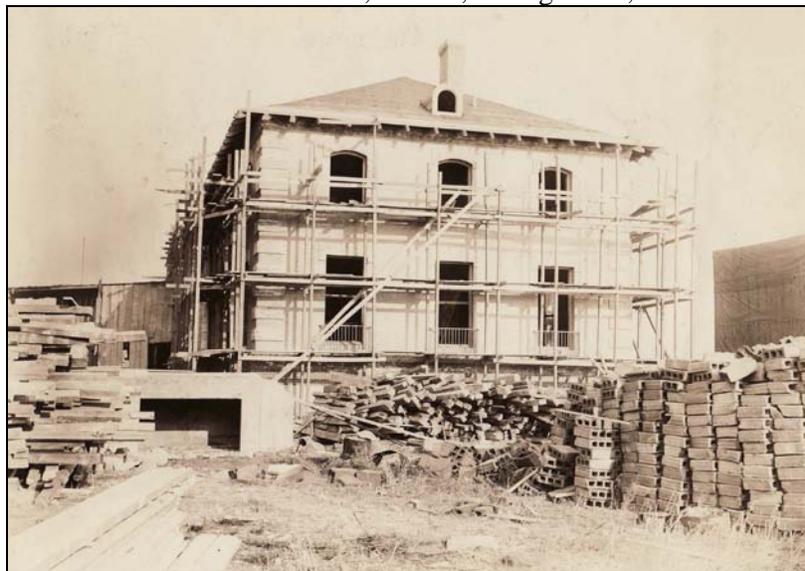
Figure 6: “Staff House Looking Southeast,” (11 January 1908),
(Photograph No. 121-BCP-38AI-23H),
Source: Record Group 121-BCP, Still Picture Branch, NARA, College Park, MD

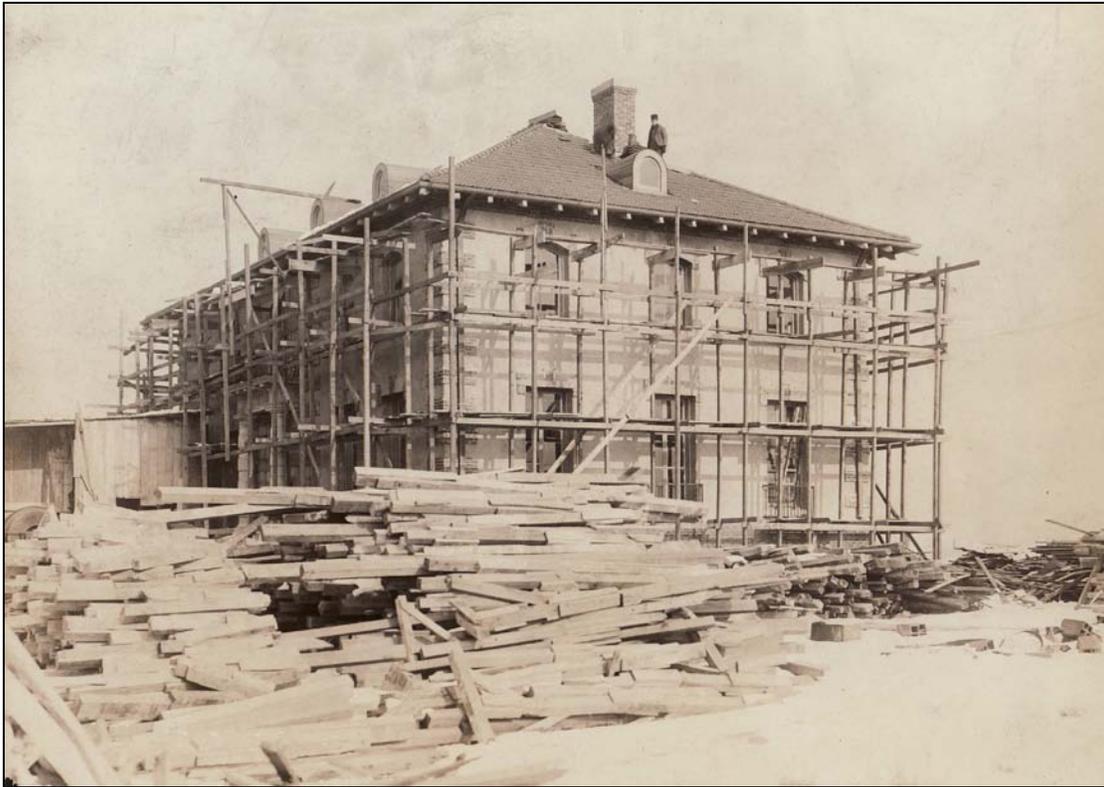
Figure 7: "Staff House Looking East," (11 February 1908),
(Photograph No. 121-BCP-38AI-24C),
Source: Record Group 121-BCP, Still Picture Branch, NARA, College Park, MD
