1101 CHESTNUT AVENUE (Commercial Building)  
Altoona  
Blair County  
Pennsylvania

HABS No. PA-6182

PHOTOGRAPHS

WRITTEN HISTORICAL AND DESCRIPTIVE DATA

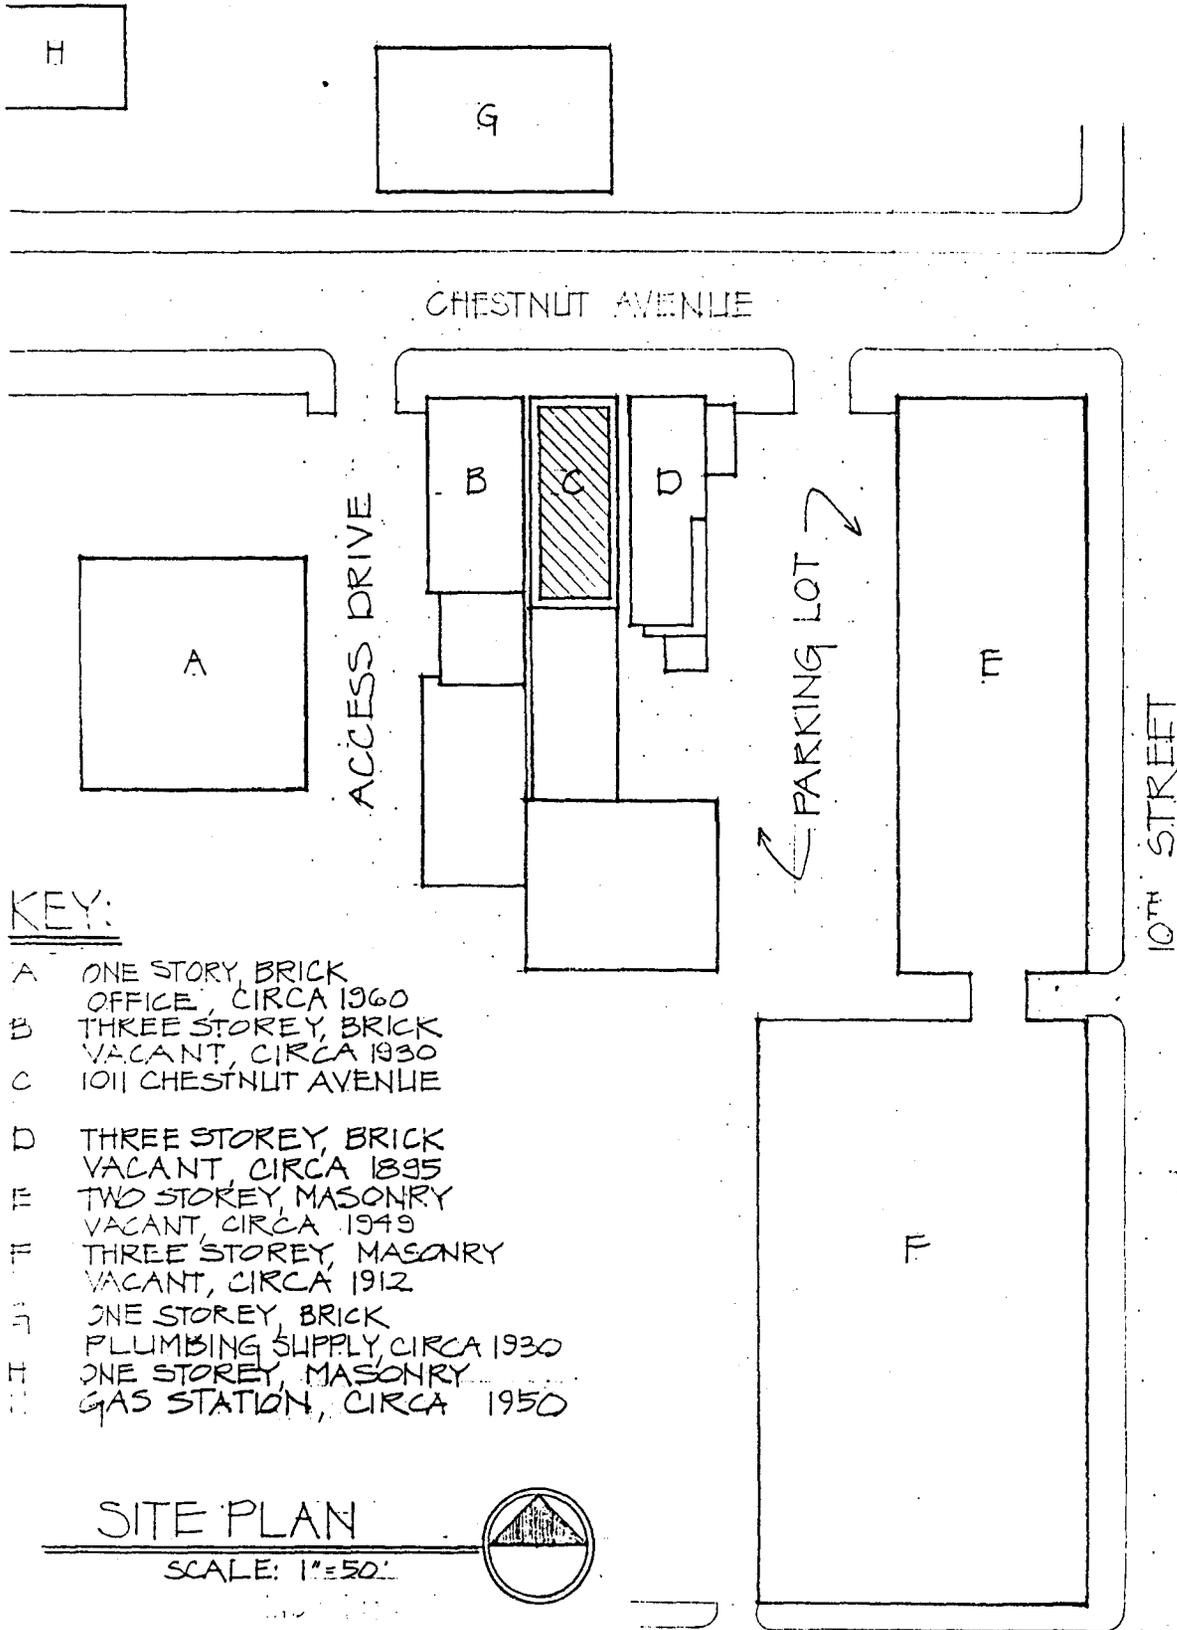
SITE PLAN

- A ONE STOREY BRICK OFFICE, CIRCA 1960
- B THREE STOREY, BRICK VACANT, CIRCA 1930
- C 1011 CHESTNUT AVENUE
- D THREE STOREY, BRICK VACANT, CIRCA 1895
- E TWO STOREY, MASONRY VACANT, CIRCA 1949
- F THREE STOREY, MASONRY VACANT, CIRCA 1912
- G ONE STOREY, BRICK PLUMBING SUPPLY, CIRCA 1930
- H ONE STOREY, MASONRY GAS STATION, CIRCA 1950

SCALE: 1"=50'

century, this section of Altoona was a thriving residential and neighborhood commercial area. In 1901, the building was valued at \$4,500.00. In 1940, the Wolfe Brothers built an automobile showroom located at the corner of Chestnut Avenue and 10th Street. This building is illustrated as building "E" on the enclosed Site Plan.

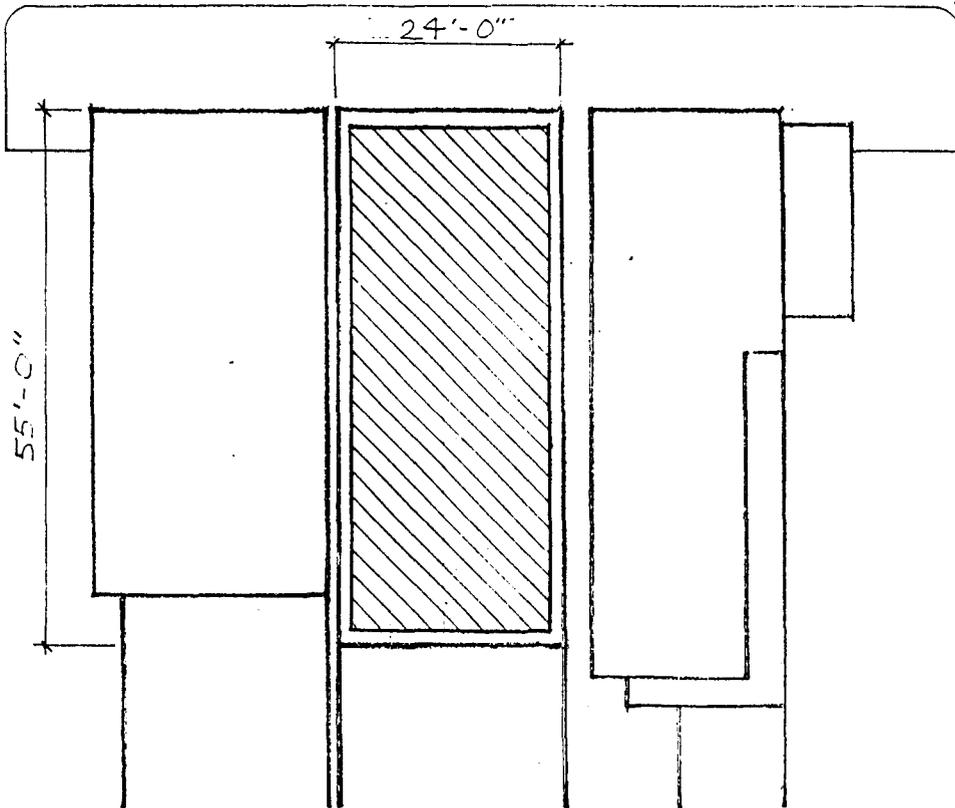
SITE PLAN

SCALE: 1" = 20'
