NATIONAL HOME FOR DISABLED VOLUNTEER SOLDIERS –
BATTLE MOUNTAIN SANITARIUM, GOVERNOR'S QUARTERS
(Hot Springs Veterans Administration Medical Center, Building No. 23)
(VA Black Hills Health Care System - Hot Springs Campus, Building No. 23)

HABS No. SD-24-B

Location: 500 North 5th Street, Hot Springs, Fall River County, South Dakota

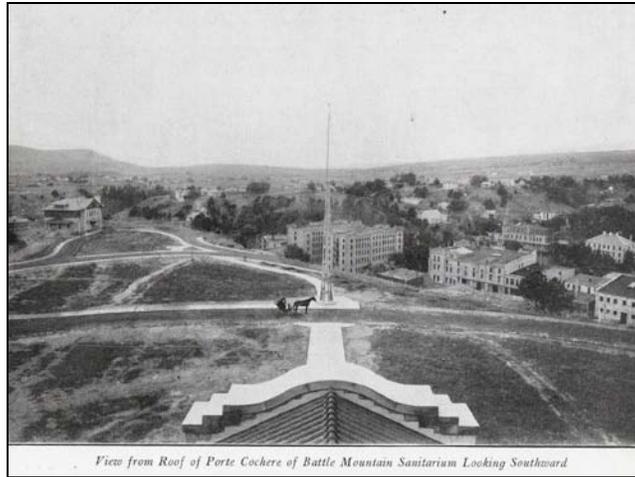
Figure 1: View from Administration Building with Governor's Quarters (on left), c. 1909
Source: *Battle Mountain Sanitarium, Hot Springs, South Dakota*

The general construction contract was let to Reynard and Oak of Omaha on August 5, 1903 and work grading the site began before the end of the month.² After the hospital complex was well underway, Kimball turned his attention to designing the officer's quarters and other support structures. In May 1905 Kimball again visited the site with Captain Palmer, the NHDVS local manager, and George Kessler, "a distinguished landscape gardener of Kansas City." Kessler recently worked with Kimball on the Louisiana Purchase Exposition of 1904, contributing the landscape design for the grounds. According to the *Hot Springs Weekly Star* "[Kimball and Kessler] arranged for the main entrance to the grounds on Tenth Street and a loop will be made in the making the ascent to the hill, which gives a very good grade."³ It is likely this trip included site selection for the officer's quarters, which were located just south of the entrance loop road (Figure 1).

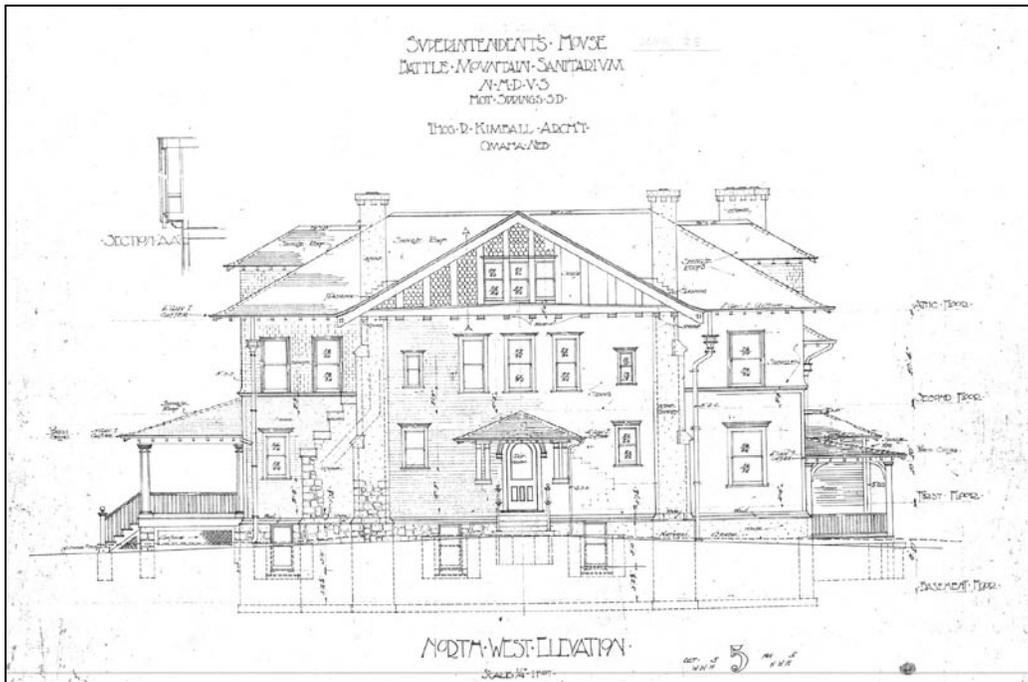
Figure 2: Thomas Rogers Kimball, Northwest (Front) Elevation of "Superintendent's House," (October 1905)
Source: Hot Springs Campus Drawing Files

5. Porches: The house has four porches, all original. The small entry porch on the northwest elevation is sheltered by a hip roof. The porch roof is supported by pairs of massive brackets with metal bolts and a notched and curved profile. The porch ceiling has exposed rafters. The original stone and pipe rail stairs here have been replaced by concrete stairs and landing with recent wrought iron railings.

- a. Doorways and doors: The house has a doorway at the center of each elevation. The front door is a round arch opening with a round arch door. The door has a round arch light in the top half and three vertical recessed panels in the lower half. It is surrounded by thick molding with a tapered profile. The side doorway at the living room porch is rectangular opening with a two leaf French door with one light in each leaf. The hardware is a lever handle. There is a thin movable transom above, hinged at the bottom. This doorway also has thick trim with a tapered profile. The rear doorway is a rectangular opening with a single leaf wood panel door. It has glazing in the top half and three vertical recessed panels with trim. The service porch doorway is a rectangular opening with a wood door. The door has glazing in the top half with four divided lights and two vertical recessed panels in the lower half (same as four panel doors in basement with windows in top half). There is an additional exterior doorway on the rear elevation providing access to the second floor porch. This rectangular opening has two leaf French doors like those on the side porch, with the same lever handle hardware. There are not exterior doors at the basement level.

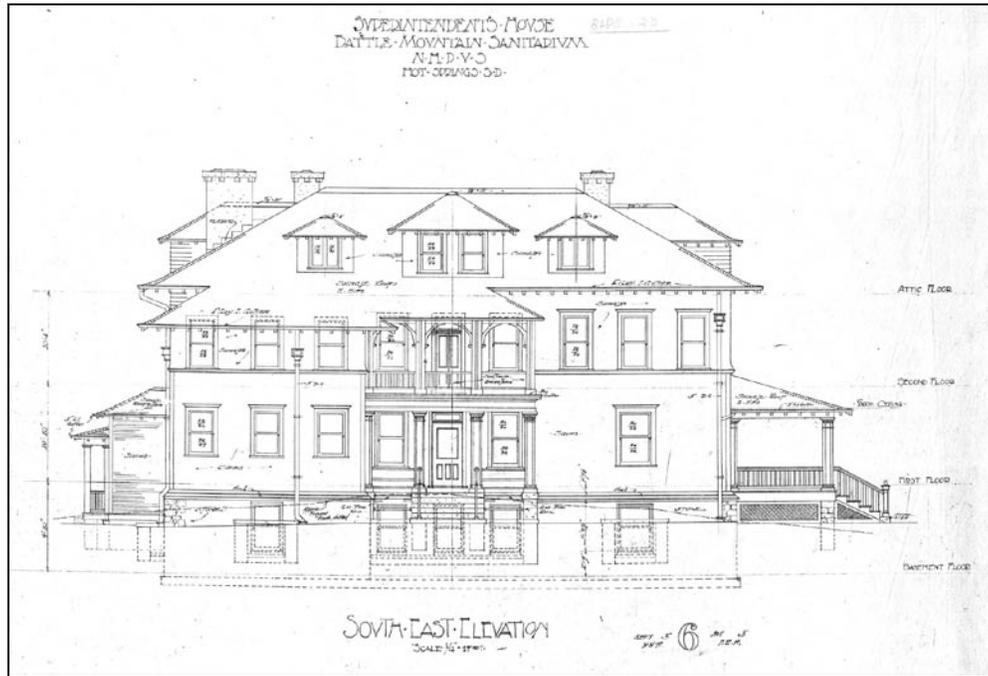
Figure 3: Thomas Rogers Kimball, Southeast (Rear) Elevation of "Superintendent's House," (September 1905)
Source: Hot Springs Campus Drawing Files

The rear, or southeast, porch is a two-story hipped roof porch that extends across three bays at the center of this façade. The south wall is formed by the small projection of the kitchen ell. This porch has wood octagonal columns like the ones on the side porch. Stone stairs with original pipe railings are just one bay wide at the center of the porch to the dining room doorway. The end columns stand on sandstone piers and the porch roof projects over the basement window well. The same original pipe railing is located around the deep window well, which is lined with sandstone. This porch has a beadboard ceiling. At the second floor, the octagonal columns are

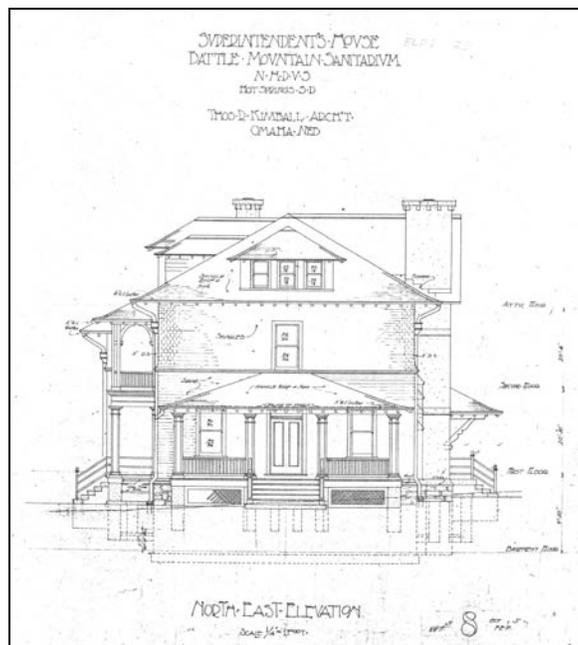
Figure 4: Thomas Rogers Kimball, Northeast (Side) Elevation of "Superintendent's House," (October 1905)
Source: Hot Springs Campus Drawing Files

A larger one-story, hipped roof porch is located on the northeast side elevation. It extends across the first floor at the living room. A doorway is located at the center of the façade and was originally on access with a porch stair (see Figure 8). This opening in the balustrade has been restored to match. The porch roof is supported by wood octagonal columns with a lamb's tongue/leaf motif in the capital. Engaged versions of these columns appear at the edges. A balustrade with square balusters is located between these columns. The wood porch floor is covered with carpet. Currently the porch is accessed from the rear yard via a concrete stair with recent wrought iron railings (original balustrade has been cut here). This porch has a beadboard ceiling.

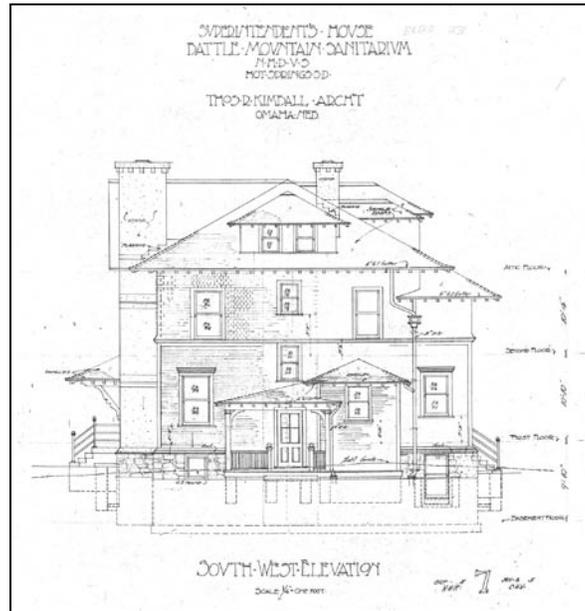
Figure 5: Thomas Rogers Kimball, Southwest (Side) Elevation of "Superintendent's House," (October 1905)
Source: Hot Springs Campus Drawing Files

The service porch on the southwest elevation is a small one-story hipped roof porch located next to the small kitchen pantry ell at the center of this elevation. It was originally open, with simple wood columns and brackets similar to those on the second floor of the rear porch. The columns remain partially encased by beadboard walls with windows above. The side wall is formed by the clapboard of the small kitchen pantry ell.

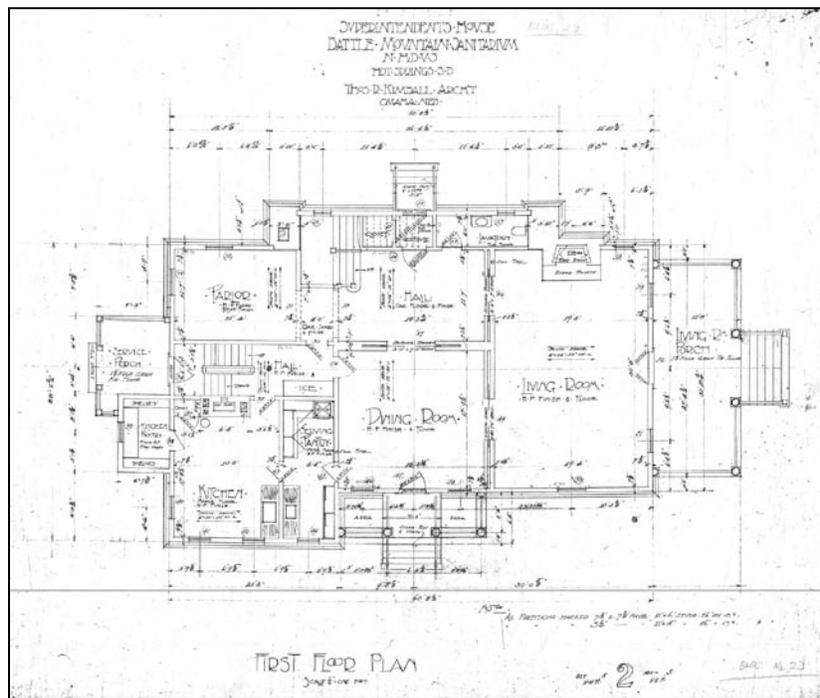
Figure 6: Thomas Rogers Kimball, First Floor Plan, "Superintendent's House," (October 1905)
Source: Hot Springs Campus Drawing Files

1. Floor plans: The Governor's Quarters features a typical domestic arrangement of living spaces and kitchen on the first floor and bed chambers on the second floor and in the finished attic. The front doorway leads to a large entry hall with an open well stairway. Rooms on the first floor include parlor, living room, dining room, kitchen, water closet and two pantries. The second floor has five bedrooms and two bathrooms arranged around the stair hall. Several bedrooms are located in the finished attic and appear to be original, or early alterations. The Governor's Quarters includes finished spaces in the basement as well.

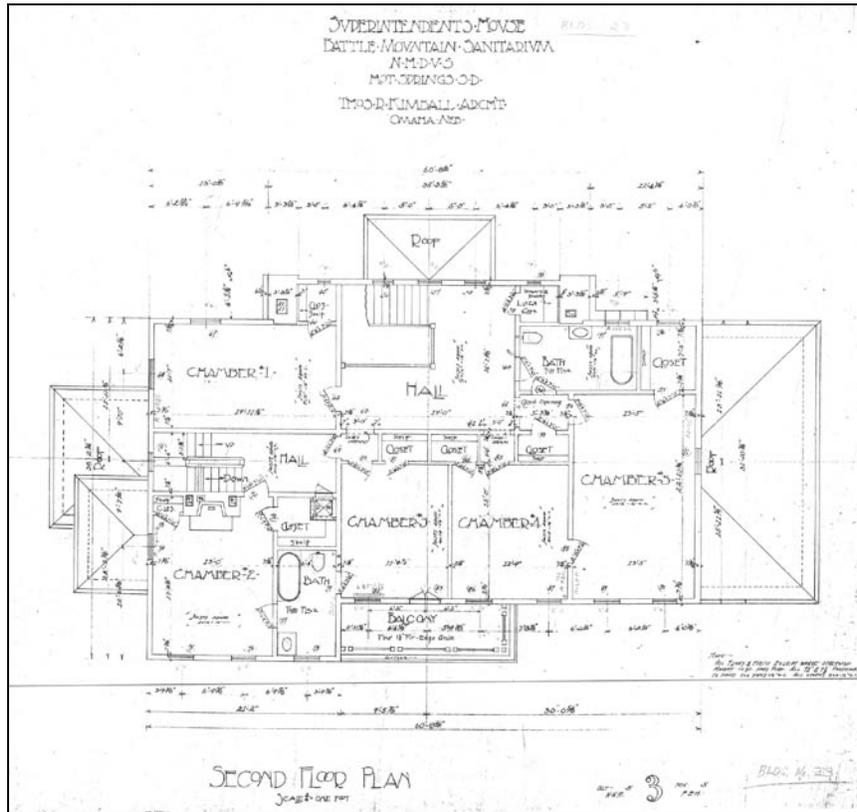
Figure 7: Thomas Rogers Kimball, Second Floor Plan, "Superintendent's House," (October 1905)
Source: Hot Springs Campus Drawing Files

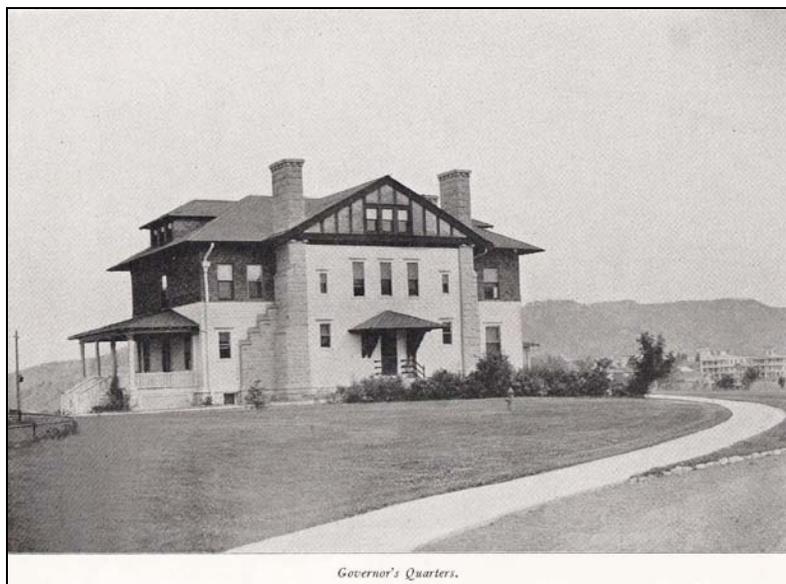
Figure 8: Governor's Quarters, c. 1919
Source: *Battle Mountain Sanitarium: Branch National Home for Disabled Volunteer Soldiers.*

Designating Battle Mountain a sanitarium rather than another branch residential home indicated the growing emphasis on medical care by the NHDVS.¹² The aging of the member population and the steady decrease of their numbers presented a particular challenge to the NHDVS. More costly medical care was needed, increasing per capita costs. This situation persisted and grew more urgent with the advent of World War I. Now rather than slowly becoming obsolete through age and deferred maintenance, the Homes would need to serve a new generation of disabled veterans, many with tuberculosis caused by trench warfare conditions. The new conflict would create unprecedented veteran demand for medical care. Governor and Head Surgeon in this period was James A. Mattison, who would go on to be Chief Surgeon for the NHDVS after the war.¹³ A photograph of the exterior of the Governor's Quarters published in a c. 1919 souvenir booklet shows the house during Mattison's tenure (Figure 8). The landscaping was starting to mature and the fine views are visible.
