ADDENDUM TO:
NATIONAL HOME FOR DISABLED VOLUNTEER SOLDIERS -
BATTLE MOUNTAIN SANITARIUM, MESS HALL
(Hot Springs Veterans Administration Medical Center, Building No. 2)
(VA Black Hills Health Care System - Hot Springs Campus, Building
No. 2)
500 North Fifth Street
Hot Springs
Fall River County
South Dakota

NATIONAL HOME FOR DISABLED VOLUNTEER SOLDIERS –
BATTLE MOUNTAIN SANITARIUM, MESS HALL
(Hot Springs Veterans Administration Medical Center, Building No. 2)
(VA Black Hills Health Care System - Hot Springs Campus, Building No. 2)

HABS No. SD-24-F

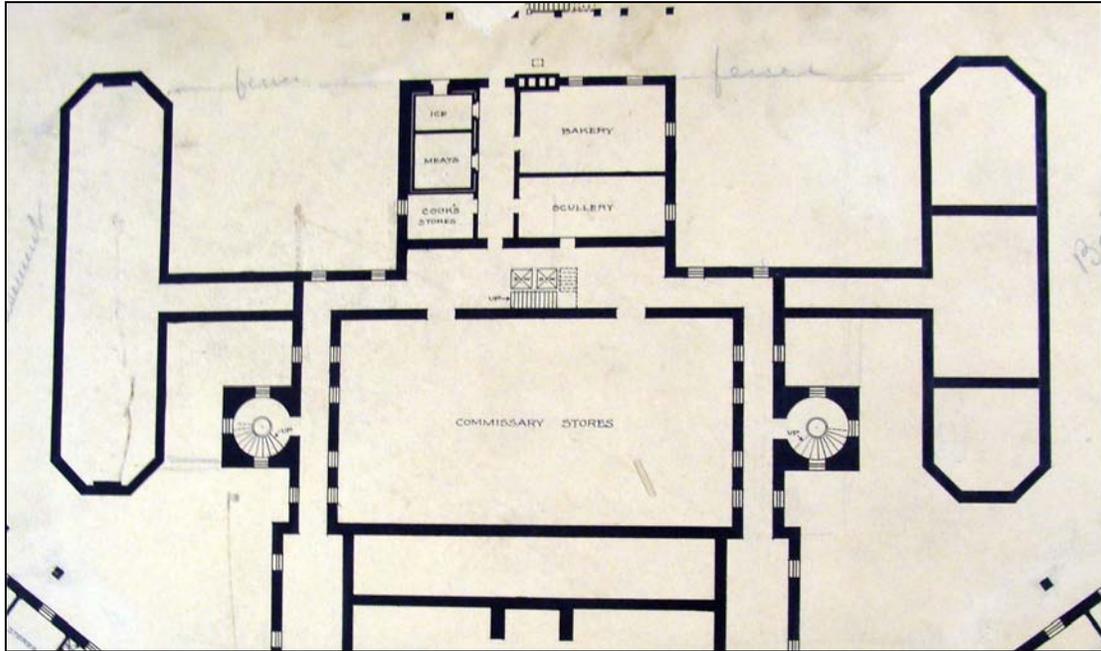
Figure 1: Excerpt of "Proposed Battle Mountain Sanitarium Basement Floor Plan" showing Mess Hall/Service Building, c. 1902
Source: Kimball Papers, Nebraska State Historical Society

Floor plans labeled "Proposed Battle Mountain Sanitarium" are available in the Thomas Rogers Kimball Papers at the Nebraska State Historical Society. These drawings do not have a date, but seem to show the Mess Hall/Service Building largely as constructed. The basement houses a large room for "Commissary Stores" under the main section and smaller rooms to the rear for a bakery, scullery, and storage for meat, ice, and additional "cook's stores" (Figure 1). The first floor plan included a 300-seat mess hall with the kitchen in an ell to the rear (Figure 2). The kitchen included a rear porch with a garbage hopper. A dog leg stair with a pair of dumbwaiters at the ell [no longer extant] was located in the kitchen at the center of the partition wall with the dining room. Circulation between the kitchen and dining room was accomplished via passages on each side of the stairs. One single passage led through a large serving closet labeled "Bread," while a pair of passages on the other side provided two-way traffic for servers, one past a china closet. The second floor was divided into separate sections for male and female employees, each accessed via its own stair tower on the side elevation (Figure 3). The male employee section occupied one third of the plan and included a large dormitory and a bath/shower room. The remaining two-thirds of the second floor included a smaller dormitory and bath for female employees, four small bedrooms, an "officers' dining room," and a serving room across the hall with access to the kitchen dumbwaiters. An L-shaped corridor in this section traveled from the spiral stair on the side to the upper flights of the dog leg stair leading to the kitchen.

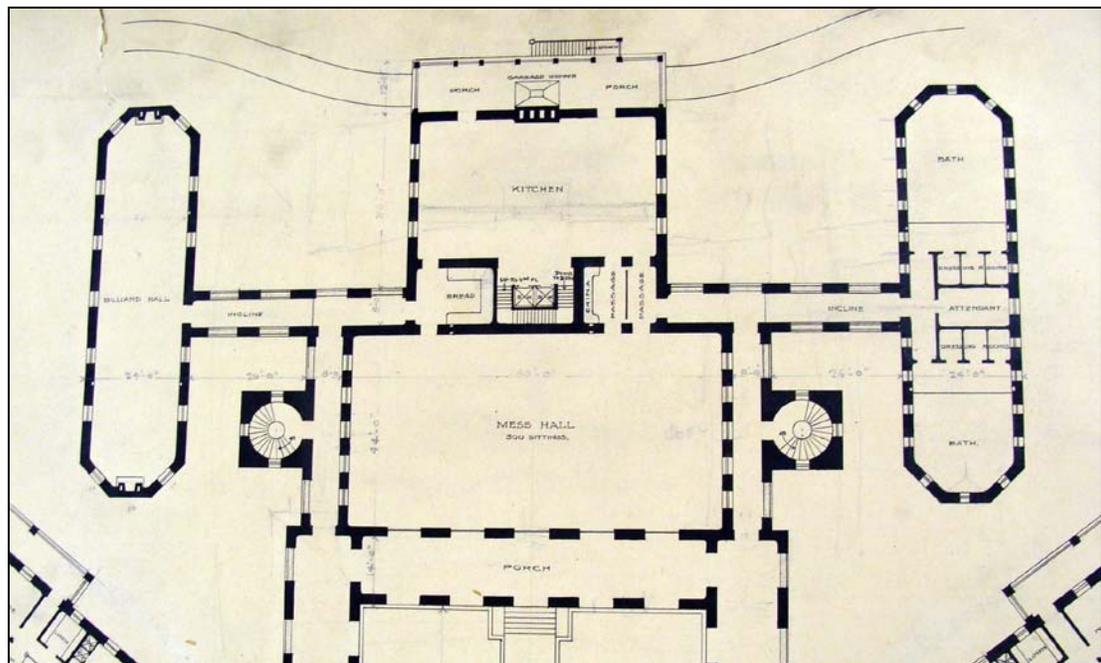
Figure 2: Excerpt of "Proposed Battle Mountain Sanitarium First Floor Plan" showing Mess Hall/Service Building, c. 1902
Source: Kimball Papers, Nebraska State Historical Society

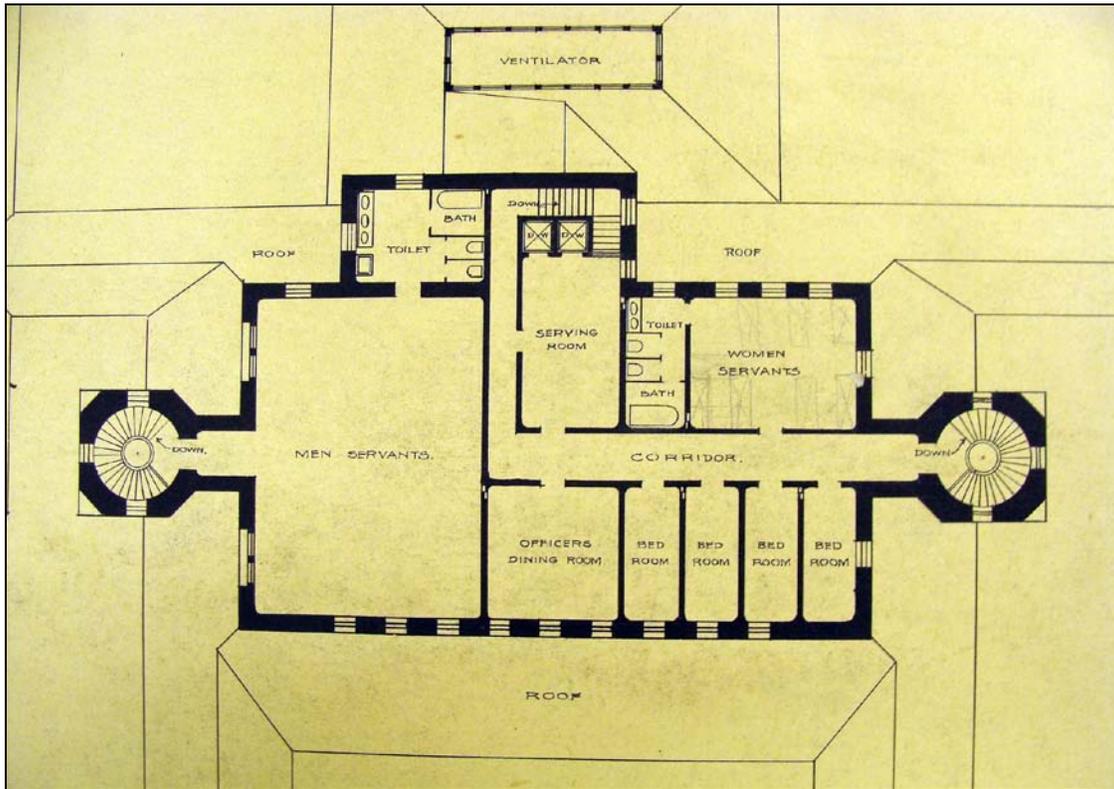
Figure 3: Excerpt of "Proposed Battle Mountain Sanitarium Second Floor Plan" showing Mess Hall/Service Building, Second Floor Plan, c. 1902
Source: Kimball Papers, Nebraska State Historical Society

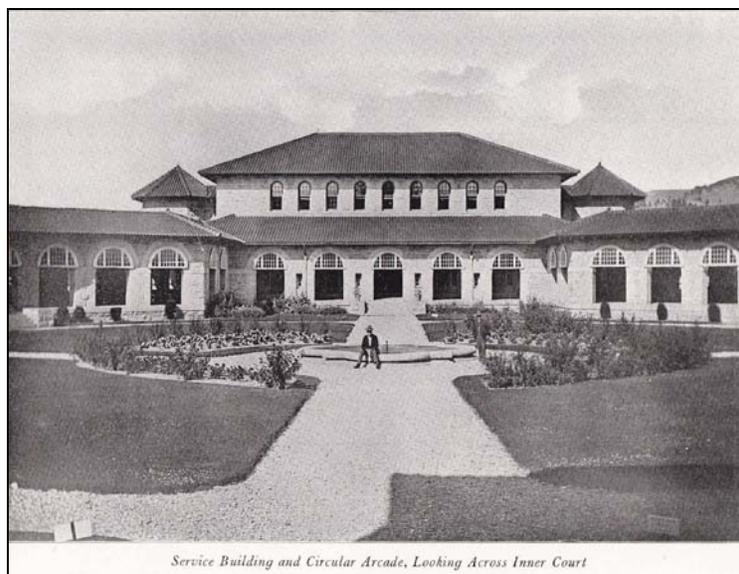
Figure 4: View of Service Building from Courtyard, c. 1919
Source: *Battle Mountain Sanitarium: Branch National Home for Disabled Volunteer Soldiers.*

room in the Mess Hall/Service Building (Figure 4).⁸ The features of this section of the Sanitarium were covered thoroughly in a local newspaper article about the opening:

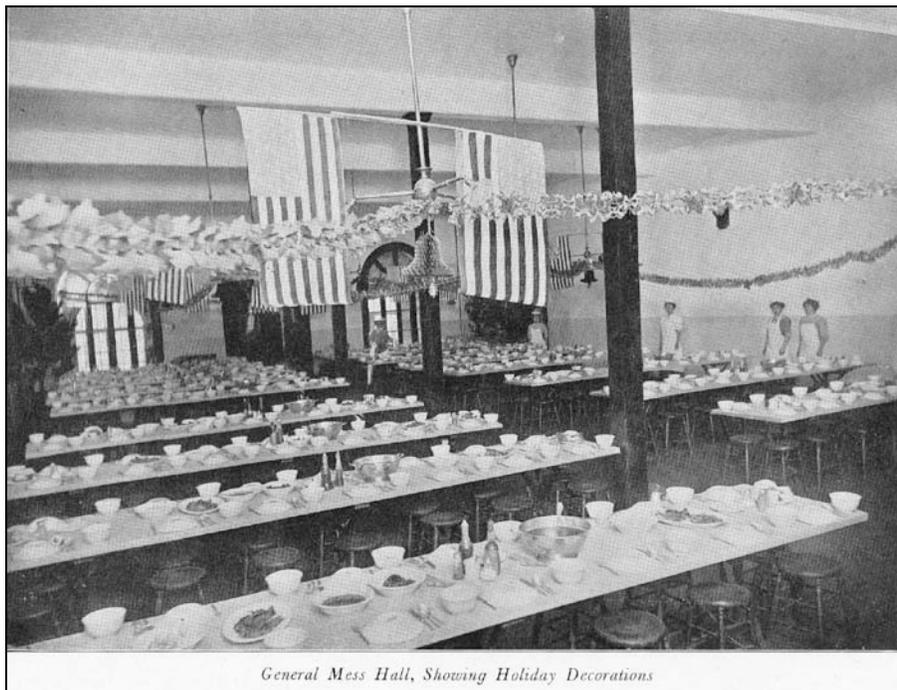
Figure 5: Interior view of Dining Room, c. 1919

Early photographs of the interior of the dining room show the long tables, with a main access aisle running laterally across the room (Figure 5). This seems to represent a change from the early plans, which showed only windows on these side walls. In a souvenir booklet for the Battle Mountain Sanitarium the spaces listed in the "service building" included the dining room, kitchen, bakery, cold storage plant, sleeping rooms for help, band room, Quartermaster's and Commissary rooms.¹⁰

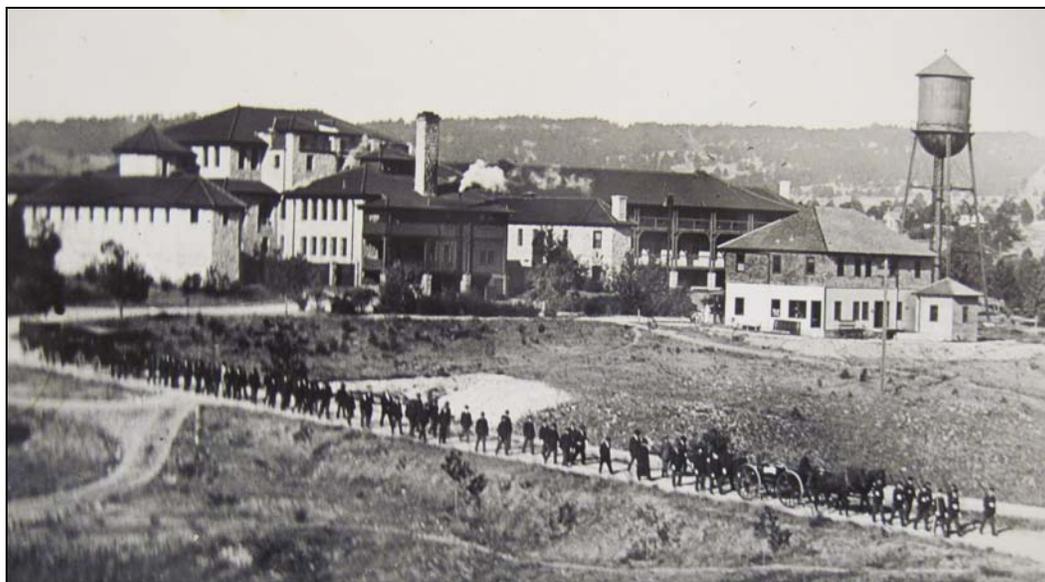
Figure 6: View of Funeral Procession Traveling to Cemetery, n.d.

Note open porch at Mess Hall kitchen ell.

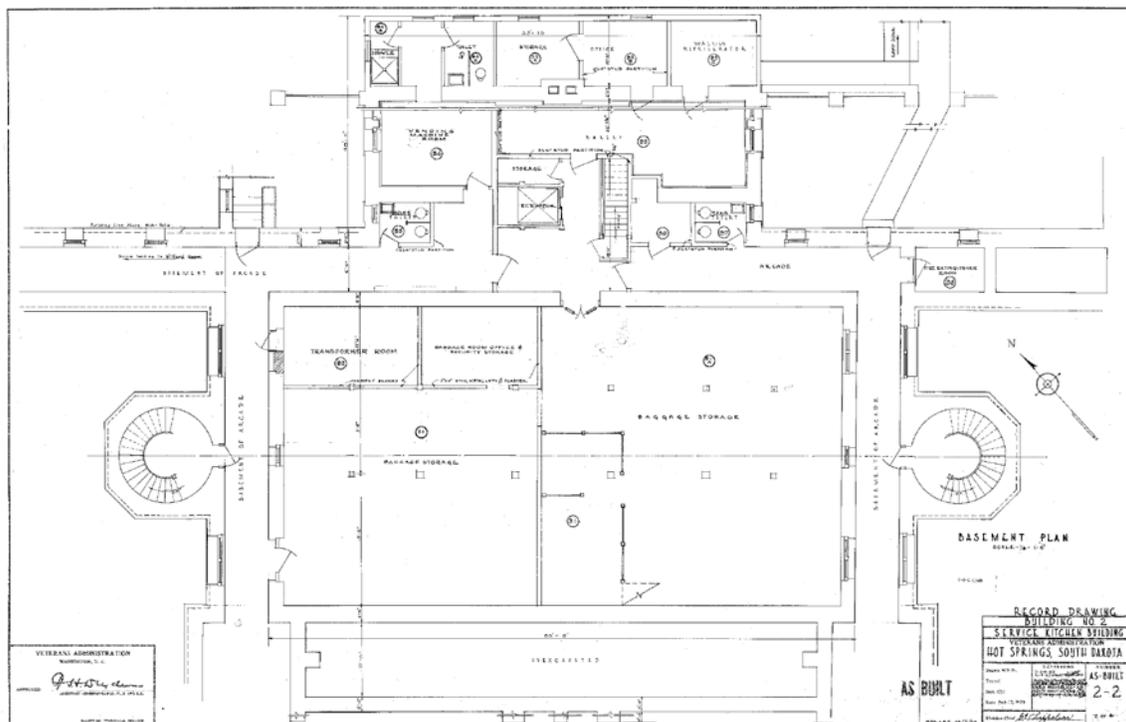
Figure 8: Building No. 2, Basement Floor Plan, 1953
Source: Hot Springs Campus Drawing Files

Floor plans from 1950s indicate the changing use of some areas in the Mess Hall/Service Building. The basement level housed a bathroom, storage room, office, and walk-in refrigerator in the former open area below the porch (Figure 8). The stairway and elevator was reconfigured, taking space away from the bakery. The storerooms in this area were also reconfigured into a single vending machine room. The large storage area under the main block was partitioned into several baggage storage rooms and a transformer room with cement block interior walls. A down staircase indicates the presence of the added subbasement. In 1959 stainless steel cafeteria fixtures were installed in the mess hall, replacing the table service provided in previous years with cafeteria-style self-serve.¹⁷ Presumably the kitchen would still provide tray service for any bedridden veterans. These changes were reflected on the revised first floor plan, including a new

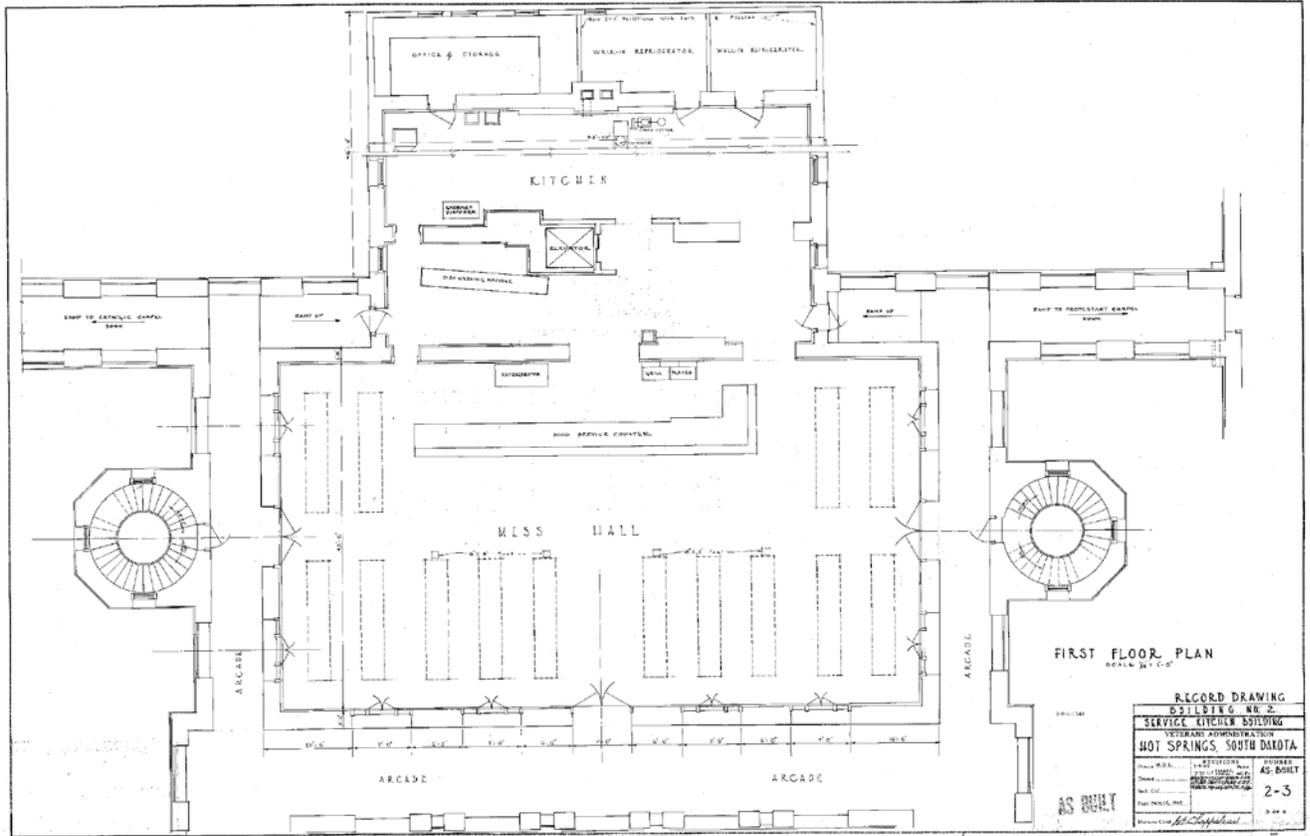
Figure 9: Building No. 2, First Floor Plan, 1953
 Source: Hot Springs Campus Drawing Files

food service counter and expanded openings between the dining room and kitchen (Figure 9). Two walk-in refrigerators were located in the originally open section of the rear porch.

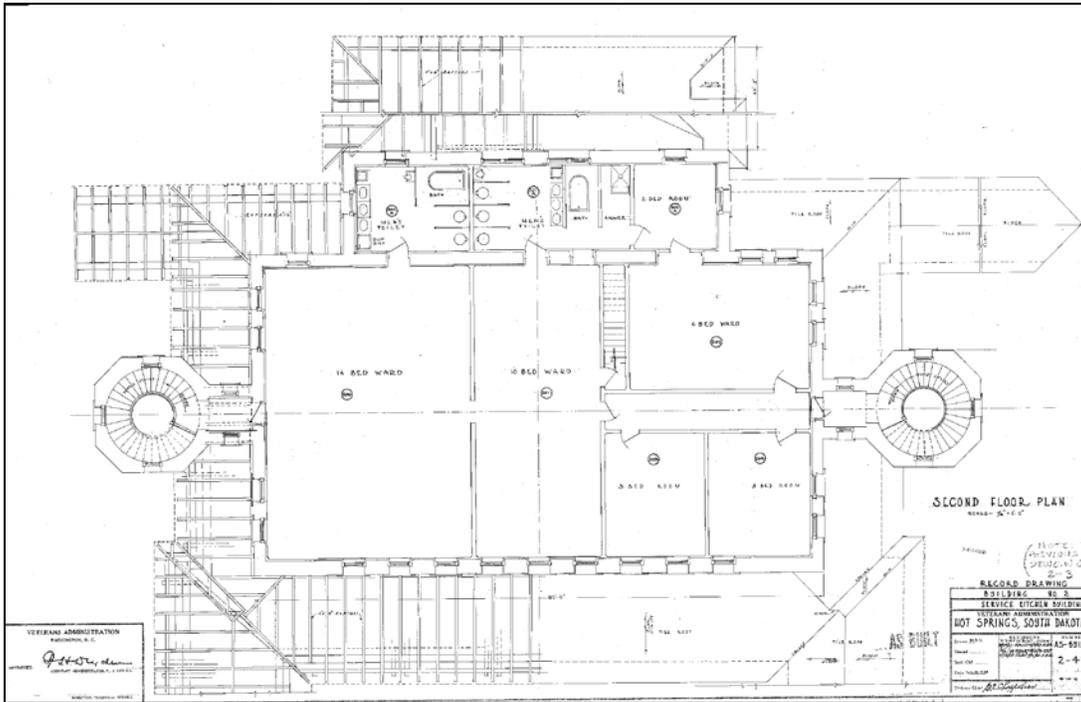
Figure 10: Building No. 2, Second Floor Plan, 1953
 Source: Hot Springs Campus Drawing Files

On the second floor, the floor plan was altered to be more symmetrical, with a transverse hall running across the main block between the side spiral stairways (Figure 10). The partially open rear balcony was now fully enclosed and contained a large bathroom and a two-bed room. The rest of the floor contained a 14-bed ward, a 10-bed ward, a 6-bed ward and two 3-bed rooms. It seems that these were used to house patients, not staff in this period. Another drawing of the second floor from 1988 shows the floor plan as it exists today, with a double-loaded transverse corridor of small offices and meeting rooms, and an elevator and modern men's and ladies bathrooms at the rear section (Figure 11).

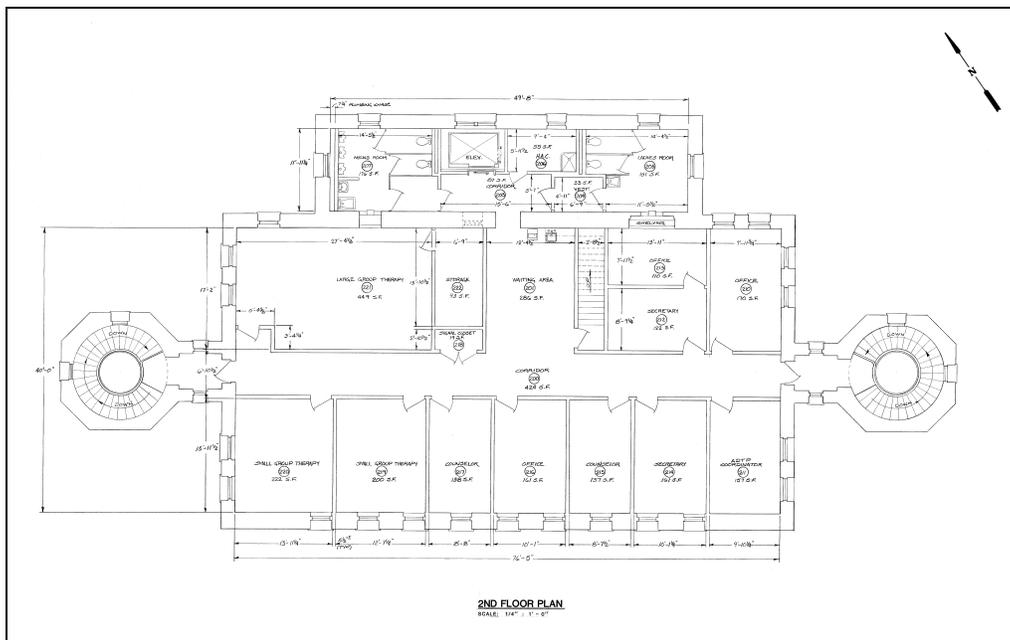
Figure 11: Building No. 2, Second Floor Plan, 1988
 Source: Hot Springs Campus Drawing Files
