CEDAR PASS LODGE, CABIN 14-16
Badlands National Park
20681 South Dakota Highway 240
Interior
Jackson County
South Dakota

HABS SD-25-L
HABS SD-25-L

HISTORIC AMERICAN BUILDINGS SURVEY

HABS No. SD-25-L

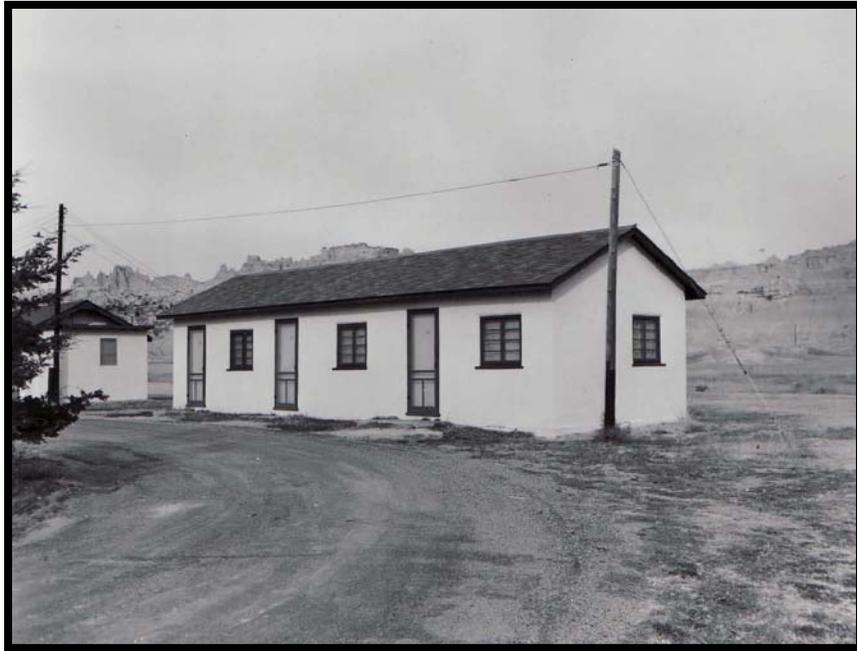
Figure 1: Cabin 14-17, front view (November 1965).

Note - the rear bedroom of Unit 16 was designated Unit 17 at this time

B. Early Views: Views from the 1960s show alteration of the stucco exterior and the intact wood sash windows (see Figures 1, 2, and 3).
