NATIONAL HOME FOR DISABLED VOLUNTEER SOLDIERS -
BATTLE MOUNTAIN SANITARIUM, WARD 4
(Hot Springs Veterans Administration Medical Center, Domiciliary 4)
(VA Black Hills Health Care System - Hot Springs Campus, Building
No. 4)
500 North Fifth Street
Hot Springs
Fall River County
South Dakota

HABS SD-24-T
HABS SD-24-T

NATIONAL HOME FOR DISABLED VOLUNTEER SOLDIERS –
BATTLE MOUNTAIN SANITARIUM, WARD 4
(Hot Springs Veterans Affairs Medical Center, Building No. 4)
(VA Health Care System - Hot Springs Campus, Building No. 4)

HABS No. SD-24-T

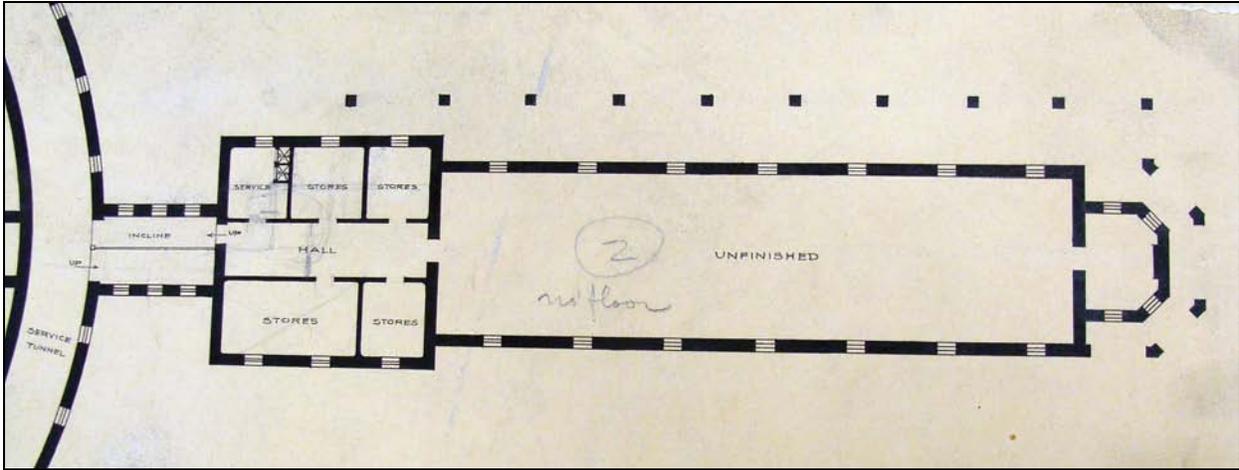
Figure 1: Excerpt of "Proposed Battle Mountain Sanitarium Basement Floor Plan"
showing Ward 2 (4), c. 1902
Source: Kimball Papers, Nebraska State Historical Society

"unfinished" while the service area near the connecting hyphen included four small storerooms and a room labeled "service" containing two dumbwaiters (Figure 1). The first floor plan shows 28 beds each placed between windows (Figure 2). The day room at the outer end of the pavilion is designated as the "smoking room." A hall travels through the connecting service block with toilet room, bath room, patients' clothing locker room on one side, and a nurses' room, linen closet, and tea room where the dumbwaiters are located. The ramps providing access between floors are indicated starting at the center of the hall in the service block.

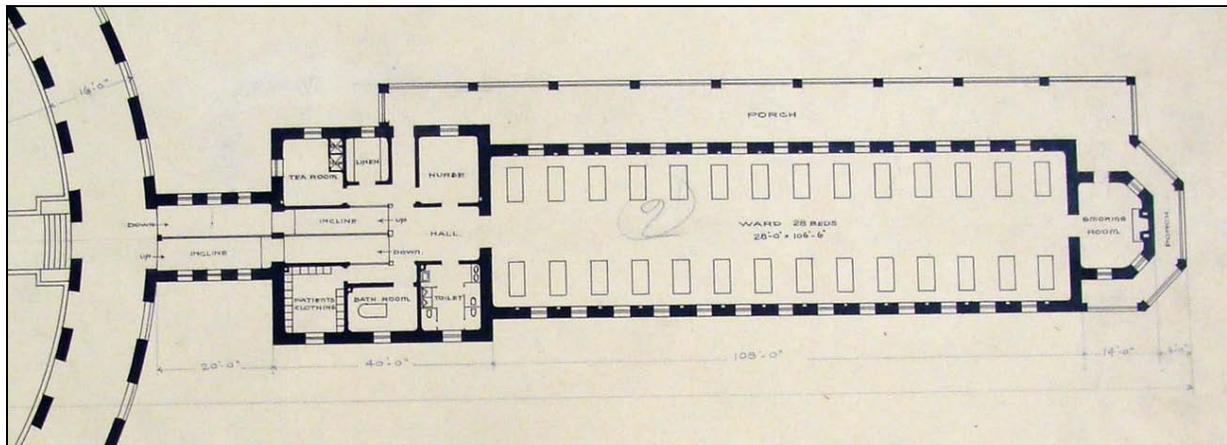
Figure 2: Excerpt of "Proposed Battle Mountain Sanitarium First Floor Plan"
showing Ward 2 (4), c. 1902
Source: Kimball Papers, Nebraska State Historical Society

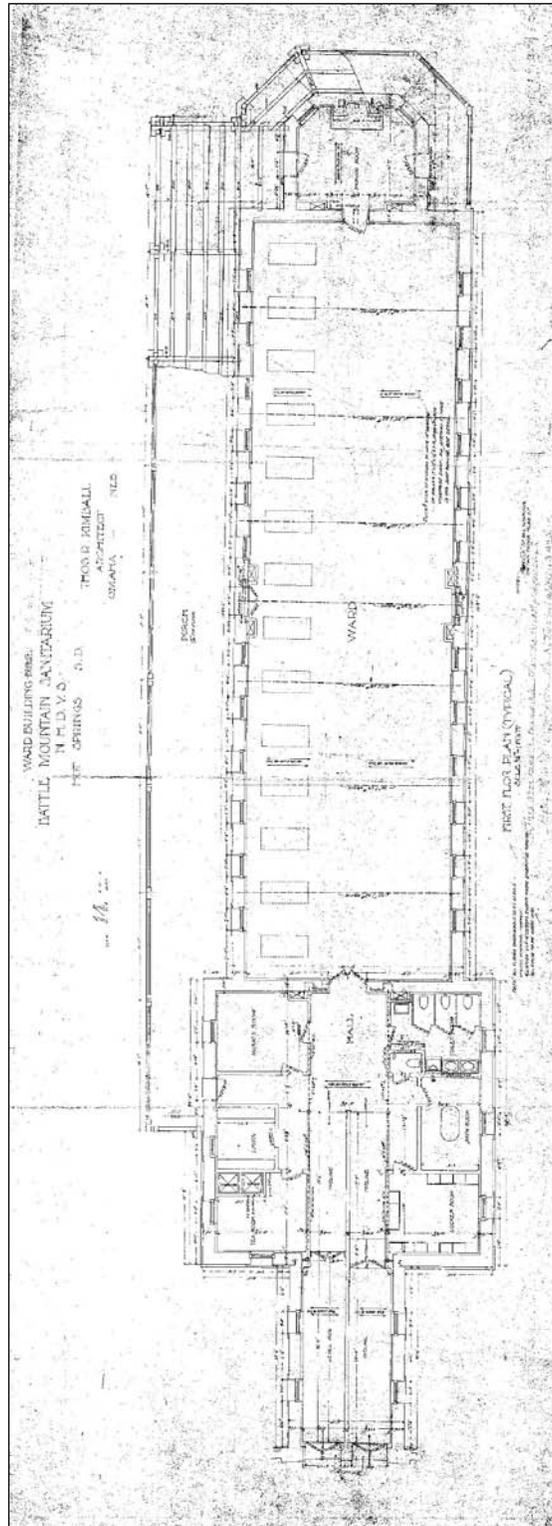
Figure 3: Thomas Rogers Kimball, Ward 2 (now 4), First Floor Plan (Typical), (11 June 1903)
Source: Hot Springs Campus Drawing Files

A more detailed version of the "Typical Floor Plan" for the three east wards is dated June 11, 1903 (Figures 3 and 4). These drawings show the first and second floors in more detail, with notes regarding pulp floors in the ward, fir floor boards at the wrap-around porch, and interior finishes of hard pine. Pulp floors were a hard fiber-based composite material considered sanitary for a hospital setting, being non-absorbent and easy to clean. Pairs of ventilation ducts are indicated at the center and ends of the wards. Air from each floor was kept separate and mechanically circulated via a system of vents and ducts connecting from the fan room in the basement to ventilators in the roof.

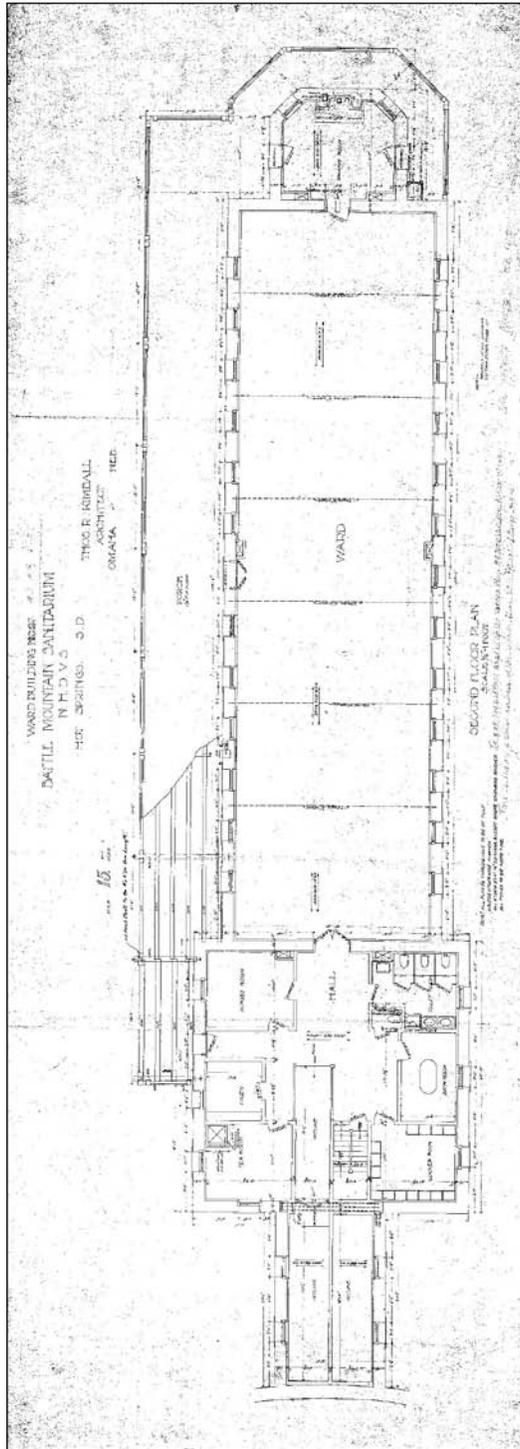
Figure 4: Thomas Rogers Kimball, Ward 2 (4), Second Floor Plan (Typical), (11 June 1903)
Source: Hot Springs Campus Drawing Files

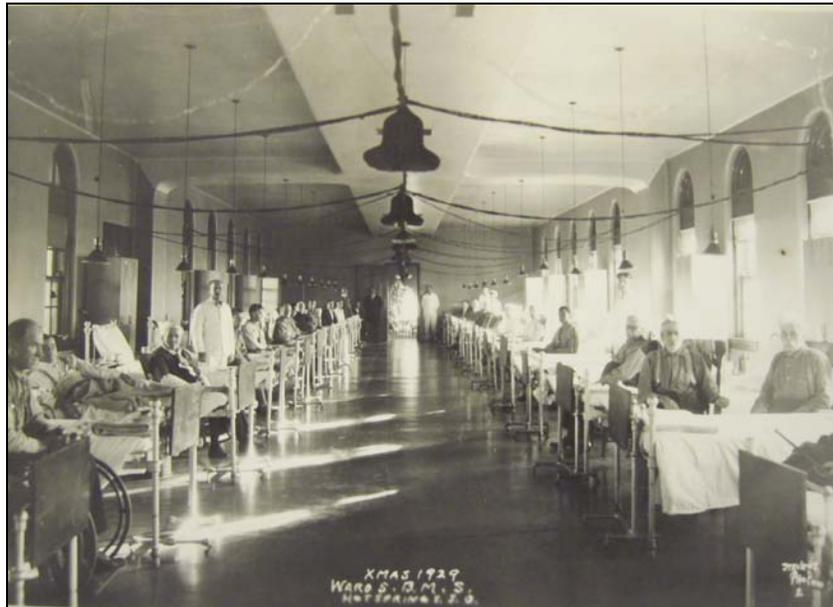
Figure 6: Interior of Ward 5 (Second Floor), (December 1929)
Note ventilation ducts and intake on ceiling and side walls.
Source: Courtesy of Hot Springs Public Library

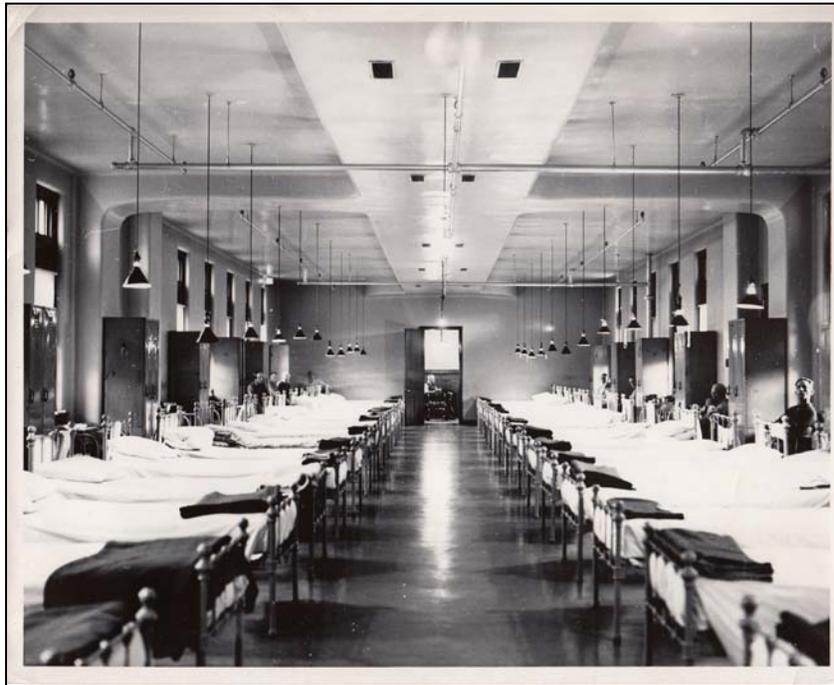
Figure 7: Interior of Ward, c. 1940
Source: Battle Mountain VA Museum Collection

During the mid-1950s, renovations to the domiciliary included new asphalt tile floors, fluorescent lighting, and new bathroom fixtures in the wards (Figures 7 and 8).²⁰ Some three-quarter height partitions were added to separate beds in the wards. While this change marred the original ventilation scheme of the open ward, creating some semi-private spaces was the priority now. Floor plans from 1952 indicate the layout of Building No. 4 shortly before some of these changes (Figure 9). The light partitions are present and all the rooms in the service area except the bath and shower rooms have been converted into 1 or 2-bed wards. The elevator has not yet been added and the bath and shower rooms retain their original configuration. The ventilation ducts are still indicated at the center of the ward, with the fan room surrounded by offices in the basement.

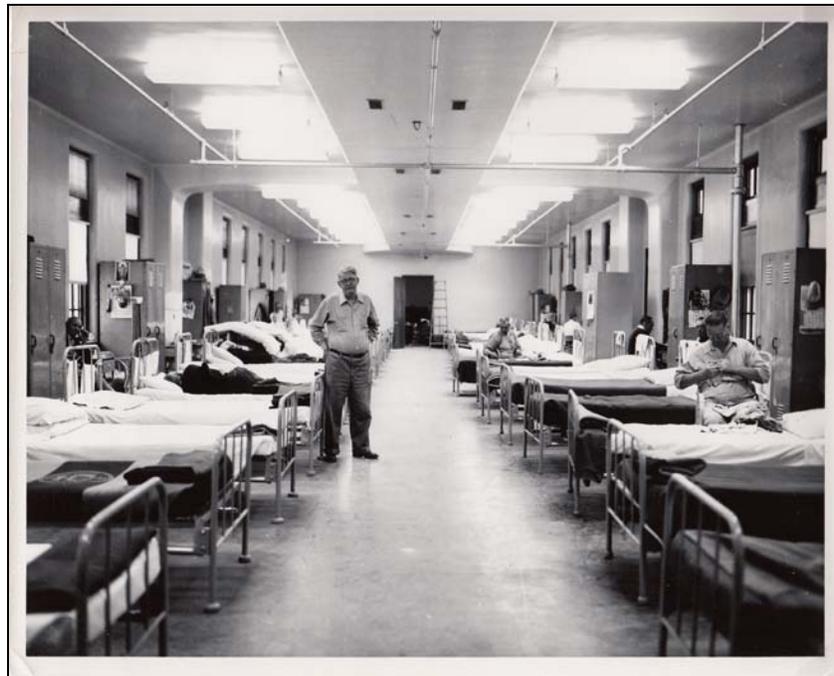
Figure 8: Interior of Ward, c. 1960
Source: Battle Mountain VA Museum Collection

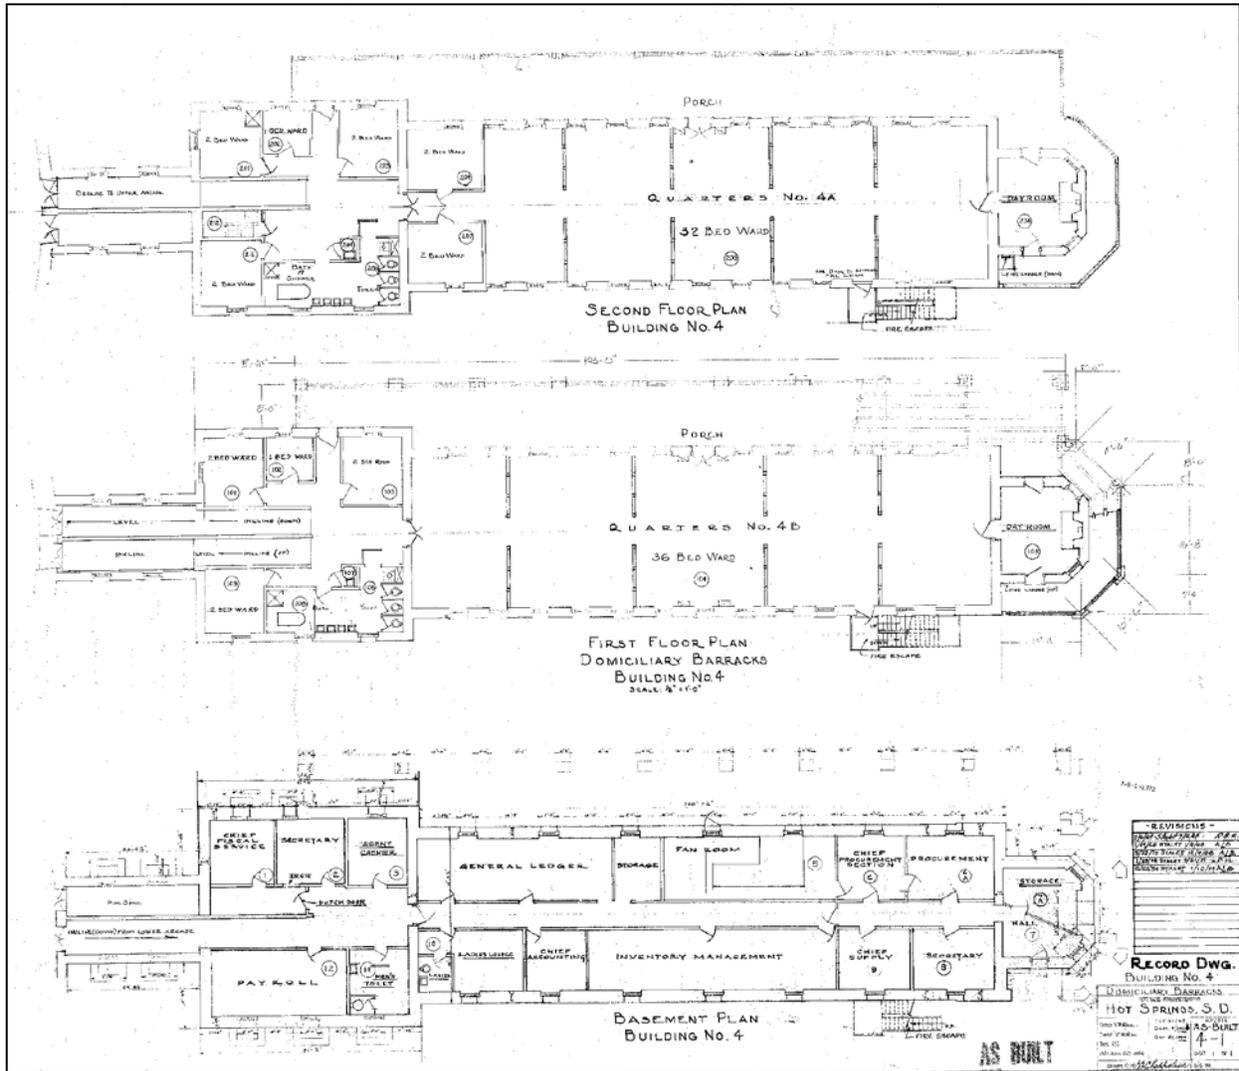
Figure 9: Building No. 4 Floor Plans, (20 August 1952)
 Source: Hot Springs Campus Drawing Files
