Eureka Post Office
205 Main
Southeast corner of Main
and Wallace Alley
~~City of Eureka~~
Juab County
Utah

HABS No. UT-136

HISTORIC AMERICAN BUILDINGS SURVEY
EUREKA POST OFFICE
EUREKA, UTAH
HABS No. UT-136

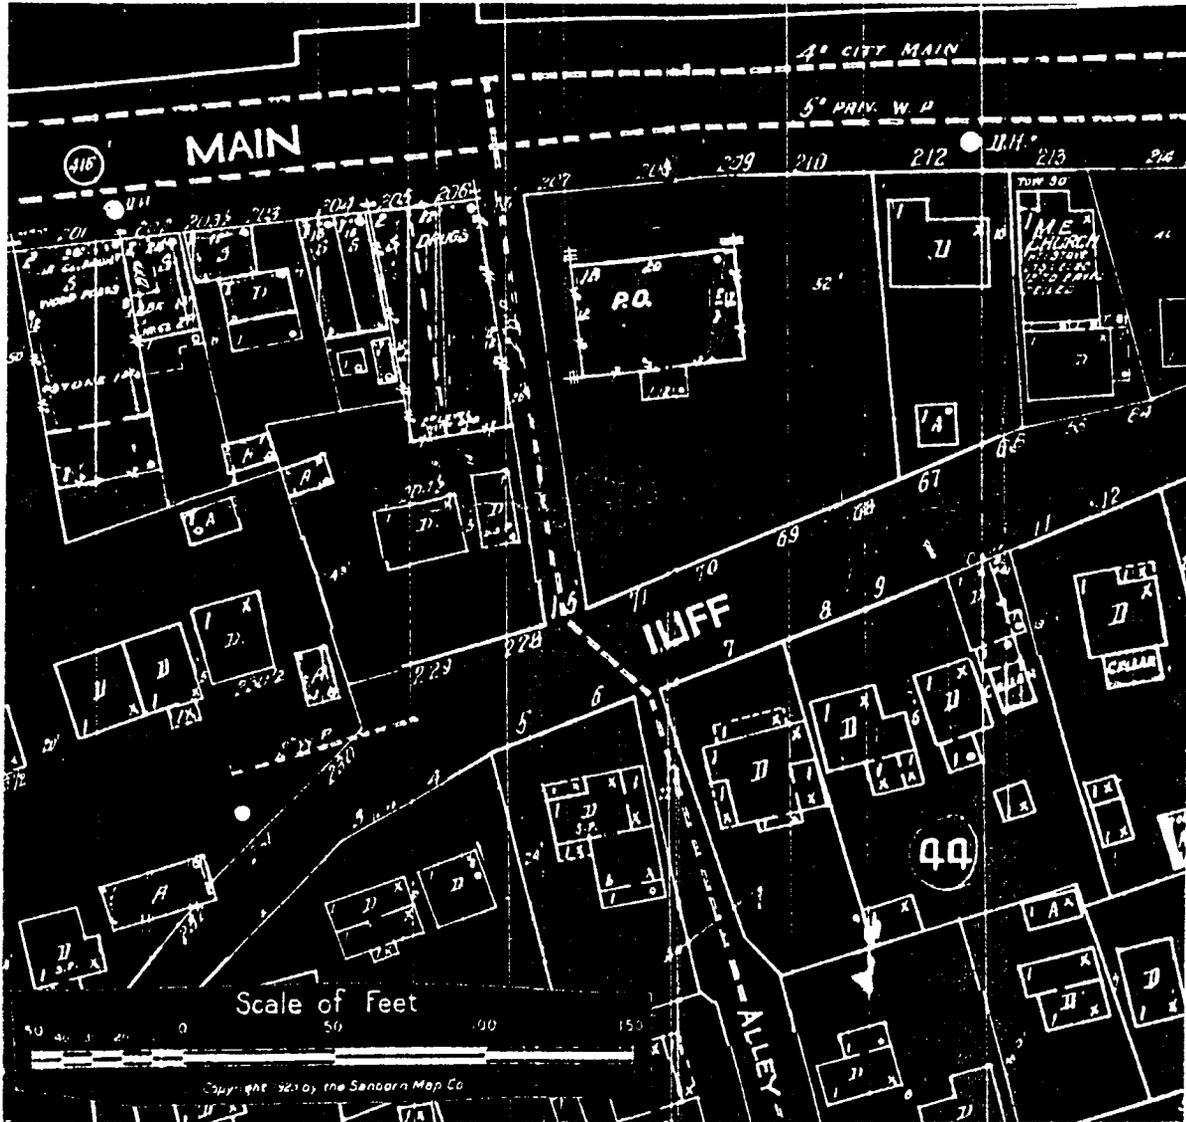
SANBORN FIRE INSURANCE MAP, 1923 (1930 update)

SOURCE: Sanborn Map Company, "Eureka, Utah," fire insurance map, 1923 (with updates through 1930). In the files of the Utah Historical Society, Salt Lake City, Utah.

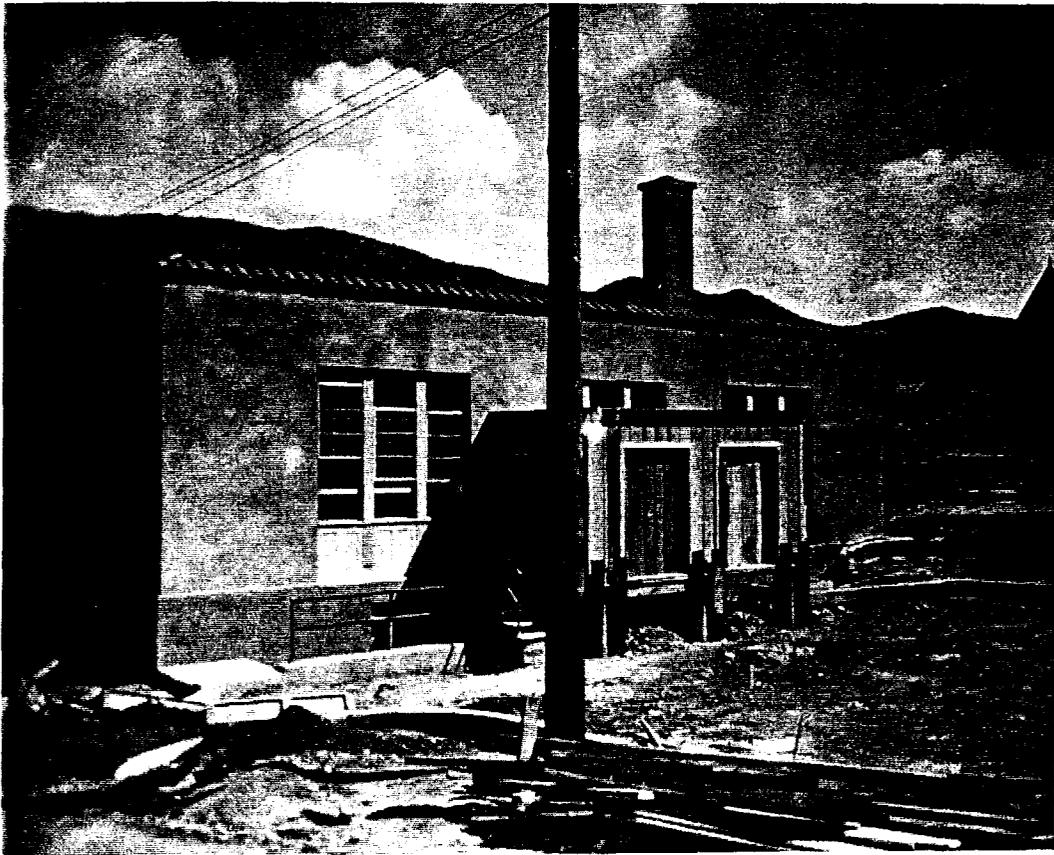
PHOTOGRAPH OF REAR, 1923

This 2 July 1923 photograph (view northeast) depicts construction progress on the rear of the nearly completed building, showing the mailing vestibule and construction debris still littering the site. SOURCE: In the files of the Postmaster, Eureka Post office, Eureka, Utah.

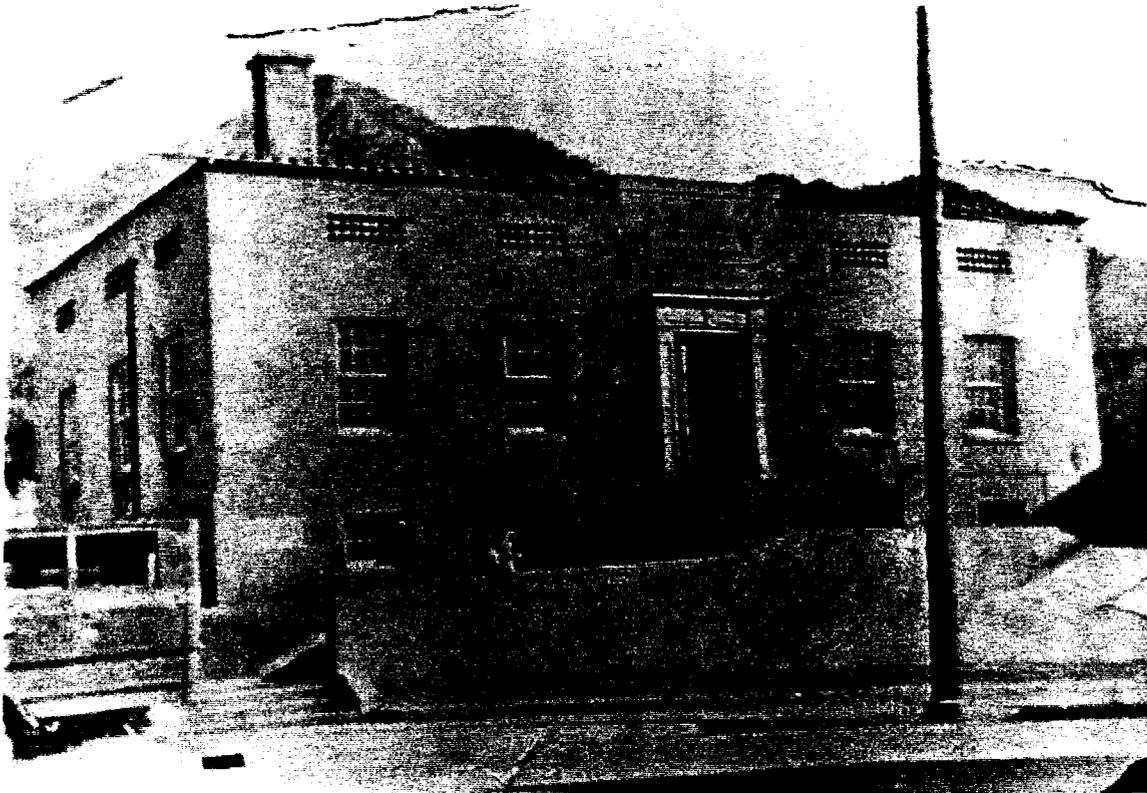
PHOTOGRAPH OF FACADE AND EAST SIDE, 1920s

The completed Eureka Post Office is shown in this 1920s era photograph (view southwest), which documents the width of the original stair retaining wall. SOURCE: In the files of the Tintic Historical Society, Eureka, Utah.
