CHOPAWAMSIC RECREATIONAL DEMONSTRATION AREA -
CABIN CAMP 1, INFIRMARY
(Prince William Forest Park Cabin Camp 1 - Goodwill, Building 70)
Prince William Forest Park
Prince William Forest Park
Triangle
Prince William County
Virginia

HABS VA-1494-C
HABS VA-1494-C

CHOPAWASMIC RECREATIONAL DEMONSTRATION AREA – CABIN CAMP 1, INFIRMARY

HABS No. VA-1494-C

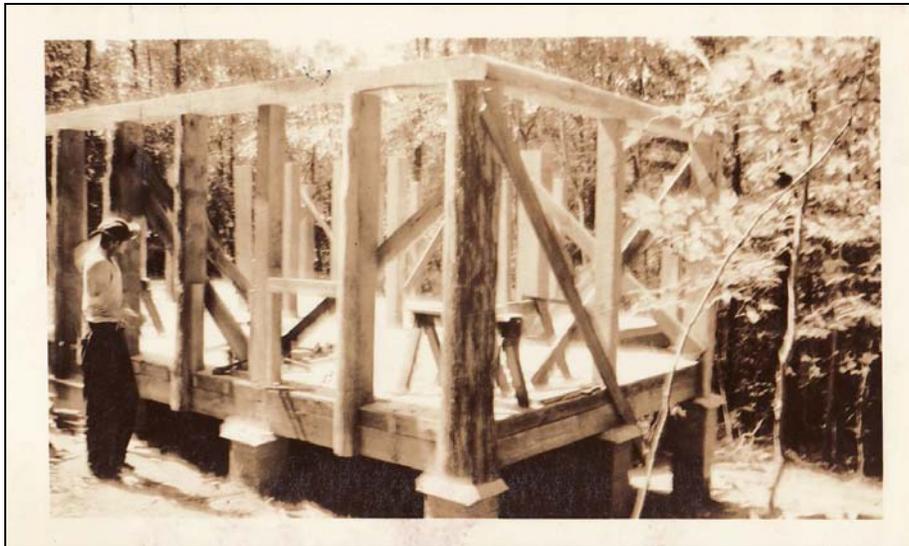
Figure 1: Camp 1 Infirmary Under Construction, 1936.
Source: File 3455, PRWI Archives.

4. Builder, contractor, suppliers: Using Emergency Conservation Work (ECW) funding, the Camp 1 Infirmary was built by CCC enrollees living on site at Camp SP-22-VA and by Local Experienced Men (LEMs) hired with WPA relief funds to provide skilled labor. Much of the construction material was acquired and processed on site, including the timber, siding, and gravel. Millwork such as window sashes and doors were purchased.

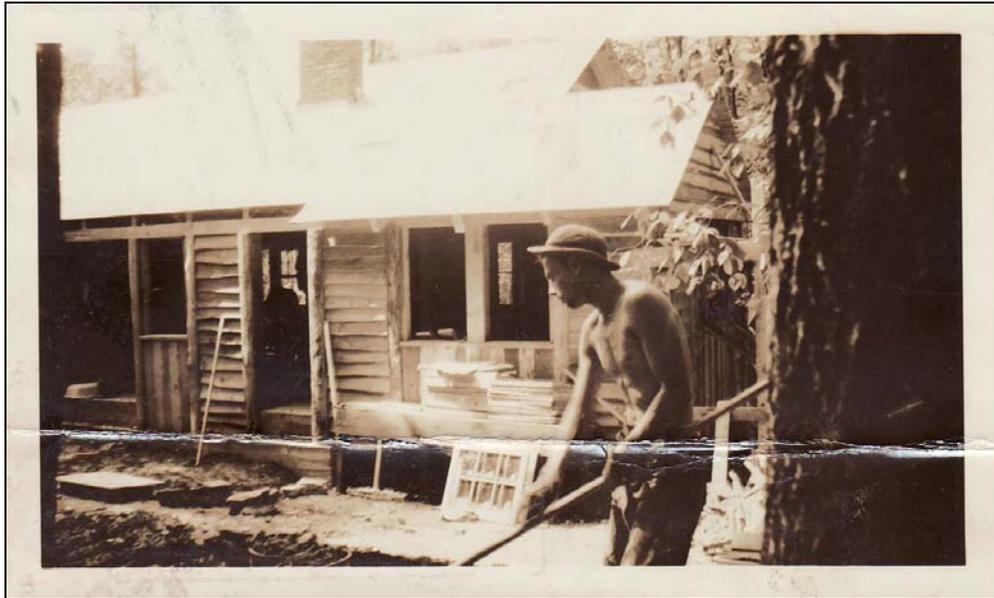
Figure 2: Camp 1 Infirmary Under Construction, 1936.
Source: File 3455, PRWI Archives.

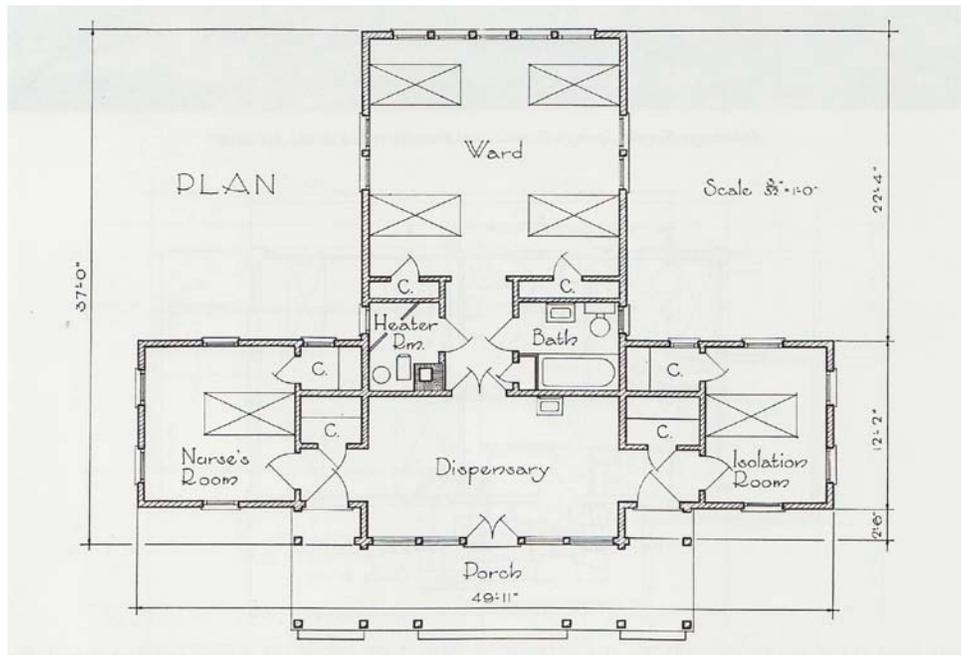
Figure 3: Chopawamsic RDA Infirmary Plan (Camp 2).
The Camp 2 Infirmary had a different plan than Camp 1, but the same types of interior rooms.
Source: adapted from Good, *Park and Recreation Structures*.

as peeled logs with the knots and texture preserved.¹¹ The "Overnight and Organized Camp Facilities" section of Good's book includes a number of examples from Chopawamsic, including a Chopawamsic infirmary with a T-shaped plan, probably Camp 2 (Figure 3).¹² While the Camp 1 Infirmary has a stepped rectangular plan instead, the interior spaces were the same -- a dispensary area immediately through the entrance, nurse's room and isolation room to either side, and a ward to the rear. This building also meets the other general recommendations for a camp infirmary published in *Park and Recreation Structures*:
