CHOPAWAMSIC RECREATIONAL DEMONSTRATION AREA -
CABIN CAMP 1, STAFF BATH HOUSE
(Prince William Forest Park Cabin Camp 1 - Goodwill, Building 95)
Prince William Forest Park
Prince William Forest Park
Triangle
Prince William County
Virginia

CHOPAWASMIC RECREATIONAL DEMONSTRATION AREA –
CABIN CAMP 1, STAFF BATH HOUSE
(Prince William Forest Park Cabin Camp 1 – Goodwill, Building 95)

HABS No. VA-1494-G

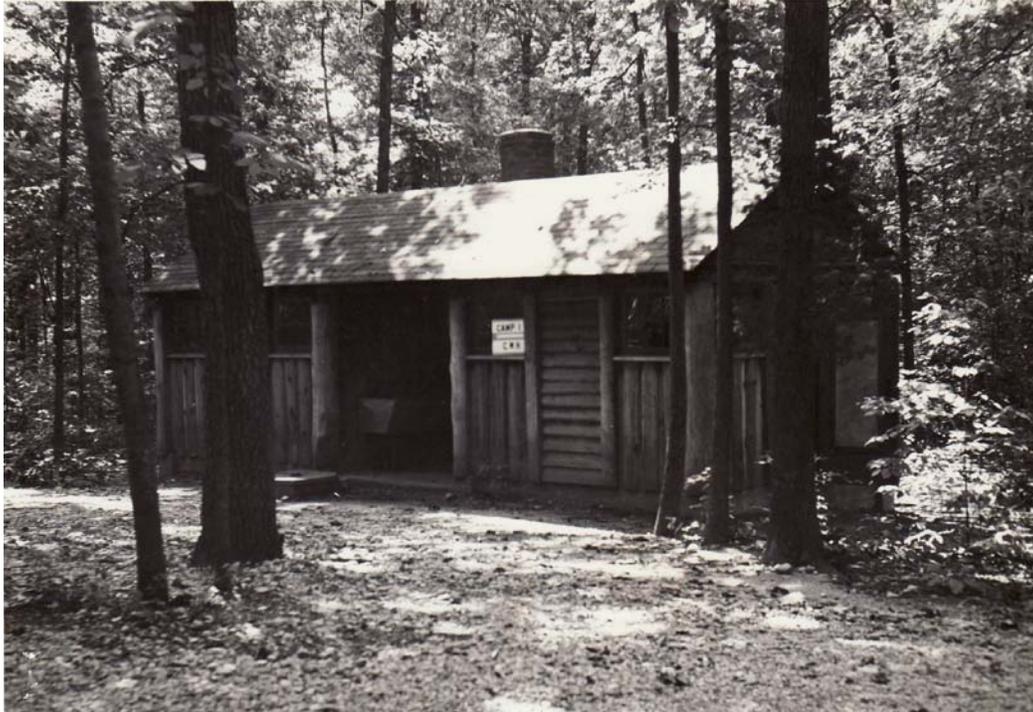
Figure 1: View of Camp 1 Staff House, 1951.
Source: File 2731, PRWI Archives.

Another blueprint from April 5th shows the current form of the building with each bathroom door on a gable end elevation (Figure 1). Skilled labor (30 hours at \$1 per hour) was requested in June to complete installation of the plumbing fixtures. The goal was to be finished by July 1st for the beginning of summer camp.¹⁵ Like all the Chopawamsic buildings, the Staff Bath House was constructed with locally-produced wood structural members and siding, and store-bought other materials such as window sash, Portland cement, and plumbing fixtures. The value of the local materials was calculated at \$29.77 and the cost of the purchased items \$540. The CCC enrollees contributed 446 man days and skilled labor was paid \$60 for plumbing work.¹⁶ The final cost of this building was listed as \$691.¹⁷

- A. Architectural drawings: Two original blueprints for the Staff Bath House are located in the PRWI Archives -- the initial plan from February 21, 1937 and a revised version (doors moved) from April 5, 1937. These drawings are not reproduced here because of the poor quality of the originals. A renovation drawing from 1979 is located in the PRWI Archives.
- B. Early Views: An exterior photograph of the Staff Bath House is located in the PRWI Archives (File 2731) as part of a 1951 inventory (Figure 1).
- C. Bibliography:
