HISTORIC AMERICAN BUILDINGS SURVEY

CHOPAWASMIC RECREATIONAL DEMONSTRATION AREA –
CABIN CAMP 1, CENTRAL BATH HOUSE
(Prince William Forest Park Cabin Camp 1 – Goodwill, Building 75)

HABS No. VA-1494-H

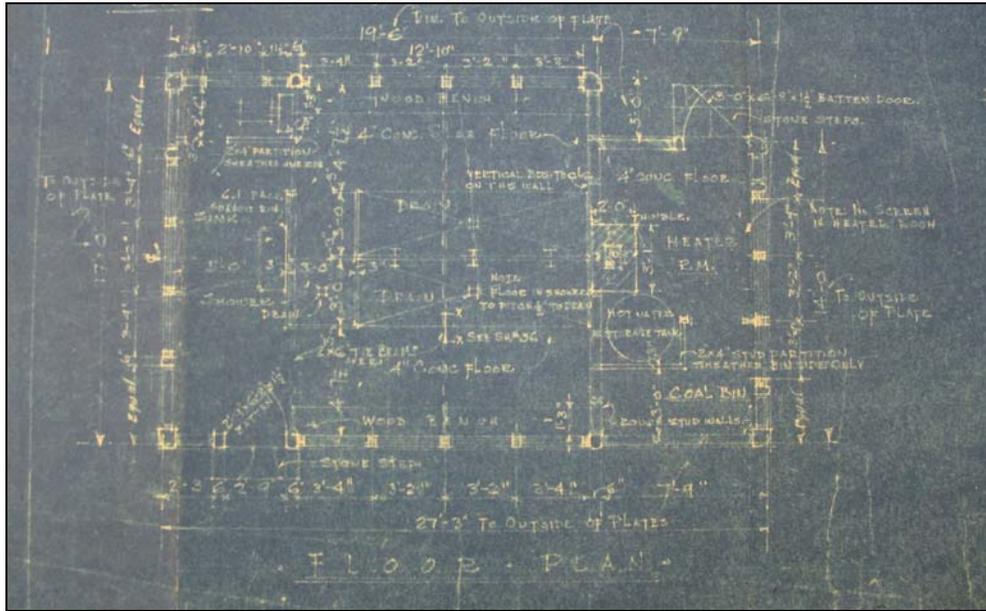
Figure 1: Floor Plan from Camp 1 Central Bath House Blueprint, 1936.
Source: File 2723, PRWI Archives.

1. Floor plans: The Central Bath House has a rectangular plan divided into three spaces – a toilet area on the east end, shower stalls in the center, and a mechanical room for the hot water heater on the west. The mechanical room is only accessible from the exterior and originally contained a coal bin on the north side (Figure 1).

the shower and dressing area. The fixtures appear to be c. 1983. There is a modern hot water heater located in the mechanical room. The original hot water heater was coal burning, as indicated by the coal bin in the 1936 blueprint.

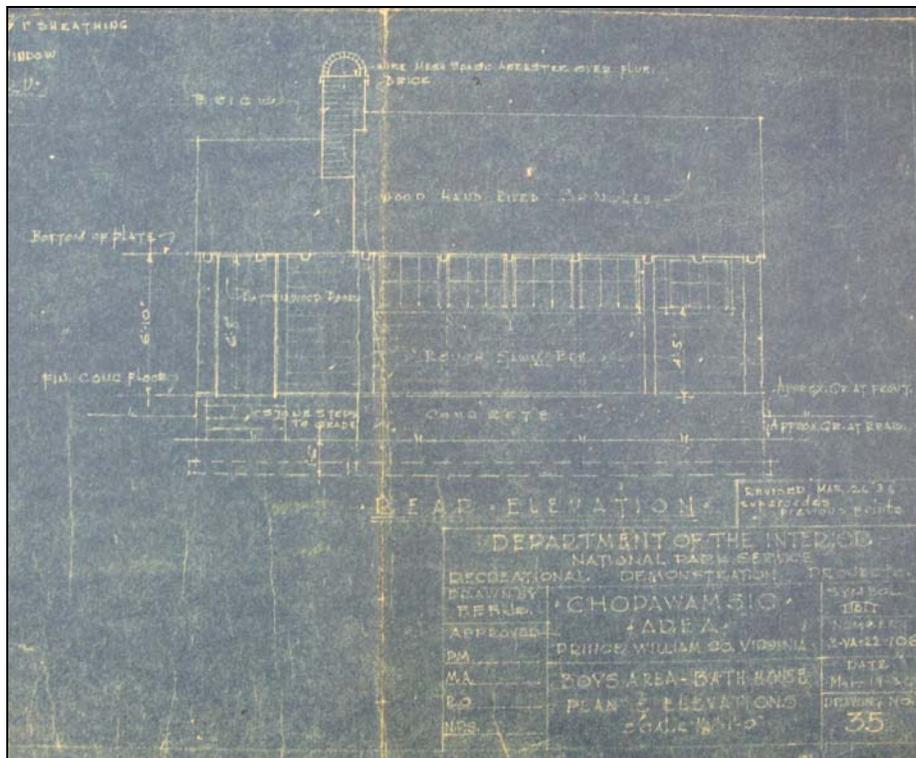
Figure 2: South Elevation from Camp 1 Central Bath House Blueprint, 1936.
Source: File 2723, PRWI Archives.

- A. Architectural drawings: A faded blueprint for the Central Bath House is housed in the PRWI Archives in File 2723 (Figure 2). The drawing is dated March 19, 1936 and including elevations and plans. Also a schematic plan from the 1951 inventory and a detailed renovation drawing from 1979 are located in the PRWI Archives (File 2691).
- B. Early Views: An exterior photograph of the Central Bath House is located in the PRWI Archives (File 2692) as part of the 1951 inventory (Figure 3).
- C. Bibliography:

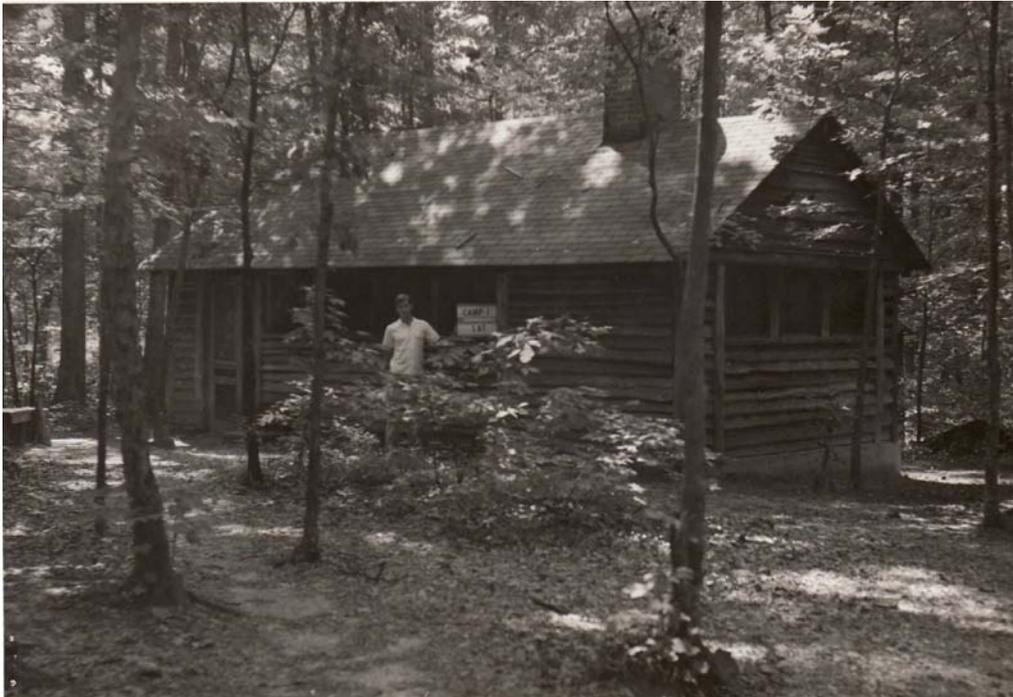
Figure 3: View of Camp 1 Central Bath House, 1951.
Source: File 2692, PRWI Archives.
