HISTORIC AMERICAN ENGINEERING RECORD

SWALLOW'S BRIDGE (Best's Bridge)

HAER No. VT-36

STRUCTURAL
TYPE: Wood covered bridge; tied arch

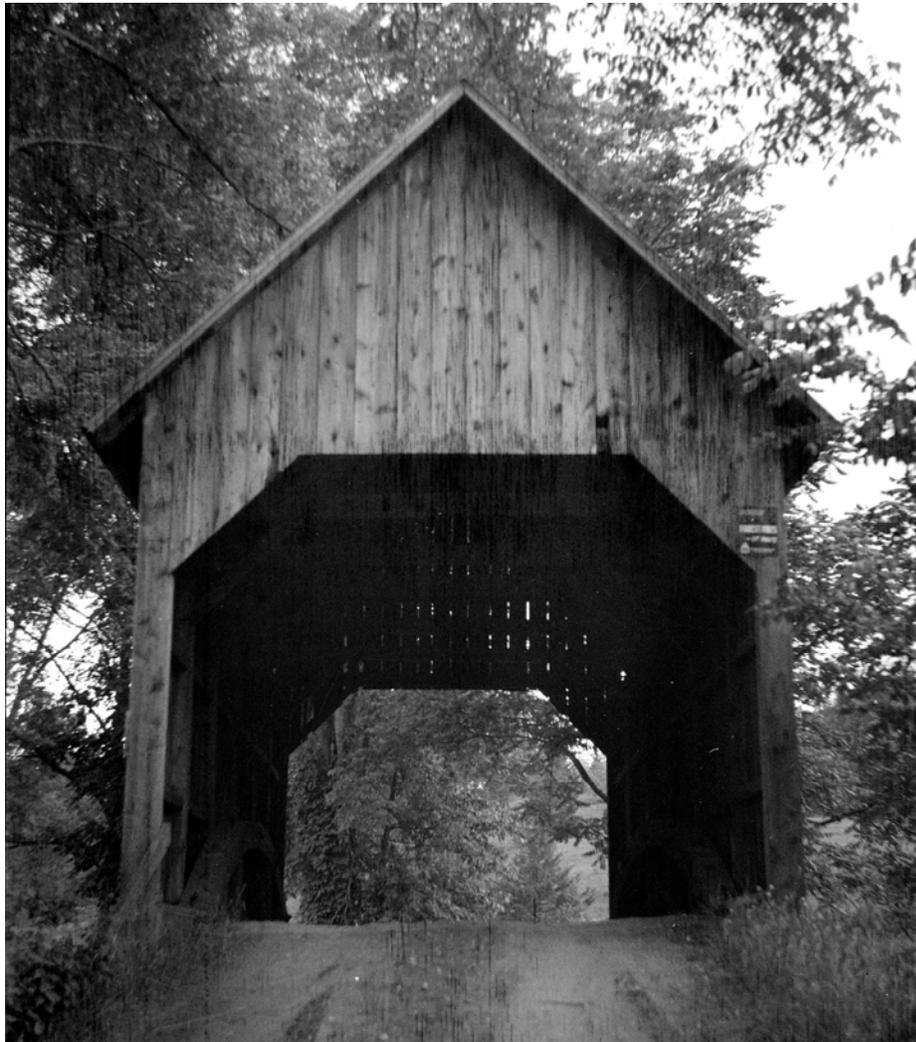
Figure 1. East portal elevation of bridge. Photograph courtesy Richard Sanders Allen Collection, June 27, 1940.

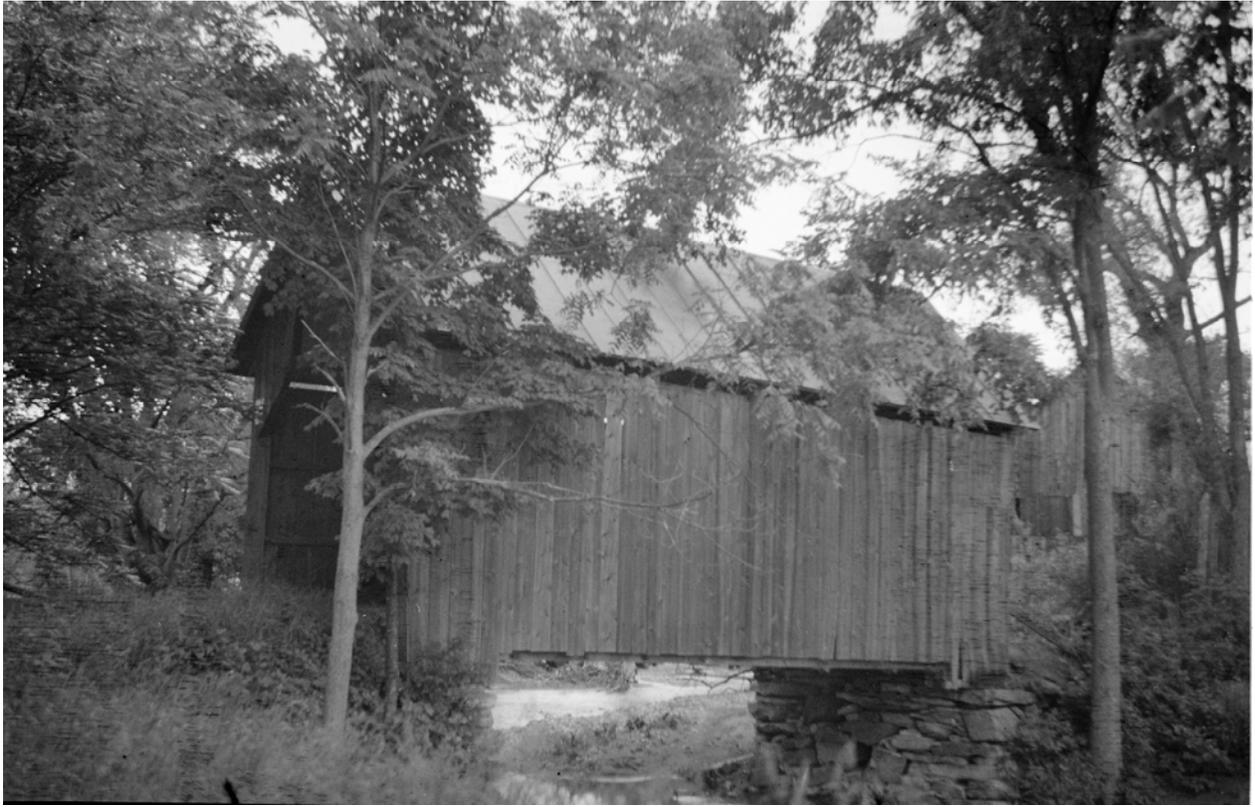
Figure 2. View of north elevation of bridge, crossing Mill Brook. Photograph courtesy Richard Sanders Allen Collection, June 27, 1940.

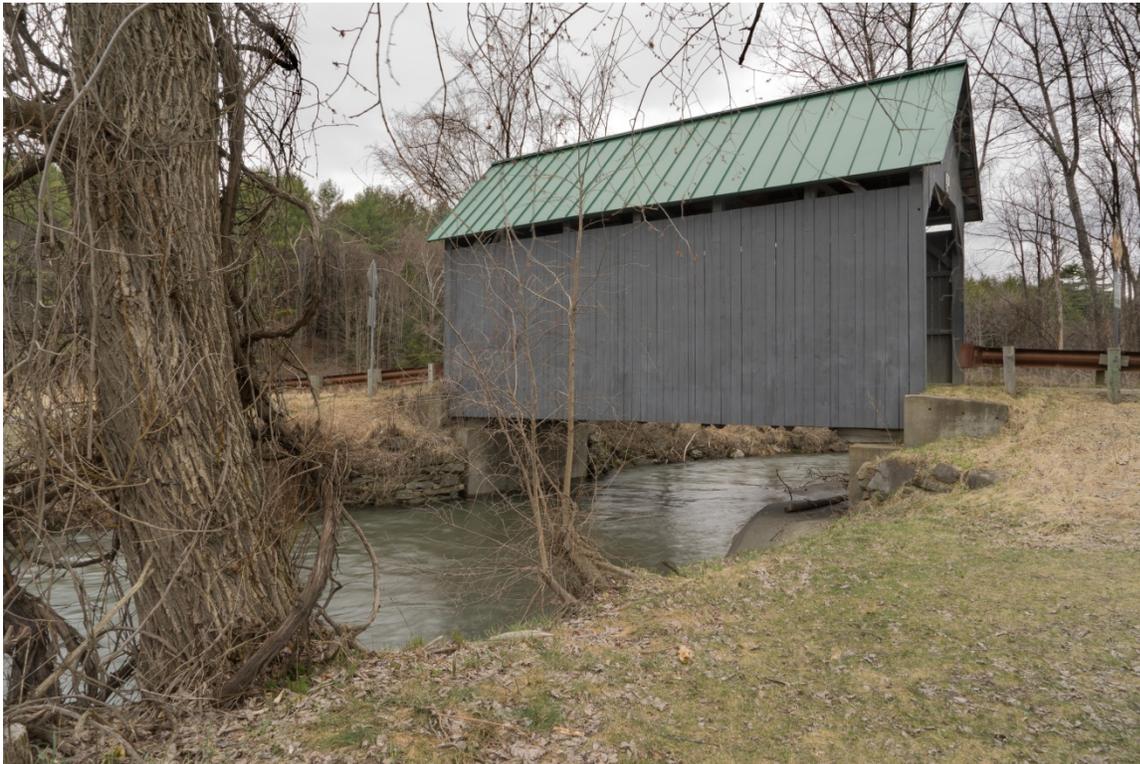
Figure 3. General view of south elevation of bridge, view to southwest.

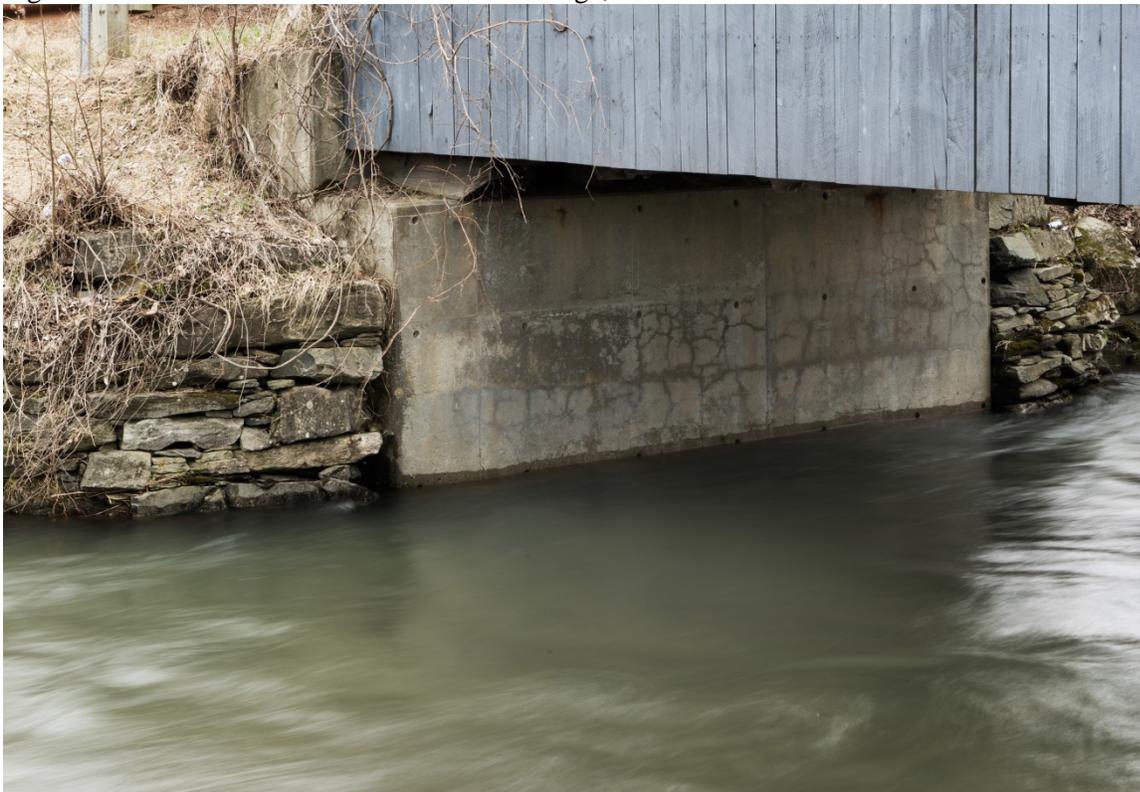
Figure 4. Detail of west abutment, showing early stone and later concrete, view to southwest.

The bridge has served the local community for well over a century, and continues to carry traffic, including heavy farm equipment. In 1973, a freshet damaged the original stone abutments and new poured concrete abutments were built alongside the old stone wingwalls. The bridge underwent structural repairs in 1993. The housing was rebuilt and a new roof added at that time. Sometime after 1995 two lamina were added to the arches of Swallow's Bridge.

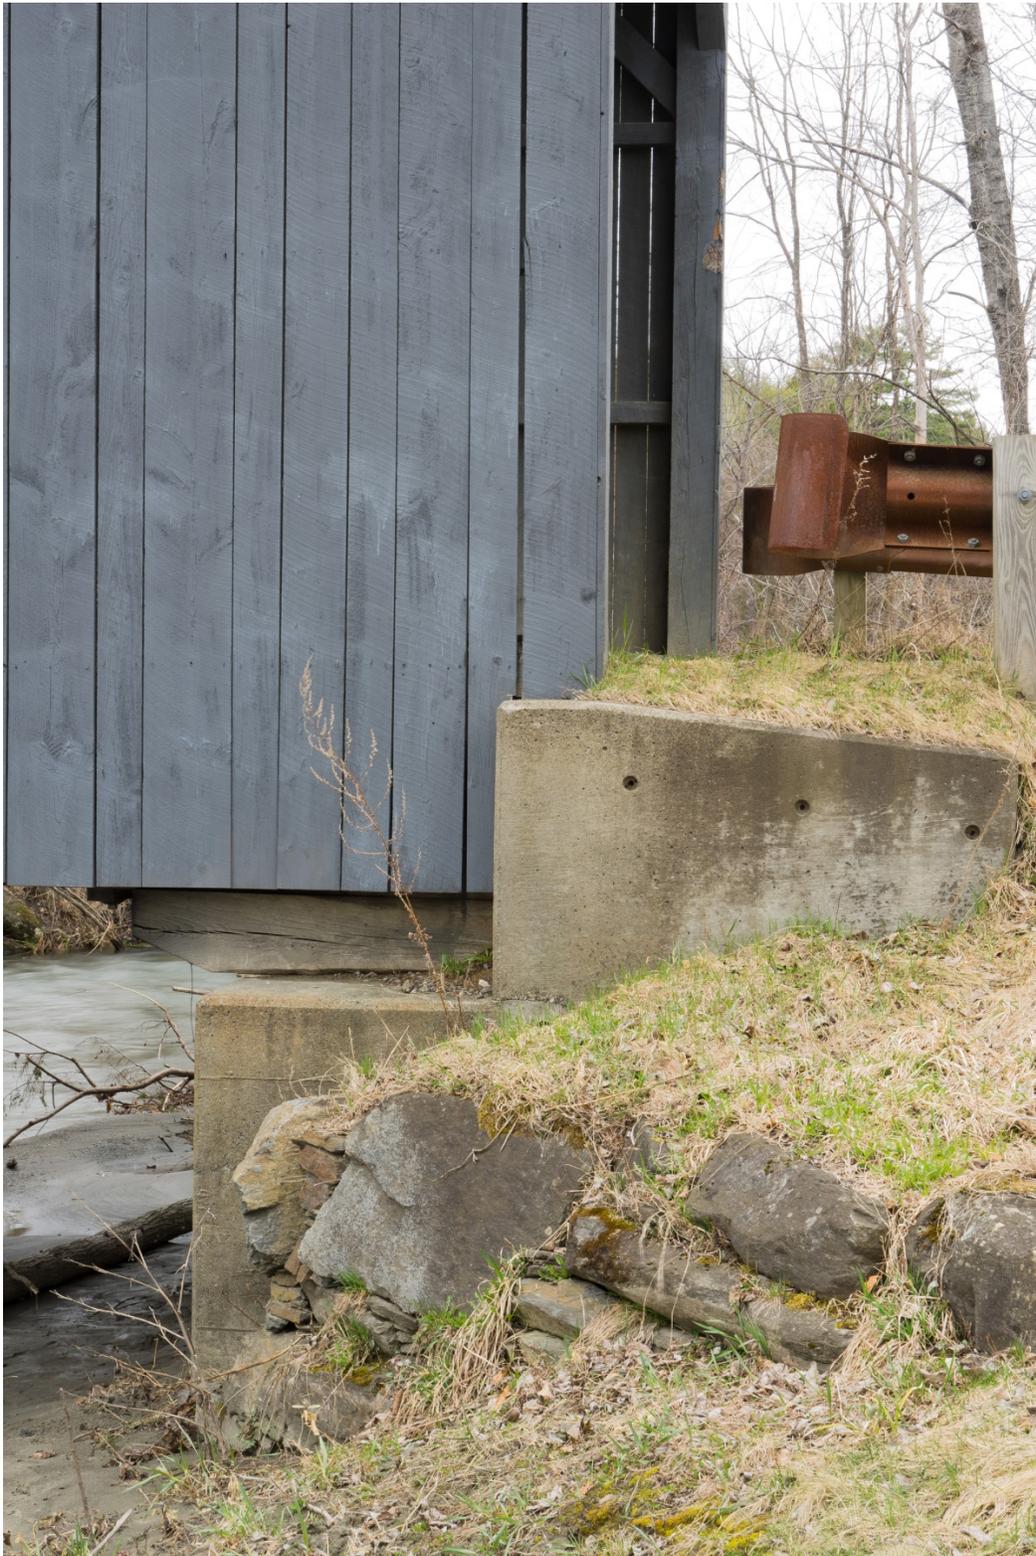
Figure 5. Detail of northeast corner of abutment.

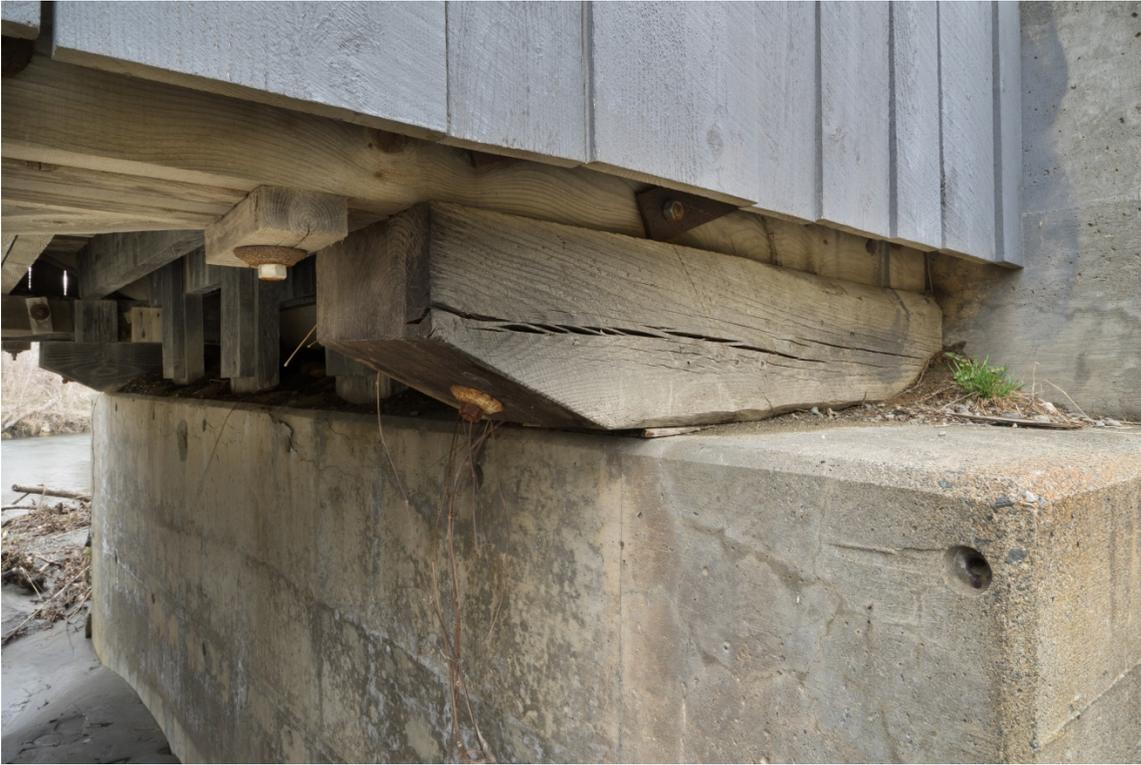
Figure 6. East abutment, showing bolster beams supported by concrete, view to northwest.

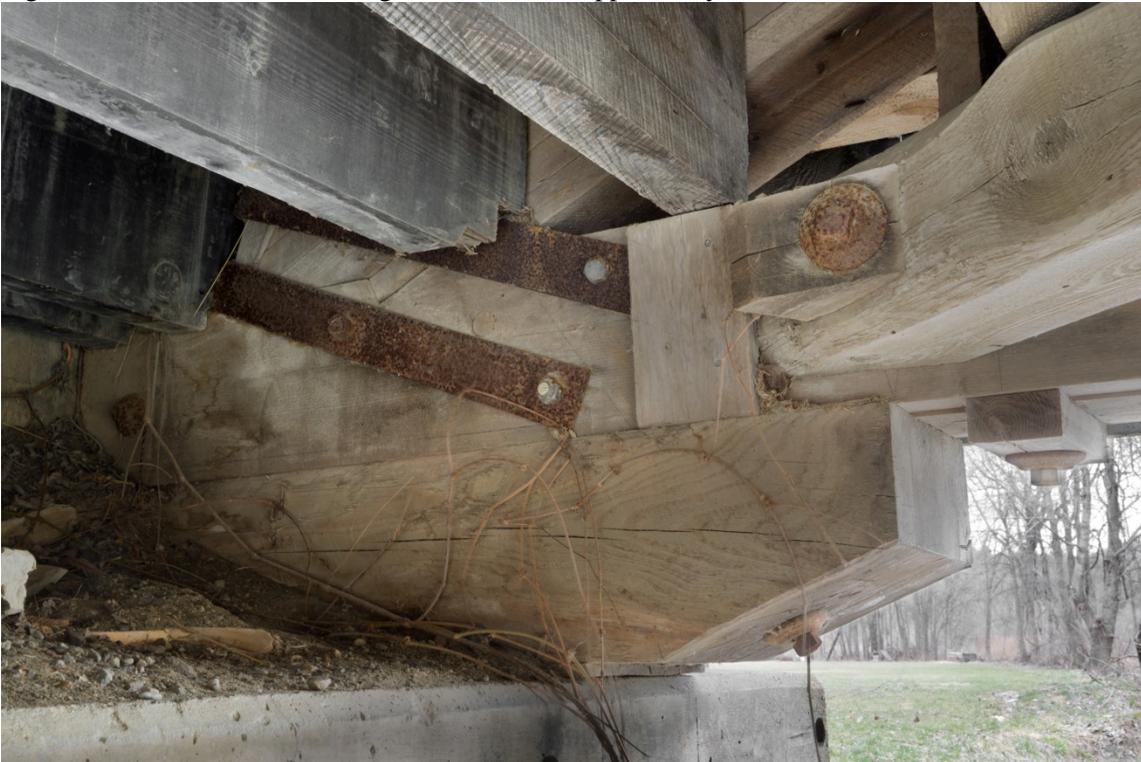
Figure 7. Detail of bolster beam, lateral bracing, and floor beams on east abutment, looking northeast.

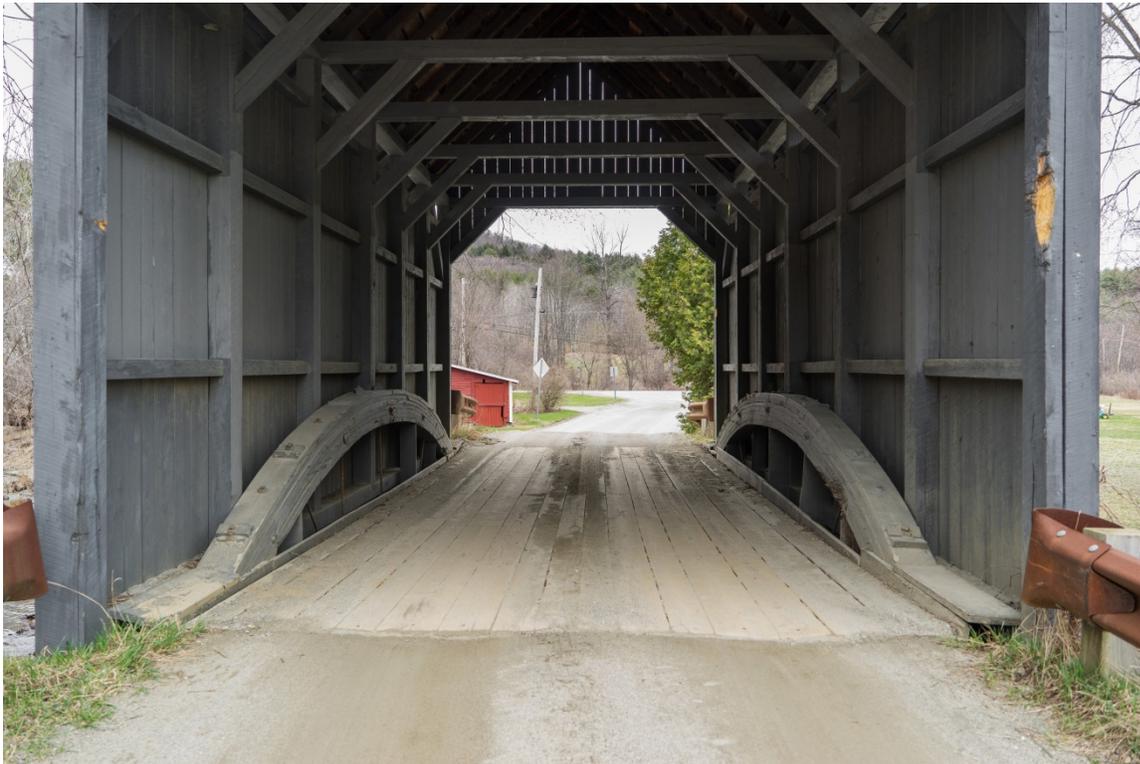
Figure 8. View through bridge, facing northeast.

The bridge is covered with a freestanding housing that rests on the outer ends of the floor beams. The post and beam frame is comprised of 6"x8" posts, 8"x8" endposts, and 6"x6" tie beams. It is covered with vertical board siding painted gray and a steeply pitched (12/12) standing seam metal roof. The portals are straight and square. There is no ornamentation.

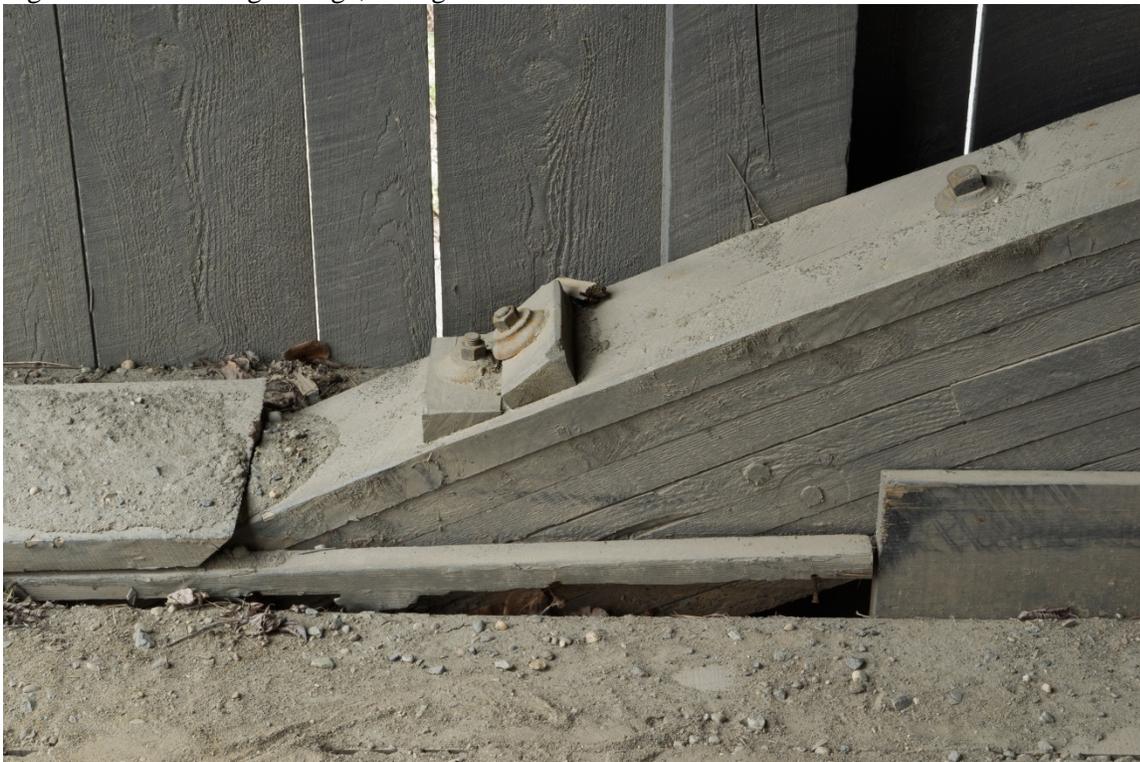
Figure 9. Structural detail of north arch, view to southwest.

The lower chord is comprised of five parallel planks laid on edge and bolted together. The 9½"x14" arches are comprised of seven (originally five) lamina laid flat and bolted together. The arches span 33' and rise to a height of 6'-0" at the crown. The ends of the arches are seated in saw-tooth cuts in the ends of the lower chords. Five vertical tension rods fastened with nuts at both ends support the lower chords. The construction date, 1889, is carved into the inner face of south arch.

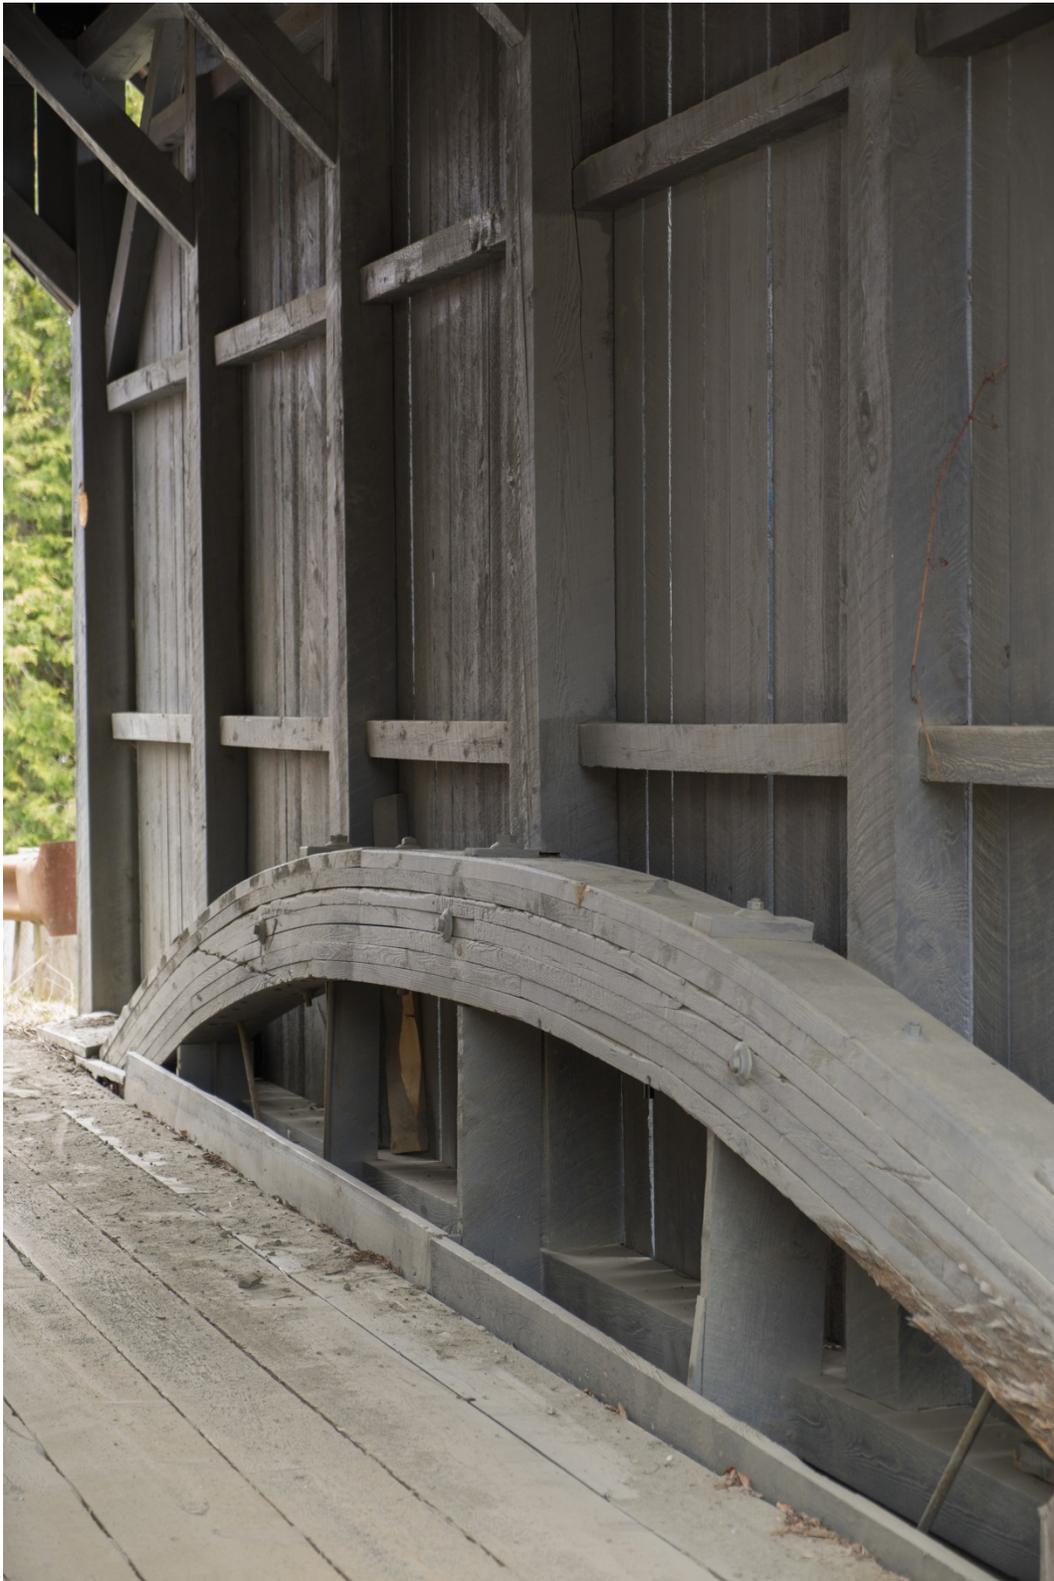
Figure 10. Interior detail of tied arch (originally five-ply, with two planks added in 1991), view to southwest.

Unlike the Burr truss, the tied arch was never part of the mainstream of covered bridge building.¹⁶ In a tied arch, the ends of the arch are fitted into slots in the lower chord rather than extending to the abutments. The lower chord "ties" the ends of the arch together, resisting the horizontal thrust that would otherwise necessitate substantial masonry. Tied arches are economical because they do not rely on heavy masonry or truss framing, but their relative lack of stiffness makes them suitable only for short spans. Swallow's Bridge is one of four surviving tied arch covered bridges in the United States:¹⁷

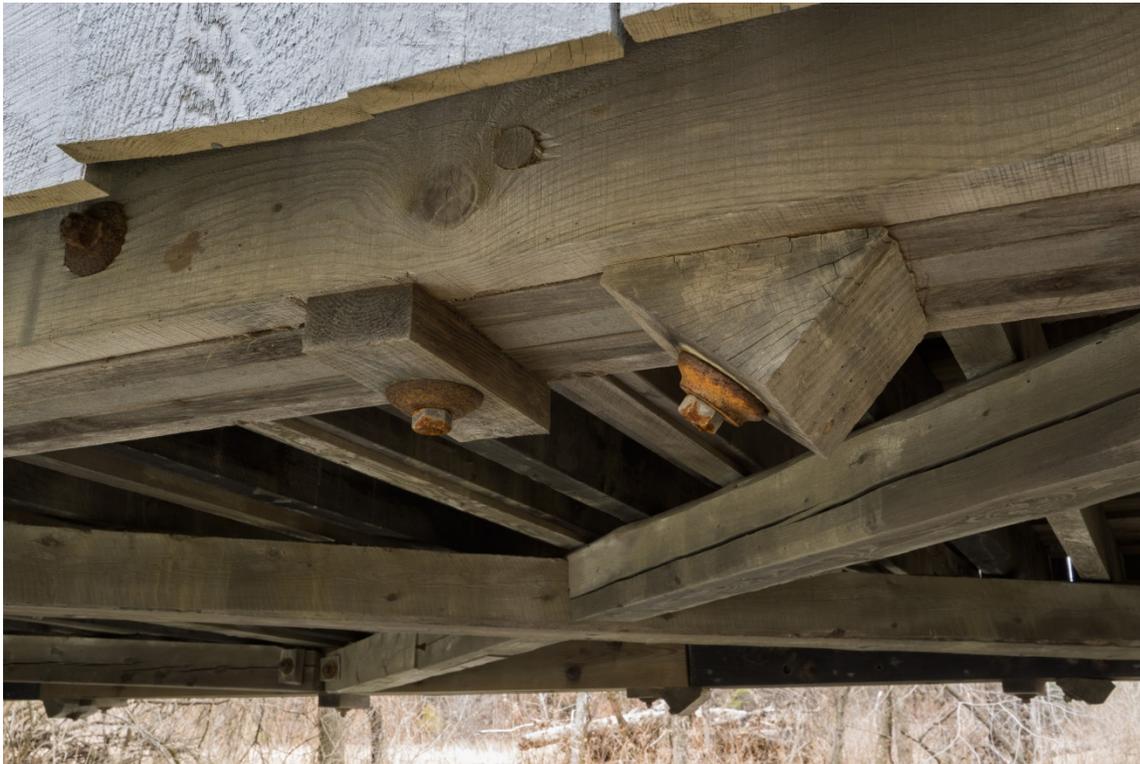
Figure 11. Detail of lower lateral bracing and threaded rod connections, view to west.

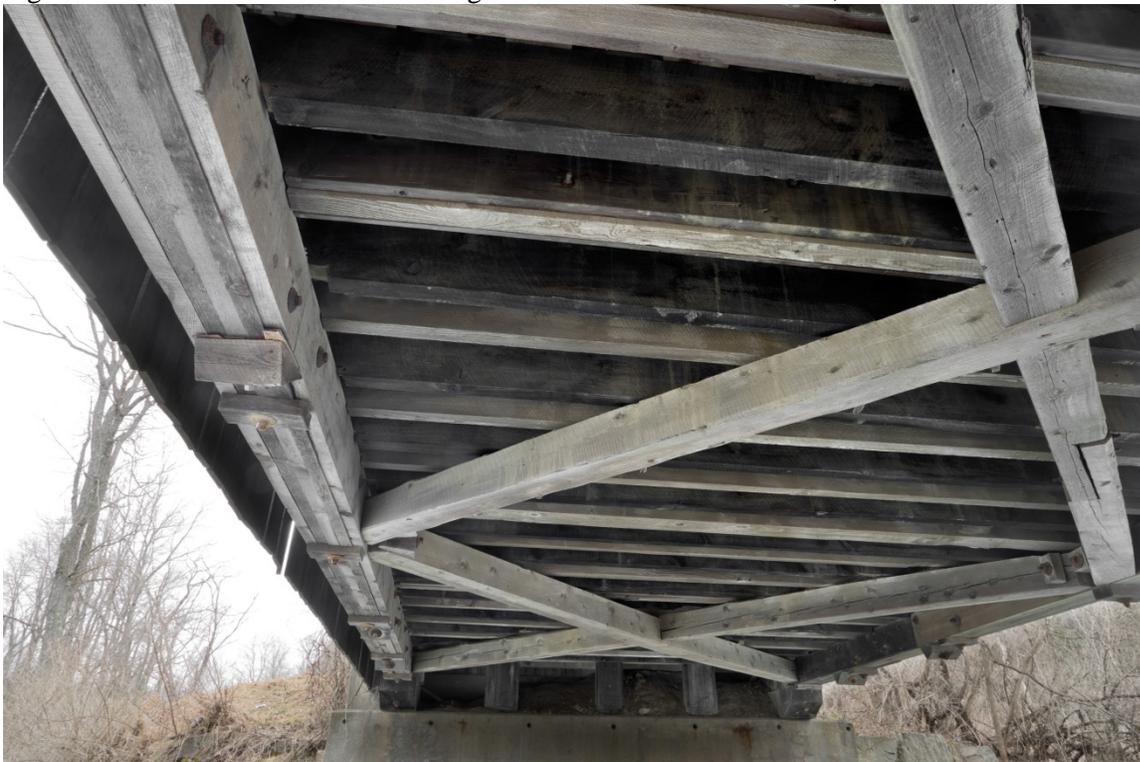
Figure 12. Sub-deck detail of south lower chord, lower lateral bracing, and floor beams, view to southwest.
