HALL BRIDGE
(Osgood Bridge)
Spanning Saxtons River at Paradise Hill Road
Rockingham
Windham County
Vermont

HALL BRIDGE¹ (Osgood Bridge)

HAER No. VT-40

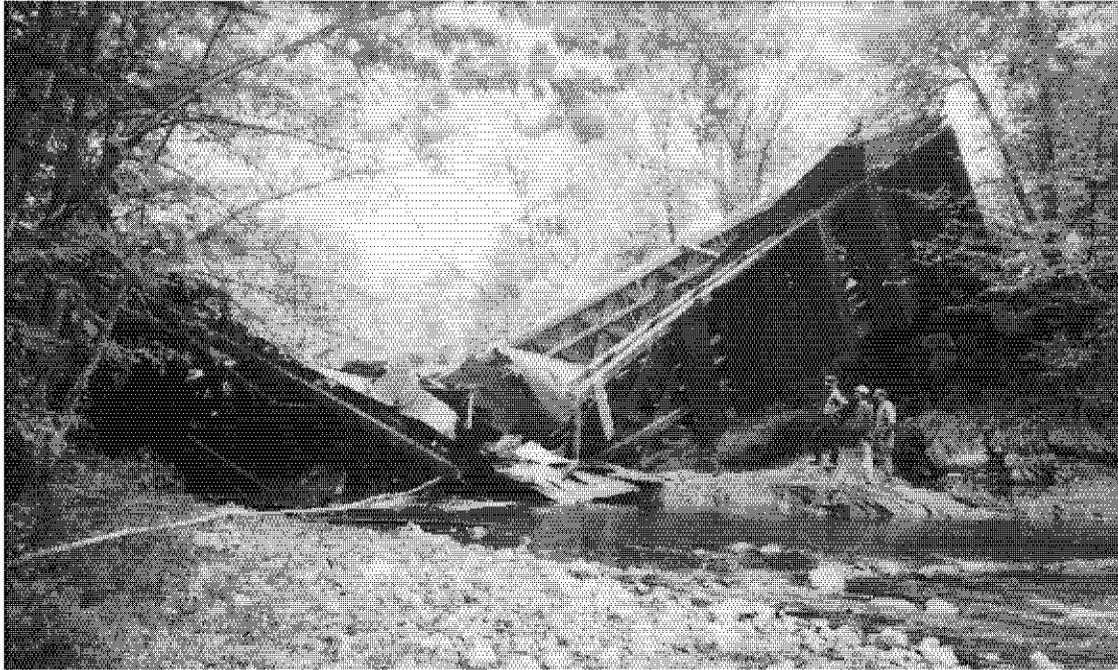
Figure 1. Original Hall Bridge after collapse due to overweight truck, 1980. Photo by Jack Peters.

On October 2, 1980, a construction worker attempted to cross Hall Bridge with a fully-loaded gravel truck. Although the driver escaped, both the bridge and the truck ended up in the river.²² The Town of Rockingham held Farnsworth Construction Company liable for the damages and settled with their insurance company for \$99,750.²³ On October 20, following some debate on whether to rebuild the damaged structure or replace it with a new span, the Rockingham Board of Selectmen voted to replace the Hall Bridge "*with another bridge of the same type.*"²⁴ The

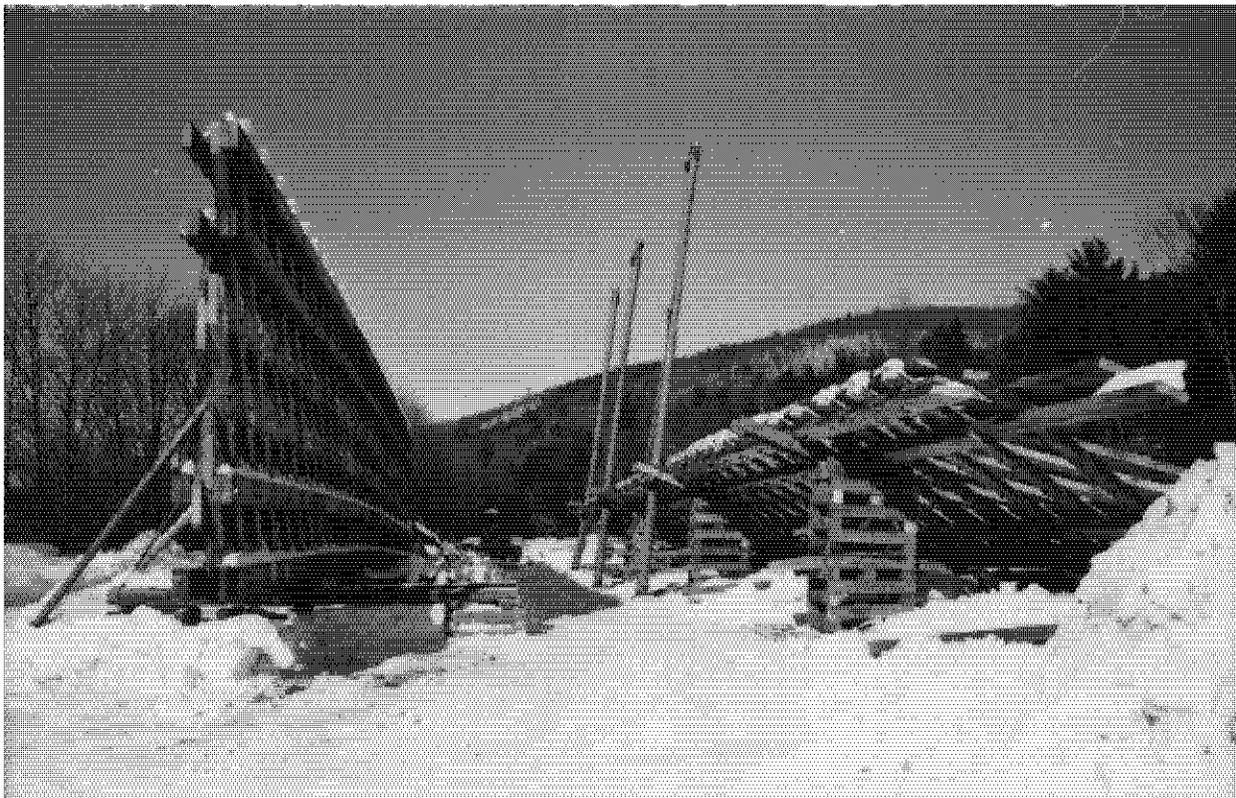
Figure 2. Graton Associates erected each Town Lattice truss separately in a neighbor's field. Photo by Jack Peters, 1982.

Construction began in the winter of 1981 and continued through the summer of 1982. The 120' trusses were framed in a field adjacent to the bridge site, using traditional joinery and 1,000 hand-made treenails. The framed trusses were then lifted upright with gin poles and plumbed on temporary timbers. Floor beams were installed and the deck fastened on top. The rafters and upper lateral bracing were then plumbed from the deck. Finally, the siding and metal roofing were fastened in place.

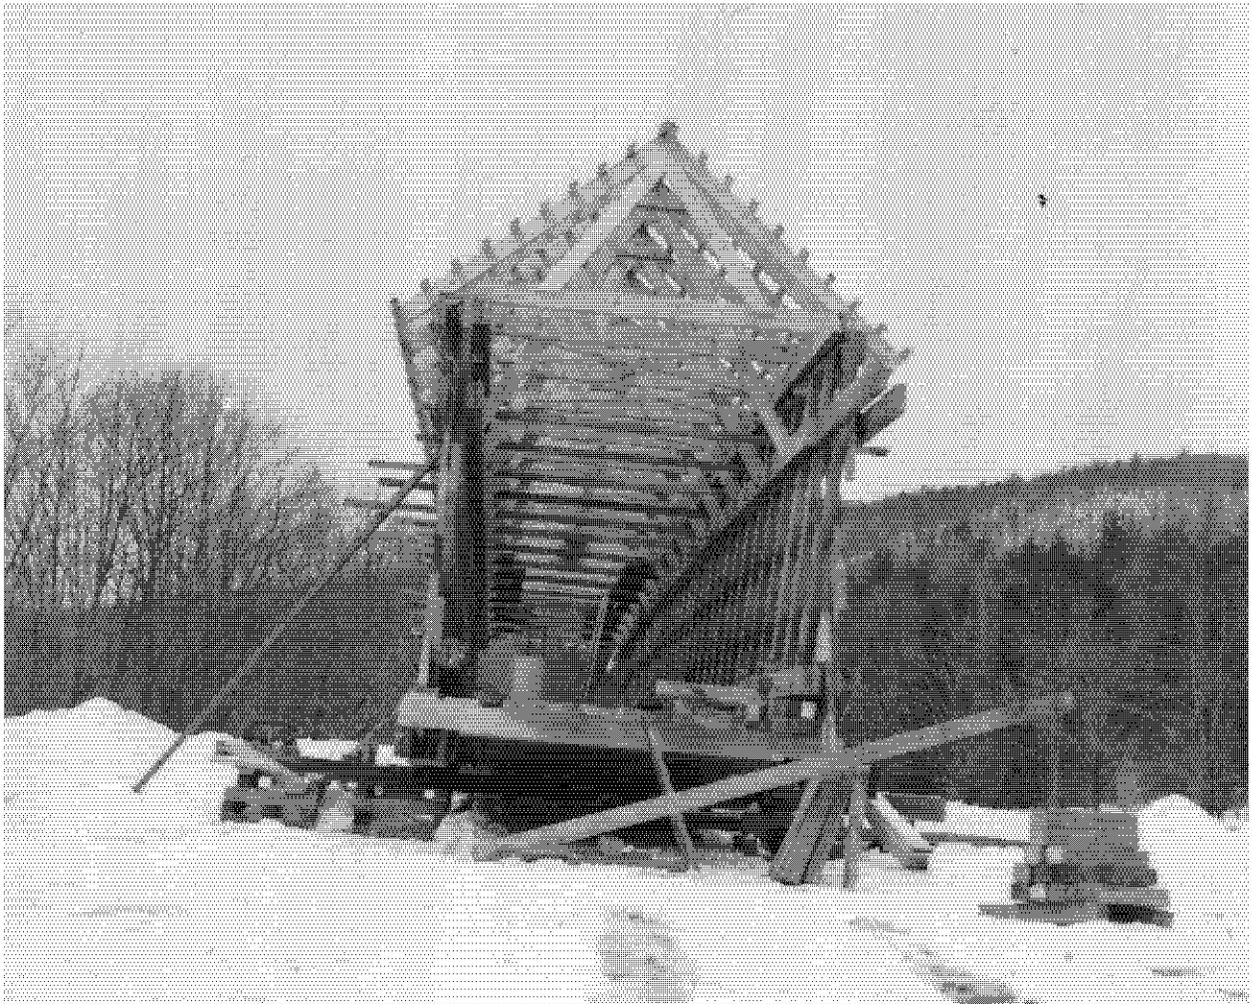
Figure 3. Completed truss with rafters ready for sheathing and roofing. Photo by Jack Peters, 1982.

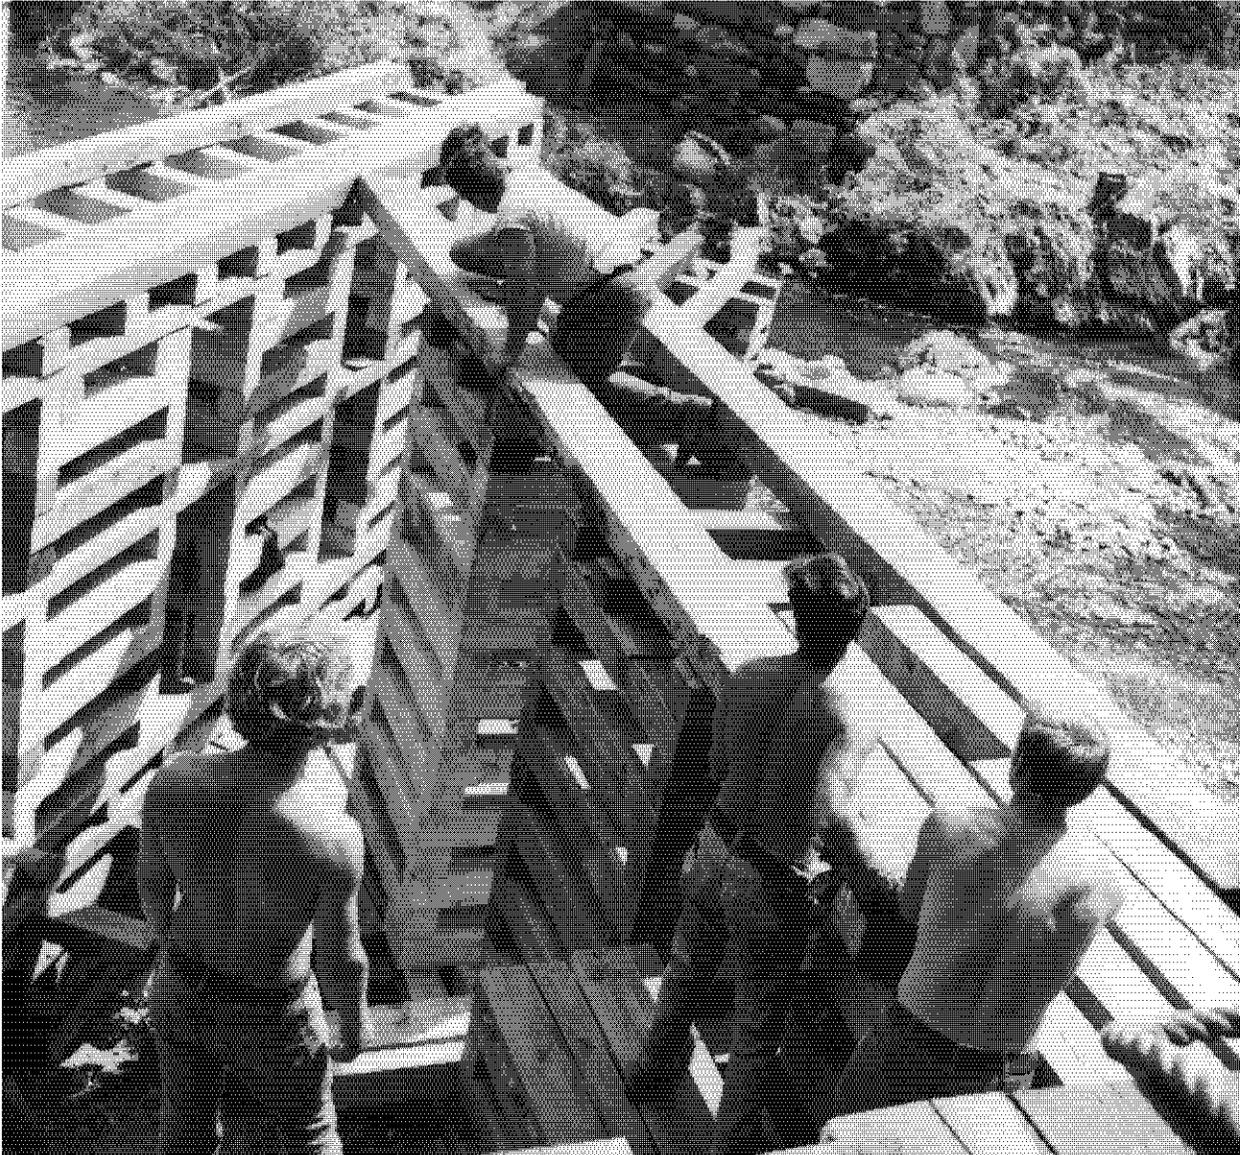
Figure 4. Graton Associates erected cribbing to support timber rails prior to rolling the bridge. Rail had to be set at a different angle because of house at the east end of the bridge. Photo by Jack Peters, 1982.

A wooden track was built across the river on cribwork. The bridge was then jacked to the required height and a series of rollers placed underneath. Due to the roadway layout, final placement of the structure required pivoting the bridge on rollers until it was in a straight line with the abutments. Over the course of five days in late July and early August, a team of oxen hauled the completed bridge out across the river. The oxen walked around a capstan connected to a block and tackle that gave them a 90:1 mechanical advantage and allowed them to pull the 135,000-pound structure a few inches during each complete turn.

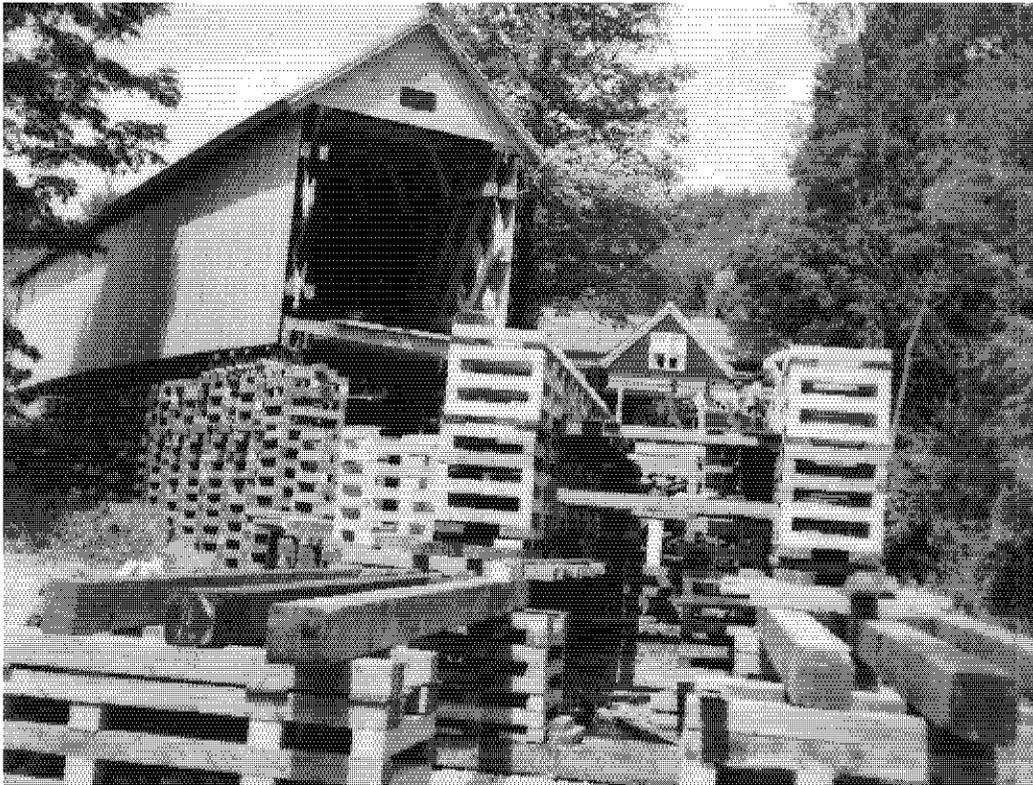
Figure 5. Bridge begins its journey across the approach track. Photo by Jack Peters, 1982.

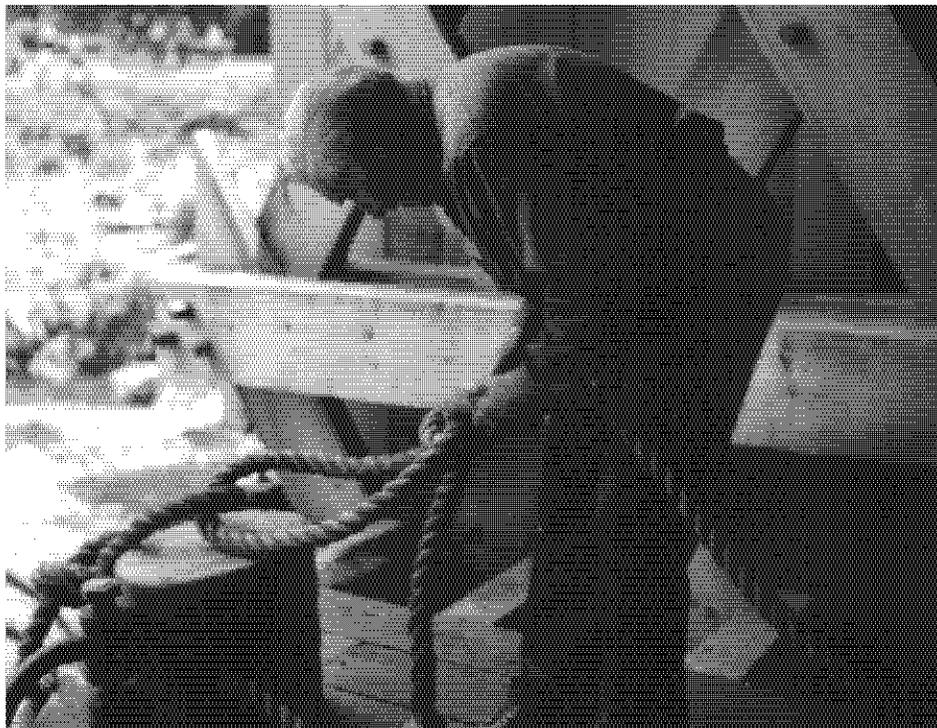
Figure 6. Milton Graton feeding rope from the capstan. Photo by Jack Peters, 1982.

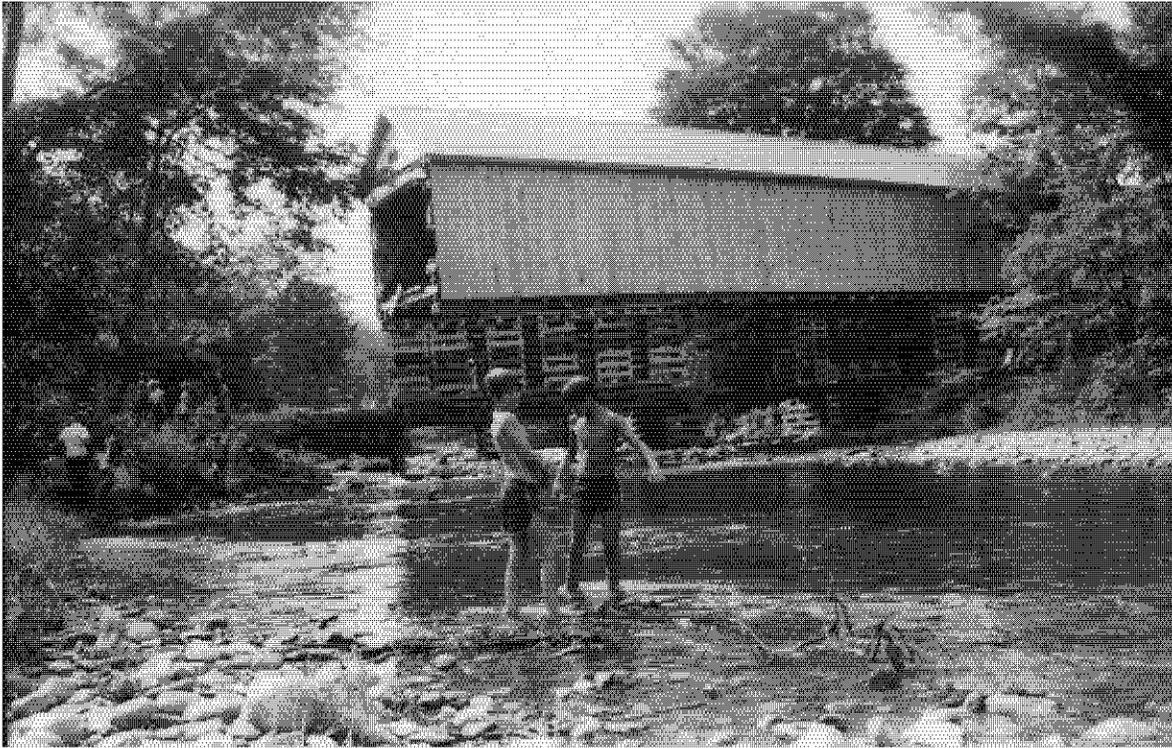
Figure 7. Bridge over half way across Saxtons River. Photo by Jack Peters, 1982.

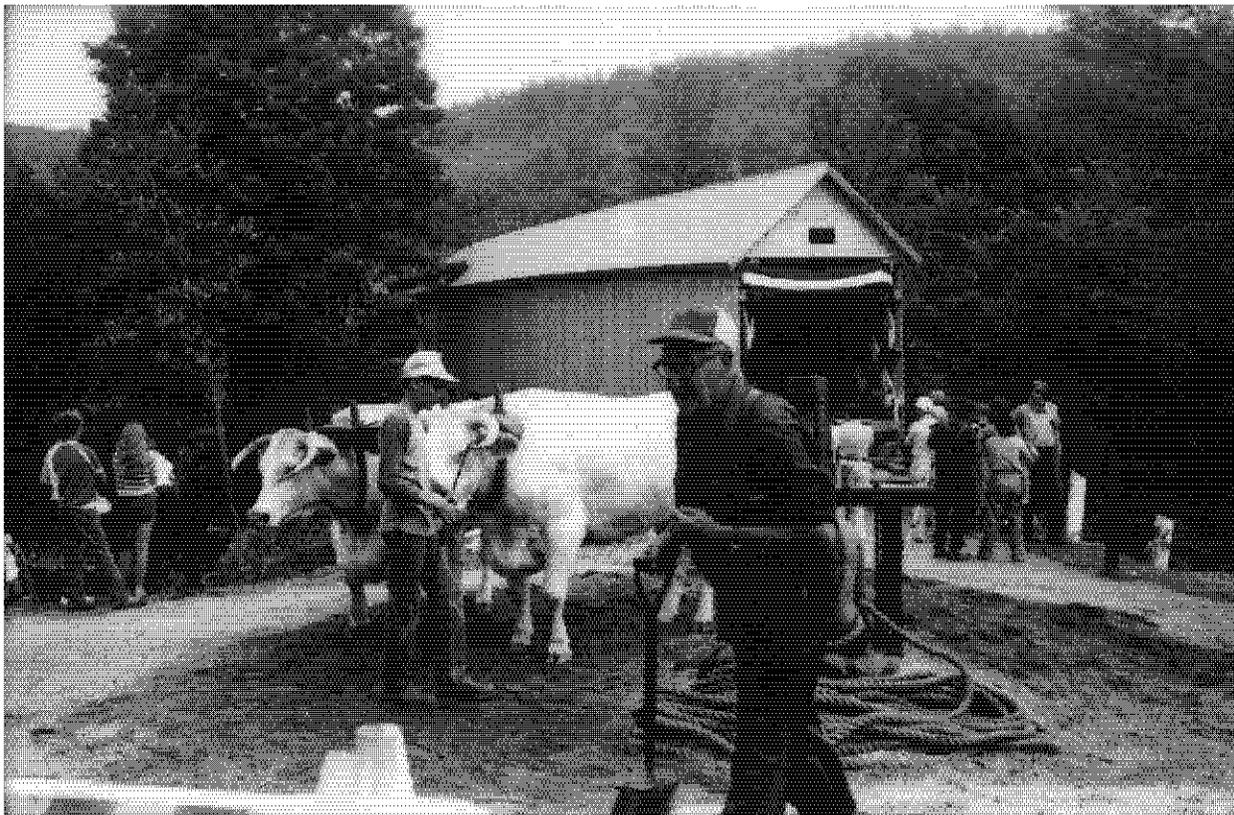
Figure 8. Oxen and capstan after moving bridge across river. Photo by Jack Peters, 1982.

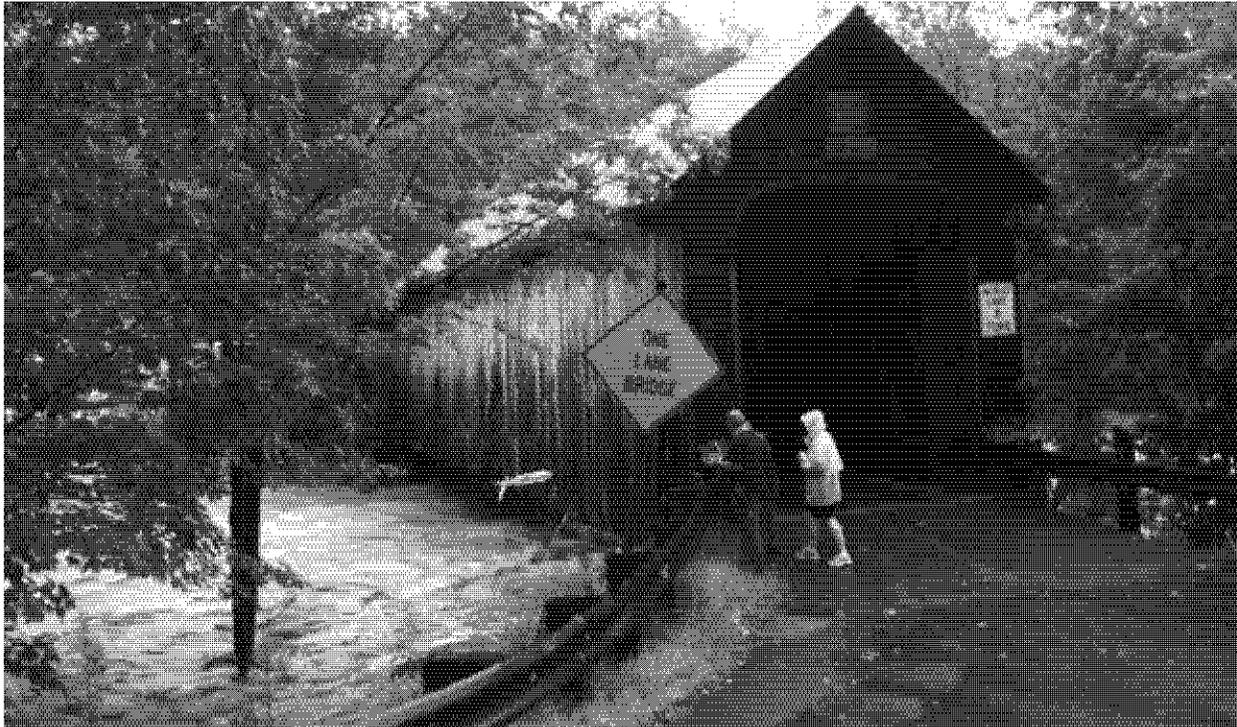
Figure 9. Hurricane Irene flooding of Saxtons River threatens Hall Bridge on August 30, 2011. Note water scouring the southwest abutment and debris piercing the siding. Photo by Aurelius Dibernardo.

The southwestern abutment was severely damaged by high water and floating debris. After the storm, an area of stone measuring 6' tall, 6' wide and 6' deep was dislodged and deposited downstream. The large section of stone removed by the flooding left the thin concrete cap above vulnerable to failure in tension. The high water and floating debris also dislodged the timber bolster beam which supports one-quarter of the bridge's dead weight. Prior to emergency measures taken on Tuesday, August 30, 2011, the bridge was in imminent danger of collapse and near total destruction.

The upstream (northwest) truss sustained damage to two of the truss's lattice planks. The section below the bottom chord known as "drops" or "relish" was severed from the affected plank. Several other lattice "drops" sustained abrasion but had no adverse structural affect. In addition, a 6"-diameter section of a tree was lodged between the two bottom chords of the upstream truss, spreading apart the connections between the adjacent lattice plank as well as the twin laminations of the third chord. Approximately 40 percent of the total length of 122' of the upstream siding needed repair. Even the metal roof of the bridge suffered damaged, presumably from floating debris riding up the roof, bending the lower, drip edge.³²

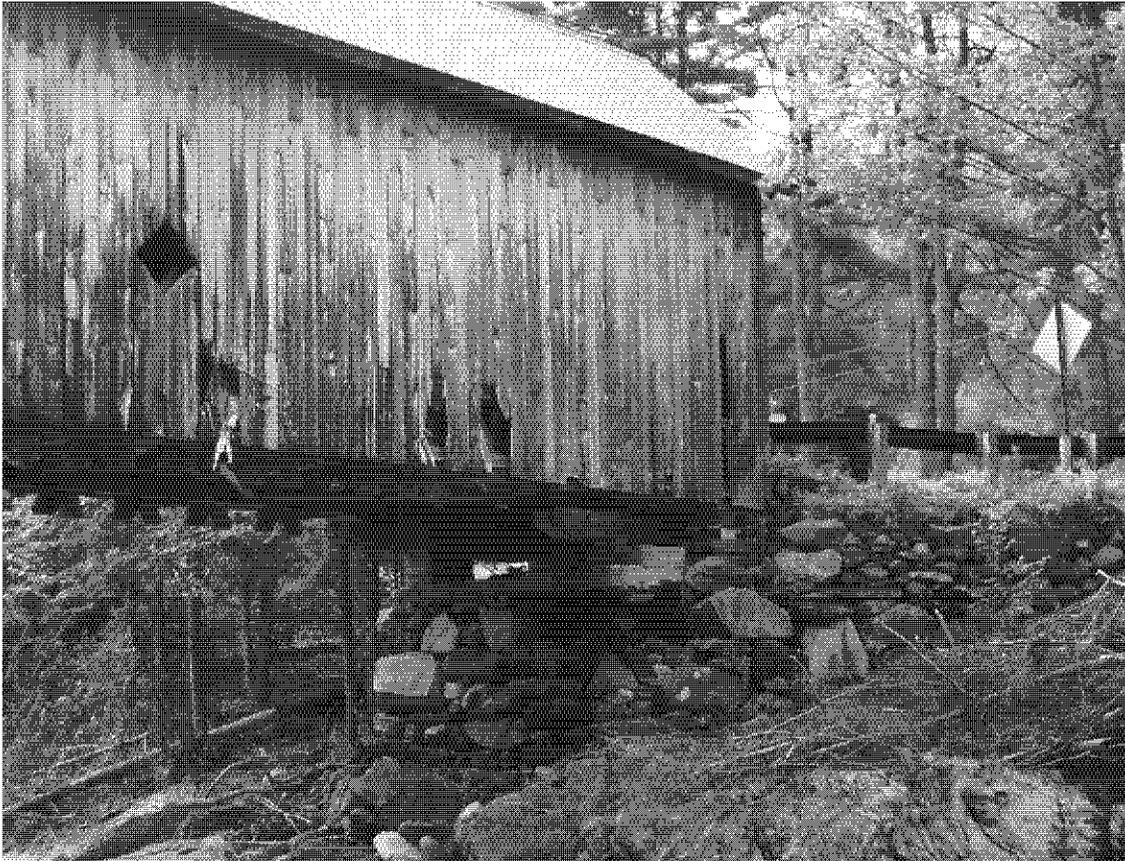
Figure 10. View of underside of bridge following hurricane, showing missing stone in corner of south-west abutment, dislodged bolster beam, and tree damage to truss. Photo by Will Truax, September 2011.

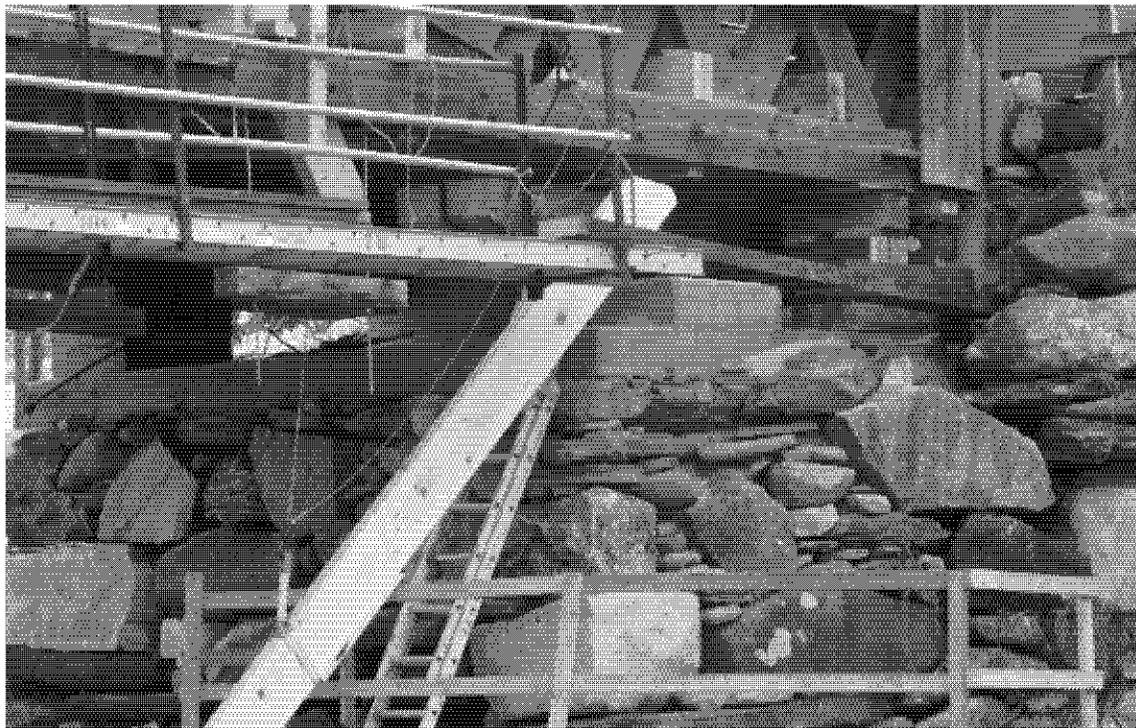
Figure 12. Detail of repaired stone and bolster beam. The large white stone at the southwest corner (center, behind railing), weighing 2,500 lbs, was found 250 yards downstream and returned to its original position. Photo by Tim Andrews, November 2011.

To repair the southwest abutment, Andrews used a combination of recovered stone, supplemented with like quality stone. He identified and recovered a 2,500 pound stone about 250 yards downstream of the bridge and returned it to its original location. He used HAER large-format photographs from 2009 to help him match the missing stone. The stones were secured with structural grout and $\frac{1}{2}$ " galvanized chain attached to expansion bolts, solidifying the new and old work. The metal roof was repaired and bent back to near new condition,

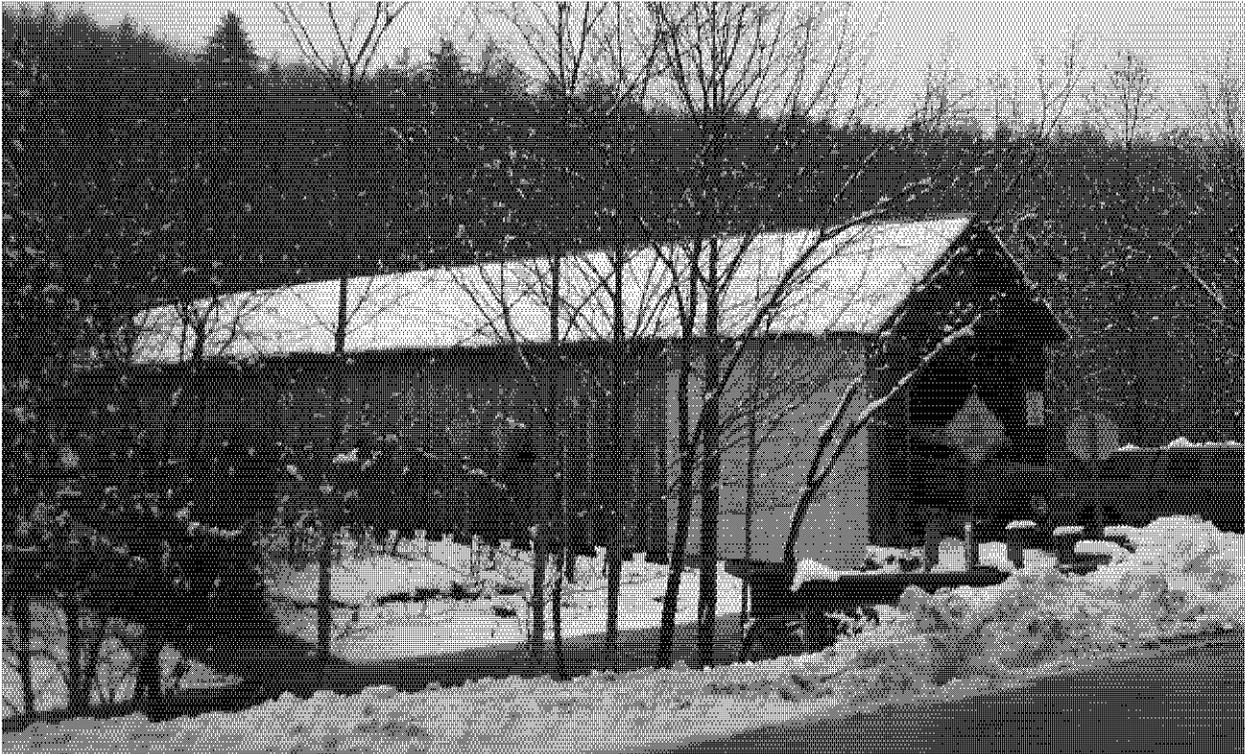
Figure 14. Rehabilitated bridge with new siding on southwest end. Photo by Will Truax, November 2011.

The bridge was closed following the storm, and Andrews repaired the bridge in October-November 2011. Working from a structural design by H.E. Bergeron Engineers, Andrews installed temporary support towers about 20' from the damaged abutment, jacked the bridge $\frac{3}{8}$ " to relieve stresses and replaced the two damaged lattice planks and six treenails. He also procured and milled 40 linear feet of new Eastern White Pine cladding and let it dry for two months prior to replacing the damaged siding.³³
