LONGMIRE SERVICE STATION
(Automotive Service Station, Longmire Springs Historic District)
Mount Rainier National Park
State Route 706
Longmire
Pierce County
Washington

HABS No. WA-239

LONGMIRE SERVICE STATION

(Automotive Service Station, Longmire Springs Historic District)

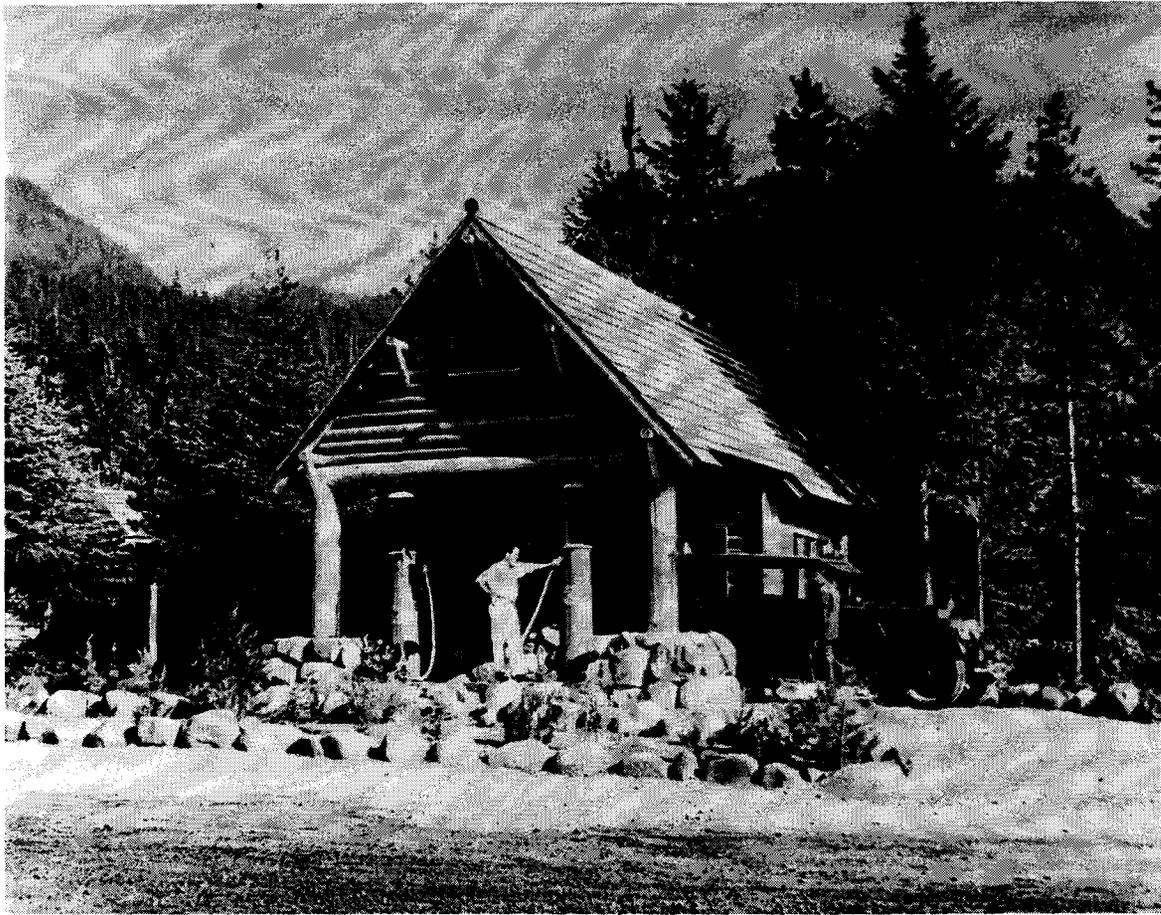
Longmire Gas Station, Dewey Collection, Negative No. 909-707, copy of historic print, Mount
Rainier Archives

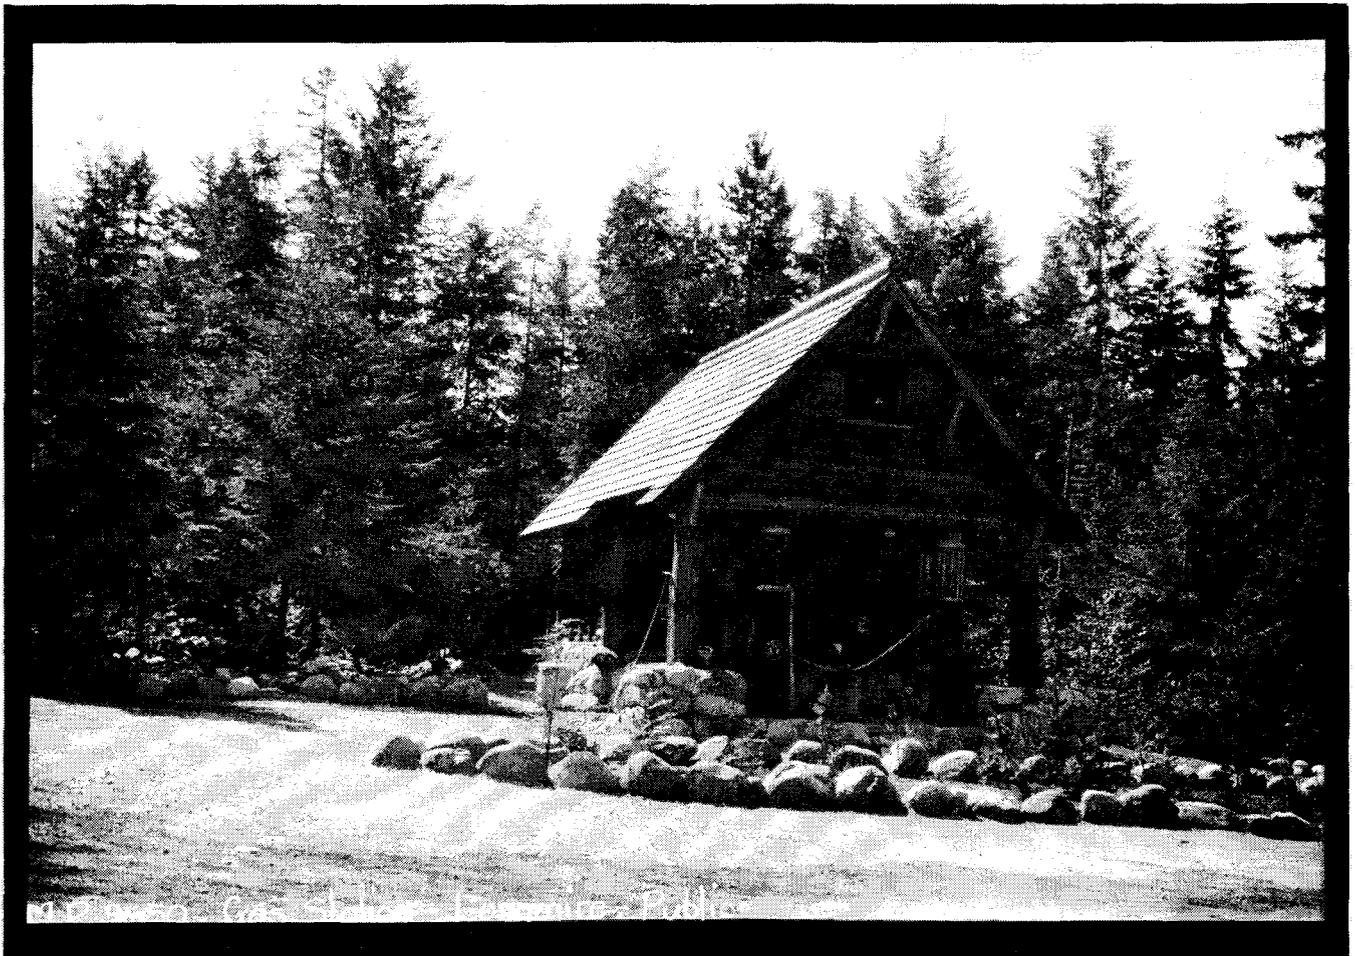
Longmire Gas Station, 01/01/29, Nitrate Collection, No. 4 (3672), Mount Rainier Archives

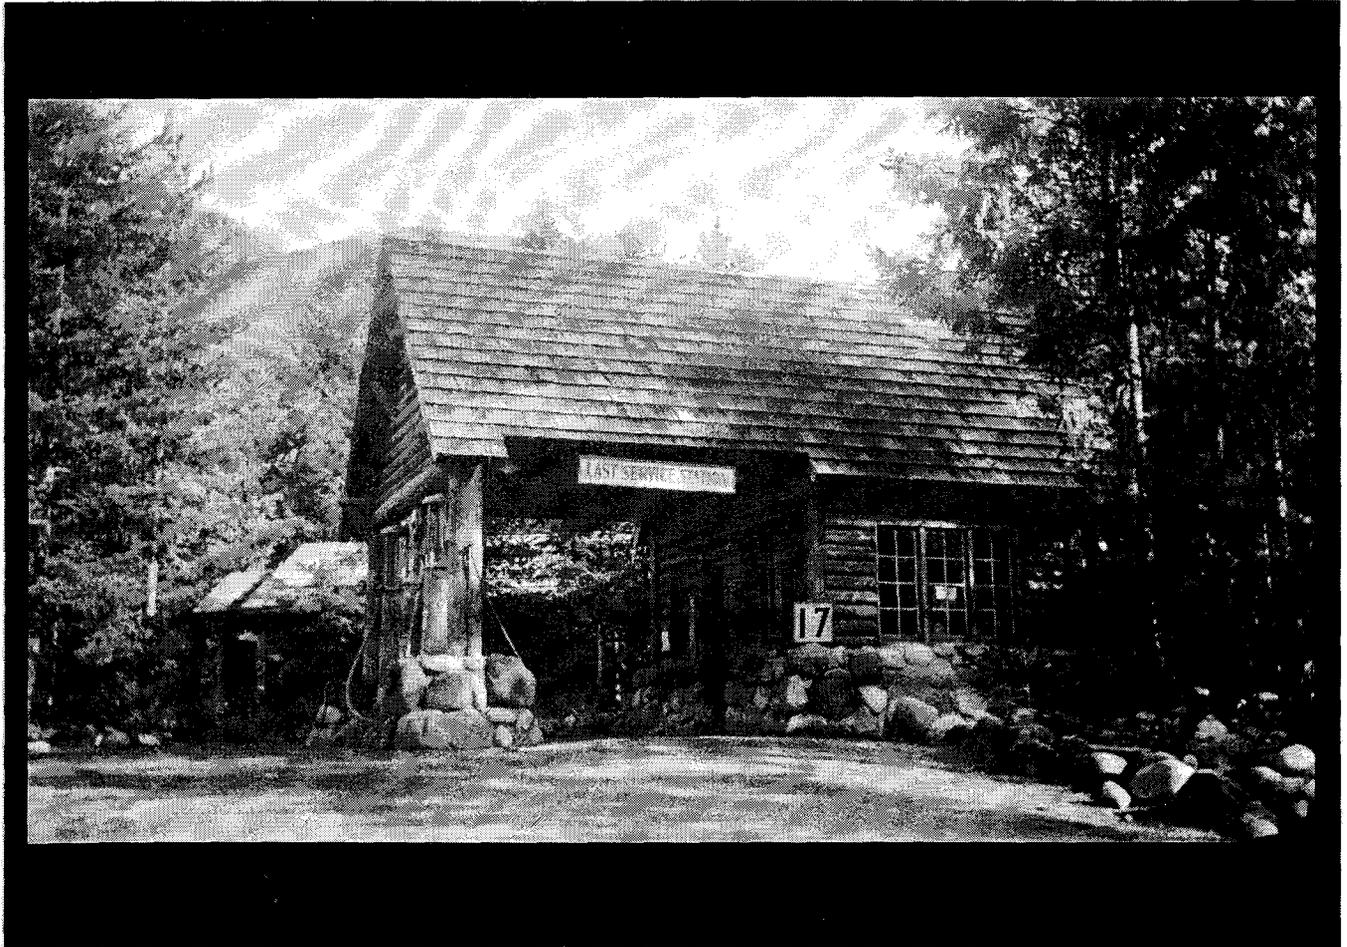
Longmire Service Station, San Francisco Collection, No. 1828, RAI-35-JB-79 SFBOX 5, Mount
Rainier Archives

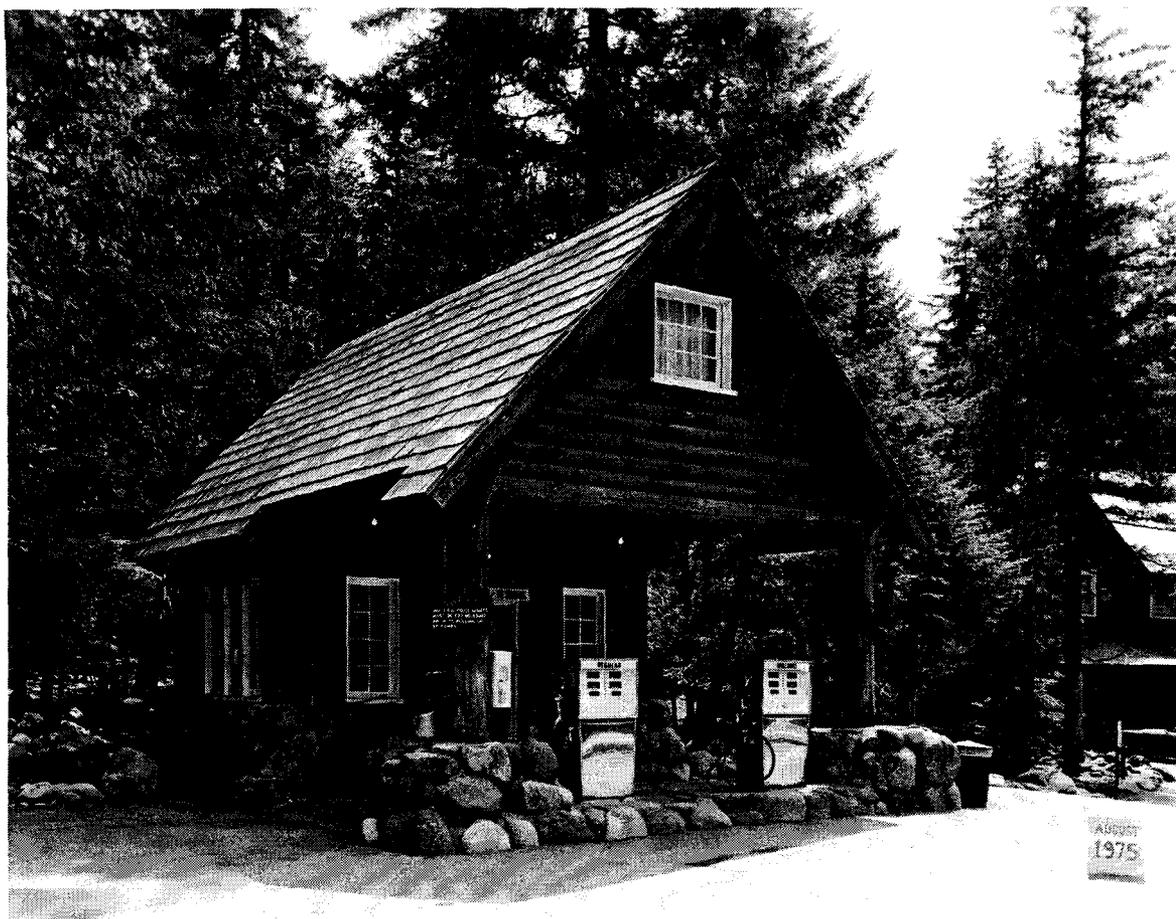
Longmire Gas Station, MORA, 725.1, Dewey Collection, Negative No. 1362, Photographer:
Ells, 8/75, for the Denver Service Center's Historic Structures Inventory, Mount Rainier
Archives
