SHERMAN FARM, BARN
44 South Sherman Road
Coupeville vicinity
Whidbey Island
Island County
Washington

HABS
WA-253-A

HISTORIC AMERICAN BUILDINGS SURVEY
SHERMAN FARM, BARN

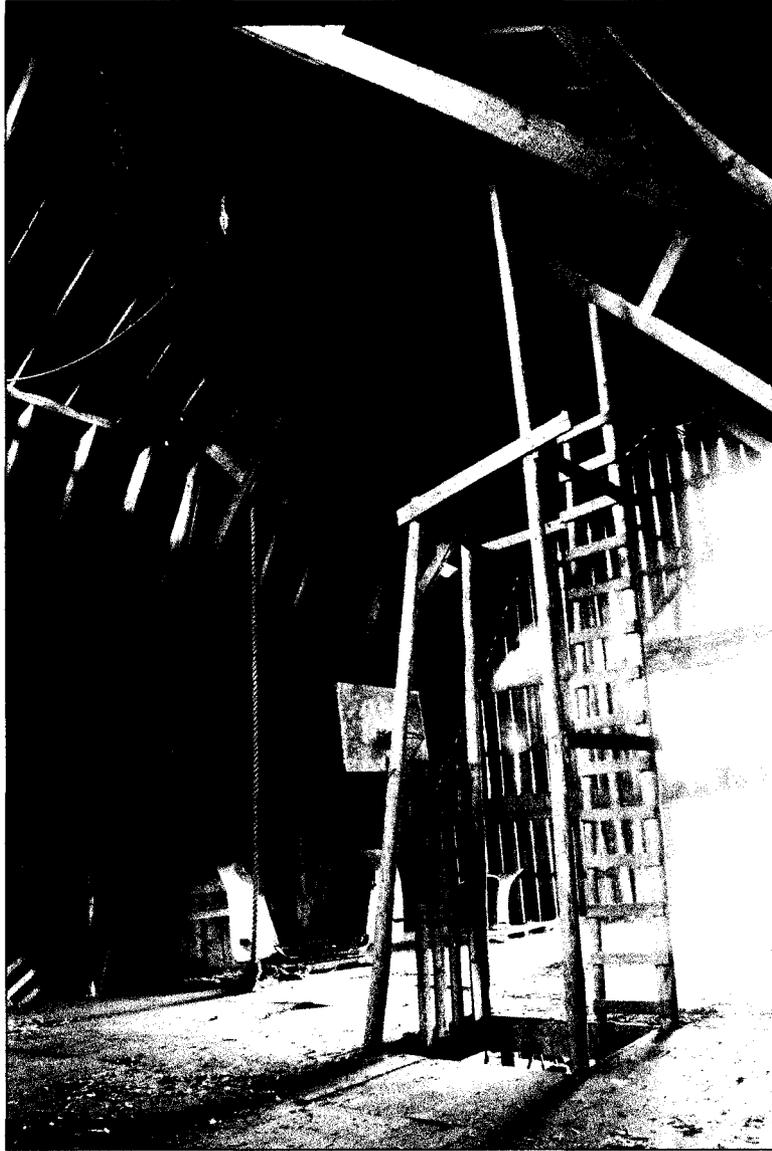
Photograph 2: BARN HAYLOFT LOOKING NORTHEAST

(The plank frame barn construction provides an open floor plan in the hayloft. The opening in the floor allows for passage of hay from the loft to the animal pens below. The original flooring has been replaced with plywood sheets.)

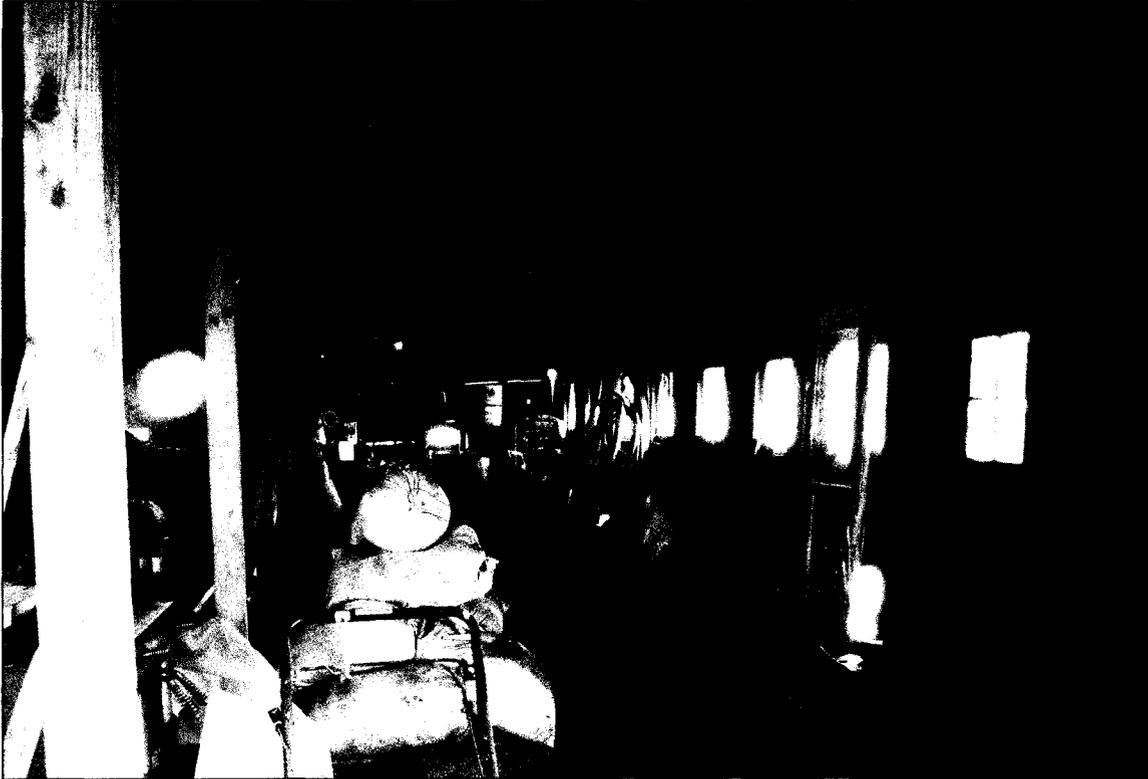
Photograph 3: NORTH ADDITION TO THE SHERMAN BARN, LOOKING WEST

(This addition to the barn was constructed with milking stanchions and a poured concrete floor. The north façade of the barn has a row of ten, two-over-two-lights in stationary sashes.)

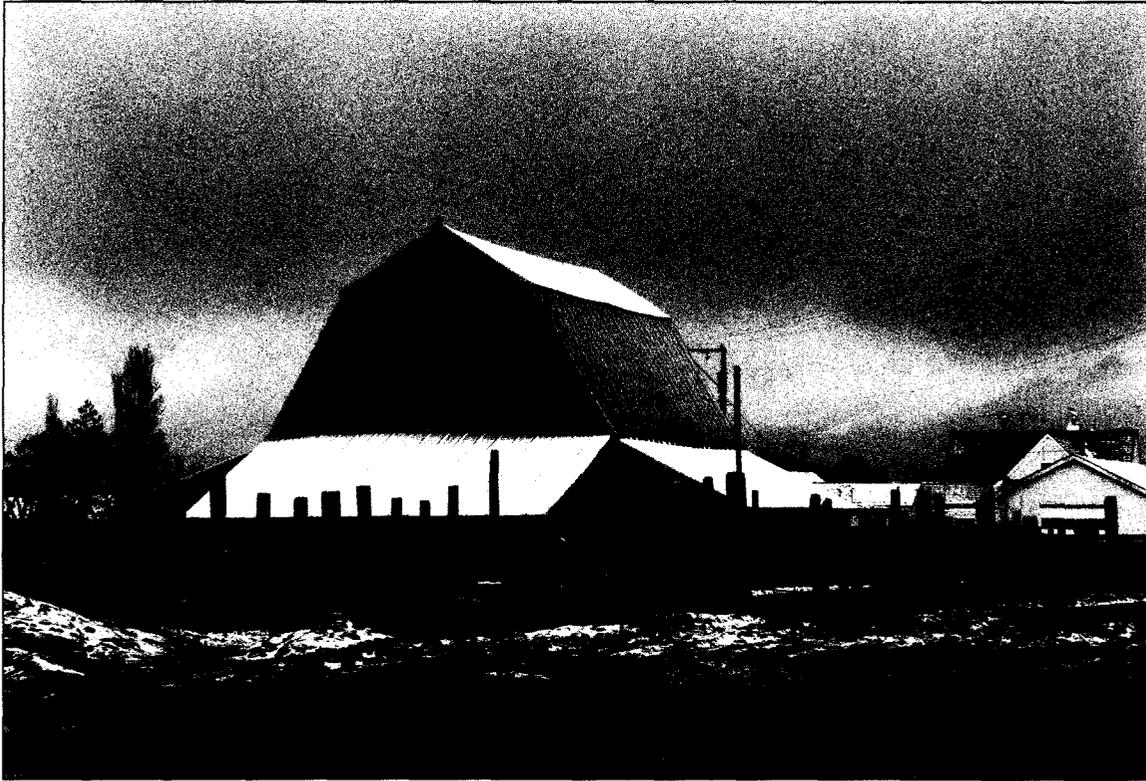
Photograph 5: BARN EXTERIOR INCLUDING THREE LEAN-TO ADDITIONS, LOOKING EAST THROUGH CORRAL

(The three early additions to the barn were used for milking and animal pens. Roger and Al Sherman built the corral system in the early 1950s.)

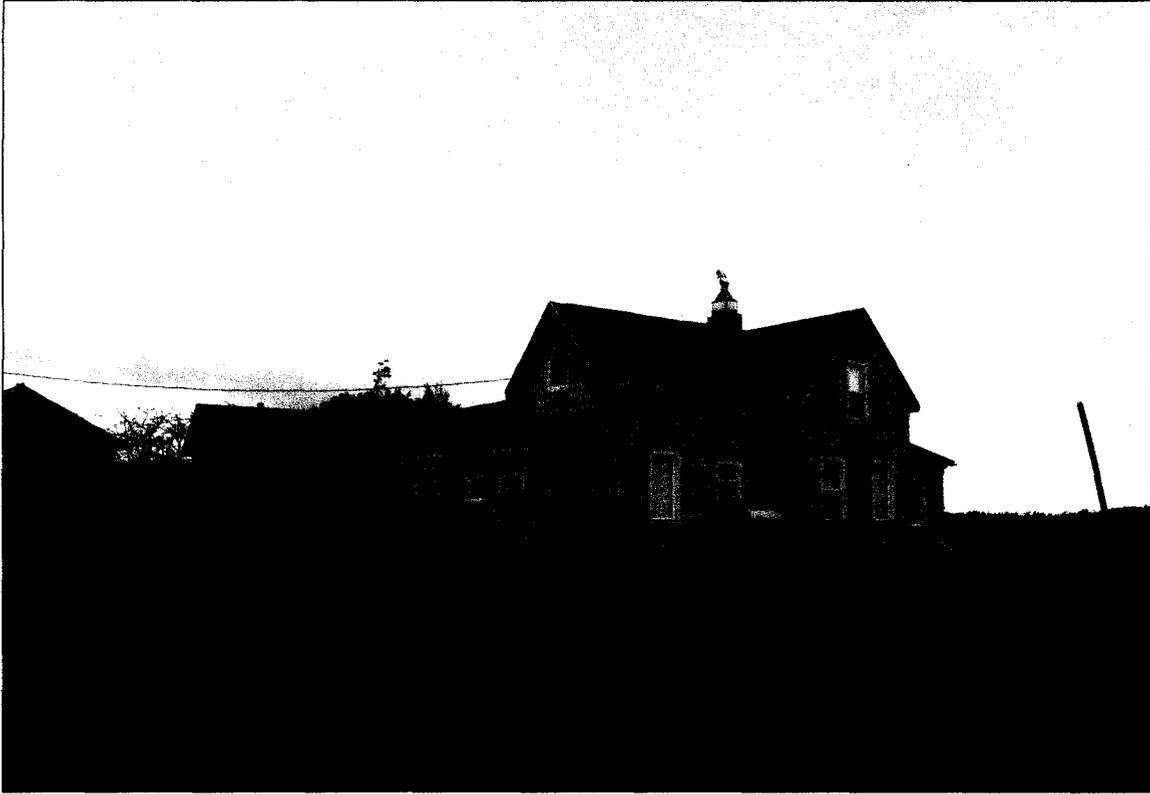
Photograph 6: COOK HOUSE LOOKING NORTHEAST

(The photograph shows the 1876 house built for Cyrus E. and Sarah Cook. The house's outbuildings are shown to the north and west.)

The Cyrus Cook house, constructed in 1876, sits south of the central driveway. This one-and-a-half-story vernacular farmhouse has a post on pier foundation and an irregular plan. The building is clad in raked wood shingles painted gray. The gable roof is covered in composite shingles and a brick chimney with metal vent sits over the southern slope. The building has one-over-one-light double-hung sashes with white trim and sills. Wooden ladders attached to the north, east, and south façades give access to the windows under the gables.

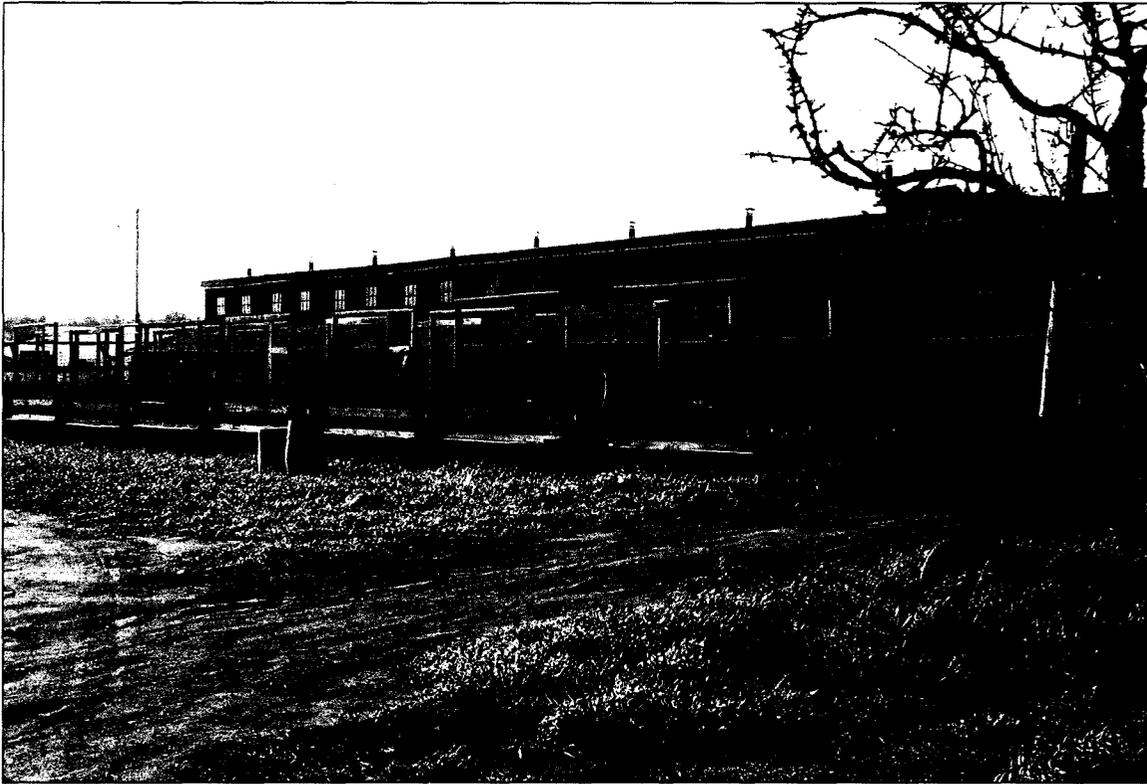
Photograph 8: A SHERMAN TURKEY BROODER HOUSE WITH SUN PORCH, 1960s

(To acclimate young turkeys to the elements, sun porches are added to the brooder houses. This brooder was located near the Shreck house. It has since been demolished. Of note: The stovepipes from oil stoves at the roofline.)
