713 D Street, NW (Commercial Building)
(D. C. Souvenirs)
Washington
District of Columbia

HABS No. DC-579

HISTORICAL AND DESCRIPTIVE DATA

713 D STREET, N.W.
(D.C. Souvenirs)
Lot 4

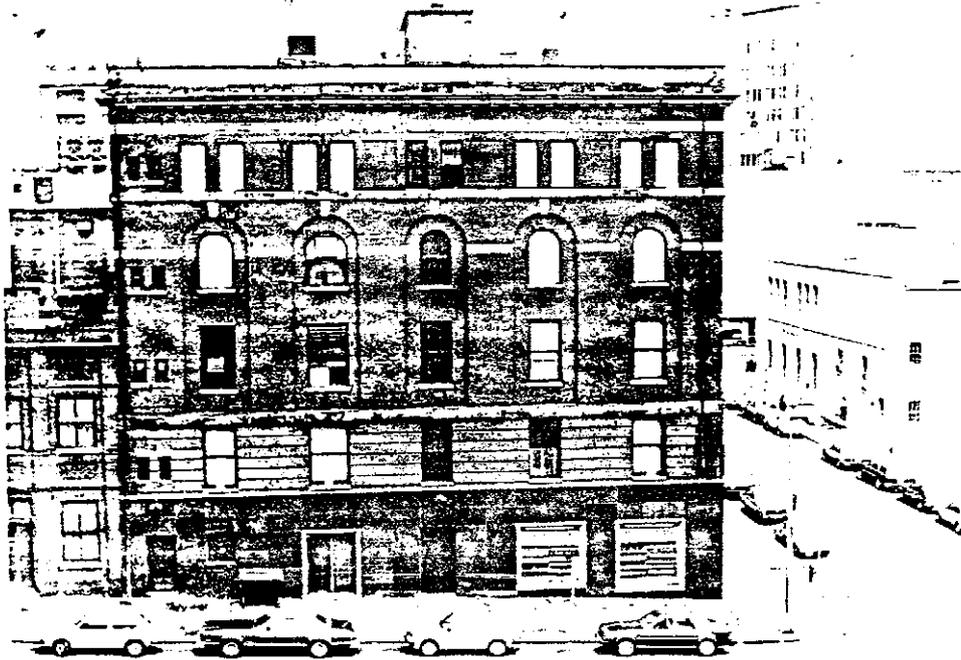
Eighth Street Facade (West)

The Eighth Street facade duplicates the arrangement of the main facade with some minor variations. The ground level's organization is erratic; its openings bear no relation to those of the upper stories. At the south end are two show windows, identical to those on the south facade. To the north of these are three randomly located door openings. A small window covered with metal grating sits to the right of the northernmost door.

Windows on the second floor, as on D Street, are deeply recessed. The adjacent bay to the north, though unchanged in panel width, carries noticeably wider windows on the second, third and fourth stories.

By far the most pronounced irregularity of the Eighth Street facade is the addition of a sixth bay of windows at the northern end. The sixth bay of each floor, second through fifth, has two small ventilation windows with one-over-one sash and stone sills.

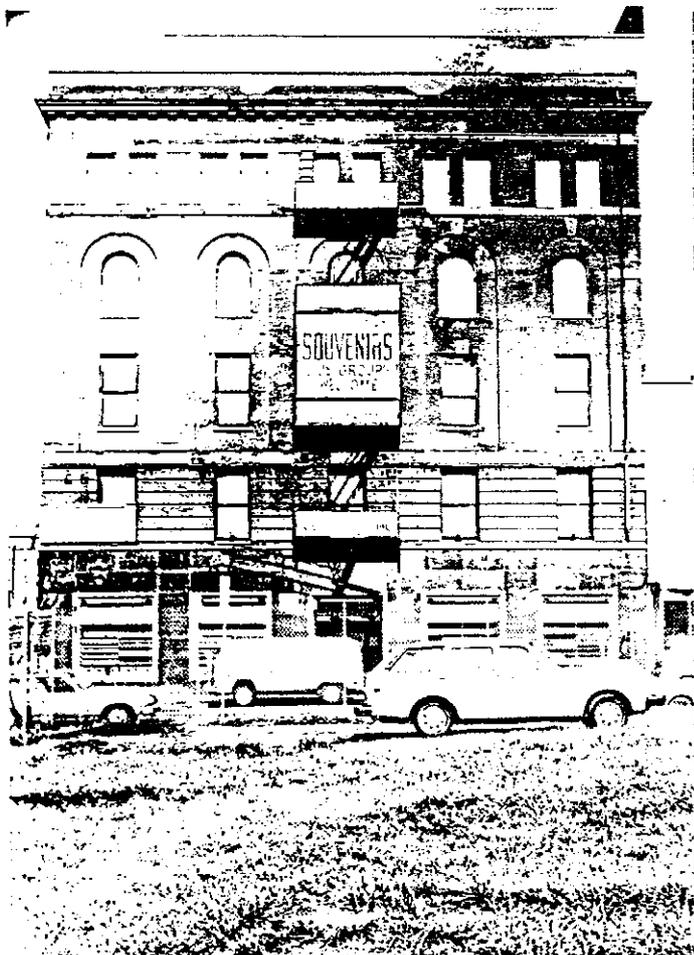
D Street Facade (South)

Although flush with the building line, the black marble storefront has covered the original facing of the first floor. The main or south storefront displays a centrally located entrance flanked by two show windows on either side. The plateglass panels are surrounded by convex limestone frames. Although unrelated to the upper level window locations, the ground level door and windows maintain the symmetry of the elevation above, and are possibly the original openings.

On the second floor the brickwork is rusticated. The square-headed windows here are recessed, emphasizing the thickness of the brick wall. The wooden window sash are one-over-one double-hung, as are all of the structure's operable windows.

The two stories of the mid-section of the building are visually unified through the incorporation of two-story blind arches which frame the recessed jack-arched windows of the third floor and the round-arched windows of the fourth floor. This composition of arches formalizes the interfenestration into a series of piers projecting upward from the second story to a stone impost course at the springline of the arches. The fifth floor inverts this pier motif through the recession of a rectangular panel between each bay of two jack-arched windows. An iron fire escape cuts a zig-zag pattern from the roof to just above the first floor entrance.
