Fort Leavenworth,
Building # 5
611 Scott Avenue
Leavenworth
Leavenworth County
Kansas

HABS No. KS-53-C

FORT LEAVENWORTH, BUILDING # 5 (SUTLER'S HOUSE)
HABS # KS-53-C

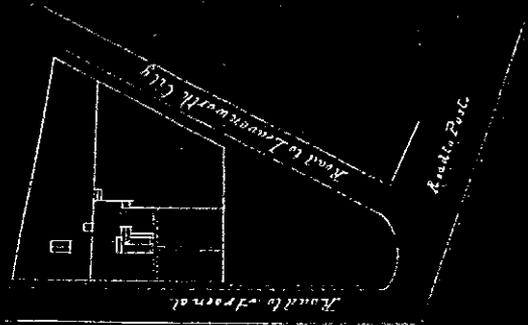
GROUNDS AT RESIDENCE OF
DEPOT QUARTERMASTER
FORT LEAVENWORTH, K.S.
SCALE 1/8" = 1'-0"

1. Residence of Depot Quartermaster

Front ele., ground & second story plan

4. Builder, contractor, supplies: Hiram Rich, builder
5. Original Plans & construction: Located at Fort Leavenworth is an undated plan of the front elevation of the original one and a half story building, first and second story plans and a site plan labeled "Residence of the Depot Quartermaster" (see Supplemental Materials # 1). Also located at Directorate of Engineering and Housing (DEH) were later undated floor plans (See supplemental Materials # 2 & # 3).

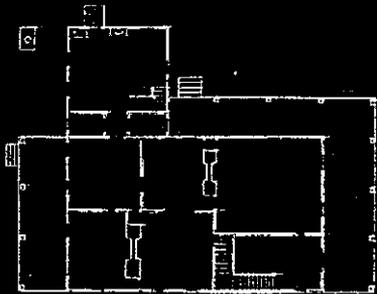
FRONT ELEVATION

RESIDENCE OF
DEPOT QUARTERMASTER
FORT LEAVENWORTH, K.S.
SCALE 1/8" = 1'-0"

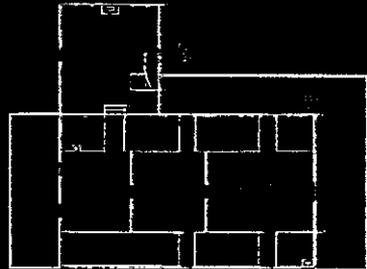
GROUND PLAN

PLAN OF SECOND STORY

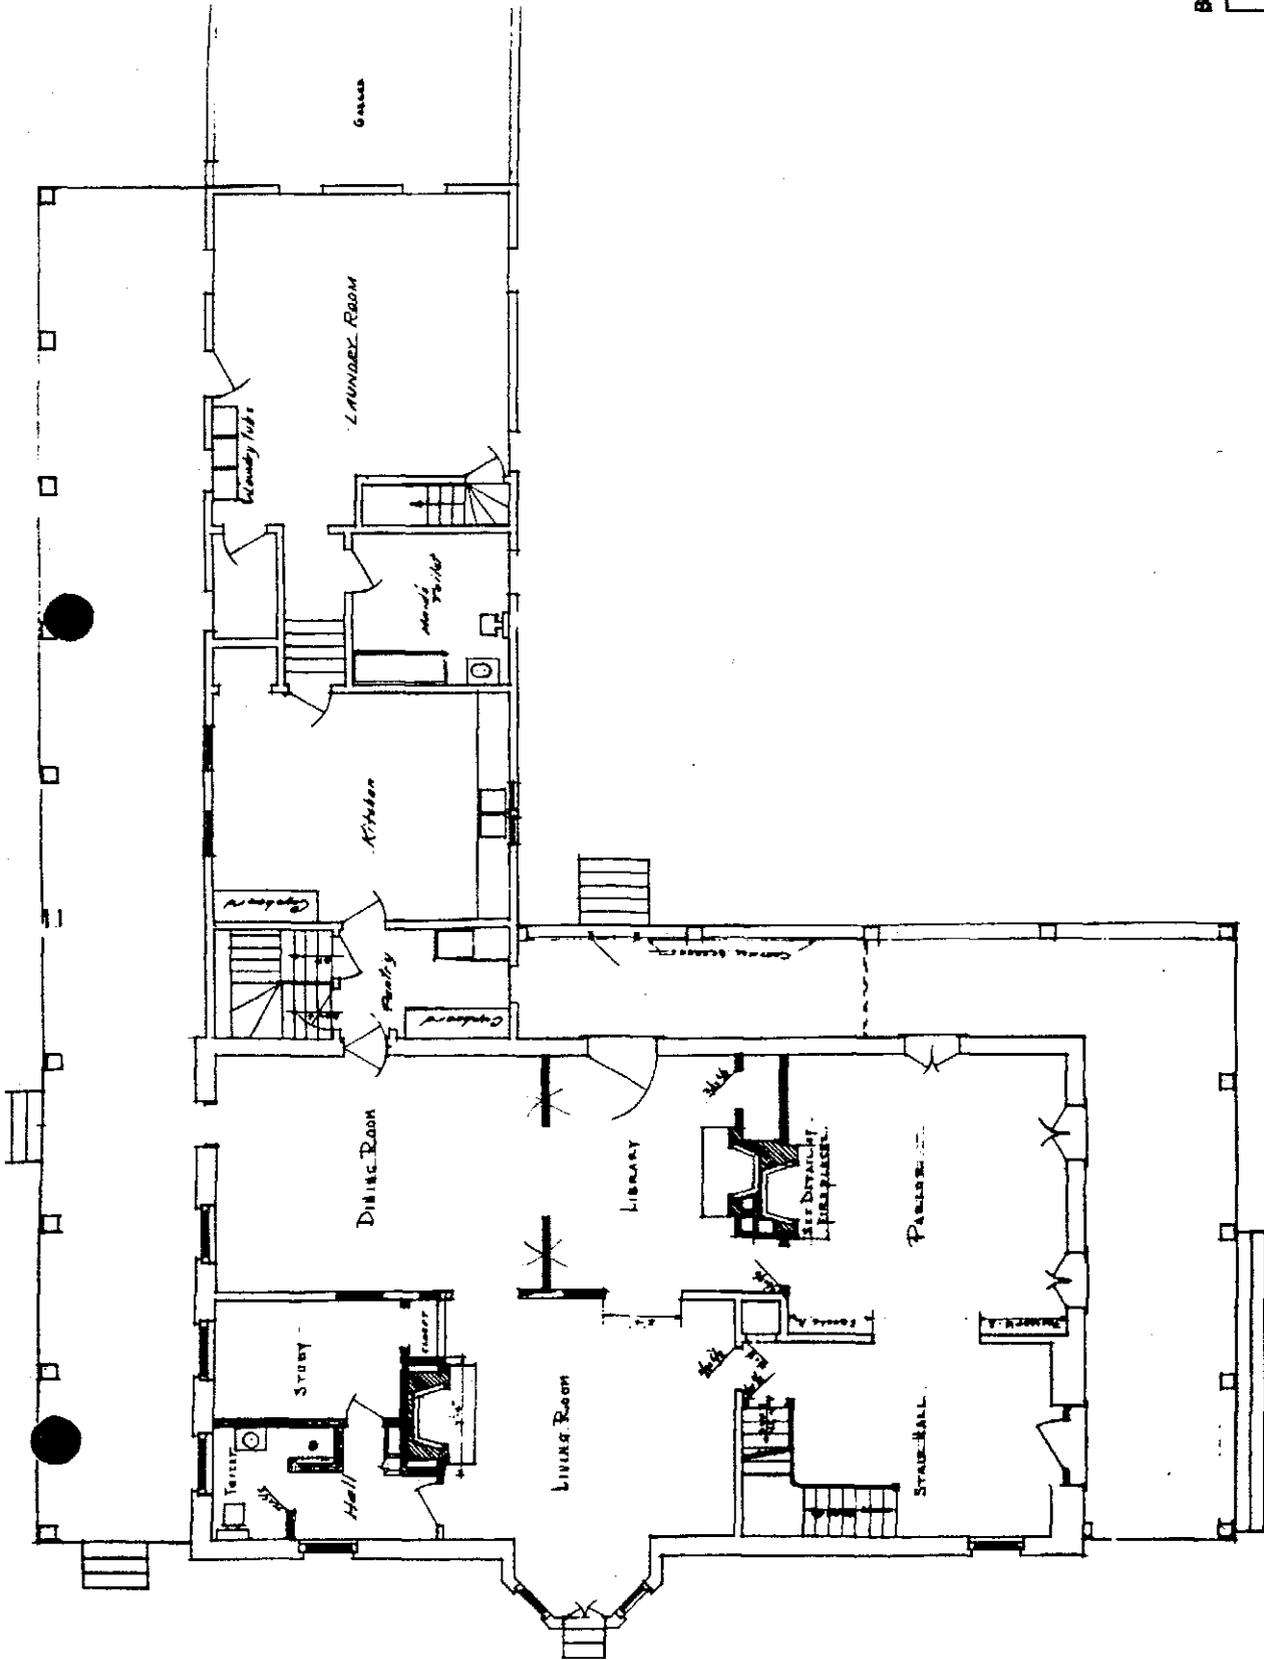
2. First floor plan

TYPICAL FLOOR PLAN #
5

FIRST FLOOR
SCALE: 1/8"=1'-0"

- b. First floor: The main entry is on the north facade of the main block, into a stair hall; stairs to the second floor are on the east and south walls, with a door beneath to the basement stair. At the rear of the hall is a doorway to the living room to the south; on the right, or west, is a wide entry to the parlor. The parlor and living room connect to the dining room which extend the remaining length of the house, with openings on the west and south porches. A short six-foot-wide hall connects the living room to a bath and study in the building's southeast corner.

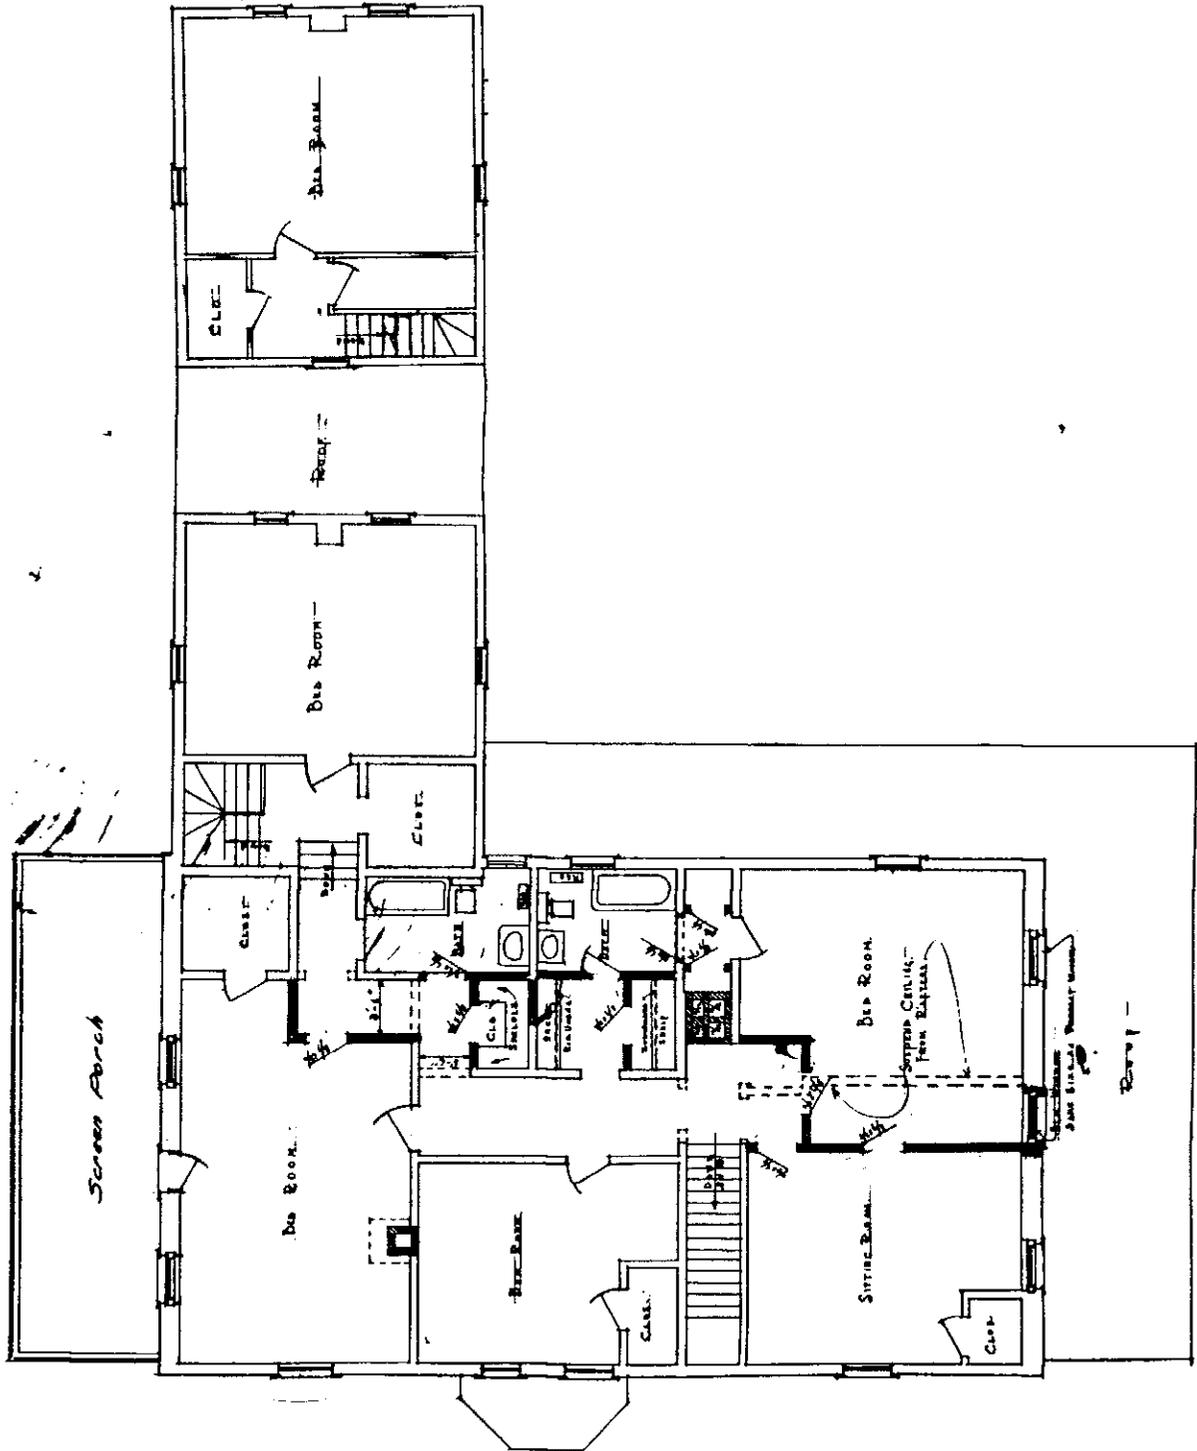
3. Second floor plan

SECOND FLOOR

- c. Second floor: The main (north) stair ascends to a hallway running north and south at the center of the building; from the plans this previously extended to the central bay at the north end of the house. Now, the north end contains an enlarged bedroom at the northwest and a sitting room at the northeast. On the south and east of the hall are large bedrooms; to the west is a storage passage to a bath which connects by another storage passage to the northern bedroom. To the southwest, off the center hall, the narrower rear hall passes a large storage closet and bath, and descends three steps to a stairhall in the wing leading to a bedroom on the west. Ceilings are approximately twelve feet in the main block, and eight

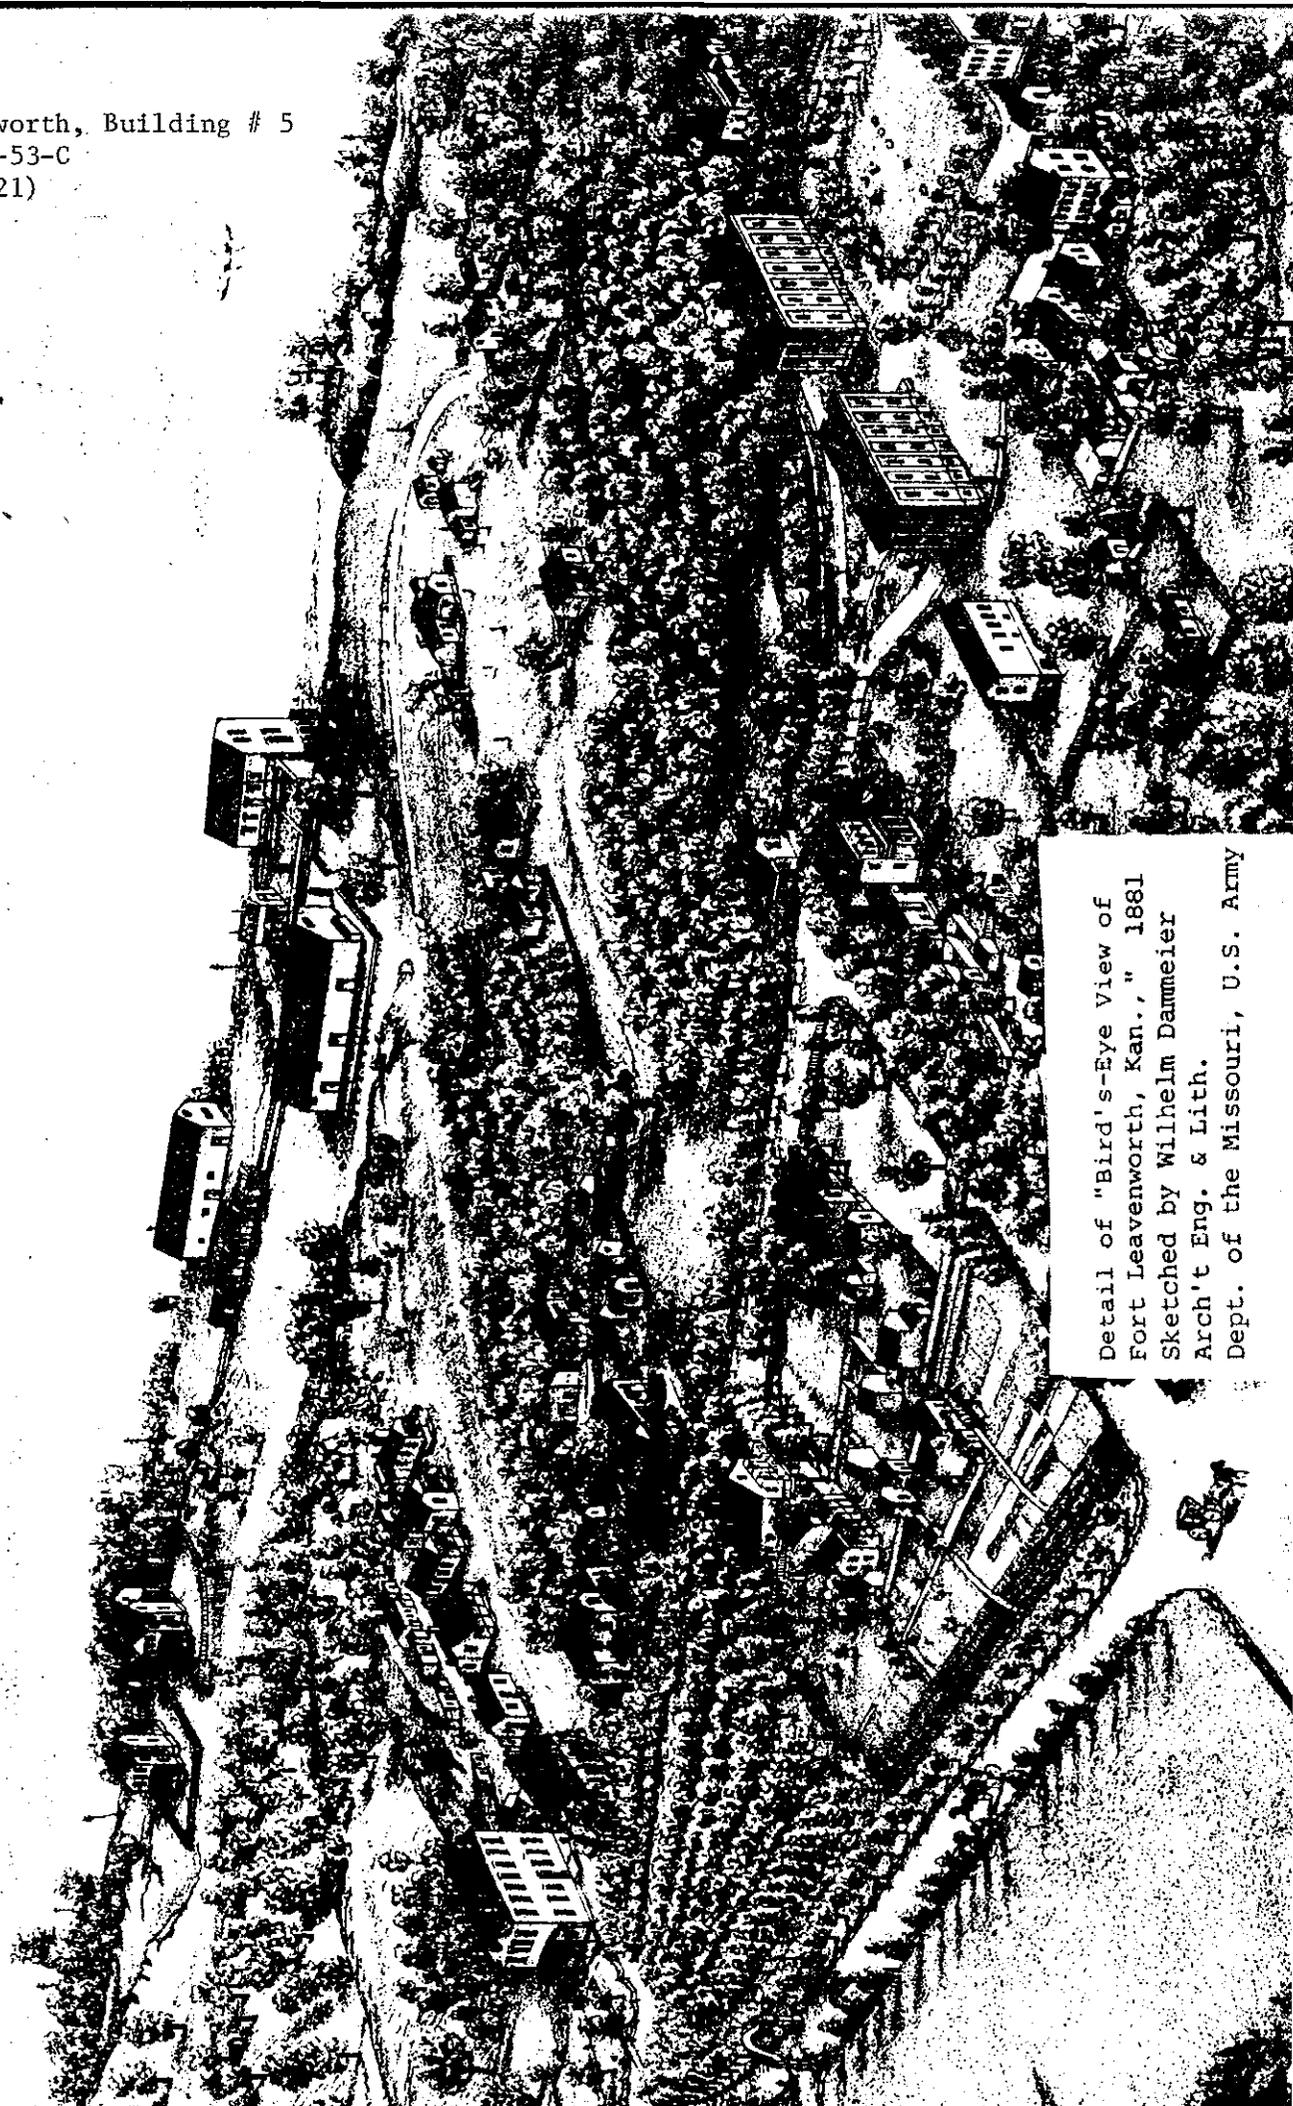
5. Fort Leavenworth, Building # 5
HABS No. KS-53-C
Data (page 21)

Detail of "Bird's-Eye View of
Fort Leavenworth, Kan.," 1881
Sketched by Wilhelm Dammeier
Arch't Eng. & Lith.
Dept. of the Missouri, U.S. Army

Unfortunately there is no precise information to date the alteration of Building # 5 from the one and a half story house with a west extension to the two and a half story building with a west wing shown in an 1895 photograph. An 1865 letter to General Meigs from the Depot Quartermaster asks for permission "to repair and fit-up the house." The next reference appears in Forty-six years in the Army, where General Schofield writes that: "some necessary improvements had been made in the quarters during the winter" before the arrival at Fort Leavenworth of the General and his wife (Schofield, p. 428). General Schofield's replacement in 1870 was General Pope, who remained at Fort Leavenworth until 1883 and was responsible for the construction of new quarters "doubling the size of the post" (Cox, p. 297). It is possible that the alteration to the main block and the enlargement of the western wing could have occurred during this period also. Dammeier's 1881 "Bird's Eye View" shows conclusively that the alterations occurred before the 1881 lithograph. A two and a half story house with a large west wing is illustrated.

Dammeier, Wilhelm, "Bird's Eye View of Fort Leavenworth, Kansas", Fort Leavenworth: U.S. Department of the Missouri, 1881, Fort Leavenworth Historical Museum.
