Walnut Hill Steam Laundry  
1032 Foraker Street  
Cincinnati  
Hamilton County  
Ohio

HABS No. OH-659

WRITTEN HISTORICAL AND DESCRIPTIVE DATA

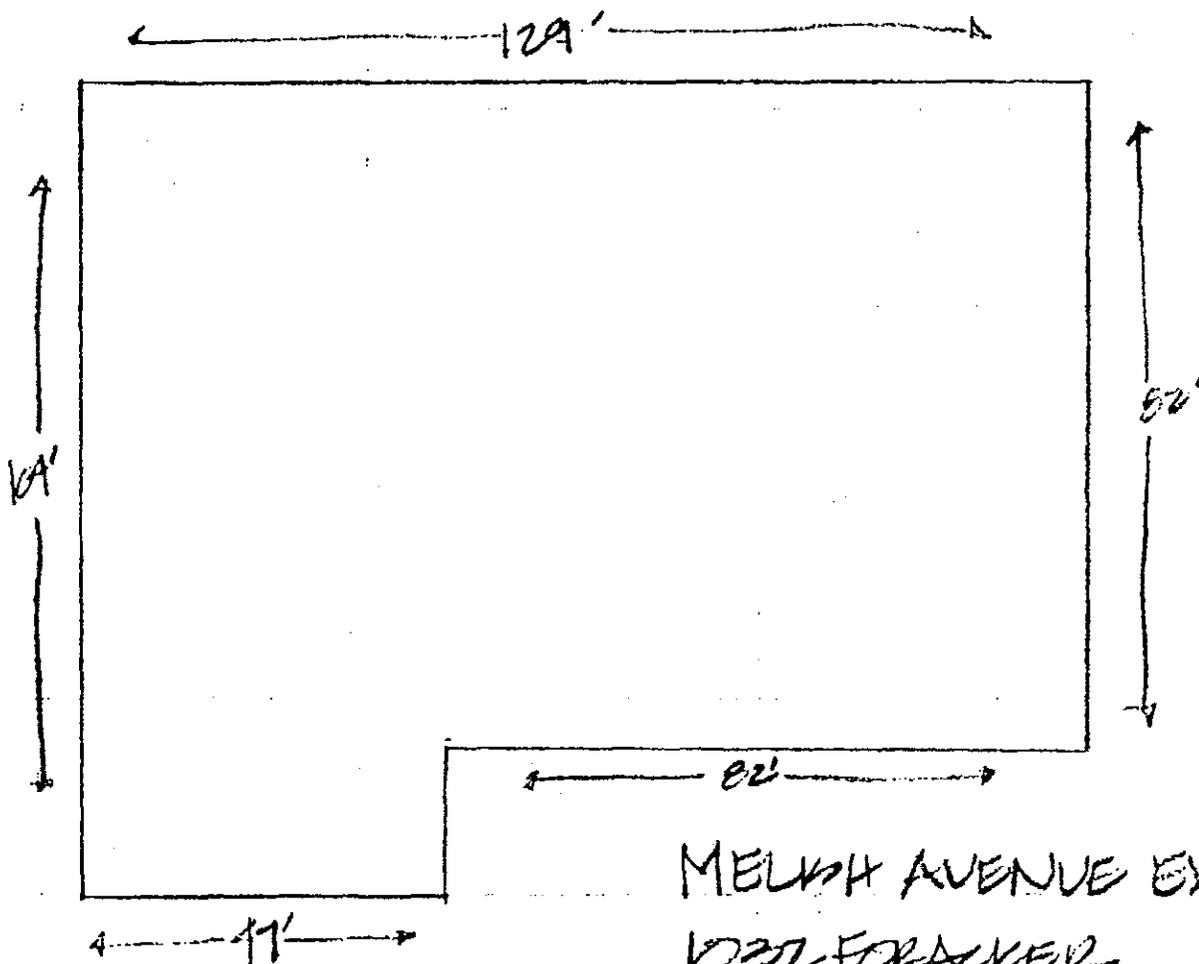
MELISH AVENUE EXT  
1032 FORAKER  
AVENUE

1 STORY BUILDING - 82' X 129'  
ADDITION - 19.6' X 47'

2 MONITORS - 15' X 82' and  
15' X 104' X 4' high

SCALE = 1" = 25'

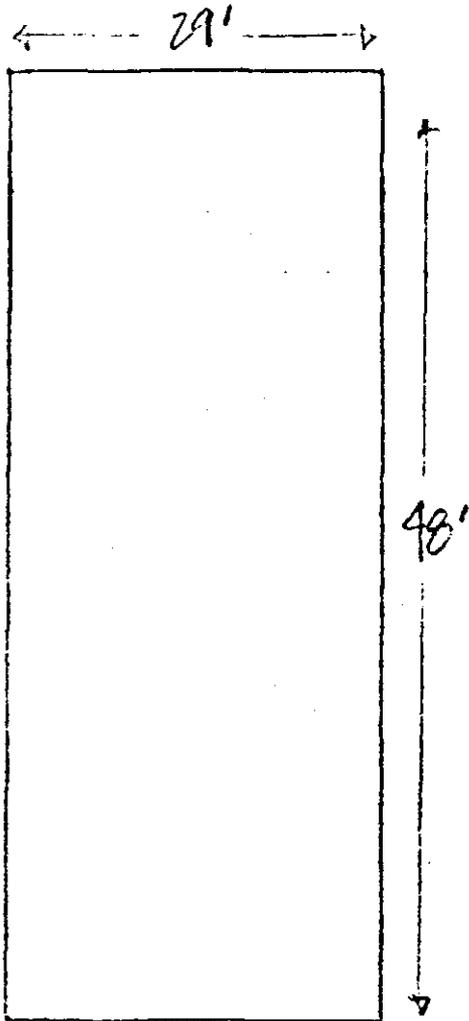
MELKSH AVENUE EXT.  
3022 PARK AVENUE

2 STORY BUILDING  
1st FLOOR - COMMERCIAL  
2nd FLOOR - APARTMENT  
ATTIC - APARTMENT

SCALE = 1" = 10'
