SAN BENITO IRRIGATION SYSTEM, PUMP HOUSE
(Cameron County Irrigation District #2, Pump House)
San Benito vicinity
Cameron County
Texas

HAER No TX-132-A

PHOTOGRAPHS
WRITTEN HISTORICAL AND DESCRIPTIVE DATA

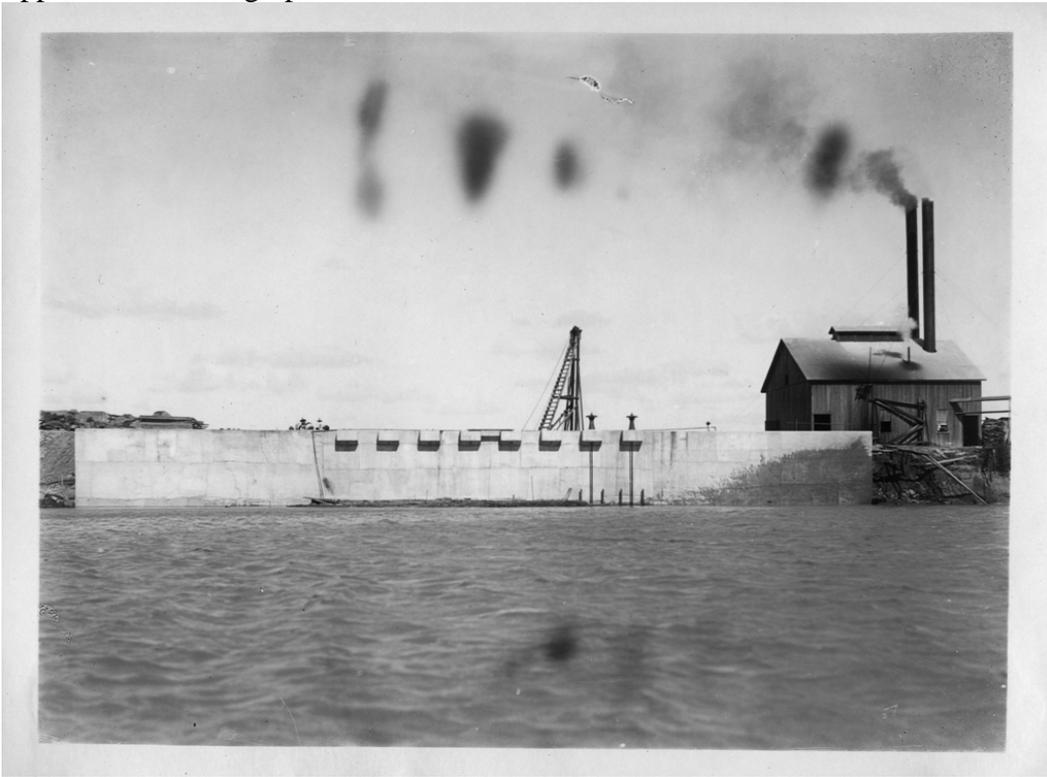
Circa 1909. Original headgates during construction viewed from Rio Grande. Structure on right is temporary construction building. Photograph: Alba Heywood Collection, University of North Texas Archives/Rare Books Department.

The original circa 1907 headworks structure consisted of a rectangular water chamber or pit approximately 65' by 70' from front to rear. Its headwall was 250' long by 22' tall built into the bank of the Rio Grande, set at the river bottom.

Built largely below grade of board-formed concrete, it ranged from 2' to 3' thick, with 17' deep steel and wood pilings. Eight 4' by 6' openings were located in the base of the wall, with wood and metal gates to control the flow of water through the openings. The gates were operated by large cast-iron turn wheels, connected by long threaded rods, set into concrete projections at the top of the wall.

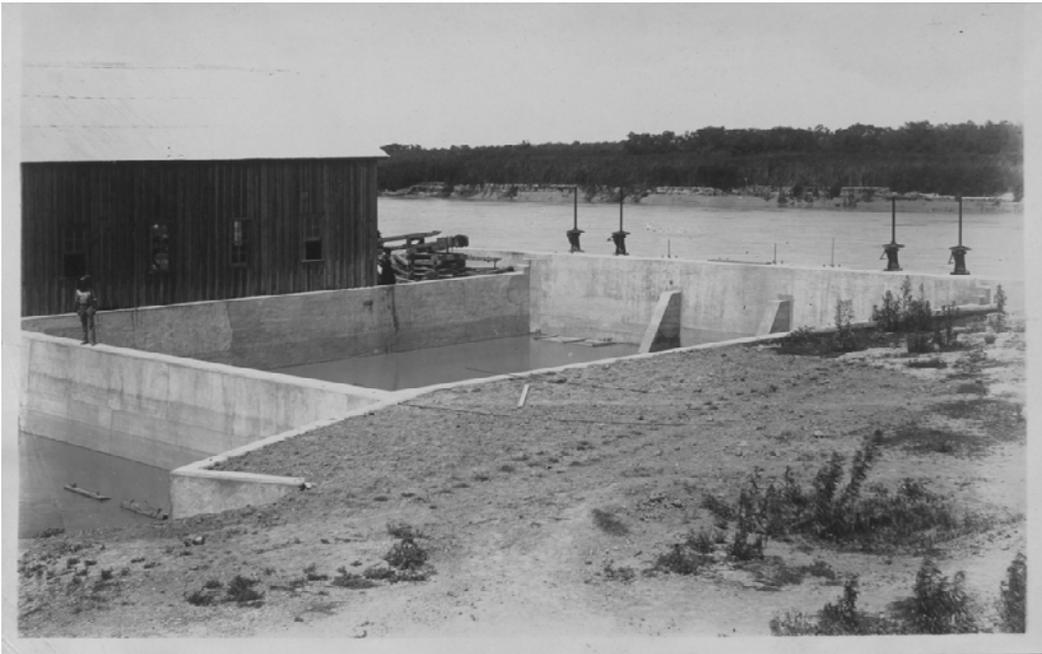
Circa 1909. Original headworks, looking towards Rio Grande. Pictured structure is the first pump house, with original pump pit. Photograph: Alba Heywood Collection, University of North Texas Archives/Rare Books Department.

Photographs dating circa 1909 show two separate wood framed and clad buildings that sat immediately south of the headworks. Both featured vertical board and batten siding, double-hung four-over-four wood windows and corrugated metal gable roofs. One building was oriented with gables on the north and south ends and had a monitor roof and two chimney stacks. This appeared to have been constructed to house boilers and other equipment related to the construction of the headworks. The second building was oriented with gables facing east and west and was constructed using the southern wall of the headworks as a foundation wall. It was setback from the headgate wall and, based on historic photographs, it appears that the original pumps were set into a separate pit from the large water chamber, between the building and the headgates. This building likely held the boiler and steam engines that powered the pumps, while the pumps themselves were left exposed. A water channel was located beneath the structure, formed by

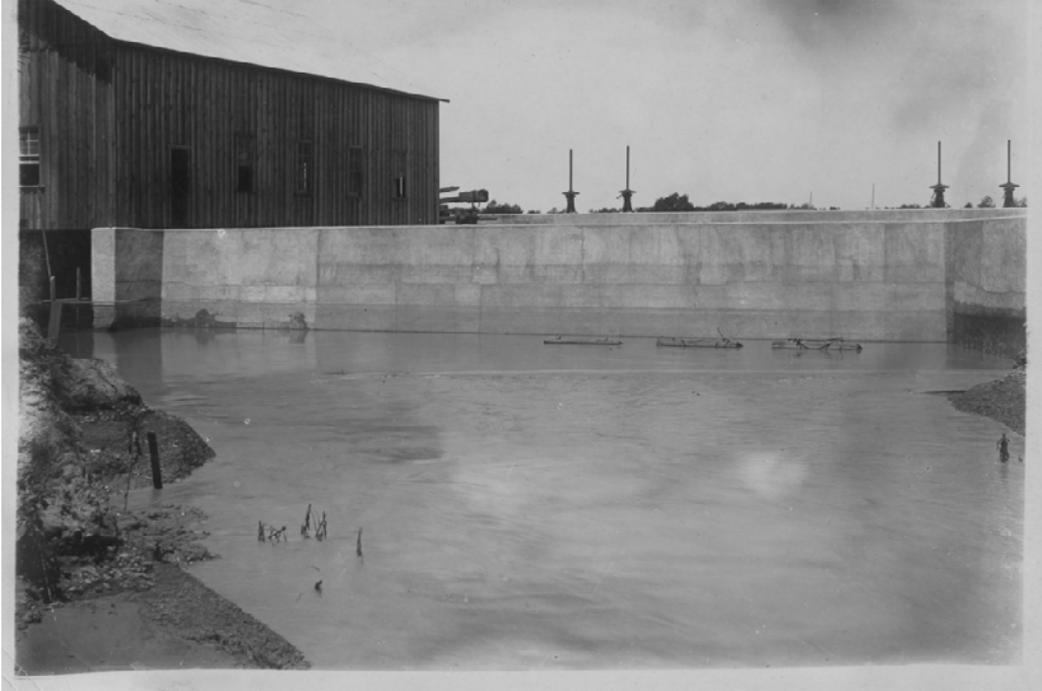
Circa 1909. View of original headworks from main canal. Pumping plant water channel can be seen on far right beneath pump house. Photograph: Alba Heywood Collection, University of North Texas Archives/Rare Books Department.

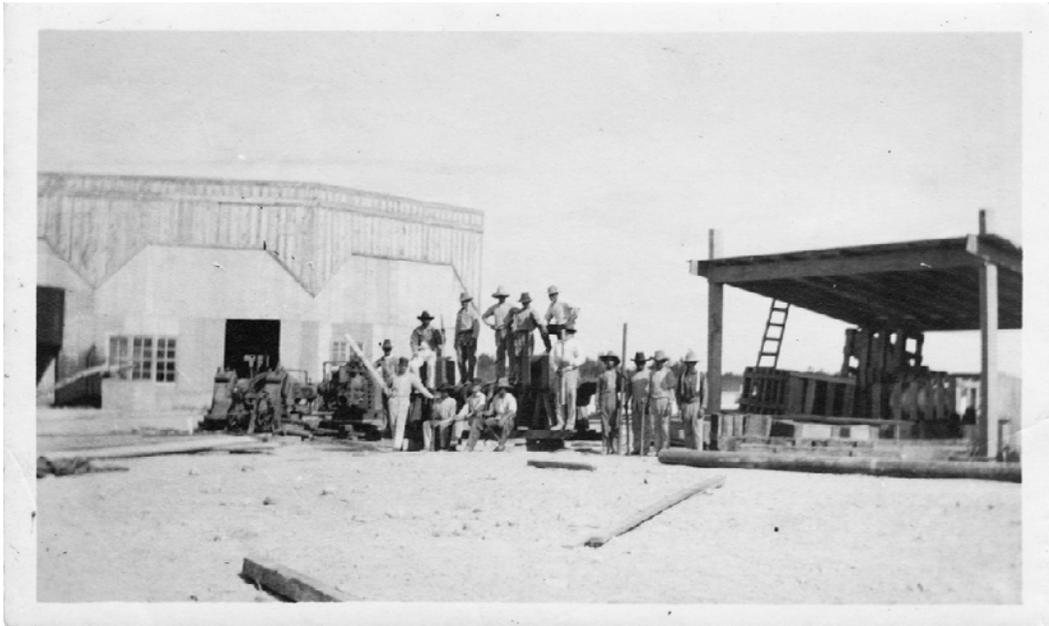
Circa 1919. Second pumping plant during construction.
Photograph: Cameron County Irrigation District #2.

The original circa 1907 pumping plant was demolished, and a new plant built sometime after 1917 when ownership of the system changed and new pumps were installed to increase the water flowing into the system. The exact date of construction is unknown. No plans or descriptions of the building exist, though it is visible in numerous historic photos. This new, larger pumping plant was constructed in the same general location as the original plant, utilizing the southern wall of the headworks as a foundation wall and retaining the water channel beneath the plant. The new pumping plant was rectangular in plan, with a canted corner over the water channel. It extended fully to the headgate wall, and enclosed all of the pumping equipment. It was clad in corrugated metal panels with a wood board and batten cornice. The plant had a roof with two parallel hips, one hip being the width of the canted wall section. Based on physical remnants at the site, the building likely had a low, board-formed concrete footer. A large brick chimney sat just east of the pumping plant, connected to it with a large duct, near an adjacent wood frame and clad workshop.

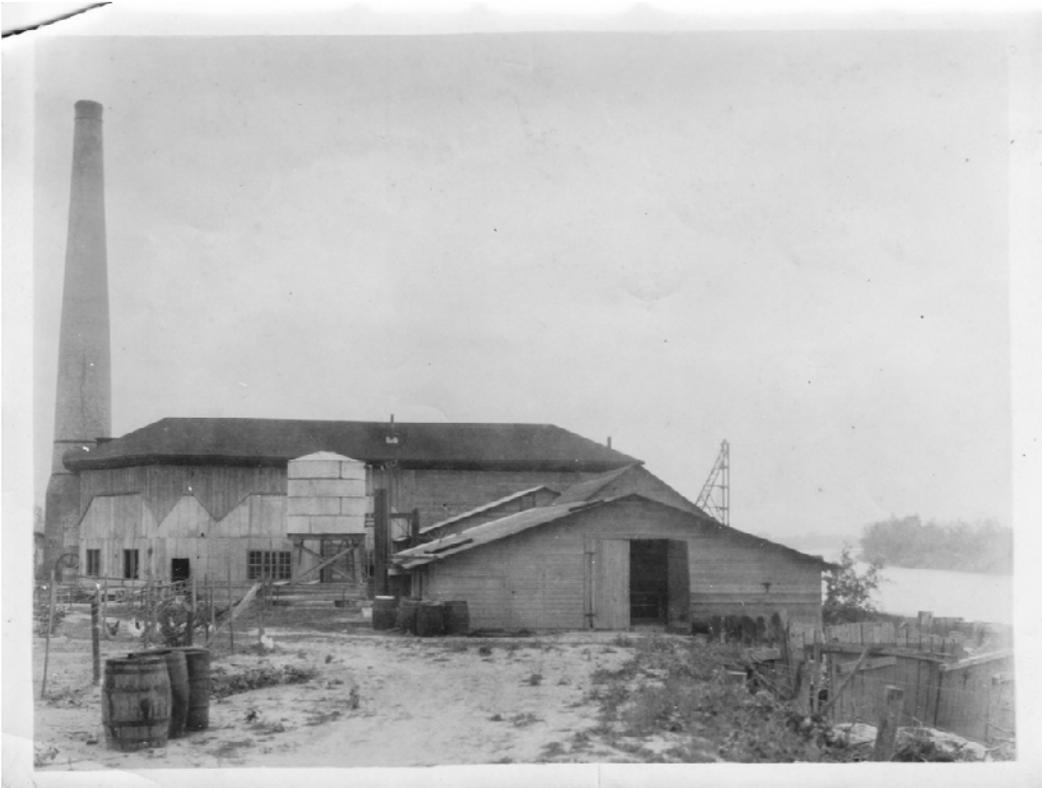
Circa 1920. Second (circa 1917) pumping plant with additions above headworks, looking south. Photograph: Cameron County Irrigation District #2.

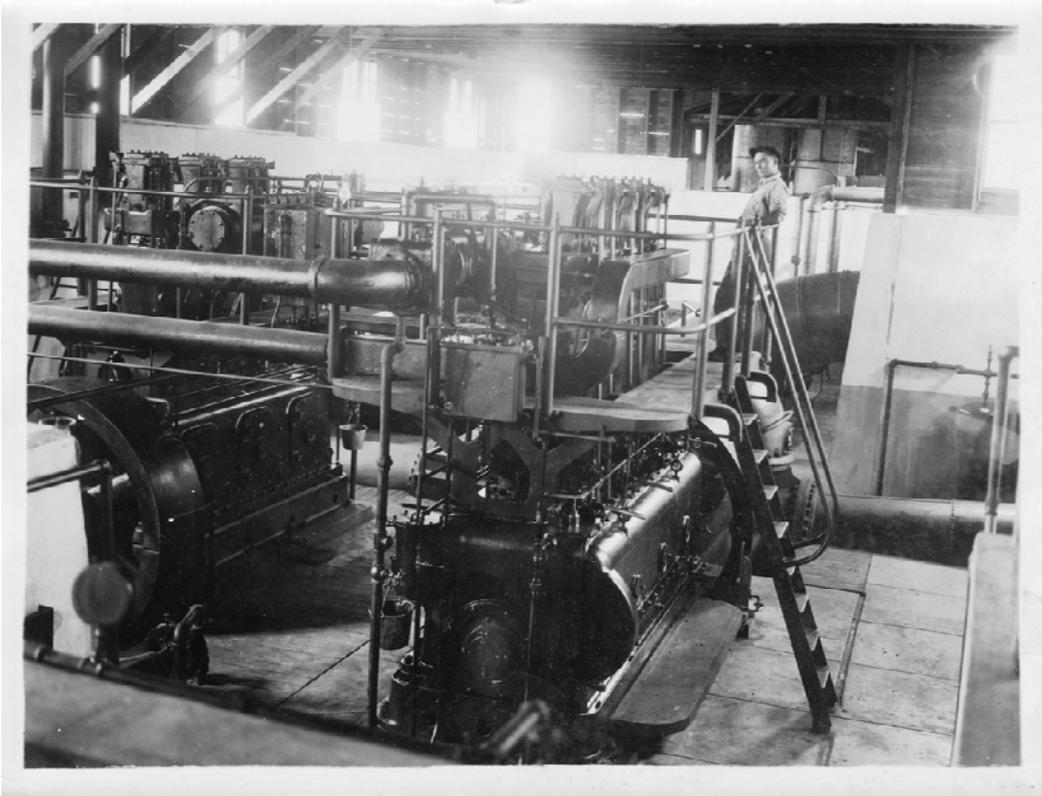
Circa 1920. Interior of pumping pit constructed within original headworks, looking north.
Photograph: Cameron County Irrigation District #2.

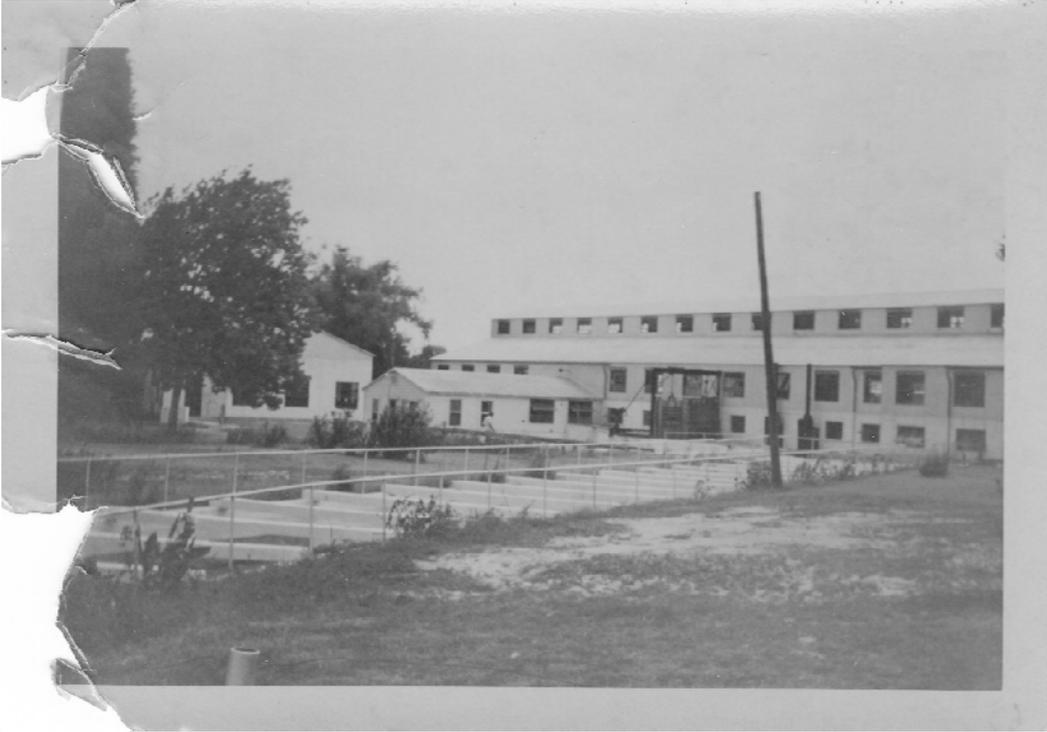
1951. Third (circa 1947) pumping plant looking across concrete connector to High Line Canal. Photograph: Cameron County Irrigation District #2.

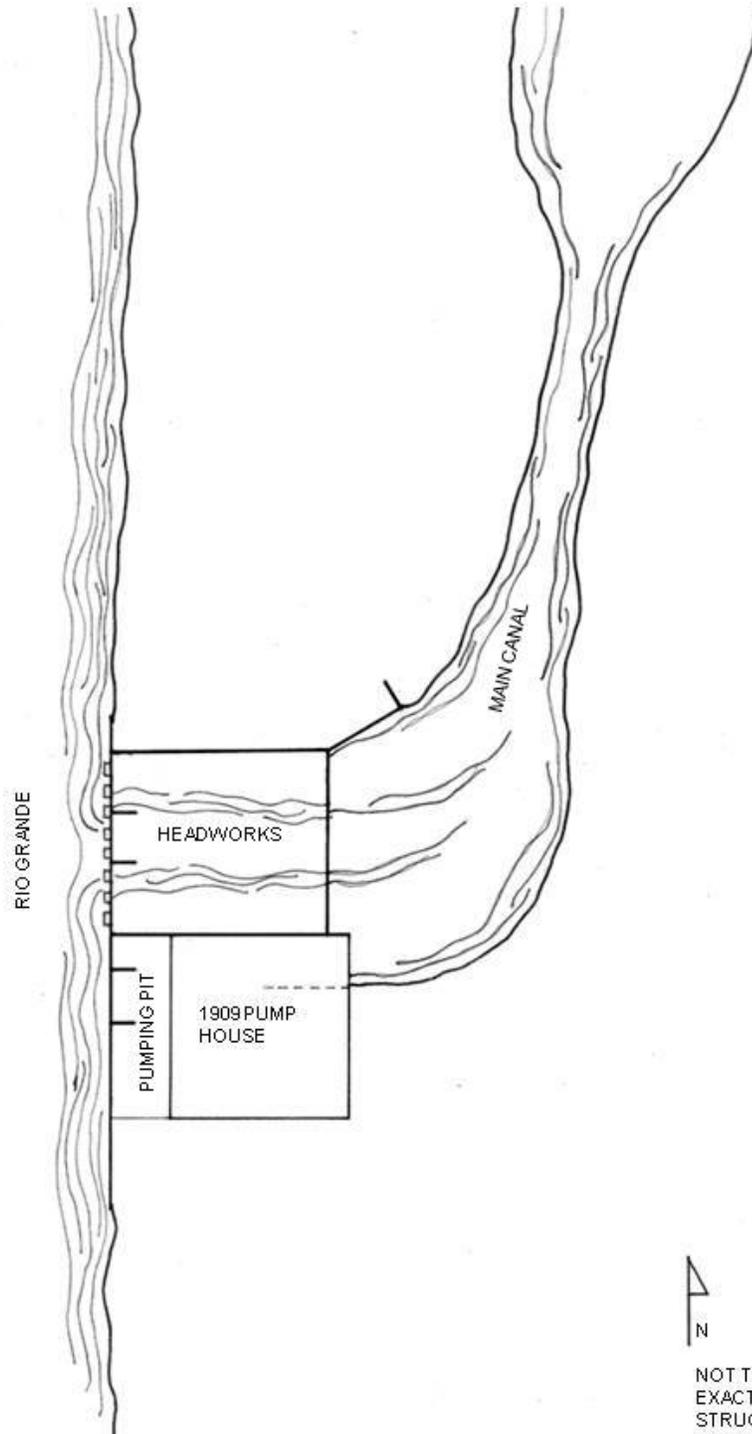
SAN BENITO PUMPING PLANT
1909-1918

NOT TO SCALE
EXACT DIMENSIONS OF
STRUCTURES UNKNOWN

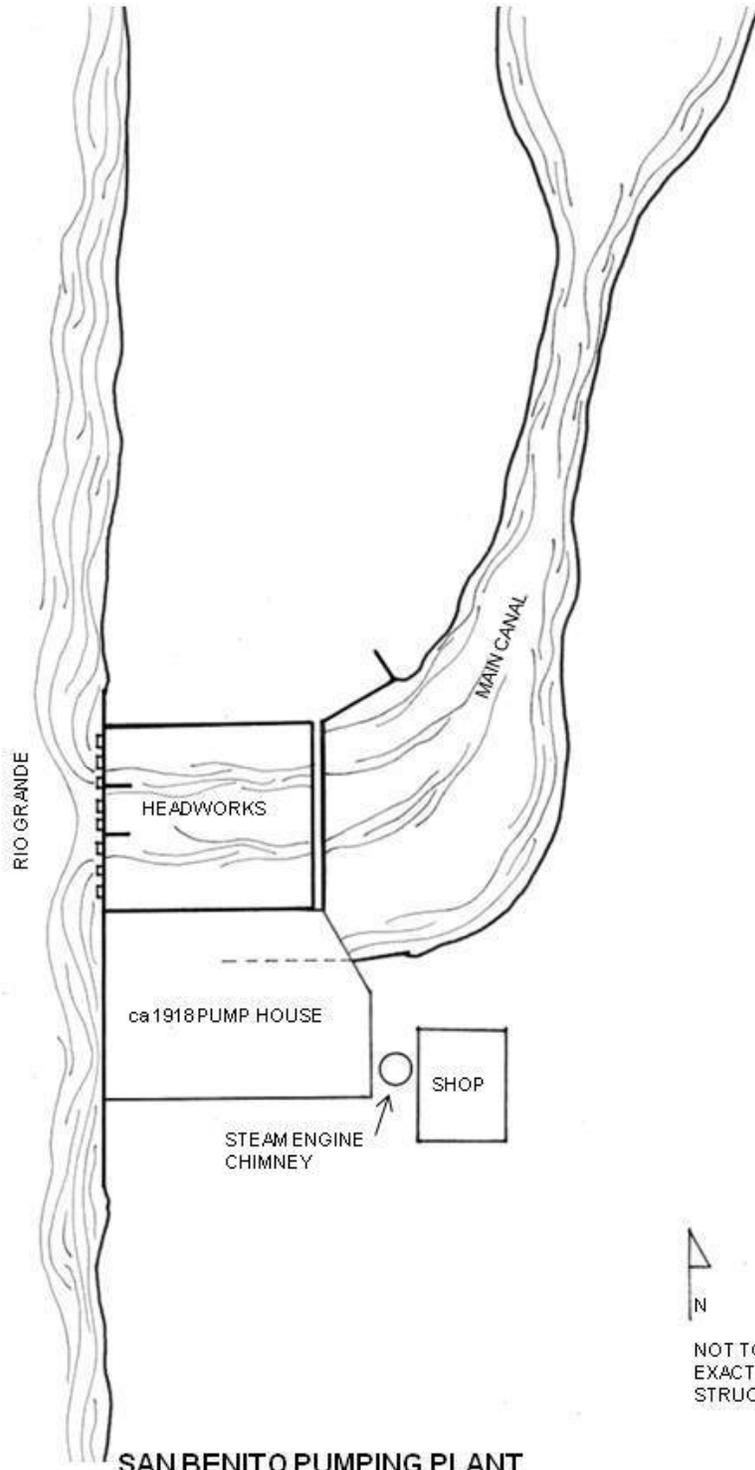
SAN BENITO PUMPING PLANT
1918-1920

N
NOT TO SCALE
EXACT DIMENSIONS OF
STRUCTURES UNKNOWN
