GILPIN'S FALLS COVERED BRIDGE
Spanning North East Creek at Former (Bypassed) Section of North
East Road (SR 272)
North East
Cecil County
Maryland

HAER MD-174
HAER MD-174

WRITTEN HISTORICAL AND DESCRIPTIVE DATA

Structural Type: Burr truss

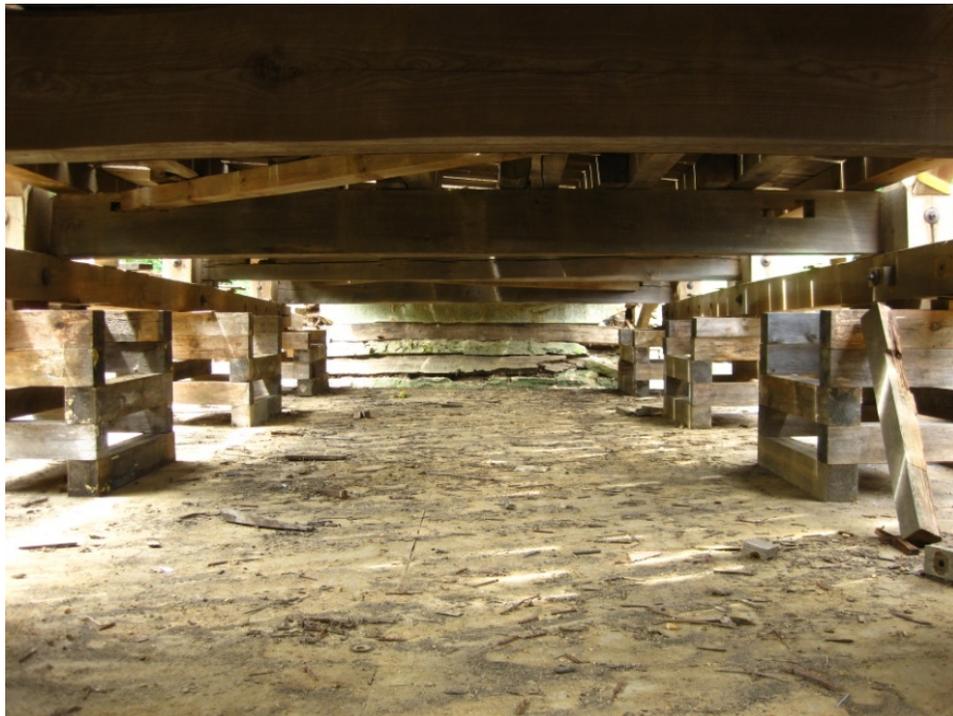
Figure 18: View from under the bridge where cribbing supporting the six posts closest to the north abutment can be seen. Note: cribbing sits on the floor of the temporary structure, which spans North East Creek. Photograph by Rachel H. Sangree.

and using cribbing on top of the temporary structure to support the truss at each post (Figure 18). The siding and floor (with the exception of the floor beam at midspan) and roof systems (with the exception of the tie beams connecting the two trusses) were removed, and the posts were raised enough by the cribbing to remove all axial forces from the truss members. With forces out of the trusses, bridgewrights “walked” the trusses back to vertical, maintaining stability by triangulating the trusses with cross-chains (Figure 19). At this point, members exhibiting damage or decay could be removed (Figure 20).

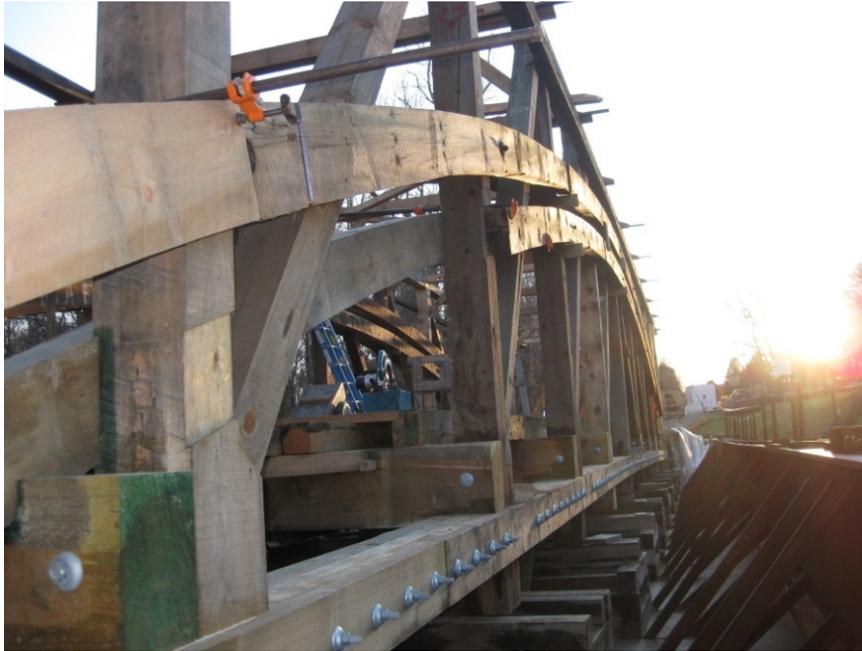
Figure 22: Installation of arch segments on the west truss. Photograph by Rachel H. Sangree.

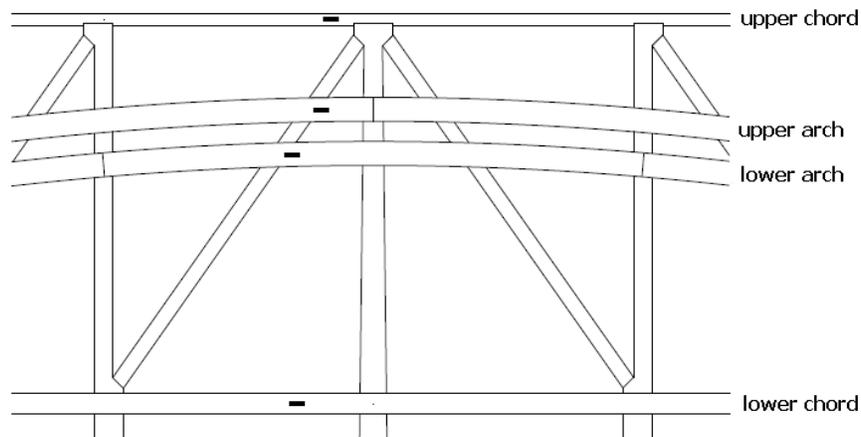
Strain gages were glued to the four main "moment-resisting" members near midspan: upper chord, lower chord, upper arch and lower arch (see Figure 24). To capture any out-of-plane strains and to provide for redundant strain measurements, strain gages were glued to the inside and outside face of each member. In all, a total of eight strain readings were recorded at a time.³⁴

Figure 24: Strain gage locations (—) just north of midspan on inside face of east truss

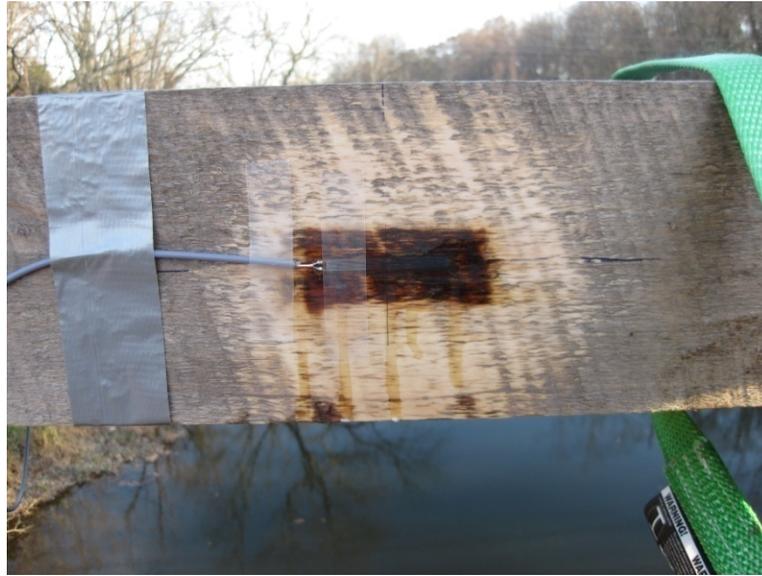
Strain gages were type N2A-06-20CBW-350, which were used because they were long enough to capture the average strain in a member over a 2" length. A strain gage is shown in Figure 25 (note: the dark region surrounding the gage is the base layer of epoxy used to create a smooth, bondable surface). Axial strains (ϵ) were recorded with National Instruments LabVIEW software and converted into axial forces (P) by the following expression:

Figure 25: Strain gage on inside face of top chord. Photograph by Rachel Sangree.

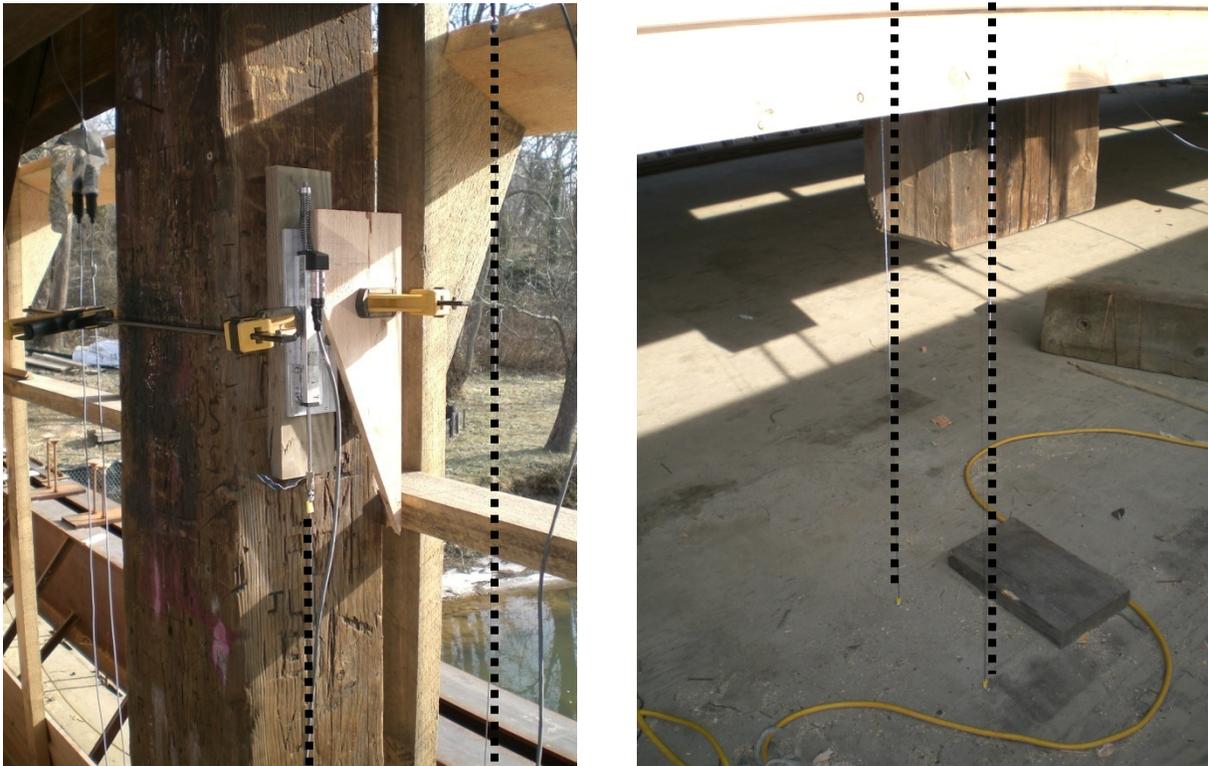
Two tests were performed after Rehabilitation Stage 3 had been completed. In the first, position transducers measured the vertical displacement of the kingpost and the lower arch at midspan as a truck was driven across the bridge, stopping so that its center of gravity was first at midspan and then at the three-quarter point (see Figure 27). In the second test, one position transducer was moved to the three-quarter point of the span so that displacement measurements were now for the kingpost at midspan and the arch at the three-quarter point.

Figure 26: Position transducers were connected to the kingpost and lower arch on the east truss at midspan (wires used to connect the position transducers to ground are highlighted for clarity). Photographs by Rachel H. Sangree.

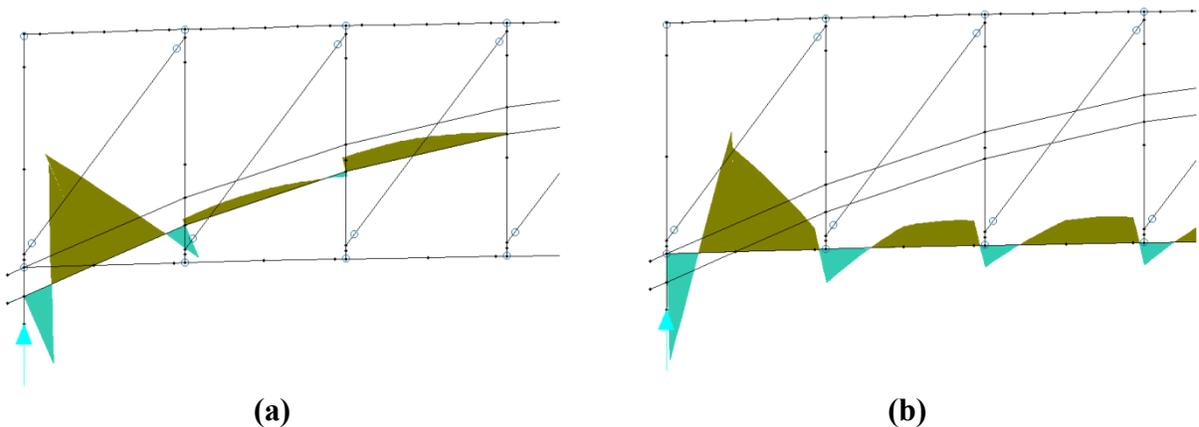
Further validation of the cause of the bridge's failure (see Section 5.2) comes from the moment diagrams generated from analyzing the tied arch system (see Figure 43). Had the arch and lower chord had use of their full sections under such conditions it is possible that they would have had the capacity to support the high bending moments (see Table 12 which assumes the full section is available). However, the lower chord had been retrofitted with a butt joint between L0 and L1, which was now subjected to tension, rendering half of its section useless in resisting the moment. Additionally, the lower arch has a significantly reduced cross-section in this area to accommodate the lower chord connection.

Figure 43: Moments induced in (a) the lower arch and (b) the lower chord resulting from a loss of support conditions at the arch ends.

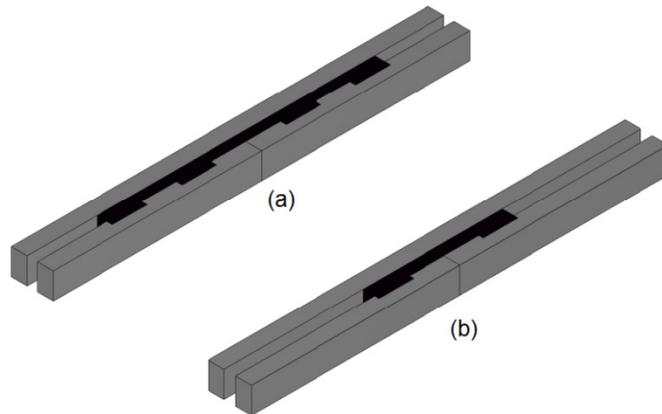
The capacity of this type of tension splice is found by calculating the minimum strength of three conditions that would result in the splice's failure: end grain bearing strength at the notch, shear strength of the notched length and the tensile strength of the net section. Prior to the bridge's rehabilitation, bridgewrights observed that most of the lower chord splice joints had failed, most often in shear (see Figure 44b), though crushing of the wood at the notches as in a bearing failure was calculated as the controlling mode and likely occurred much earlier.

Figure 46: Lower chord tension splices: (a) reconstructed and (b) original designs. Note: lower chord members are shaded gray; fish plates are shaded black.

The following calculations, in addition to the observed failure mechanisms discussed above, confirmed that the original lower chord tension splice was undersized. The fish plates were redesigned to include two – 2" deep notches (the original design used one – 1" deep notch) and two – 12" long shear planes (the original design used one – 12" long shear plane), resulting in a tension splice with 30 percent more capacity than the original (see Figure 45 and

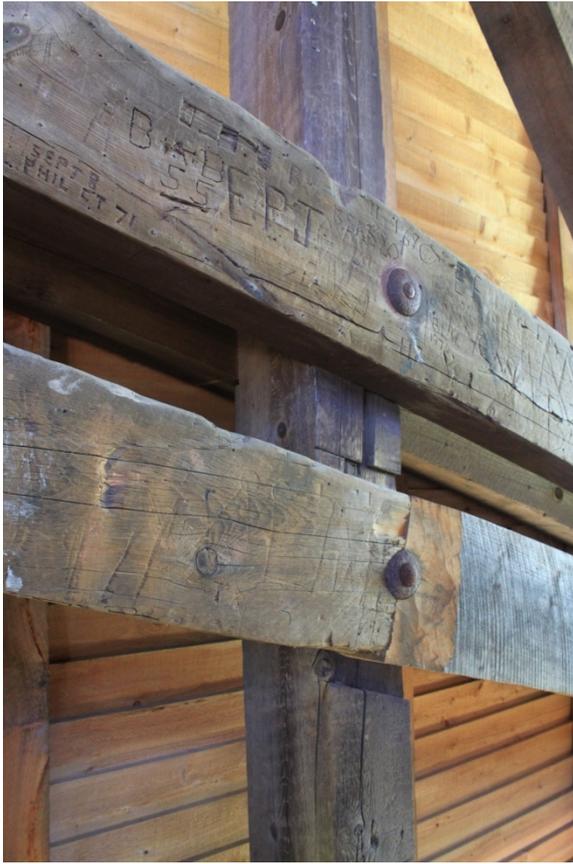
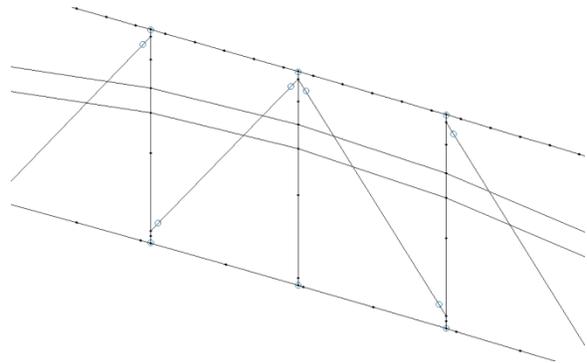
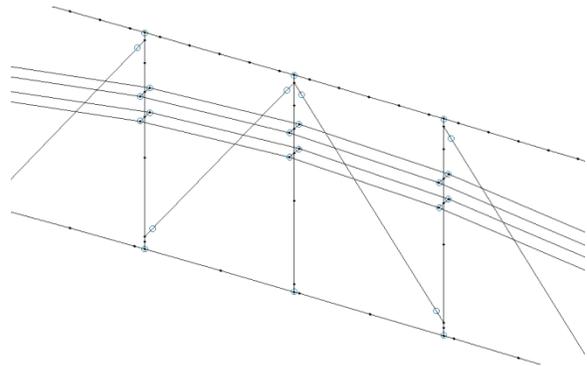
Gilpin's Falls Covered Bridge uses a typical connection between the arch and truss consisting of a $\frac{5}{8}$ "-diameter wrought-iron through-bolt passing through the inside arch, truss post and outside arch. In addition, the post is notched $\frac{1}{2}$ " on both faces to accommodate the arches (see Figure 47a). The numerical models discussed in Section 7 were two-dimensional, idealizing the truss elements (i.e. arches and truss) as being located in a single plane, when in reality the through-bolt that connects the arch and truss is perpendicular to the plane of the truss, and the arch is offset from the truss. Both the arch and truss are continuous through their connections, but in reality they can rotate about the z-axis with respect to one another. Thus, the single-plane idealization has implications on the joint rotation allowed between the arch and truss.

Figure 47: Arch-to-post connection (a) as it appears at the bridge (most of the connections looked like the one on top, but in a few locations the arch was not seated in the post notch) (b) in a plane frame model and (c) in a space frame model.
